# National Transportation Safety Board

ANC25MA018

## **AIRPLANE PERFORMANCE STUDY**

Location: Nome, Alaska  
Date: February 6, 2025  
Time: 1520 Alaska standard time (AKST)  
0020 GMT February 7, 2025  
Airplane: Cessna C-208B Grand Caravan EX, N321BA

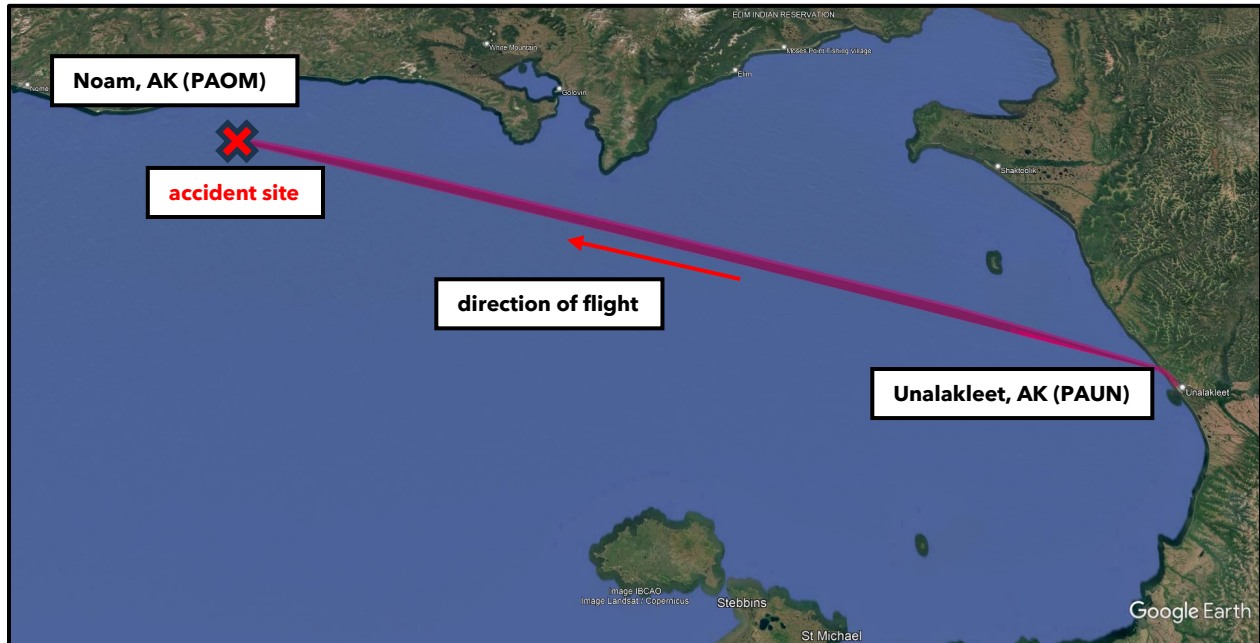
### 1.0 G1000 Ground Track for the 43 Minute Flight from Unalakleet to Nome

On February 6, 2025, about 1520 Alaska standard time (AKST), a Cessna 208B Grand Caravan EX, a single engine, turbine-powered airplane, N321BA, was destroyed when it was involved in an accident near Nome, Alaska. The pilot and nine passengers were fatally injured. The airplane was operated by Bering Air, Inc., as a Title 14 *Code of Federal Regulations* (CFR) Part 135 scheduled flight. The flight departed Unalakleet Airport (UNK), Unalakleet, Alaska, at 1437, on an instrument flight rules (IFR) flight plan. The flight was destined for Nome Airport (AOM), Nome, Alaska. The recorded ground track for the forty-three-minute flight is shown in Figure 1.

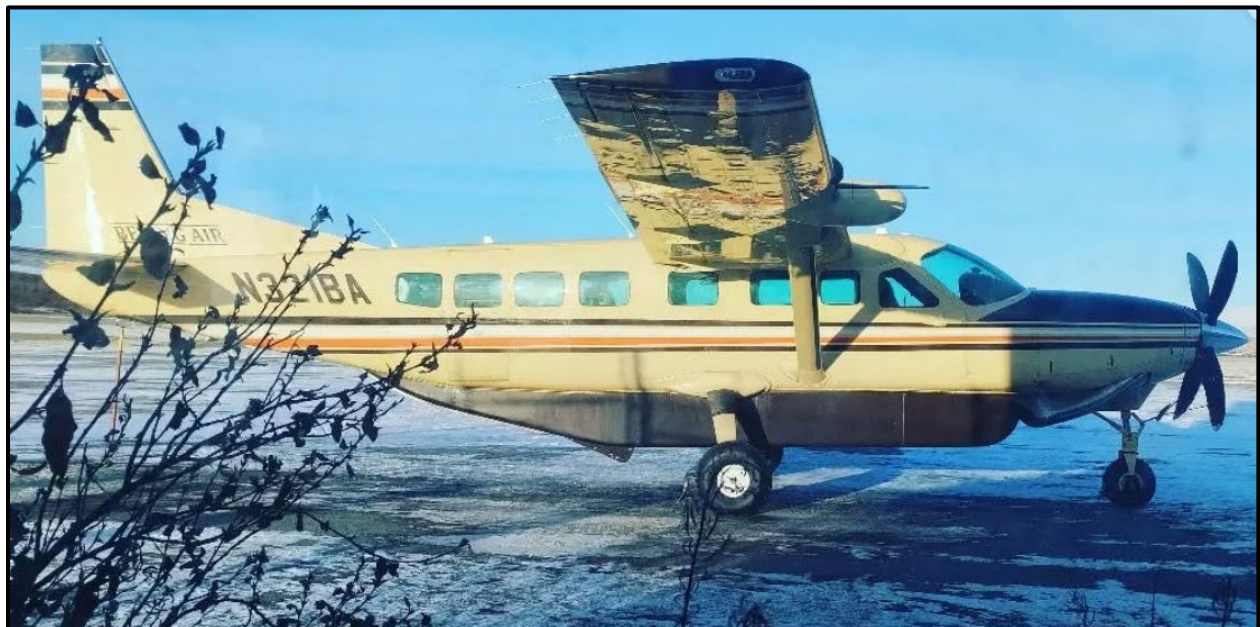
### 2.0 Accident Airplane, a Cessna 208B Grand Caravan EX, N321BA

A picture of the accident airplane, N321BA, a Textron Aviation (Cessna) C-208B Grand Caravan EX, is shown in Figure 2. The airplane was manufactured by Textron in 2020 and is registered to Bering Air, Inc. The airplane was equipped with a Pratt & Whitney PT6A-140 turbo-prop engine rated for 867 shaft horsepower (HP).

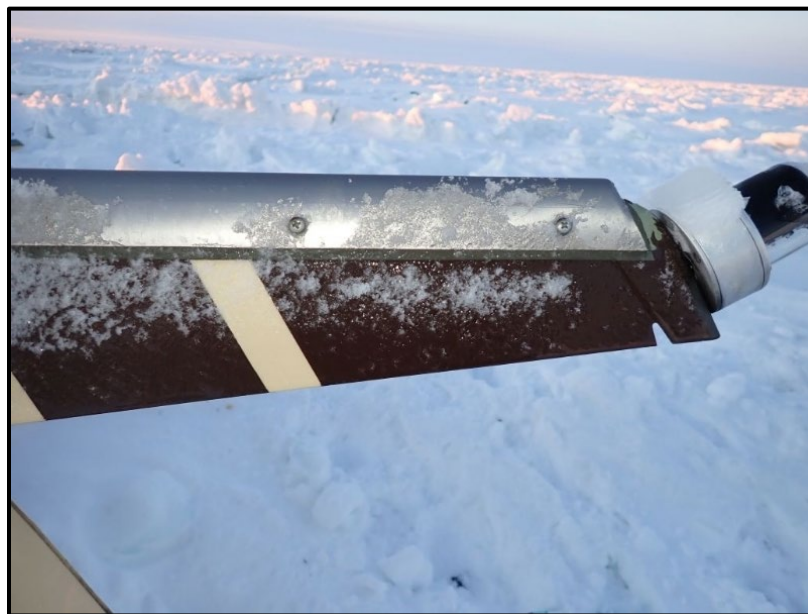
### 4.0 Ice Attached to Unprotected Portions of the Wreckage

<sup>8</sup> Based on airplane performance and autopilot data recorded on the G1000 and weather information for around the time of the accident, it is believed that the TKS system on N321BA was turned on and operating properly. However, ice was found attached to unprotected portions of the wreckage. See Figure 4. Note: the ice/snow on and behind the TKS panel likely resulted after impact.
