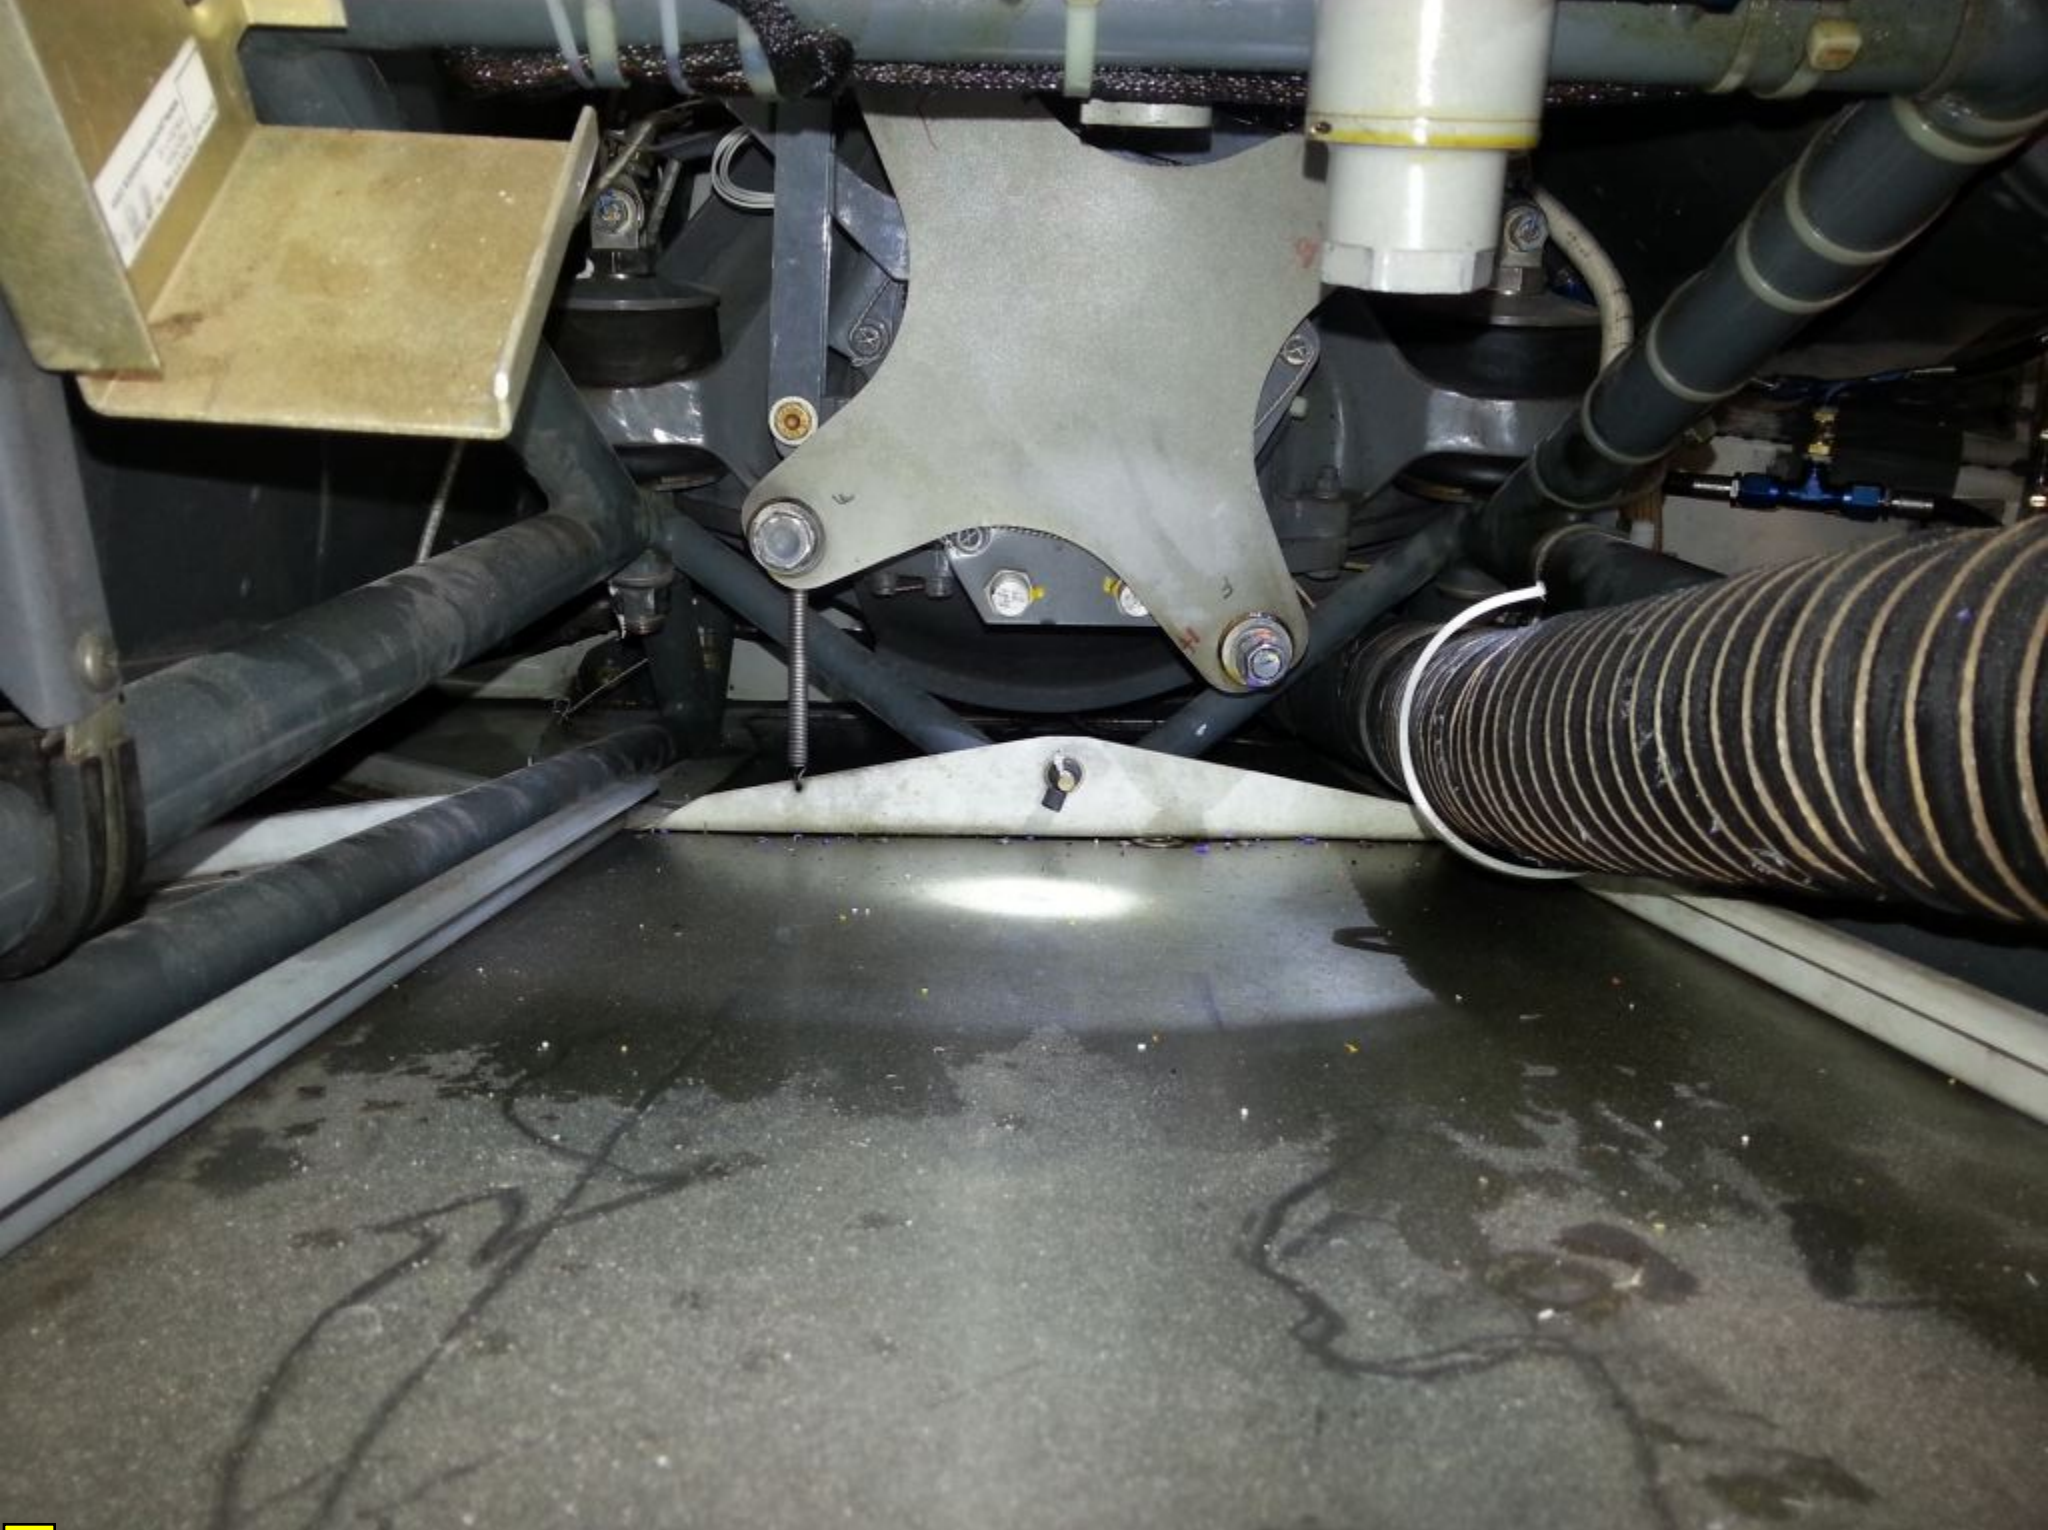
Photo 5 - The magnet was found affixed to a bolt just aft of the yoke, and a small dent was found on the horizontal firewall.
