# NATIONAL TRANSPORTATION SAFETY BOARD

## GPS Data Factual Report

Location: La Junta, Colorado  
Date: May 7, 2013  
Aircraft: Bell 206L-1  
Registration: N20Z  
Operator: Corporate Aircraft Services  
NTSB Number: CEN13LA310

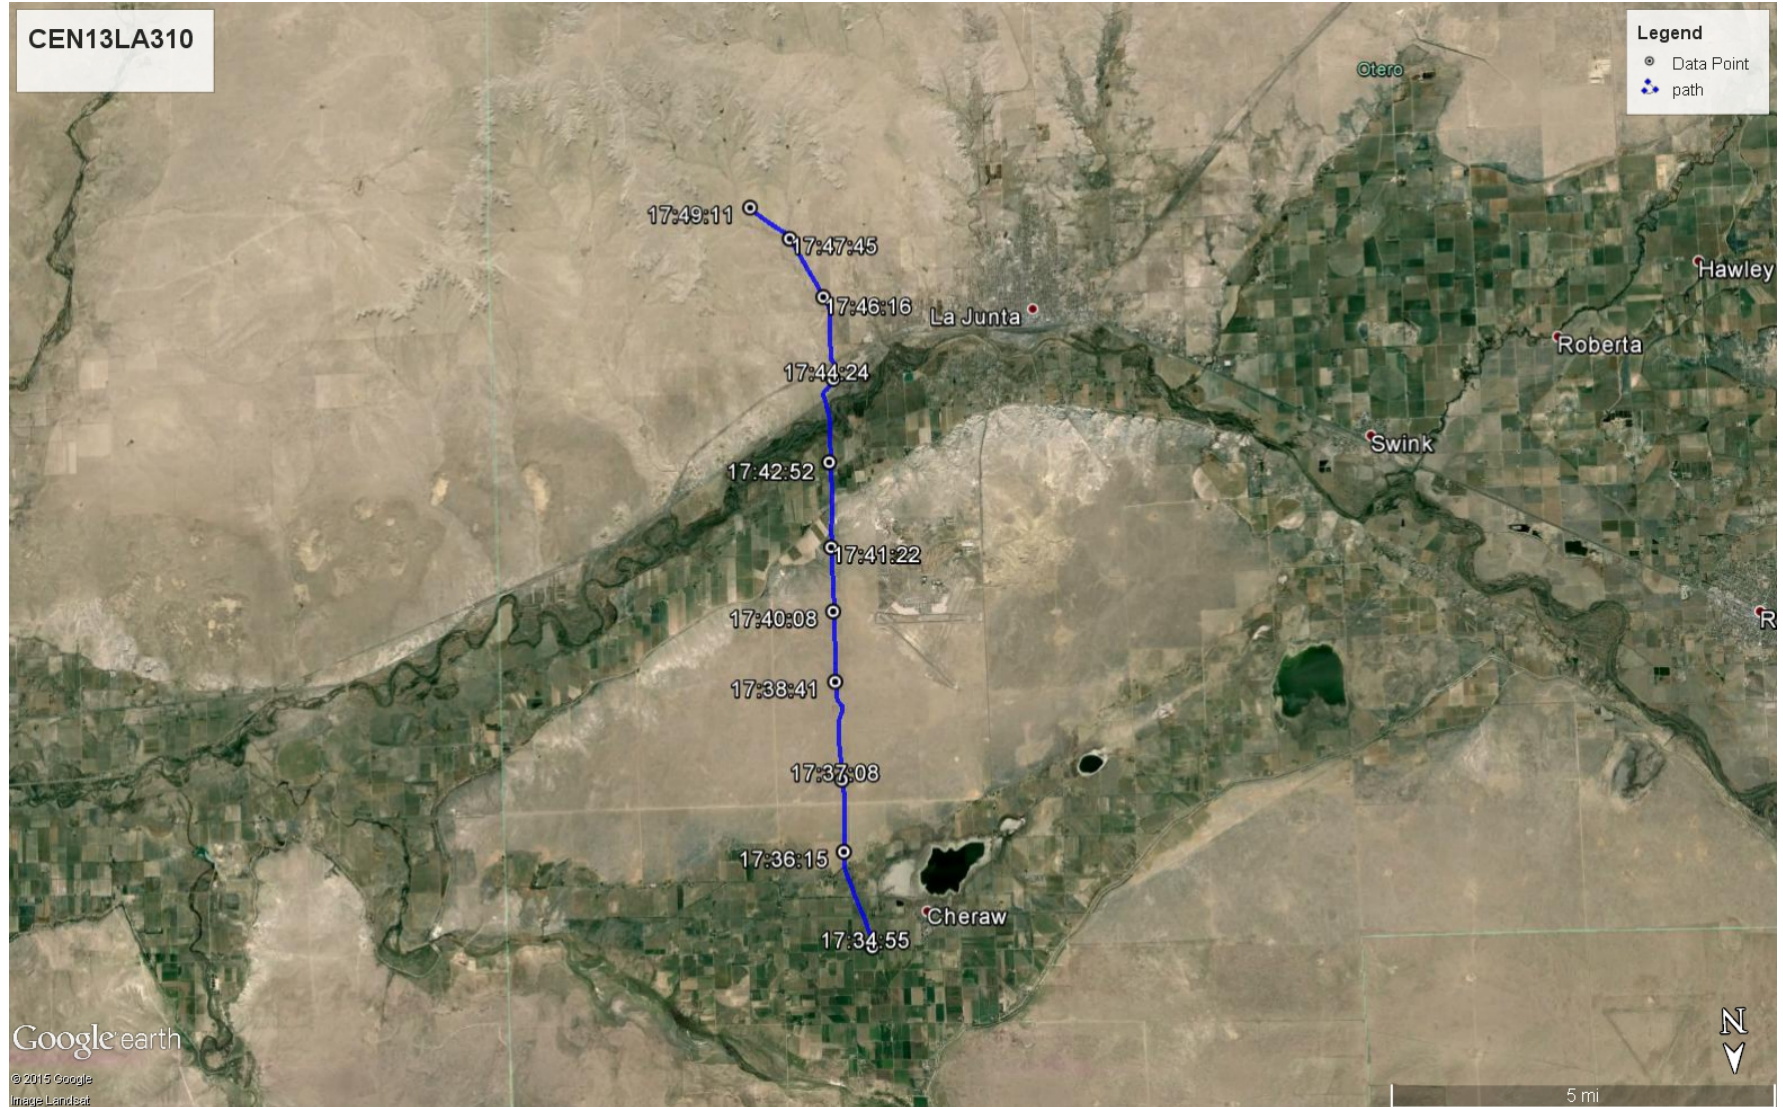
Figure 1. Overlay of extracted data containing the accident flight.

Figure 2 is an overlay of the entire extracted GPS data. The overlay begins with the aircraft tracking in a southern direction. The first and last recorded data points are shown at 17:34:55 and 17:49:11 UTC.

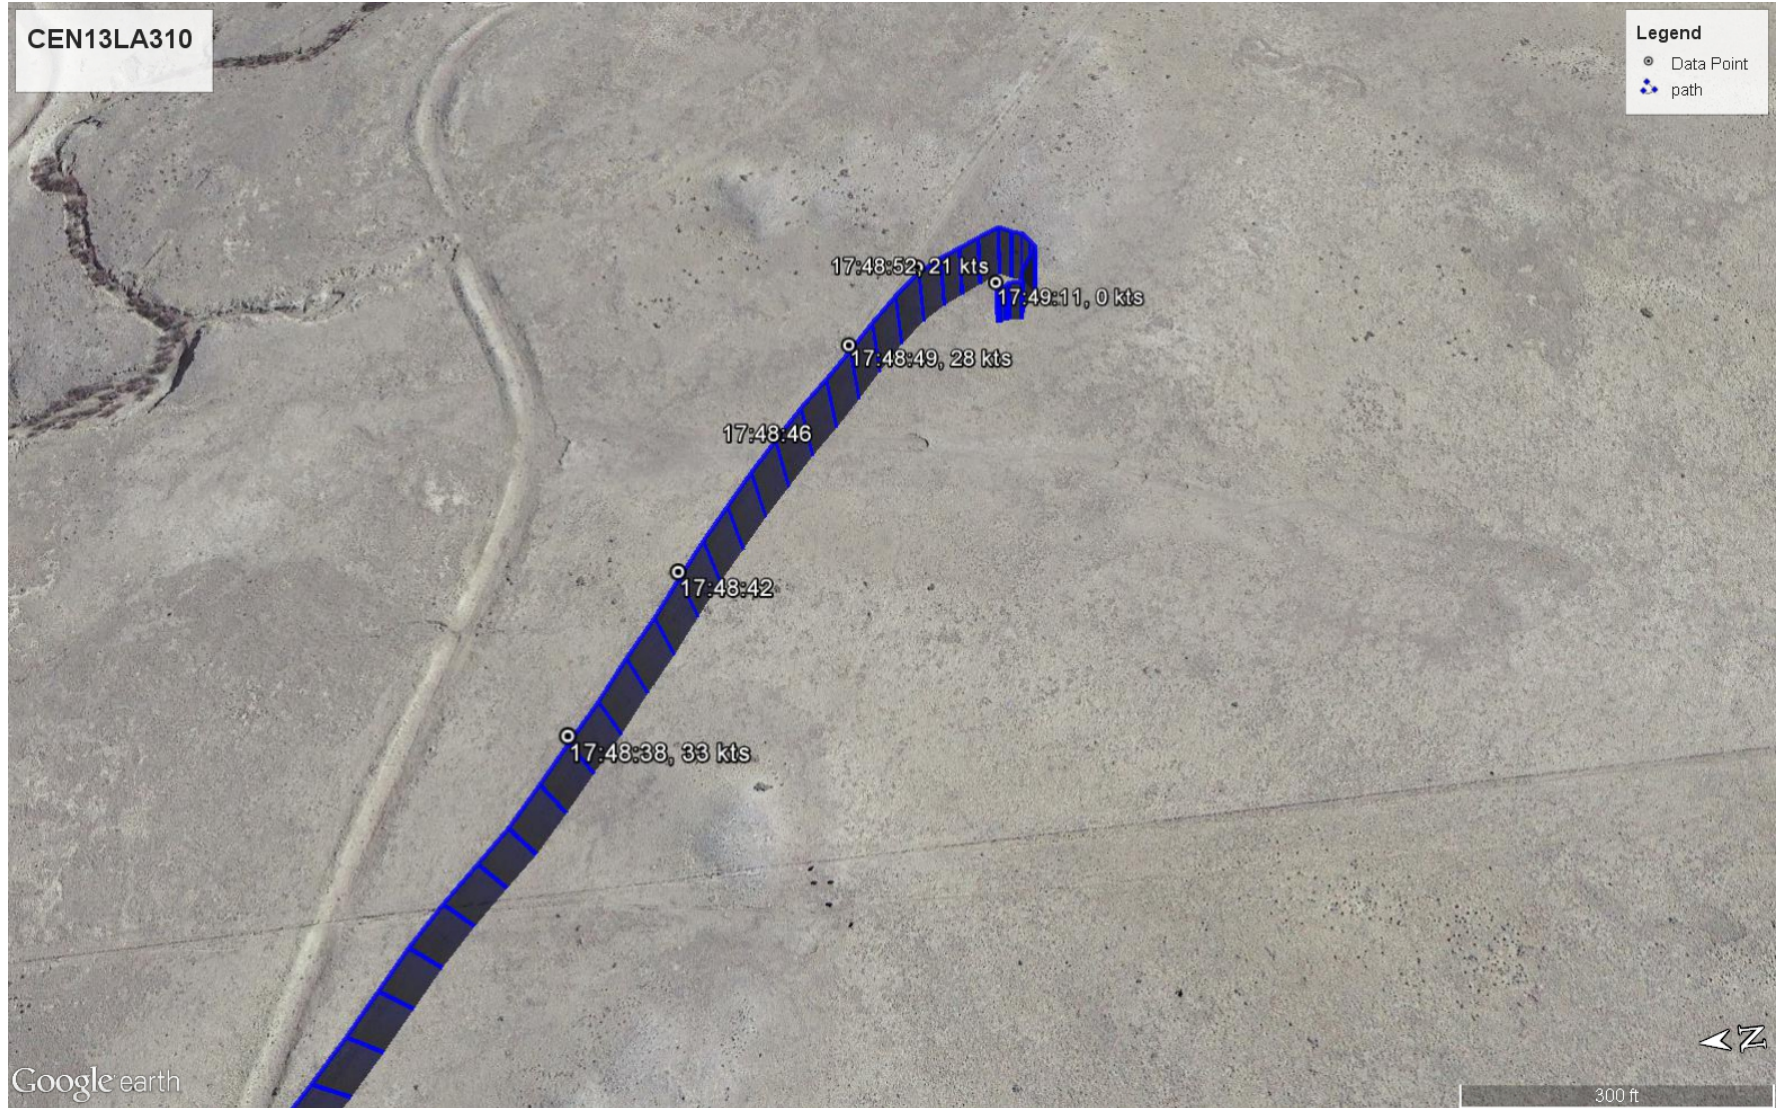
Figure 2. Aircraft track highlighting last recorded data points.

Figure 3 is a detailed overlay that highlights the time of impact. The first shown data point shows the derived track and groundspeed at about 130 degrees and 33 kts. At this point the groundspeed begins to decrease over time to about 28 kts at 17:48:49 UTC.

Concurrently, the track begins to increase to the right. The track and groundspeed continue their trends until the last recorded data point at 17:49:11 UTC, with a groundspeed and track of 0 kts and 345 degrees.
