# NATIONAL TRANSPORTATION SAFETY BOARD

## GPS Factual Report

Location: Huntingburg, Indiana  
Date: July 19, 2013  
Aircraft: Air Tractor AT-802A  
Registration: N86BM  
Operator: Private  
NTSB Number: CEN13LA424

On July 19, 2013, about 1030 Eastern daylight time, an Air Tractor AT-802A airplane, N86BM, impacted terrain after striking a pair of suspended power lines during low altitude maneuvering near the Huntingburg Airport (KHNH), Huntingburg, Indiana. The commercial pilot sustained serious injuries and the airplane sustained substantial damage. The airplane was registered to and operated by Milhon Air, Inc under the provisions of 14 Code of Federal Regulations Part 137 as an aerial application flight. Visual meteorological conditions prevailed for the flight, which operated without a flight plan. The flight originated from KHNH at an unknown time.

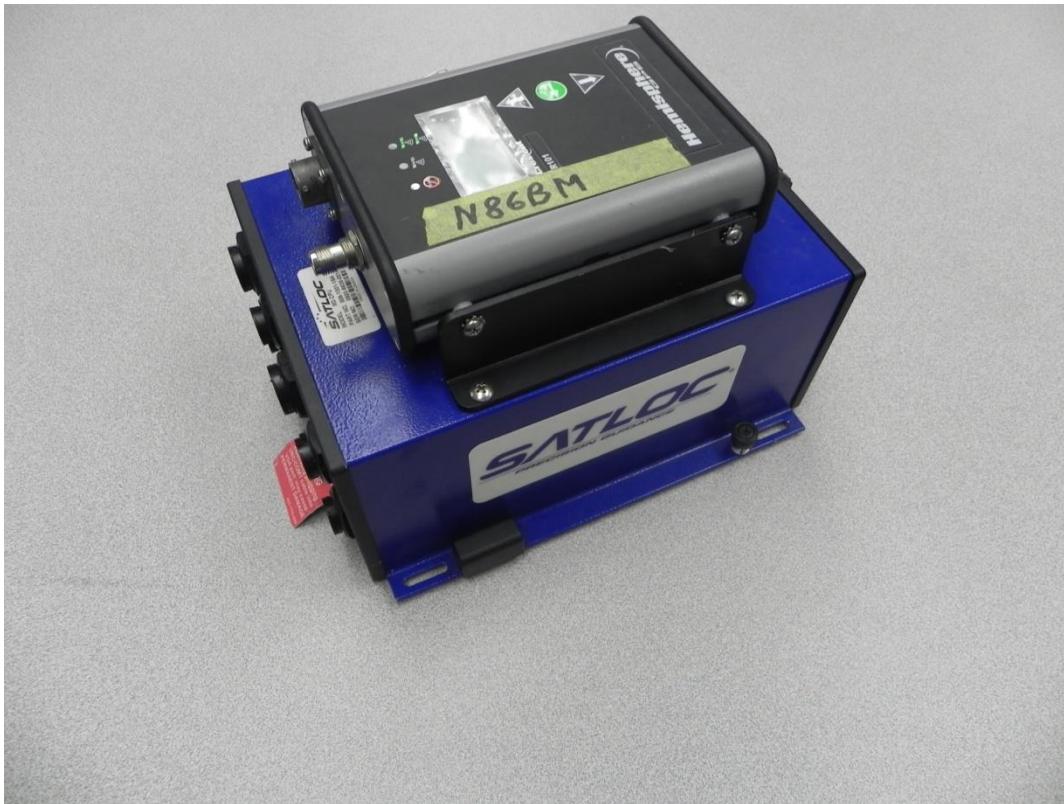
Upon arrival at the Vehicle Recorder Laboratory, an exterior examination revealed the unit sustained negligible impact damage (figure 1). An interior inspection was performed and the unit's internal hard drive was located and removed. The data was successfully obtained from the unit's hard drive.

Figure 1. Photo of the SATLOC M3 CPU

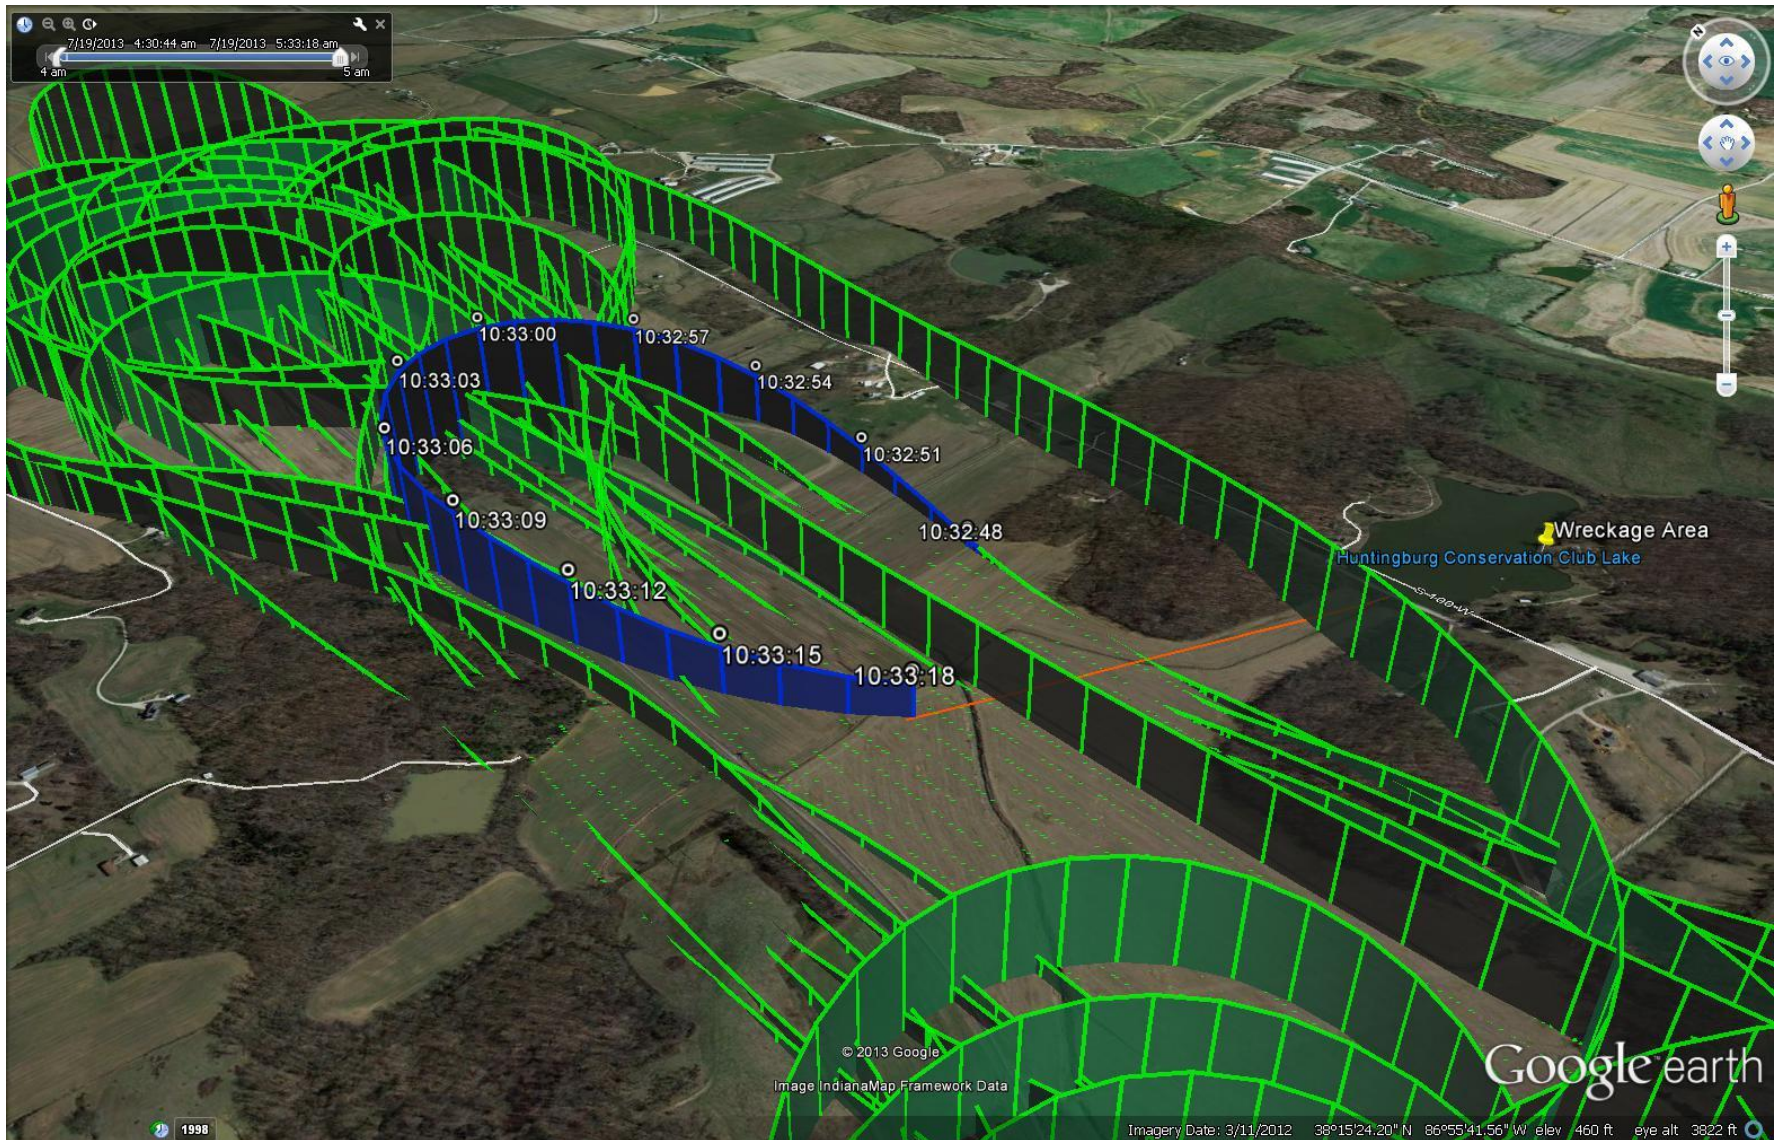
Figure 4 is an isometric view of the impact area of the blue flight path.

Figure 4. Isometric view highlighting last 30 seconds of flight.

Tabular data used to generate figures 2 through 4 are included as Attachment 1. This attachment is provided in electronic comma-delimited (\*.CSV) format.
