**NATIONAL TRANSPORTATION SAFETY BOARD**

## **GPS Data Factual Report**

Location: Silt, Colorado  
Date: January 27, 2013  
Aircraft: Bell 206L-3  
Registration: N207DS  
Operator: Delta Bravo Sierra Inc  
NTSB Number: CEN14FA122

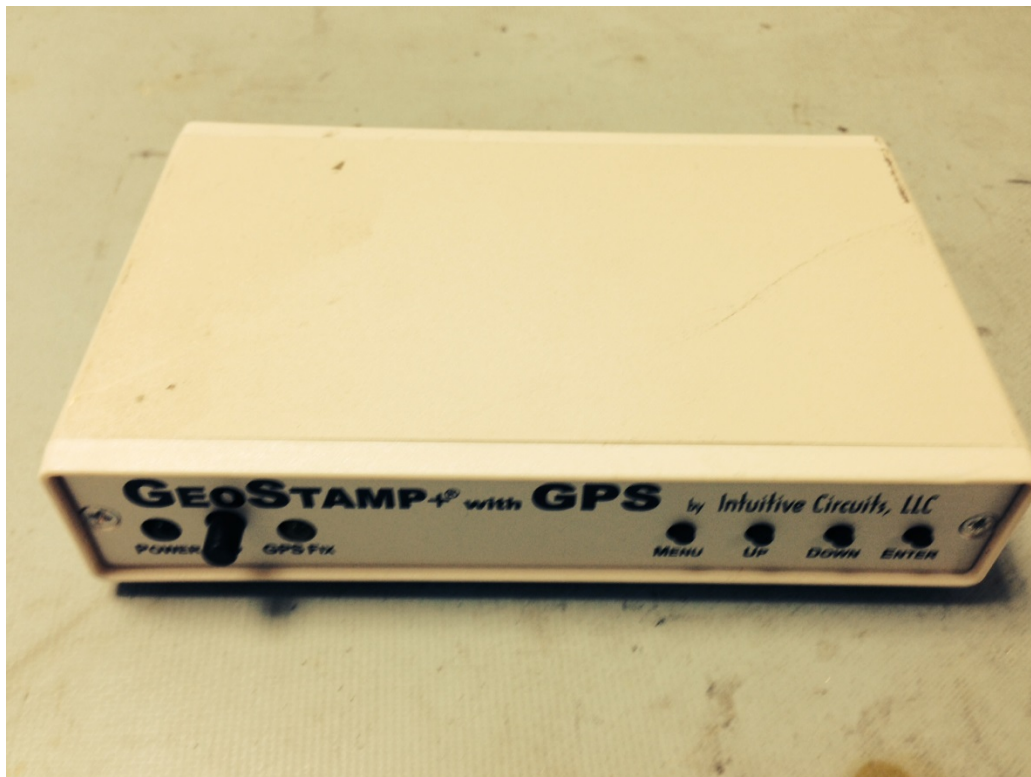
**Figure 1. Photo of GeoStamp Plus as received.**

Upon arrival at the Vehicle Recorder Laboratory, an exterior examination revealed the unit had sustained negligible impact damage. The device was determined to not record any data. An SD card was sent to the Vehicle Recorder Laboratory in addition to the GeoStamp Plus, and contained video of the accident with the GPS stamped information. The GPS information was extracted successfully from the video using OCR software.

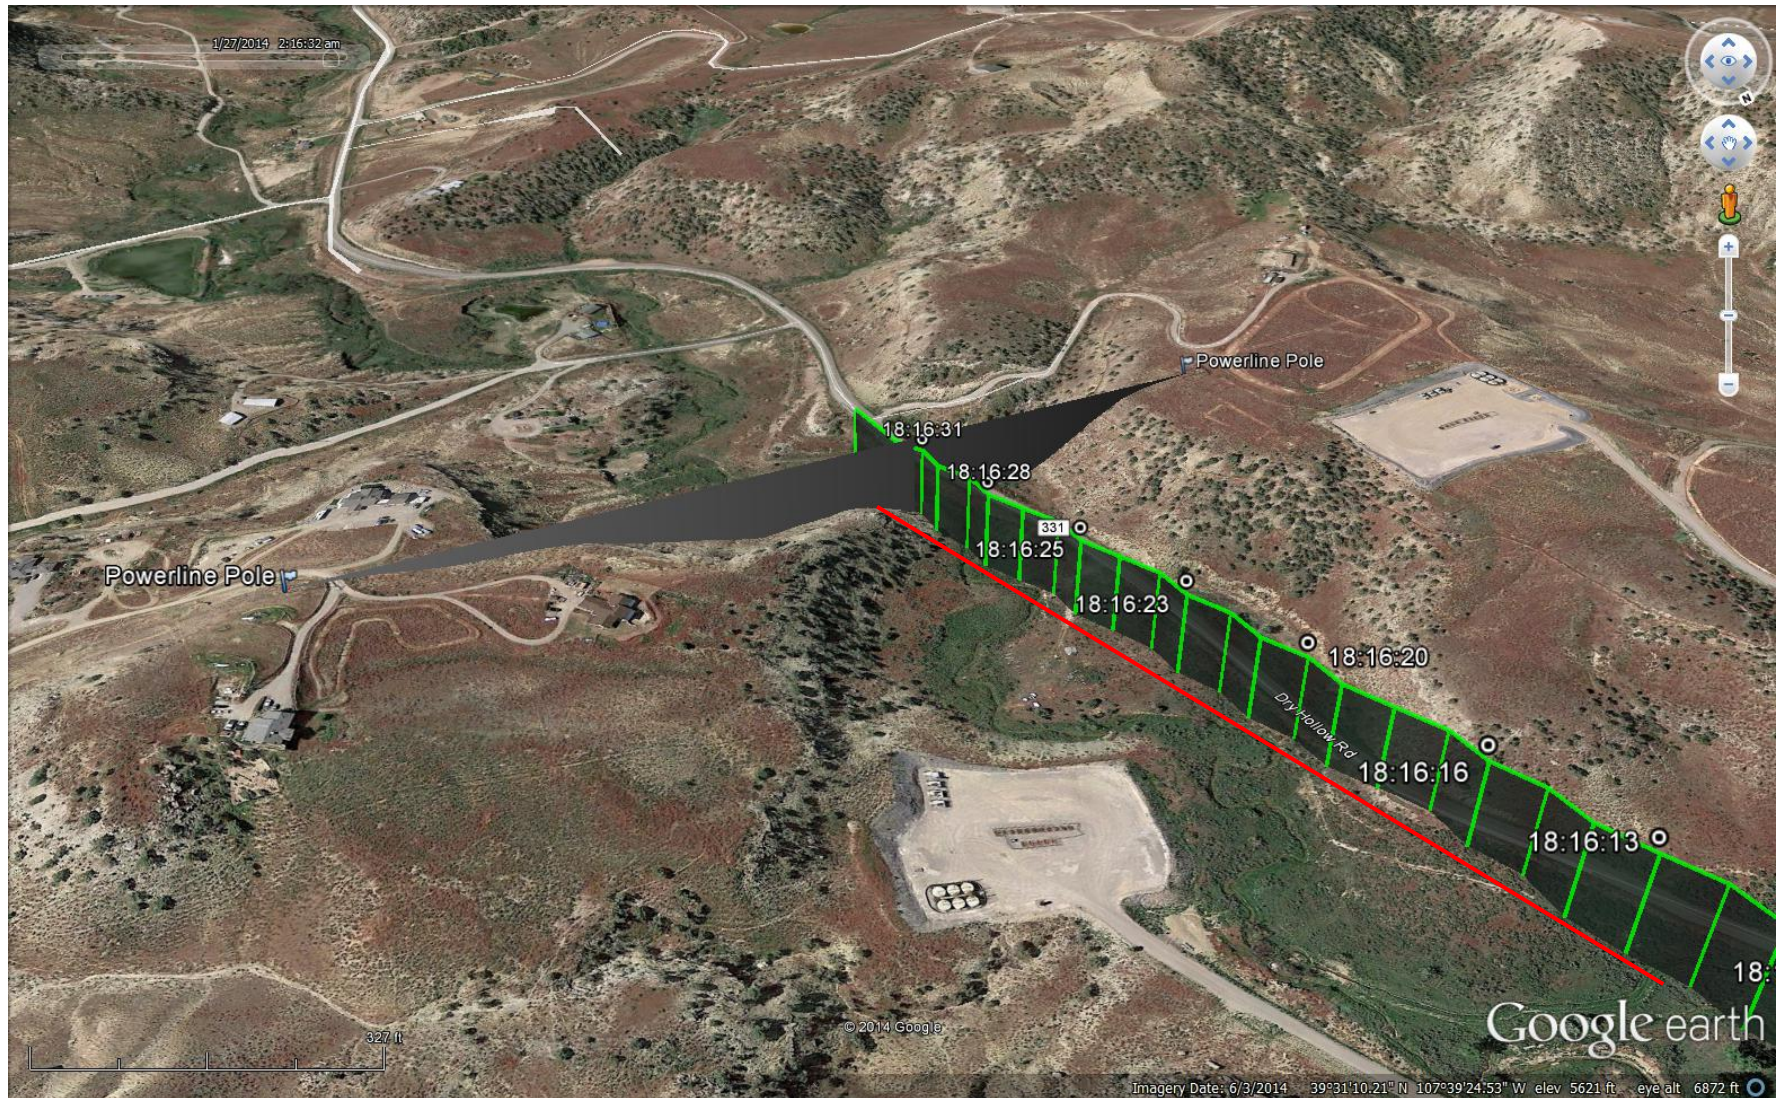
Figure 3 is an overlay that shows the points leading up to the last recorded data point. A red line is shown that highlights a portion of power lines that run parallel to the aircraft's track. A higher set of power lines are depicted in gray, which are joined by two towers. The GPS altitude of the base of the tower is 5663 ft (not shown), as determined using Google Earth. The aircraft's track intersects the higher power lines at about 18:16:31 UTC.

Figure 3. Aircraft track highlighting last recorded data points.

The following overlays were created using Google Earth. The green path represents the aircraft's track.
