# NATIONAL TRANSPORTATION SAFETY BOARD

## Electronic Devices Factual Report

Location: Ranger, Texas  
Date: August 16, 2014  
Aircraft: Lancair LC-40  
Registration: N6500Z  
Operator: Private  
NTSB Number: CEN14FA437

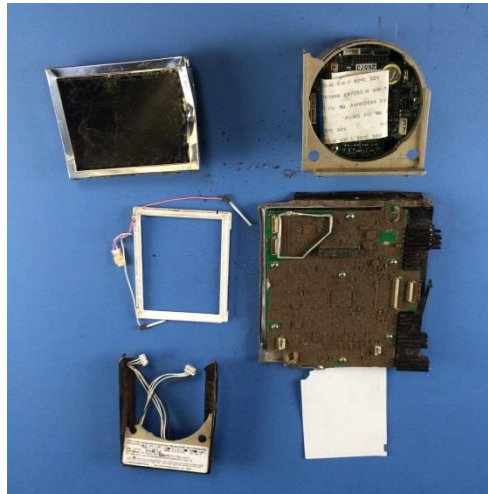
**Figure 1. The JPI EDM-700 as recovered from the wreckage site.**

The device arrived at the laboratory in a non-functional state (figure 1). The device exhibited heavy impact damage and was broken into five major pieces. The screen had detached from the device and the main board had become separated from the device’s mounting components. The main board was covered in a heavy layer of dirt. The portion of the device containing the NVM was cleaned and the critical data chip was identified as the U16 indexing chip. The U16 chip was removed from the board and was readout via PC through the appropriate binary chip fixture.

The binary data read from the chip was attempted to be converted through existing methods but did not reveal any flight data. The binary data revealed a brief engine log dated April 14, 2013 but was not a complete flight. Additionally, the binary data revealed an empty flight log file “flt00063” dated on August 17, 2014. The file, however, was 0 kilobytes in file size and did not contain any flight data. The process was repeated and the subsequent readout produced the same results.

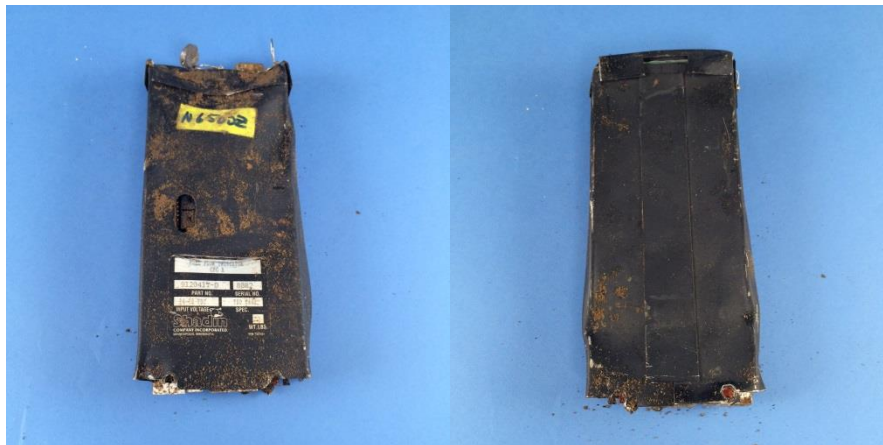
**Figure 2. The Shadin MiniFlo-L as recovered from the wreckage site.**

The Shadin Miniflo-L exhibited heavy impact damage to the device's exterior casing (figure 2). The exterior casing was removed and the internal components were evaluated for physical damage (figure 3). The device's internal components appeared damaged in the area near the display boards. Switches near the display boards were broken and the lower power board near the connector appeared damaged. The top processor board where the memory is housed, appeared mostly undamaged.

The manufacturer of the device was contacted and the possibility of conducting a binary readout of the chip was discussed. Since the only data that would be recovered was initial fuel state and fuel used until the time of power interruption (impact), in consultation with the Investigator-In-Charge, binary download of the device was not pursued.

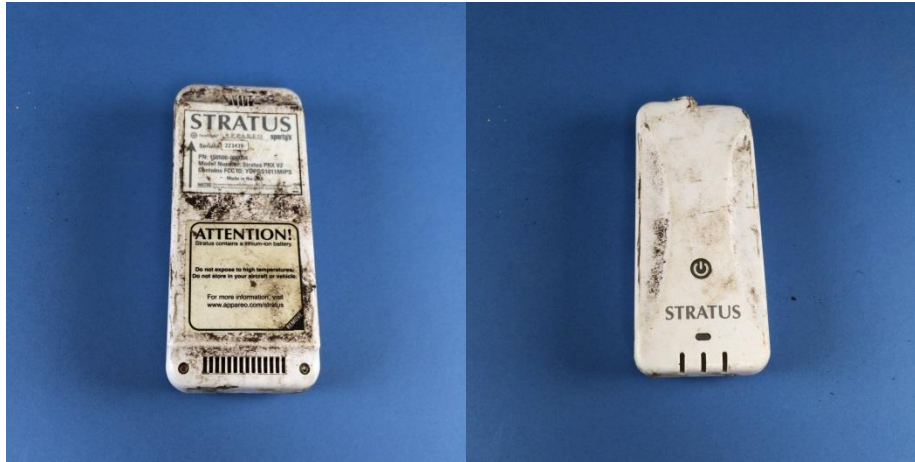
**Figure 4. The Appareo Stratus PRX V2 as recovered from the wreckage site.**

The device arrived at the laboratory in a non-functional state (figure 4). The device's outer casing exhibited a general misalignment and some punctures. The device's outer casing was removed and the internal electronics were inspected. The power pins from the battery to the device were bent and not making contact with the internal electronic board. The pins were straightened and the device was secured back together to ensure the power pins would make contact with the electronic board. The device was then able to power on.

The manufacturer indicated that this unit would not have contained a firmware update that would have allowed recording of data to non-volatile memory. The crash occurred in August and the manufacturer did not offer the software update until late November of 2014. It was determined that the device contained no flight data.

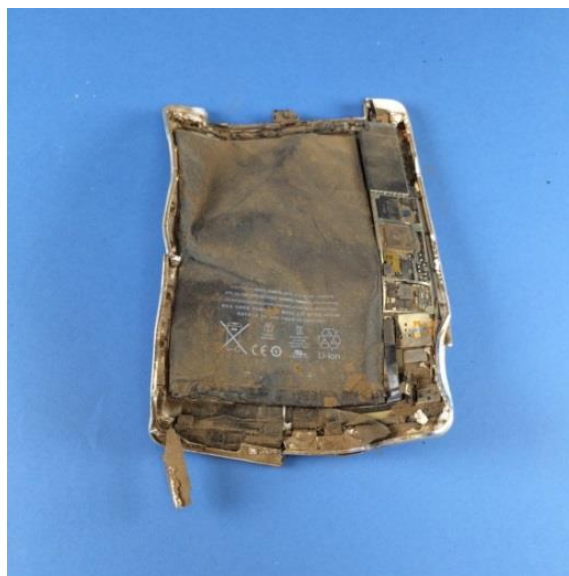
**Figure 5. The Apple iPad Mini as recovered from the wreckage site.**

The device was found to be in an extremely damaged state (figure 5). The screen was shattered and portions of the device were missing. The device's chassis was heavily bent throughout and many of the internal components were damaged or displaced. The device was covered in dirt and debris. The internal memory portion of the device was extracted and examined (figure 6). The main functional memory board was found to be cracked in a portion of the board (figure 7). Additionally, the board was bent and chips exhibited the possibility that they were electrically detached from the board. Figure 6 shows the memory board removed from the unit on the laboratory work station. Figure 7 shows the extent of the damage to this portion of the memory board. It was determined that the device was damaged beyond repair and further recovery attempts were not made.

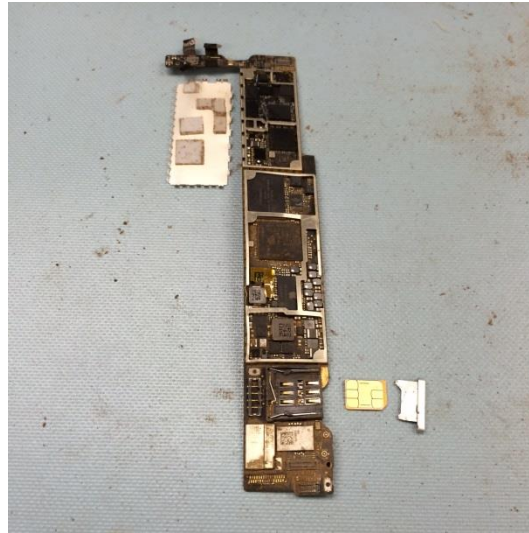
**Figure 6. The iPad mini's memory board removed from the device.**

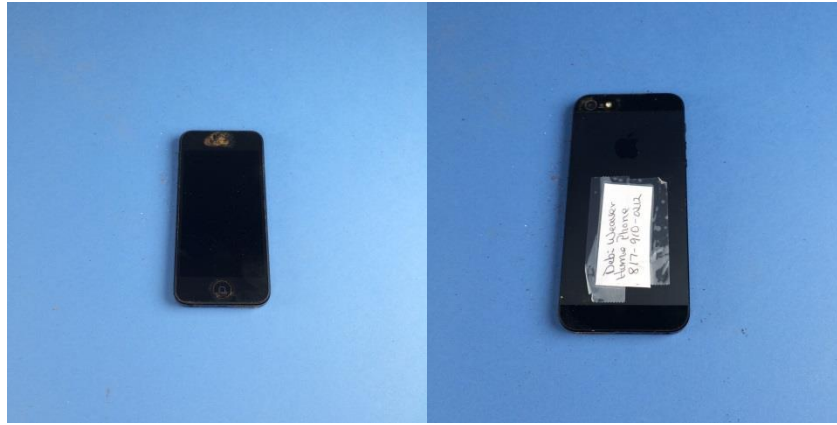
**Figure 8. The Apple iPhone 5 as recovered from the wreckage site.**

The Apple iPhone 5 was determined to belong to a passenger who was seated in the rear right seat of the aircraft during the accident flight. The iPhone was housed in a plastic case which protected the device from the impact forces of the crash. When the device was removed from its case, it was found in a mostly undamaged state (figure 8). The device was charged and was found to function normally. Upon powerup the device was found to be password protected. The password was obtained from a relative of the passenger and was used to unlock the device.

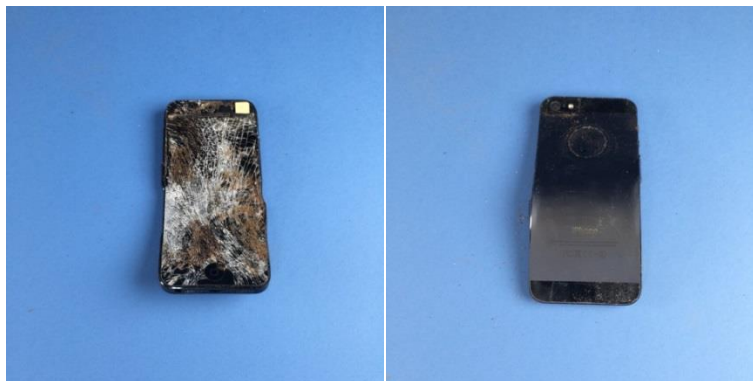
**Figure 9. The Apple iPhone 5 as recovered from the wreckage site.**

An additional Apple iPhone 5 was determined to belong to the pilot of the accident aircraft who was seated in the front left seat of the aircraft during the accident flight. The phone arrived heavily damaged (figure 9). The screen was cracked and was non-functional. The device was also slightly bent. The device was opened in the laboratory and the unit's internal memory was extracted and placed in a surrogate device.

The device was not able to boot successfully. No data was recovered from the device.

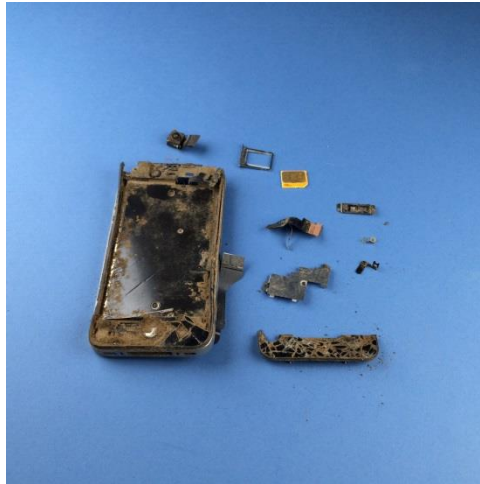
**Figure 10. The Apple iPhone 4S as recovered from the wreckage site.**

The Apple iPhone 4S was determined to belong to a passenger who was seated in the front right seat of the aircraft during the accident flight. The screen exhibited complete shattering and was non-functional (figure 10). The device was also bent. The device was opened in the laboratory and the unit's internal memory was extracted and placed in a surrogate device.

The surrogate device was powered successfully and the device was found to be password protected. The password was obtained from a relative of the passenger and was used to unlock the device.
