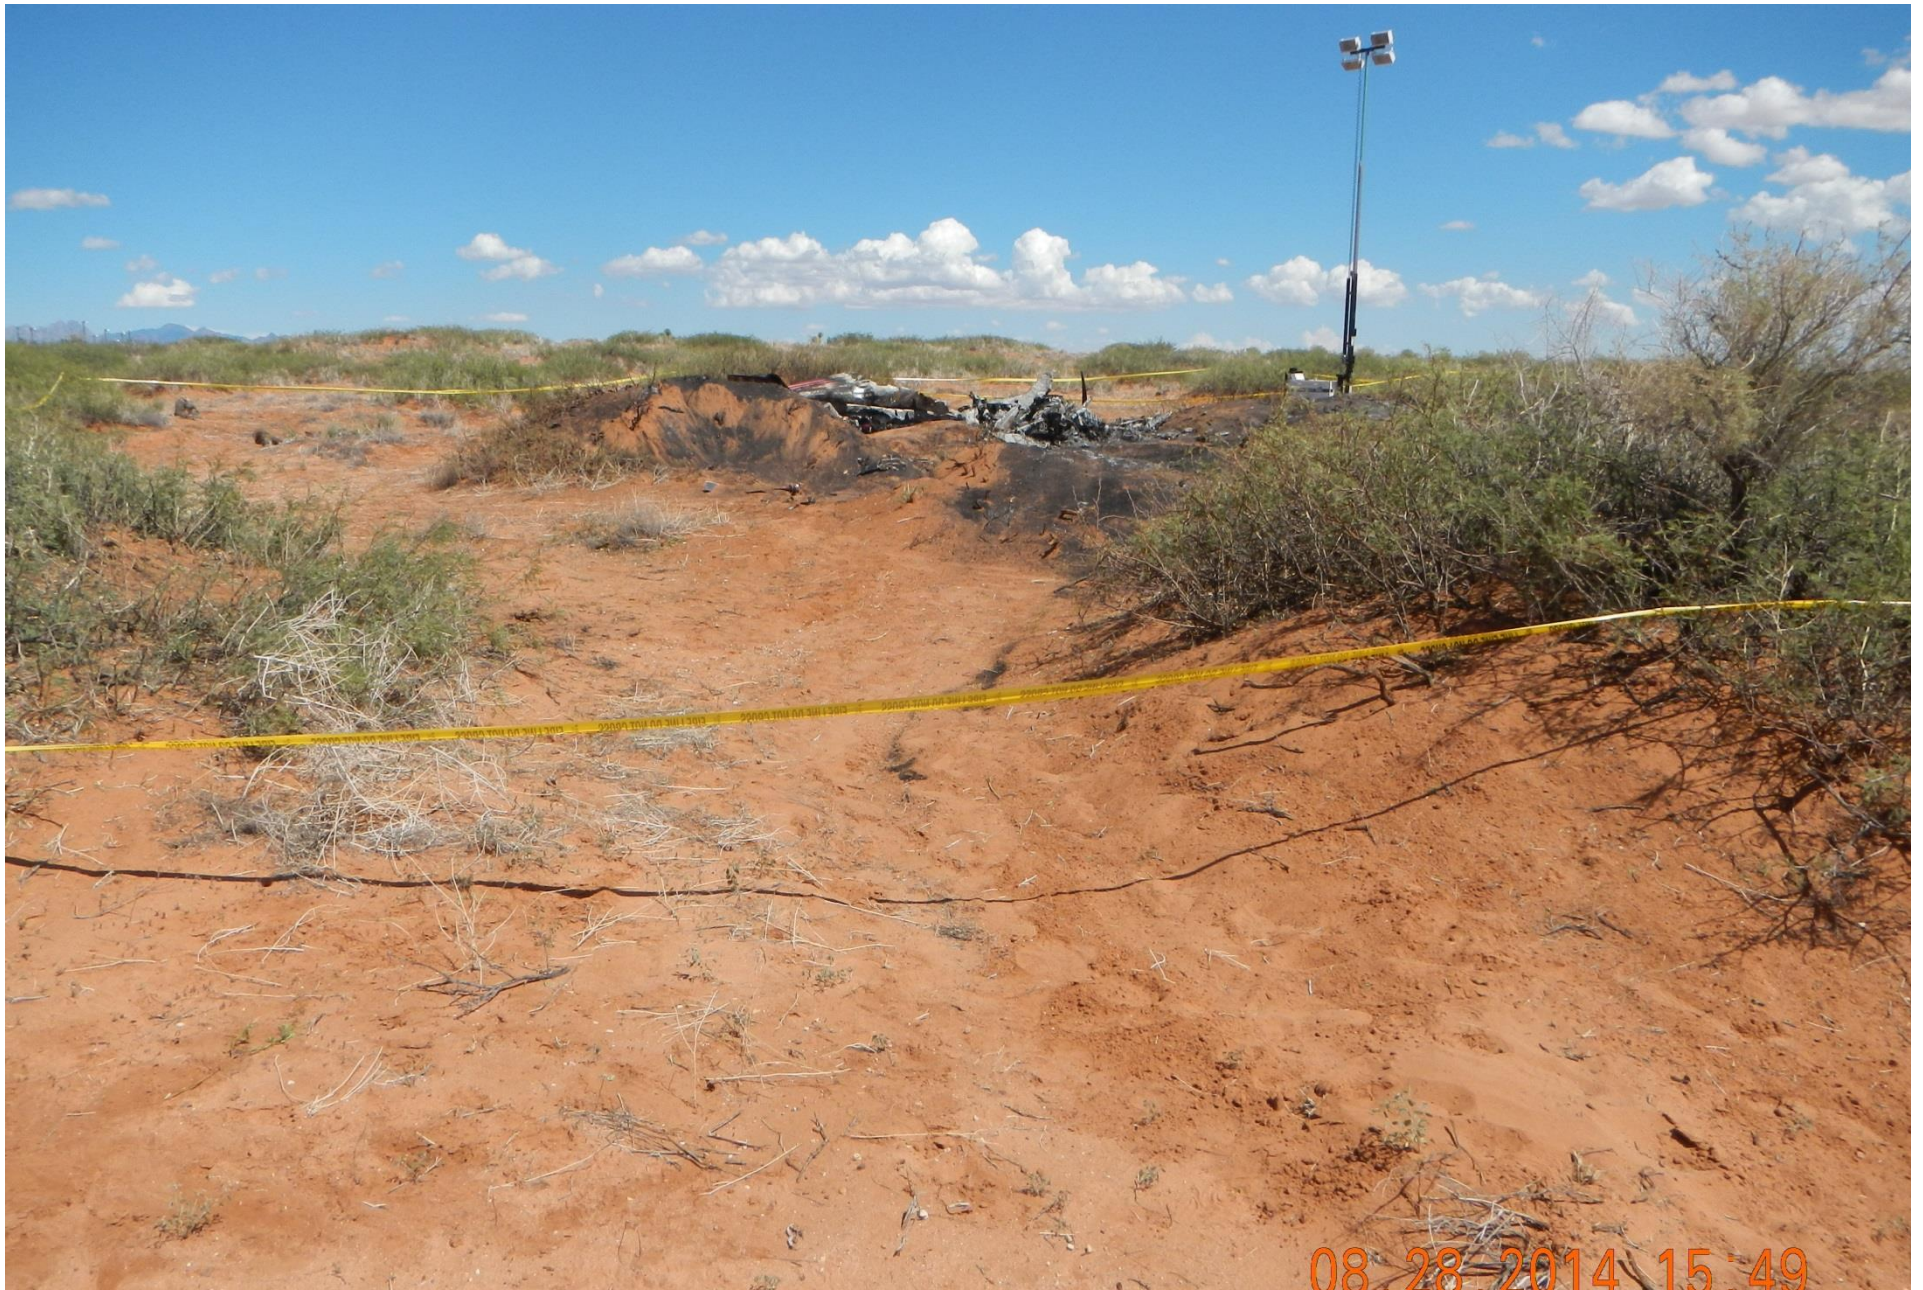
**Photo 2 – Initial impact point, viewer looking east at main wreckage (Continental Motors Photo)**

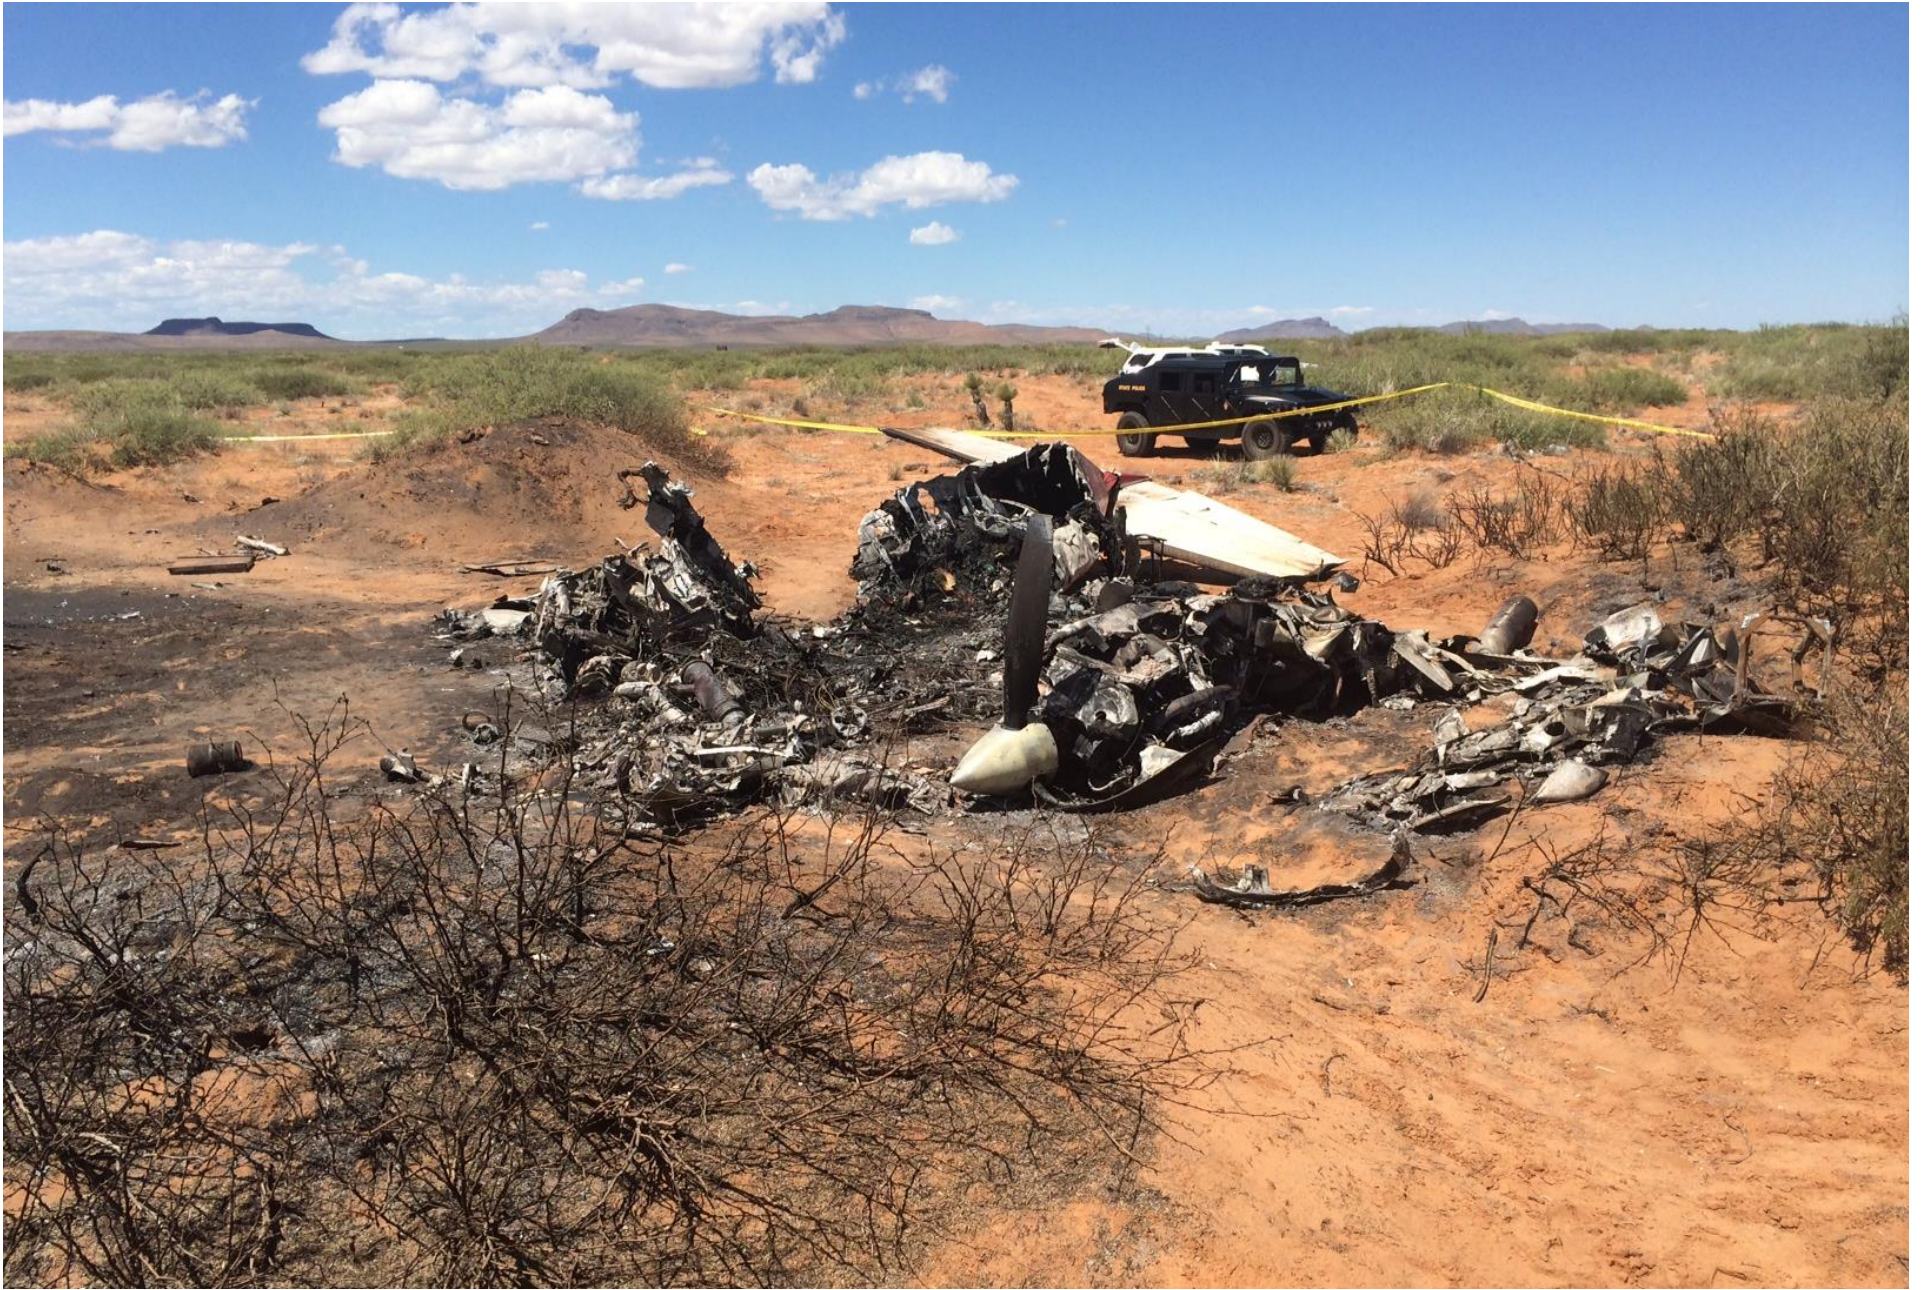
**Photo 3 – Main wreckage, viewer looking to the northwest (NTSB Photo)**

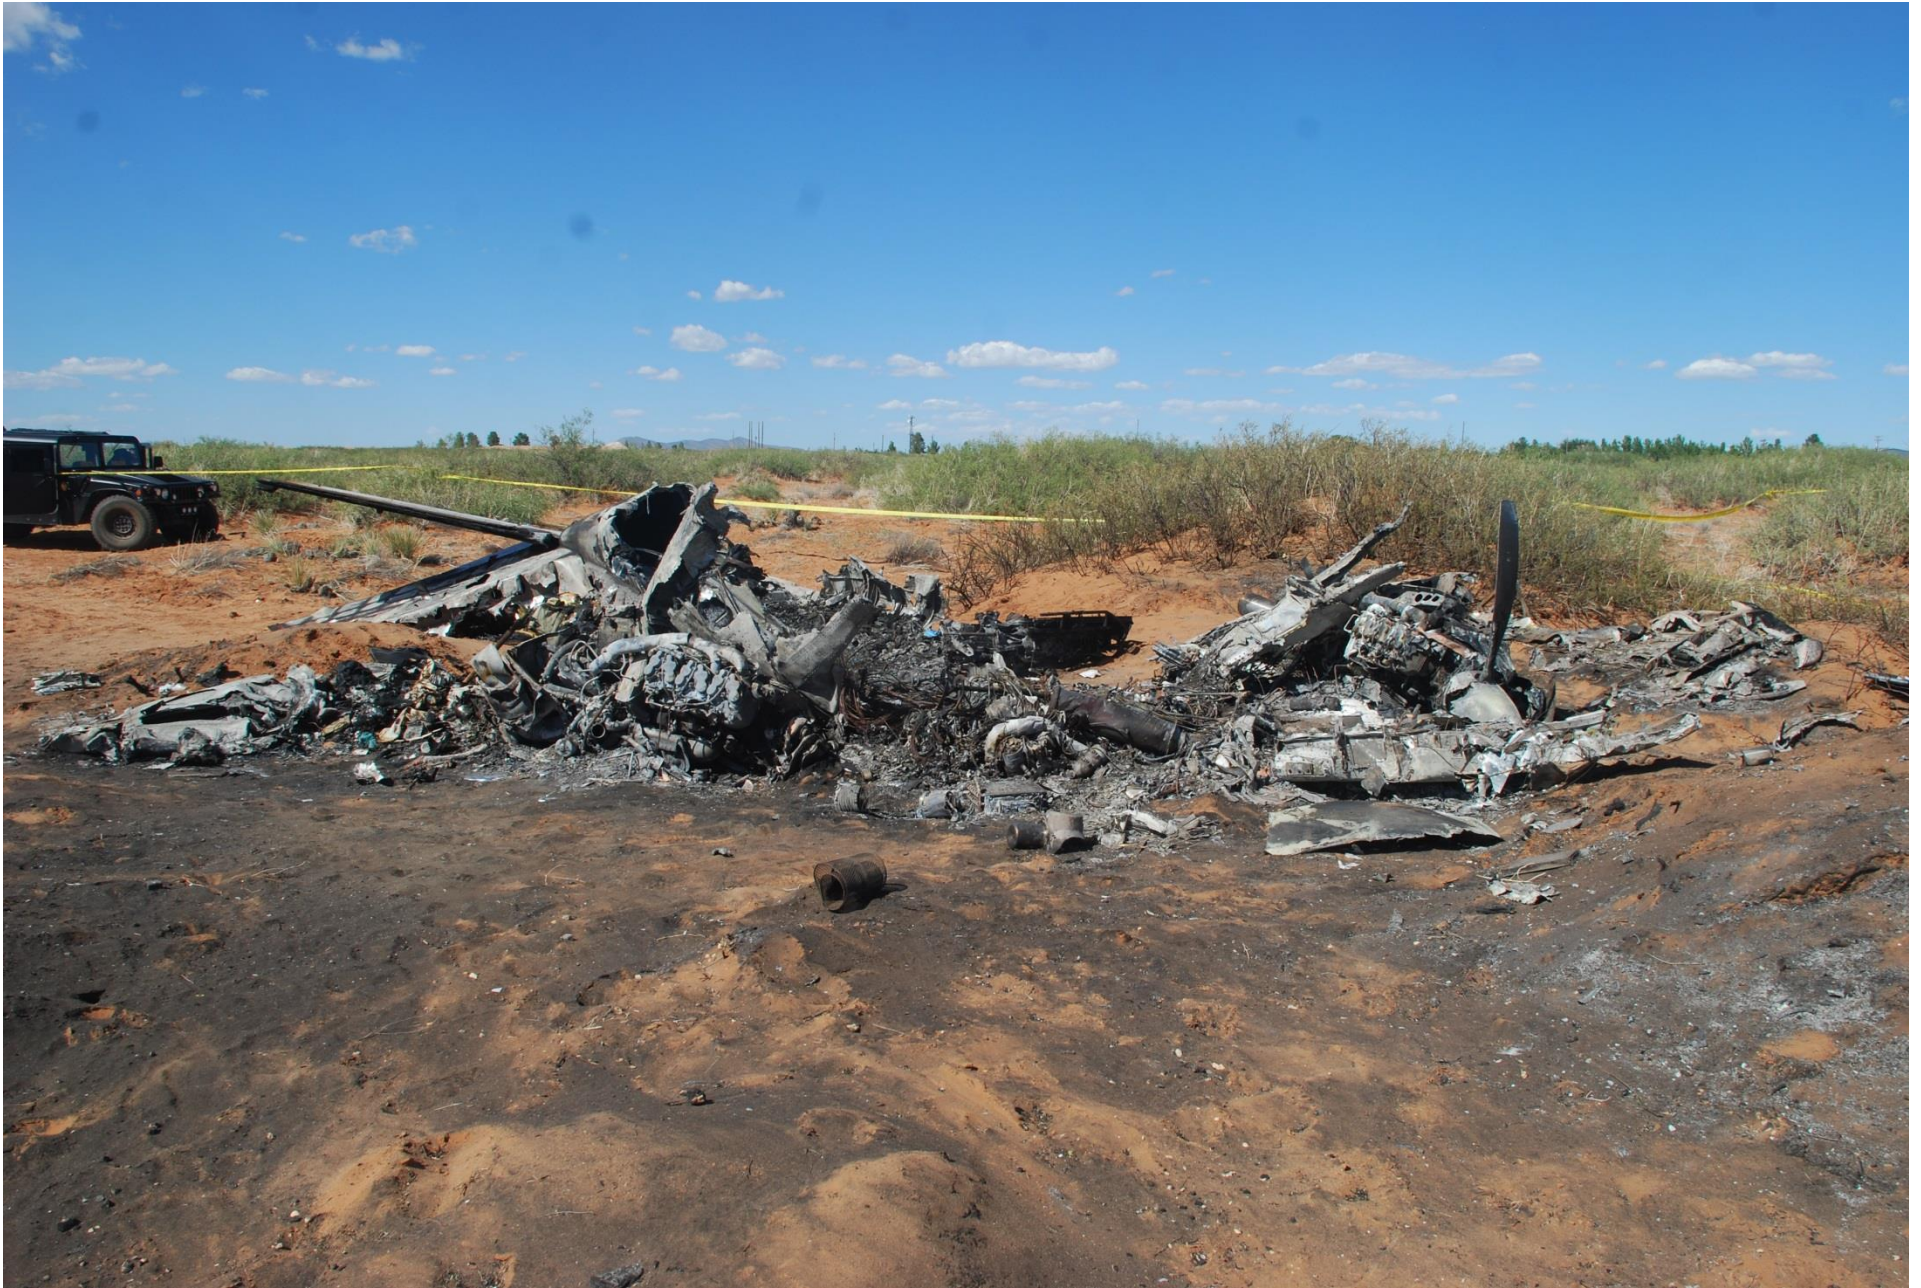
**Photo 4 – Main wreckage, viewer looking to the northeast (Textron Photo)**

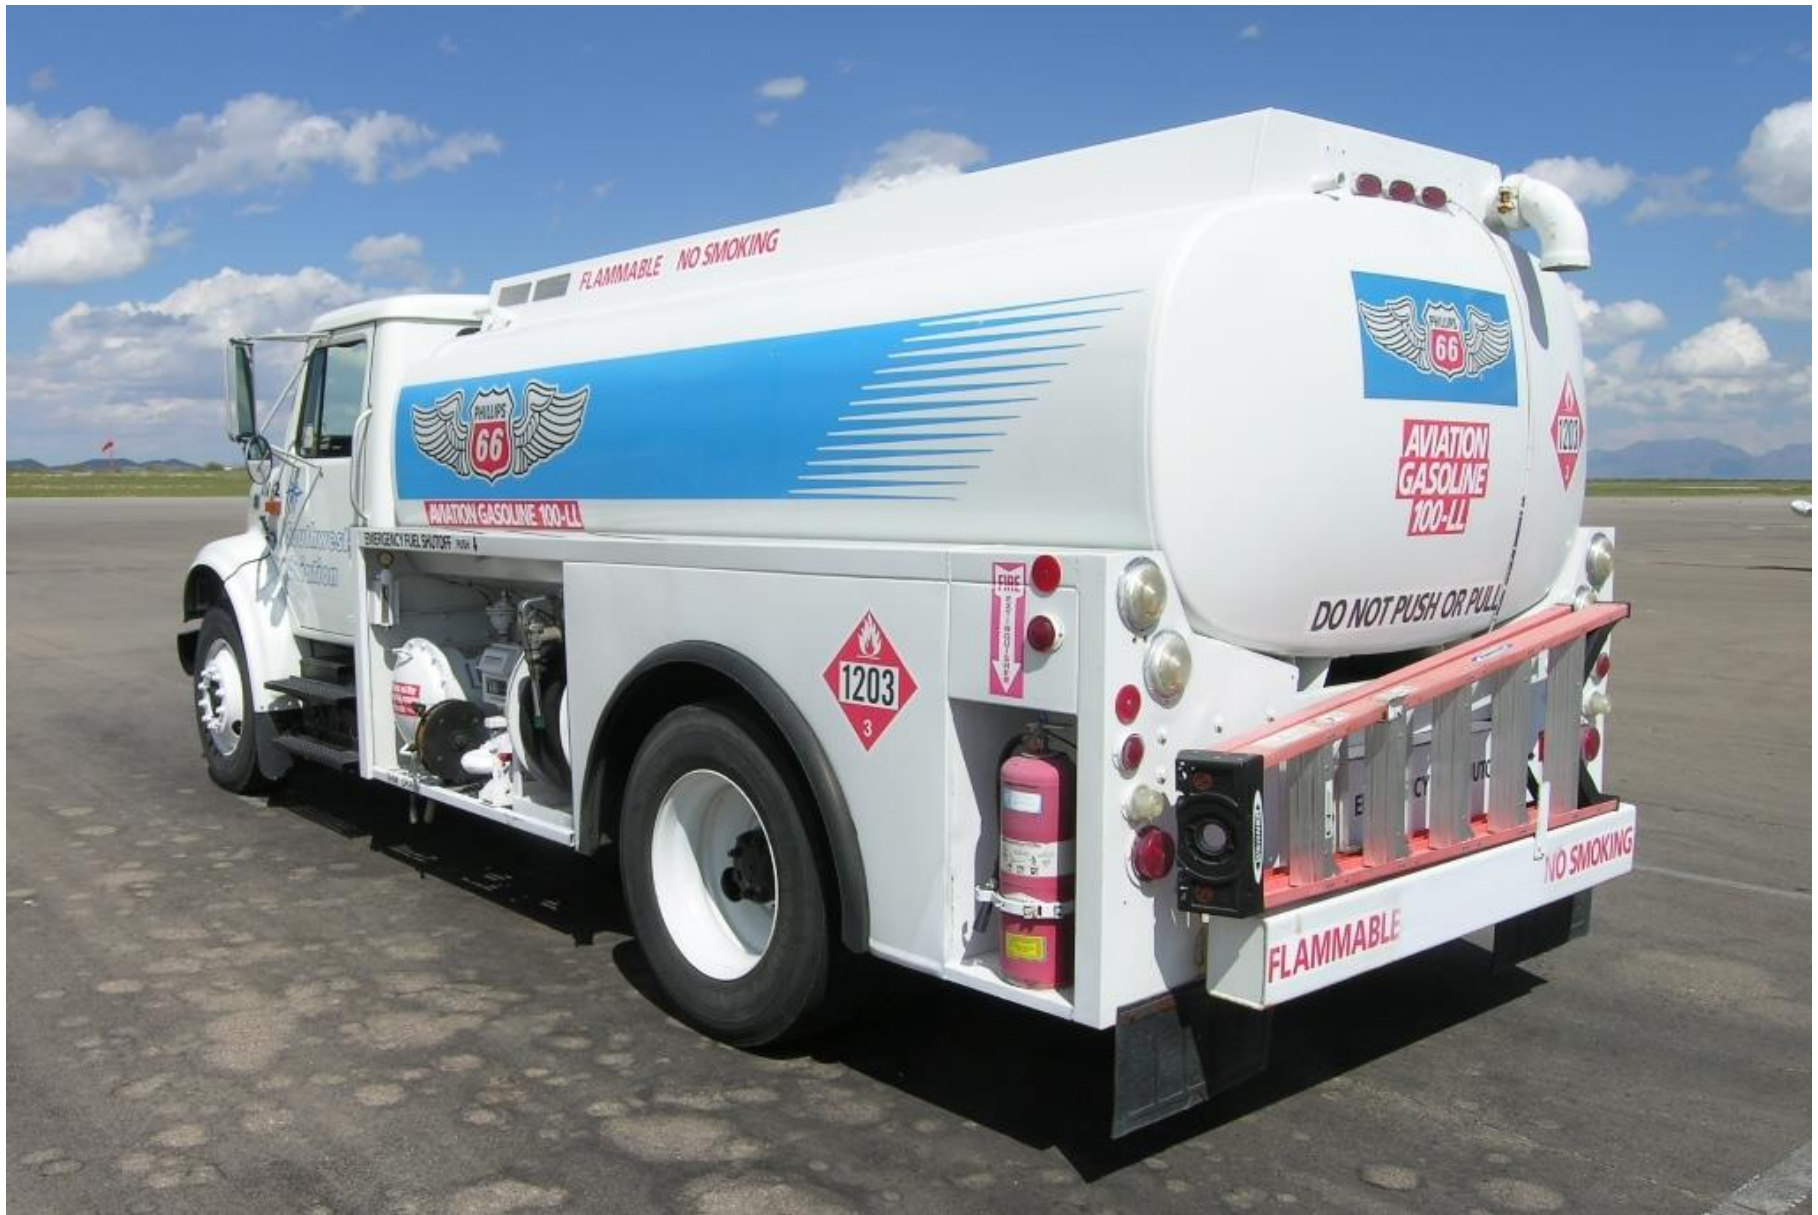
**Photo 5 – LRU airport – fuel truck AV-1 (NTSB Photo)**

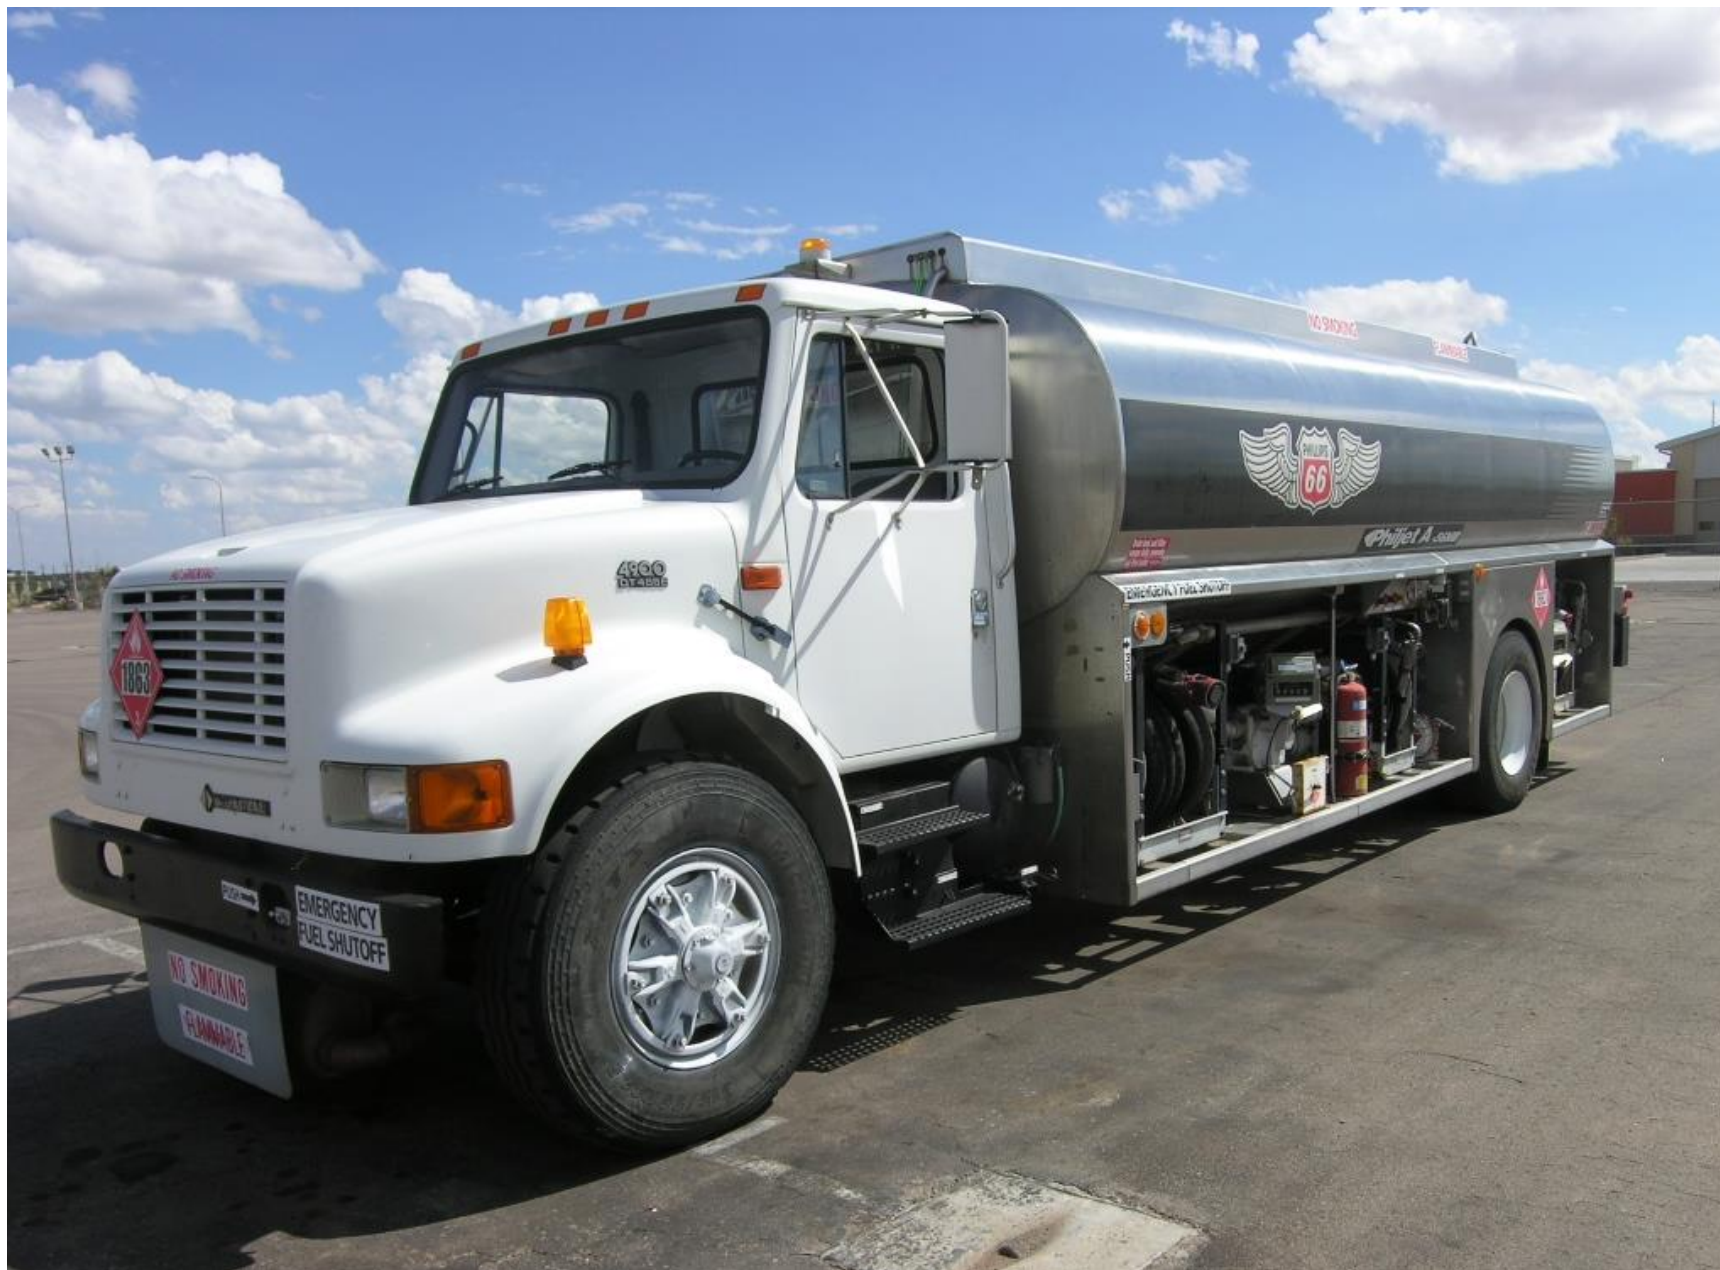
**Photo 6 - LRU airport – fuel truck Jet-2 (NTSB Photo)**

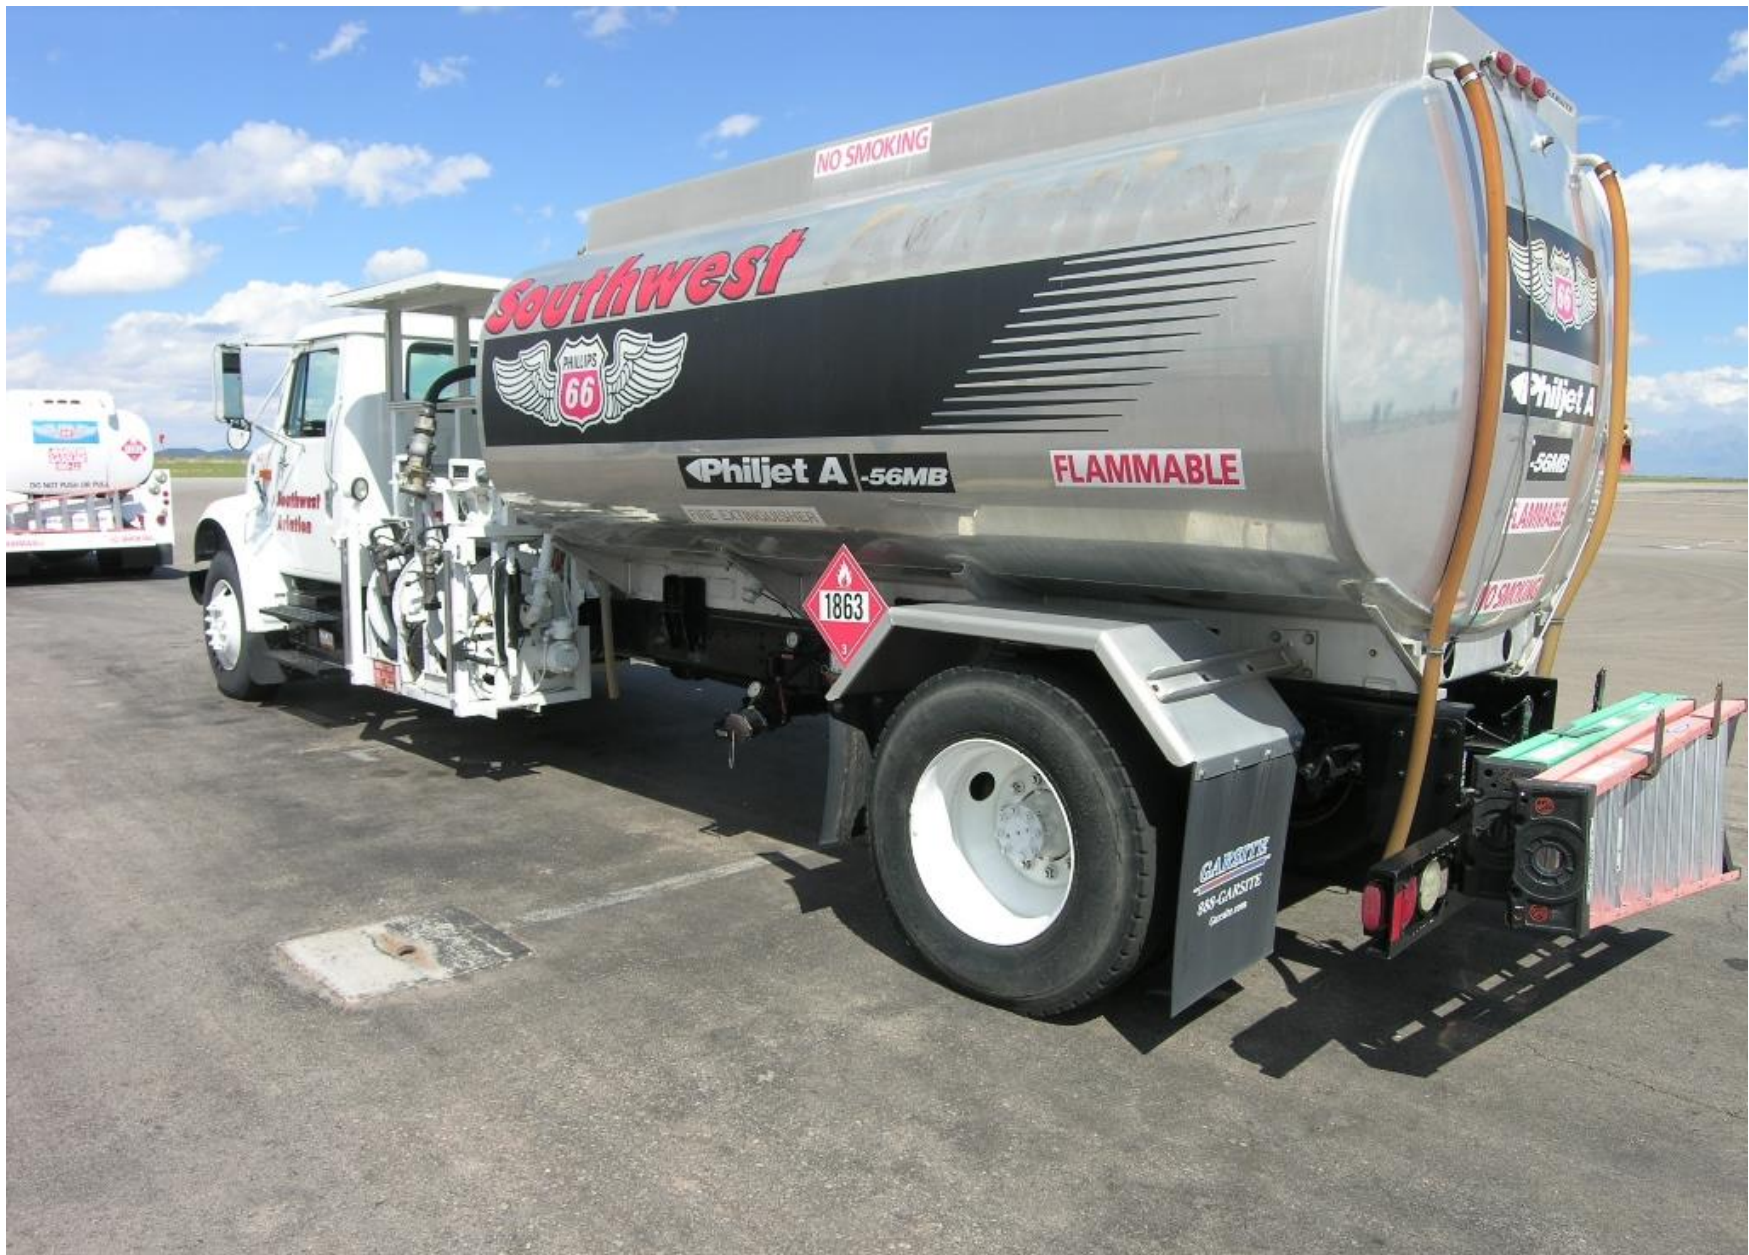
**Photo 7 - LRU airport – fuel truck Jet-3 (NTSB Photo)**

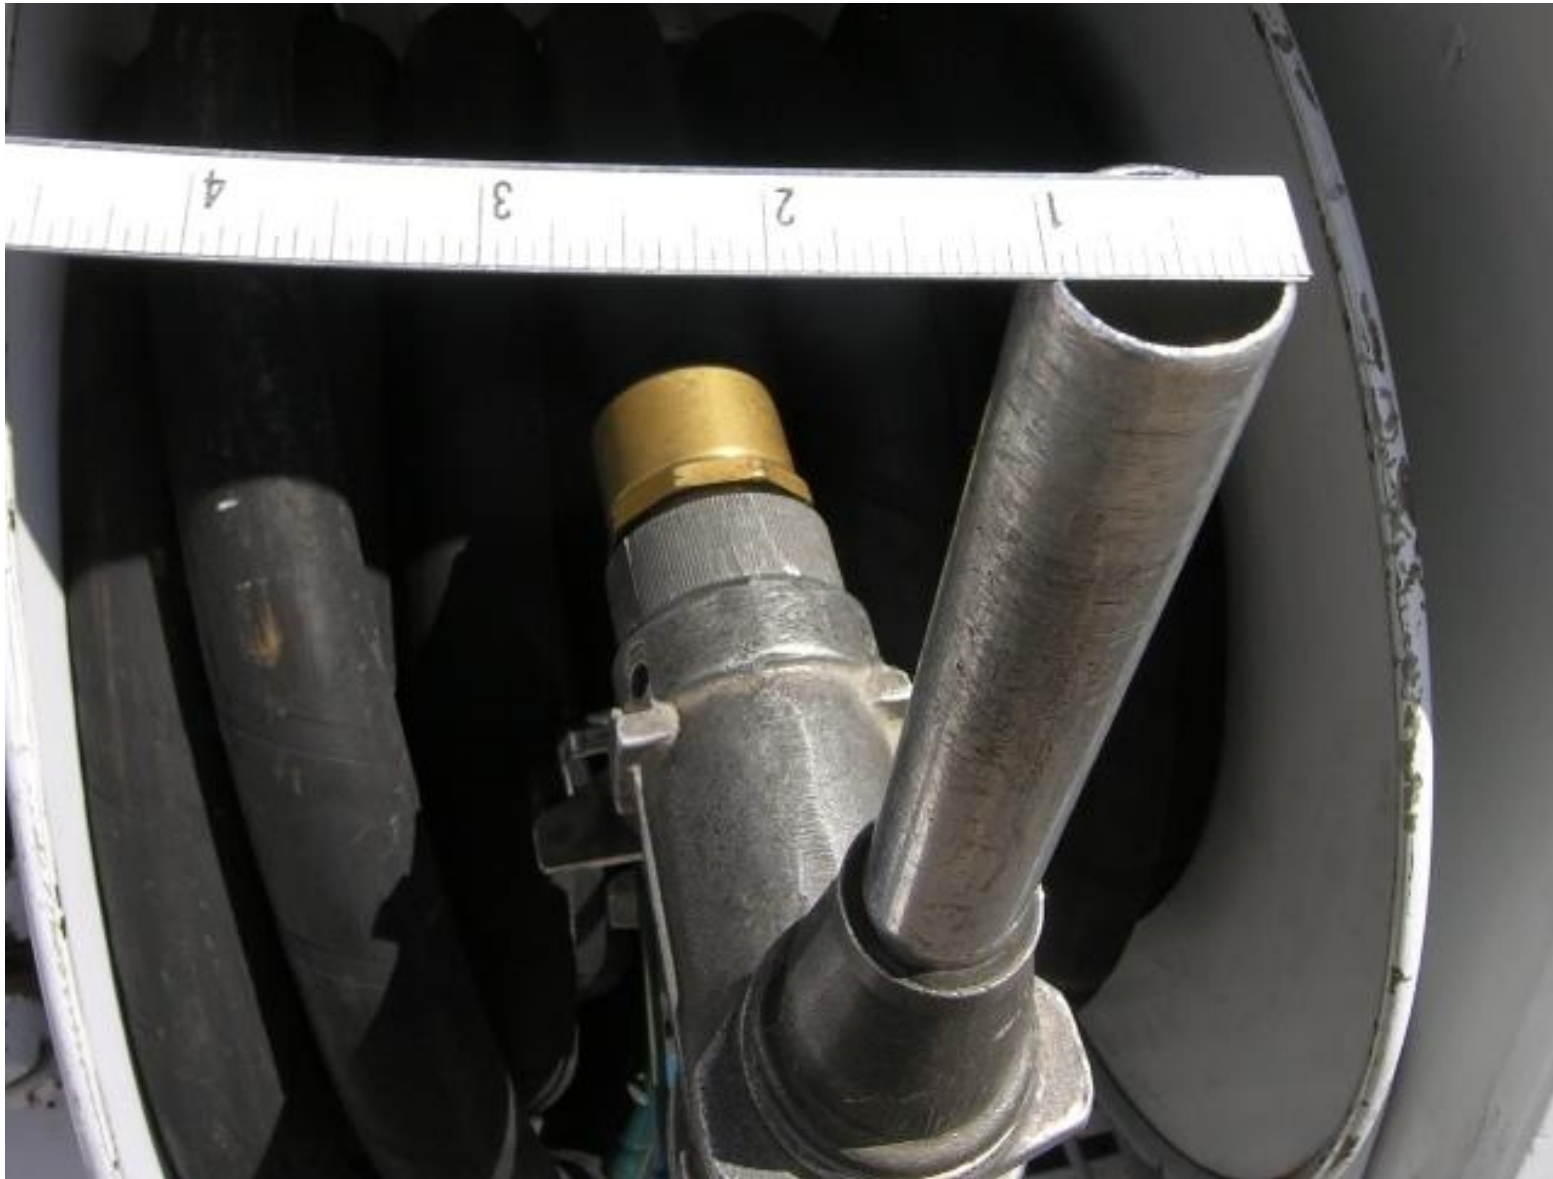
**Photo 8 - LRU airport – 1 inch diameter Avgas fuel nozzle (NTSB Photo)**

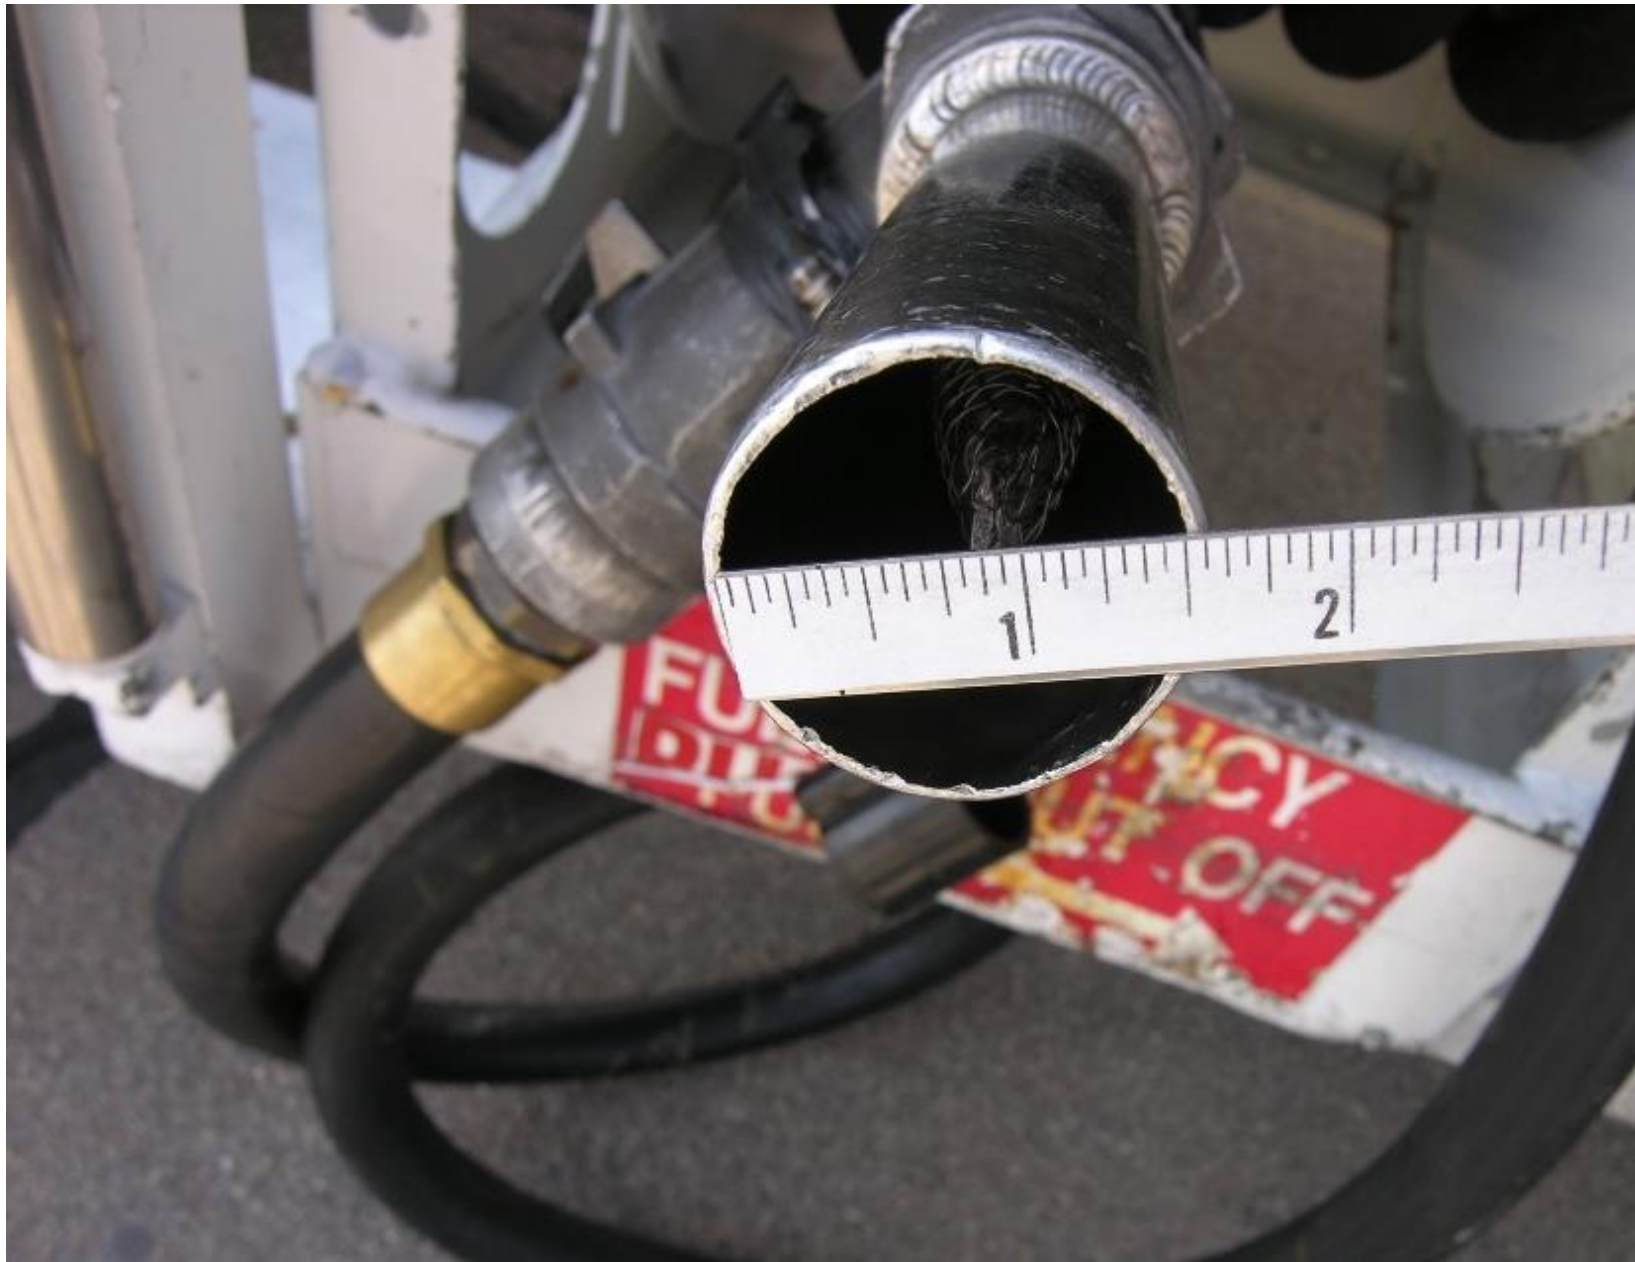
**Photo 9 - LRU airport – 1 5/8 inch diameter Jet fuel nozzle (NTSB Photo)**

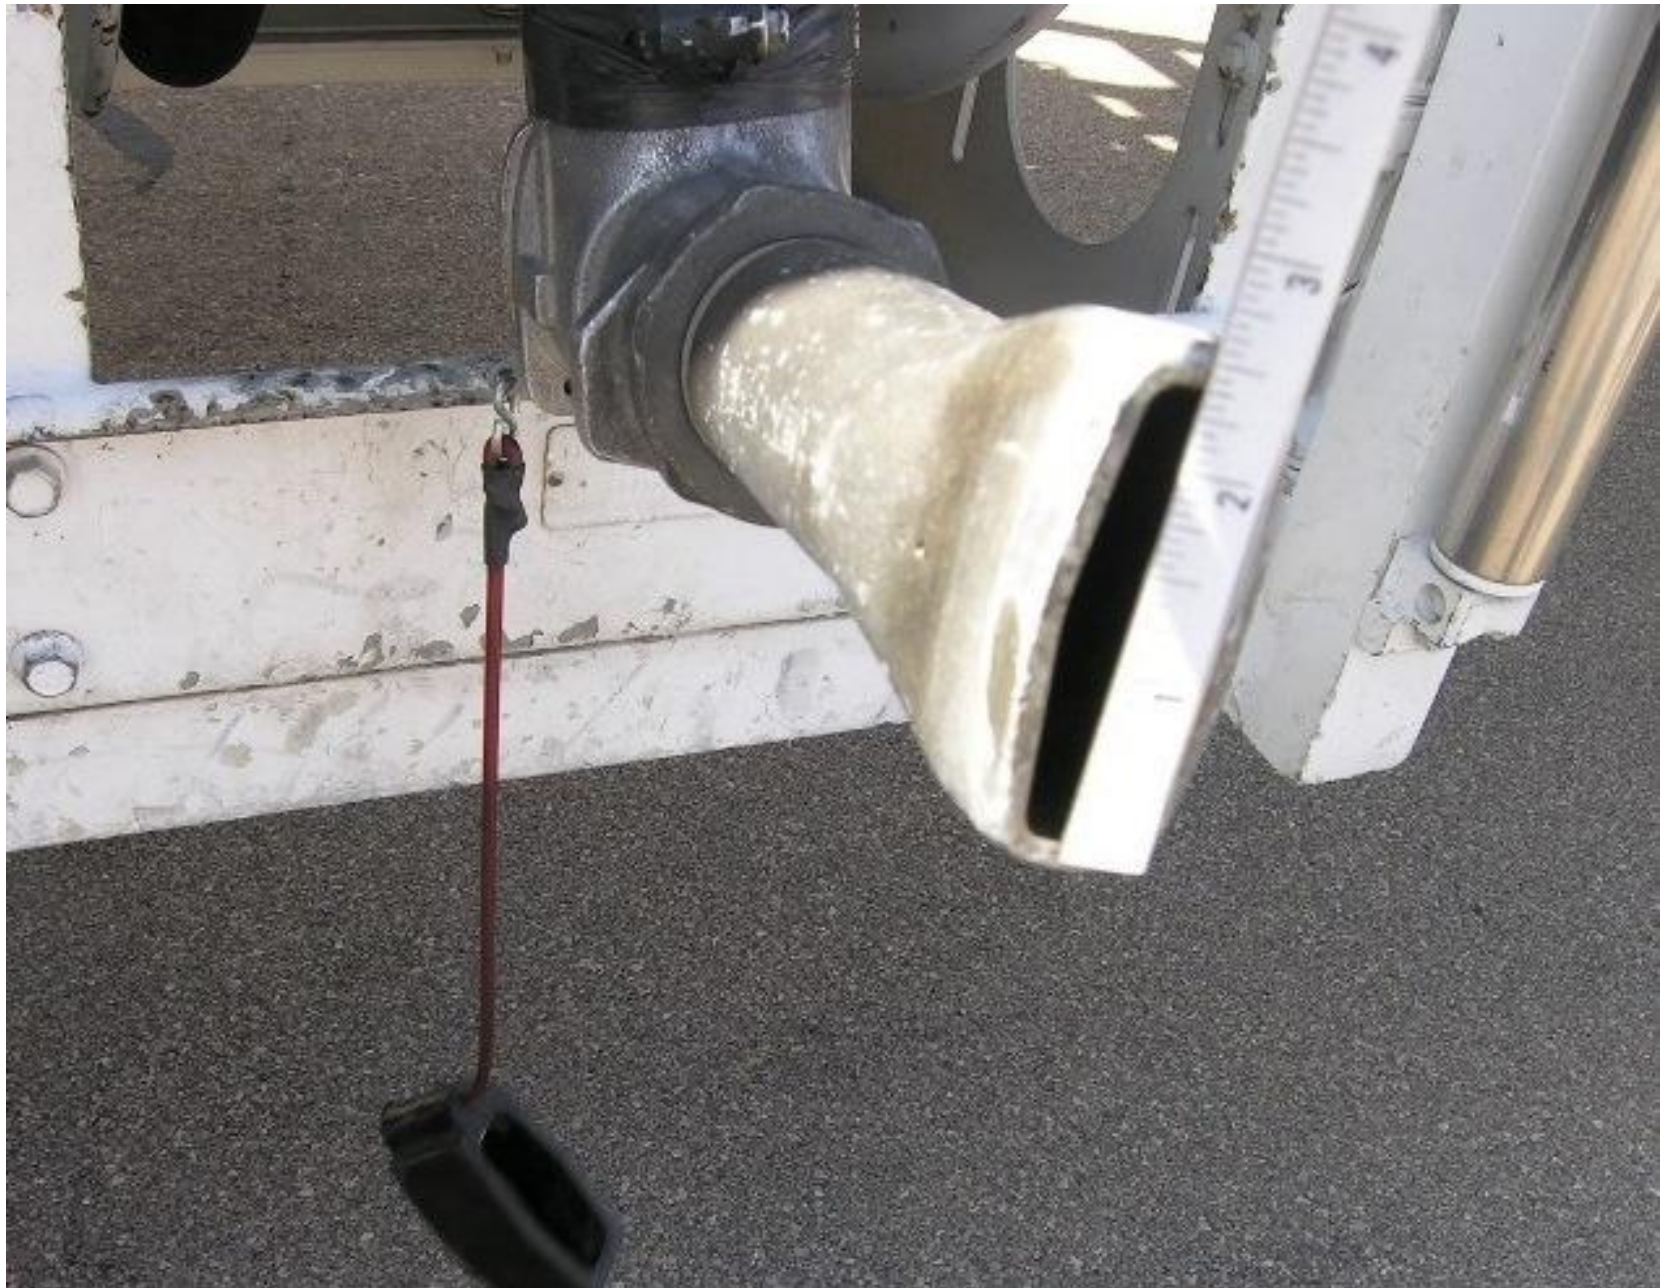
**Photo 10 - LRU airport – 2 ½ inch wide “Duckbill” Jet fuel nozzle (NTSB Photo)**

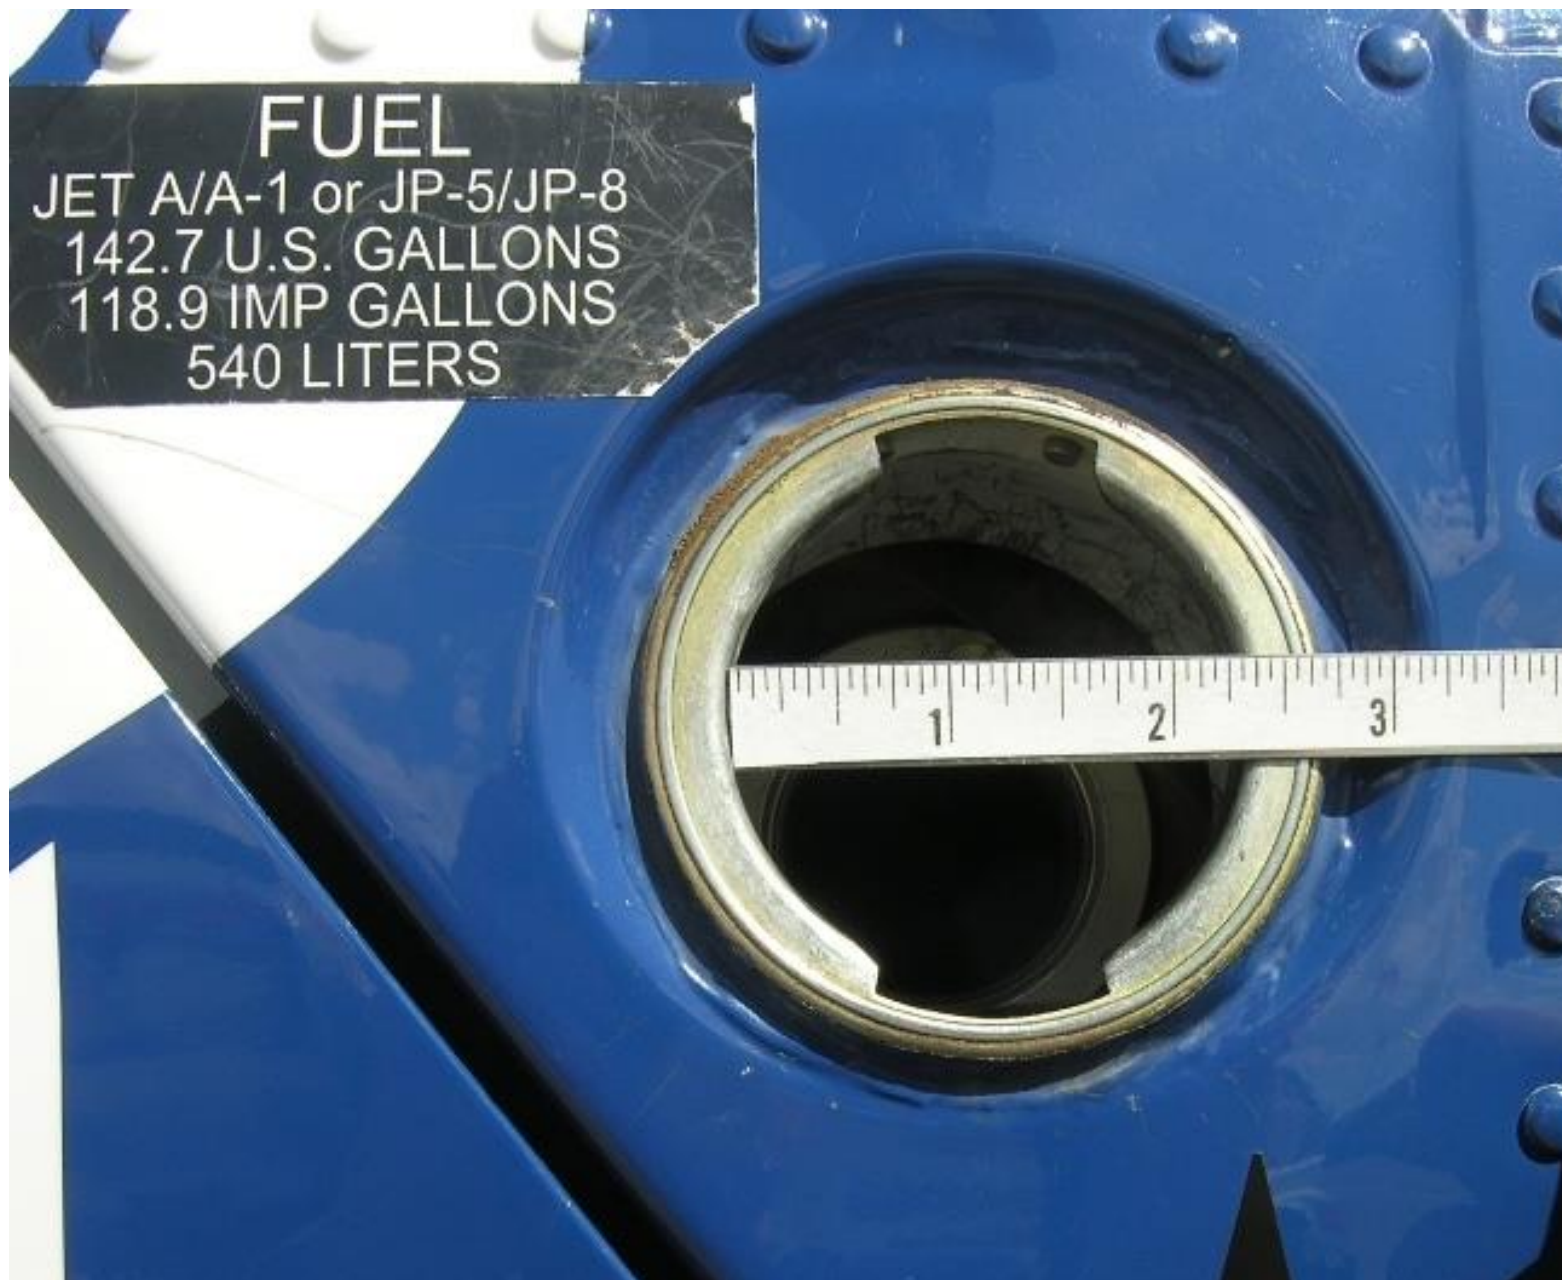
**Photo 11 – LRU airport – 2 ¼ inch diameter fuel port on an AS-350 helicopter (NTSB Photo)**
