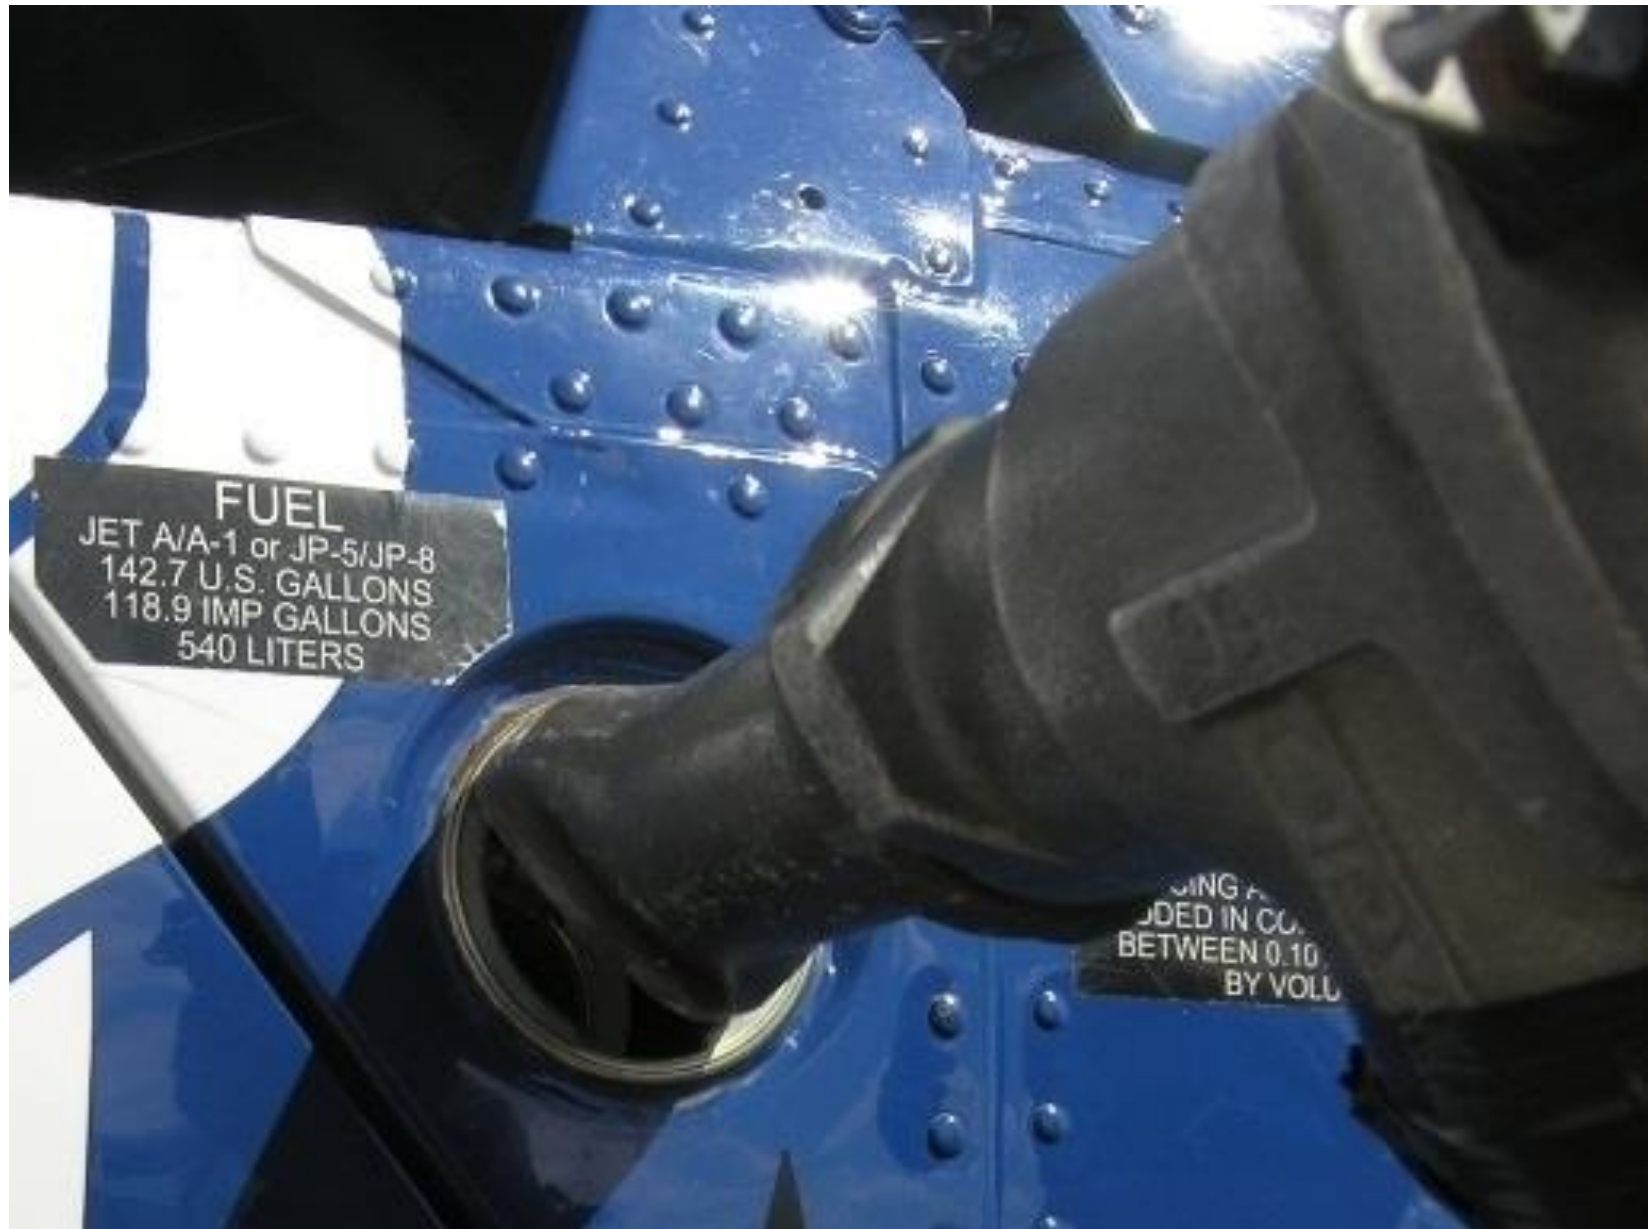
**Photo 12 - LRU airport – “Duckbill” fuel nozzle shown next to the 2 ¼ inch diameter fuel port on an AS-350 helicopter (NTSB Photo)**
