# **NATIONAL TRANSPORTATION SAFETY BOARD**

## **KCXO Runway 1 Examination Test Report**

Location: Conroe, TX (Lone Star Executive Airport (KCXO))  
Date: September 19, 2014  
Time: 08:47 Central Daylight Time (CDT)  
(13:47 Universal Coordinated Time (UTC))  
Aircraft: Embraer EMB-505, N322QS  
NTSB#: CEN14FA505

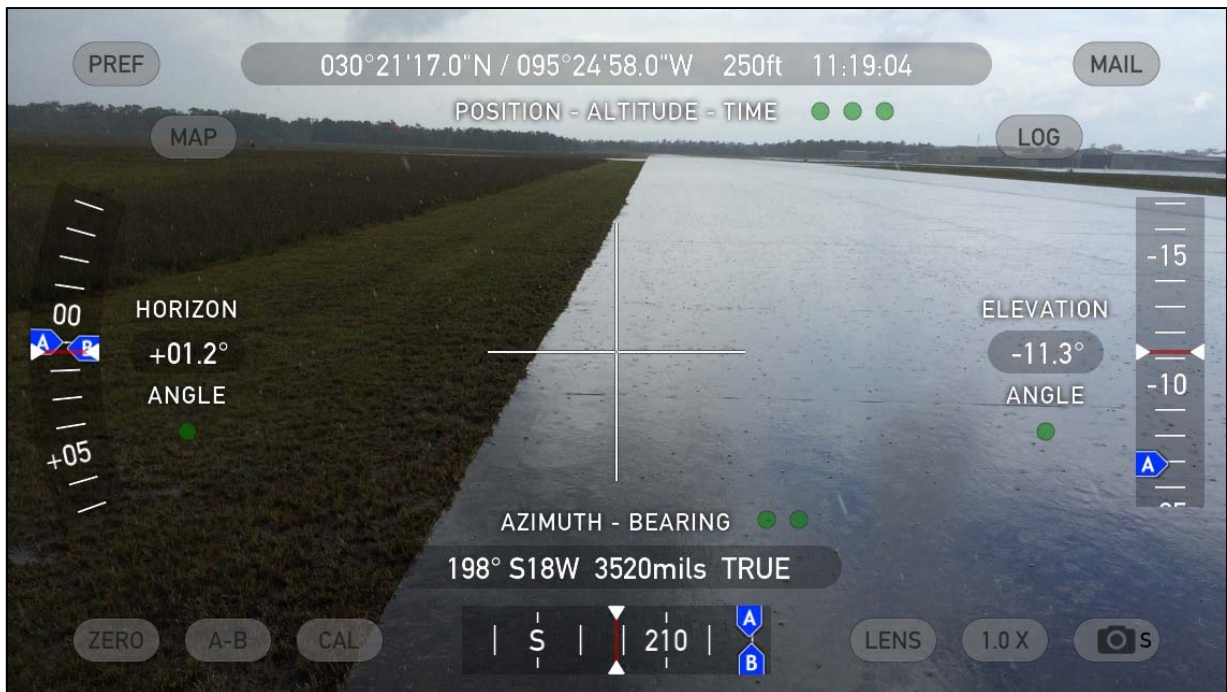
**Figure 2a.** Photo of east edge of KCXO runway 1 during a 0.5 in./hr. rain event.

The runway edges were examined for vegetation or other matter that could interfere with proper drainage from the runway and cause flooding. No obstructions were observed, and actual rain runoff from the runway was observed during a rain event, with no significant buildup of water at the edges (beyond approximately a foot from the edge; see Figures 2a-2b). A plot of the rainfall measured by the Automated Surface Observation System (ASOS) at KCXO, and the corresponding rainfall rate, is presented in Figure 3. At the time of the observations on the runway corresponding to the photographs in Figures 2a-2b (about 11:20 CDT), the rainfall rate was about 0.5 inches / hour. About 10 minutes earlier, the rainfall rate was as high as 2.1 inches / hour.

No obstructions were observed at the edges of the runway that would interfere with proper water drainage, and actual rain runoff from the runway was observed during a 0.5 inch/hour rain event, with no significant buildup of water at the runway edges.

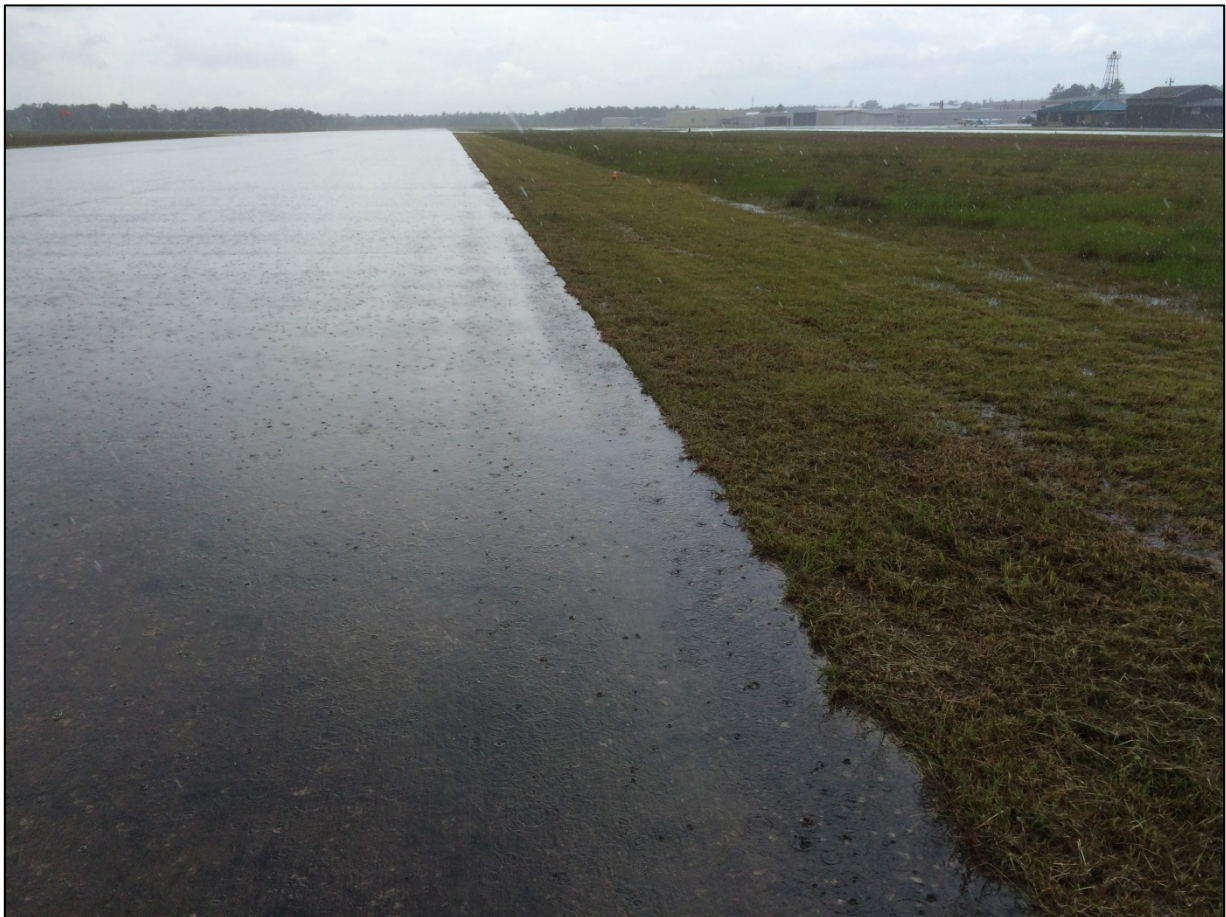
**Figure 2b.** Photo of west edge of KCXO runway 1 during a 0.5 in./hr. rain event.
