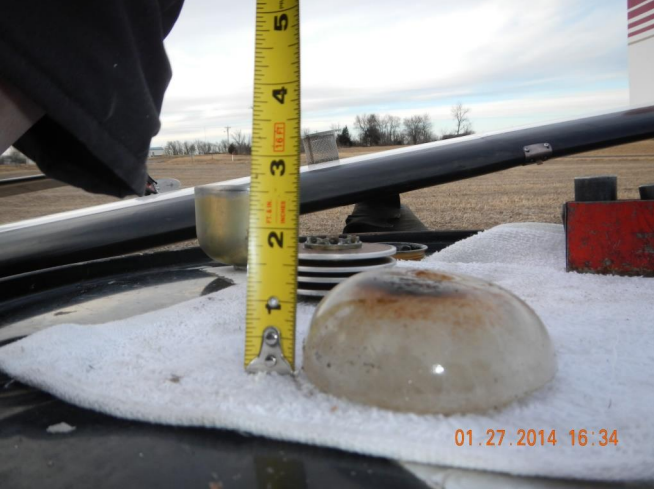
Photo 2. Ice from left fuel strainer bowl (Photo courtesy of Continental Motors)
