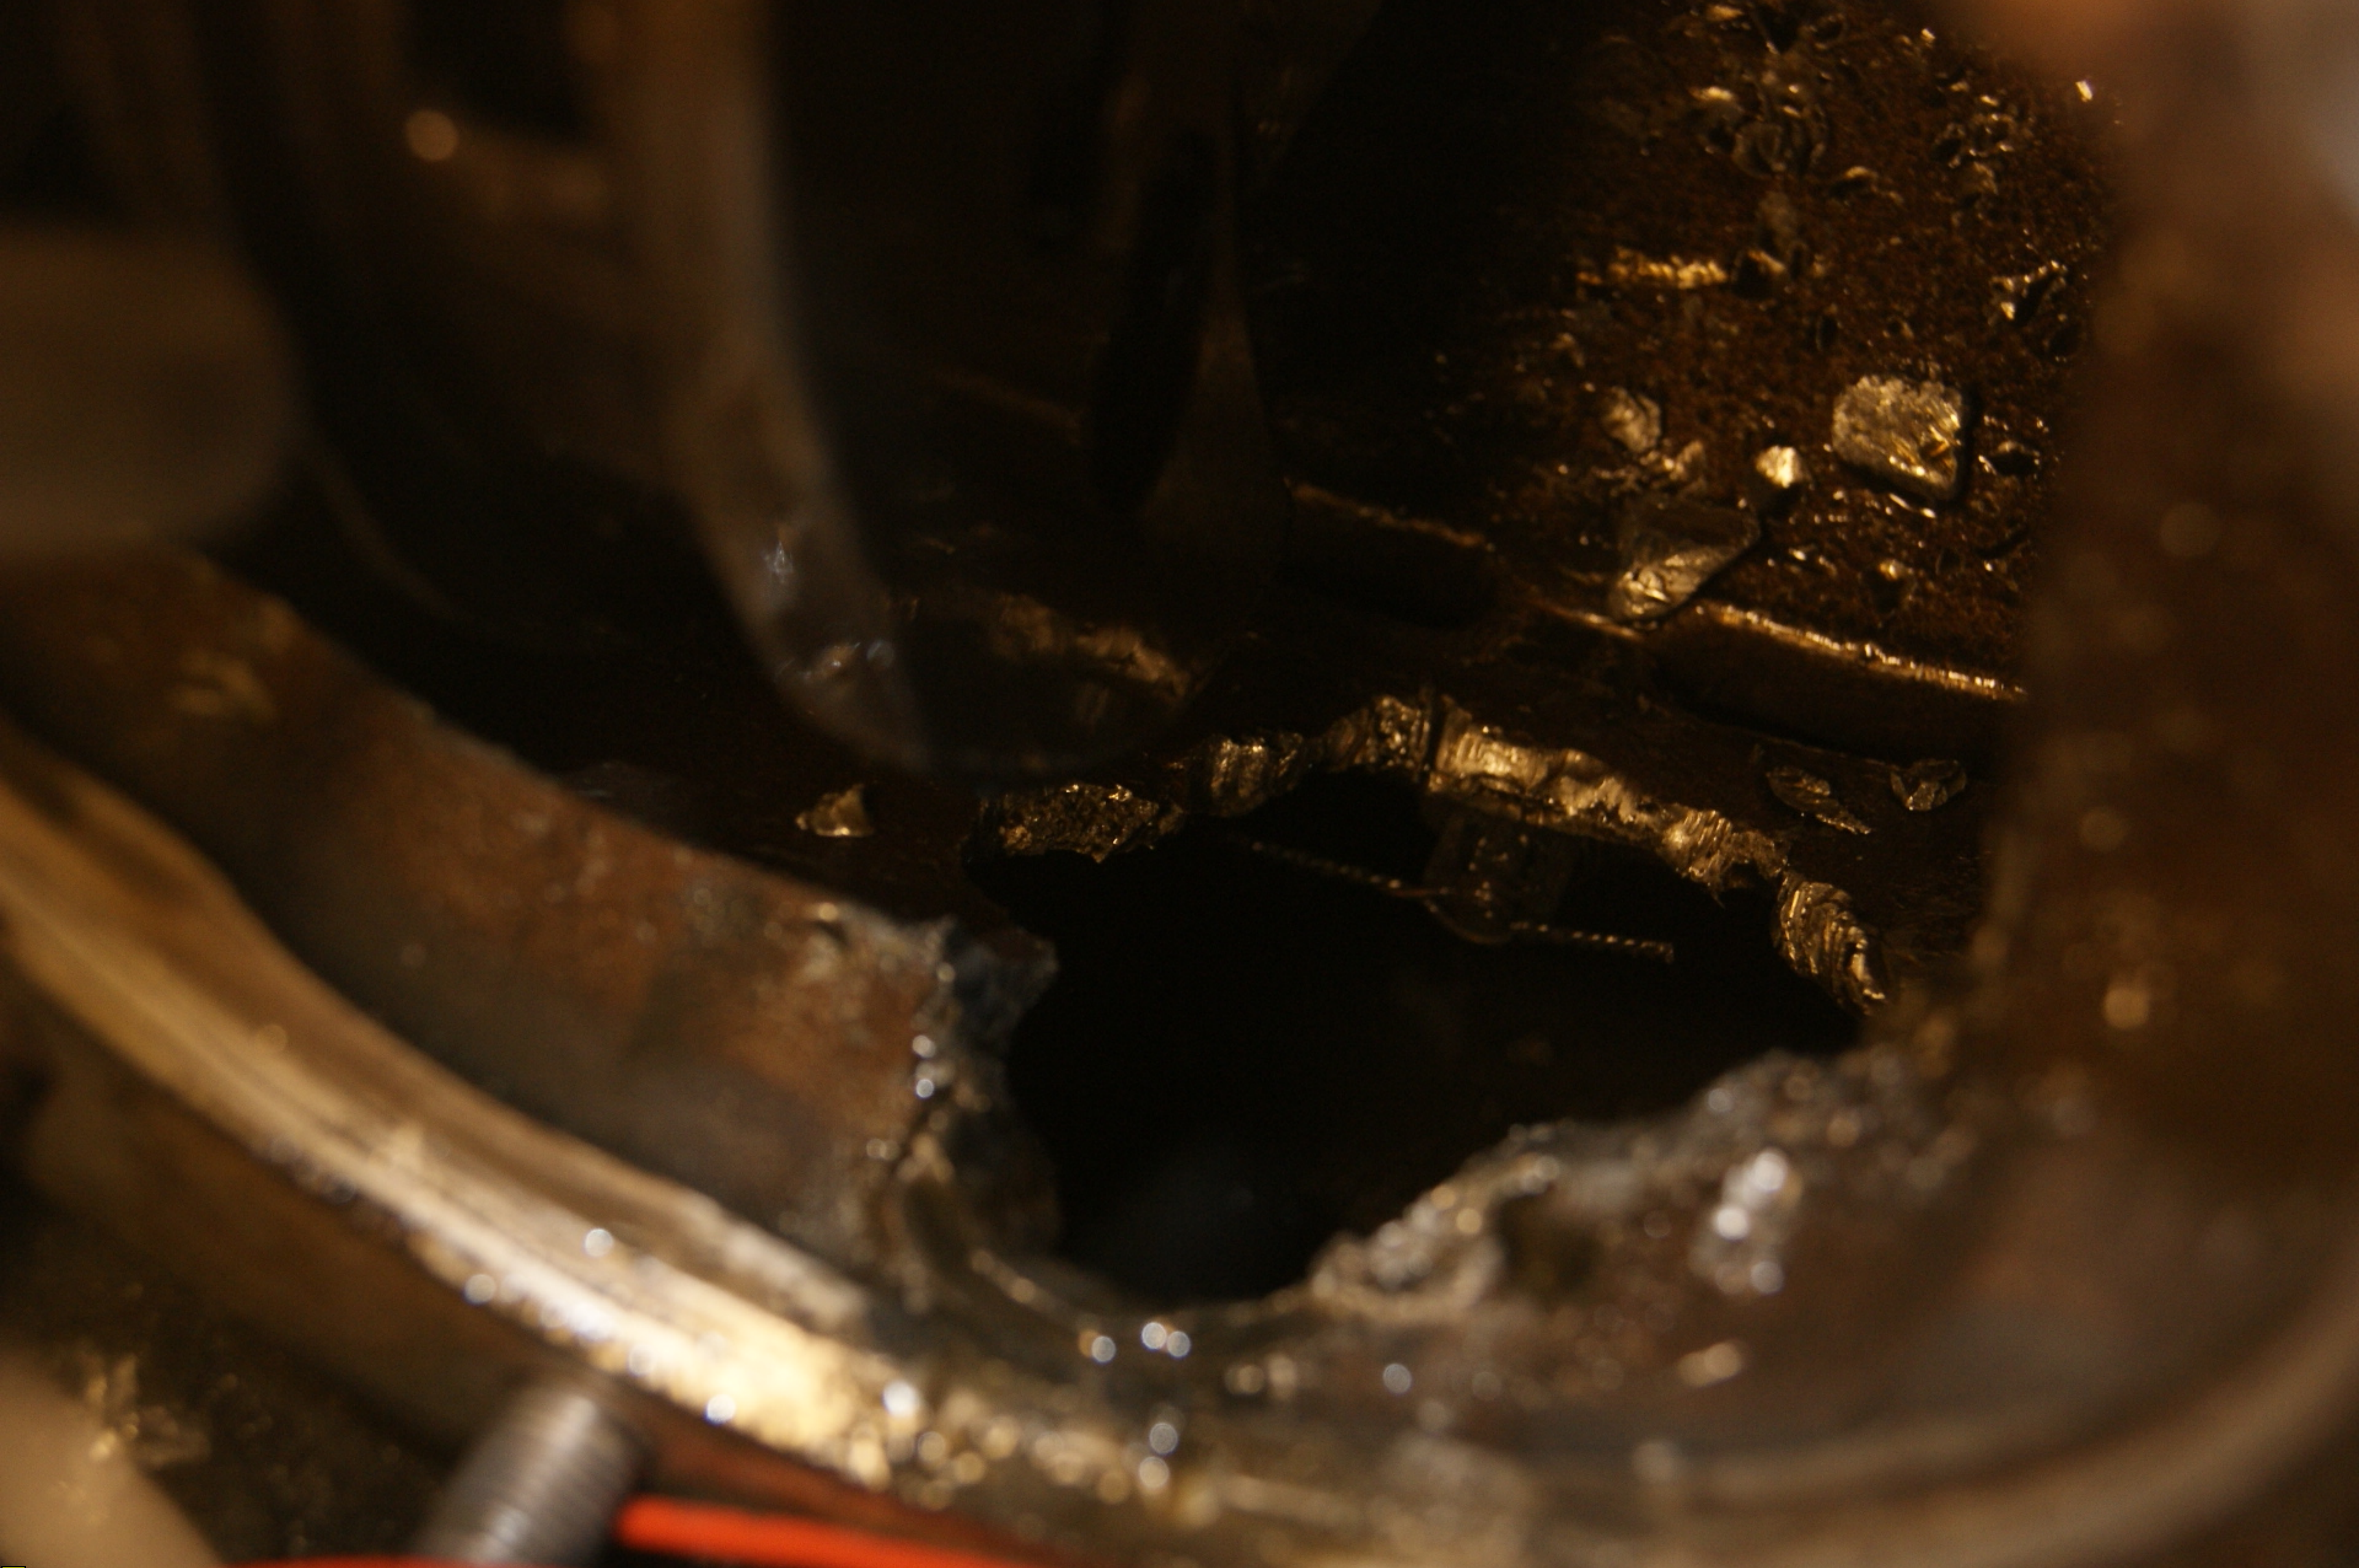
Photo 7 - Hole in crankcase below number 5 cylinder and piston
