**National Transportation Safety Board**  
Office of Research and Engineering  
Washington, D.C. 20594

## Airplane Performance Study

Location: Argyle, TX  
Date: February 4, 2015  
Time: 2109 CST (0309 GMT)  
Airplane: Cessna Model 441 "Conquest II", Registration N441TG  
NTSB Number: CEN15FA136

**Airplane Performance Study**  
**CEN15FA136, Cessna Model 441, Registration N441TG, 2/4/2015**

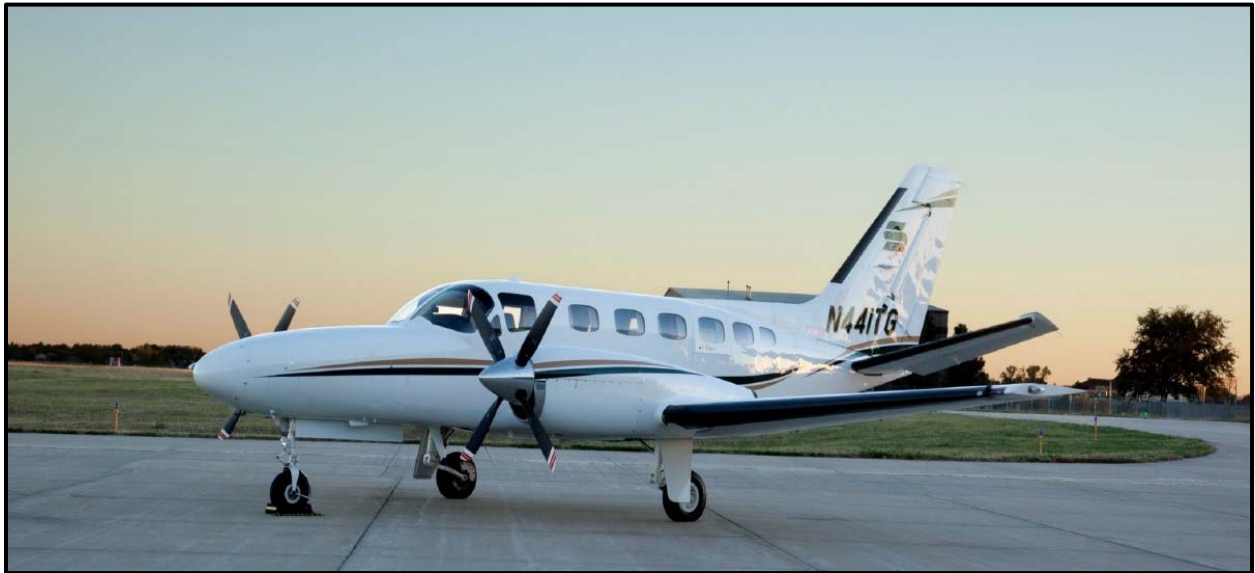
Figure 1: Accident Airplane N441TG, a 1981 Cessna Model 441 “Conquest II”

On February 4, 2015, about 2109 central standard time (CST), a Cessna model 441 twin turbo-prop, N441TG, was substantially damaged when it collided with terrain following a loss of control during an instrument approach to Denton Municipal Airport (KDTO), Denton, Texas. The commercial pilot was fatally injured. See Figures 1 and 2 for pictures of the accident airplane and the accident site.

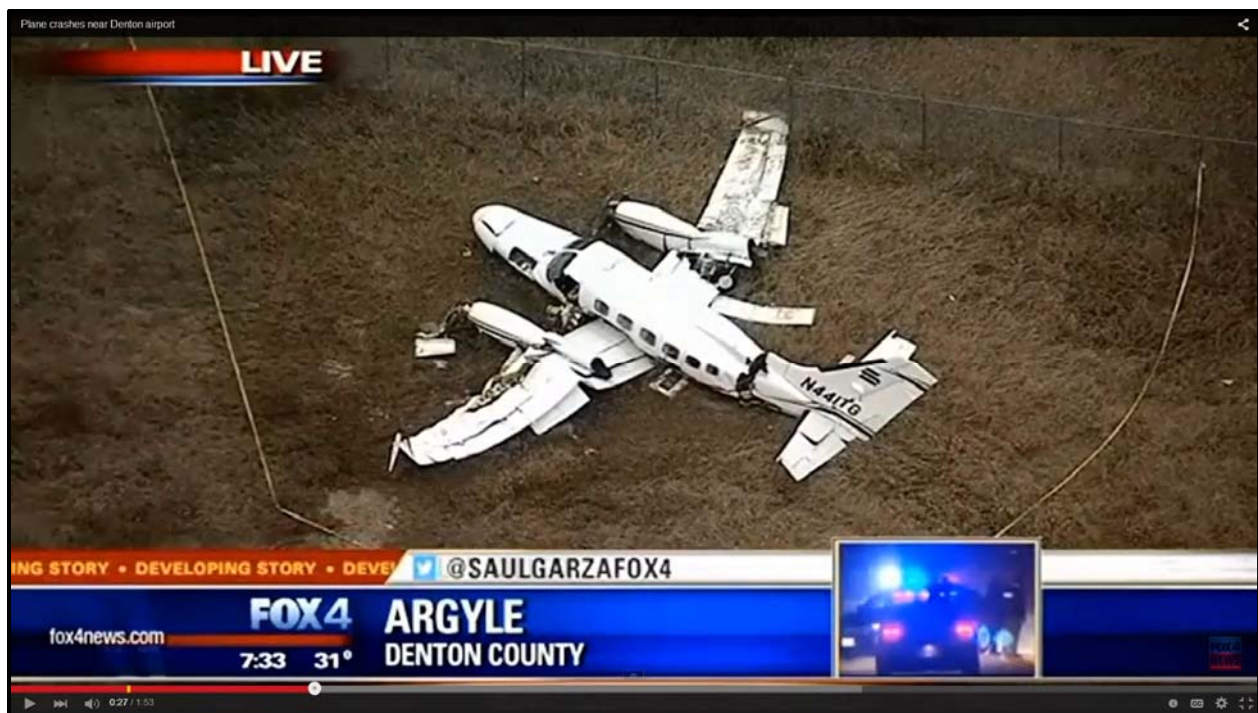
Figure 2: Accident Site

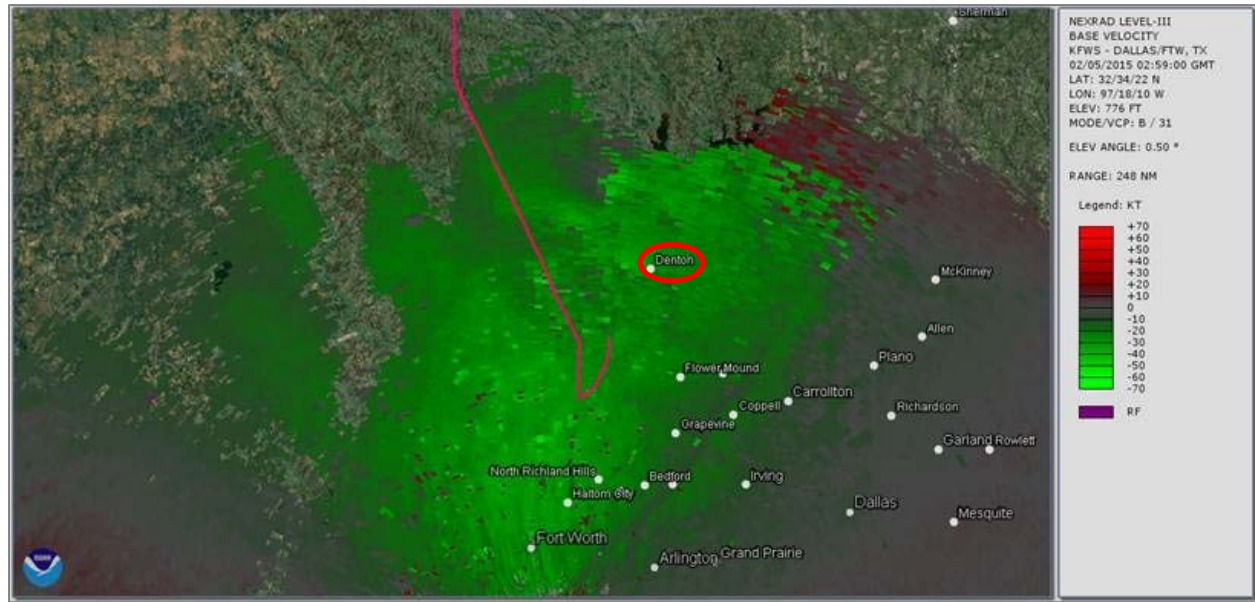
**Figure 5: Doppler Radar Radial Velocity Image at 0259 GMT / 2059 CST in Kt**

At approximately 2010 CST or about an hour before the accident, a weak cold front moved through the Denton area. Following the passage of the cold front, KDTO experienced slightly lower visibilities and ceilings, higher surface winds, and slightly lower air temperatures. A second cold front went through the area at 2059 CST (ten minutes before the accident) and is depicted as a “fine line” (heading to the southeast) in Figures 4 and 5 .
