**NATIONAL TRANSPORTATION SAFETY BOARD**  
Vehicle Recorder Division  
Washington, D.C. 20594

## **Multiple Electronic Devices**

**Specialist's Factual Report  
by George Haralampopoulos**

Location: Advance, Indiana  
Date: April 3, 2015  
Aircraft: Aerostar Yak-52TW  
Registration: N555GD  
Operator: Private  
NTSB Number: CEN15FA194

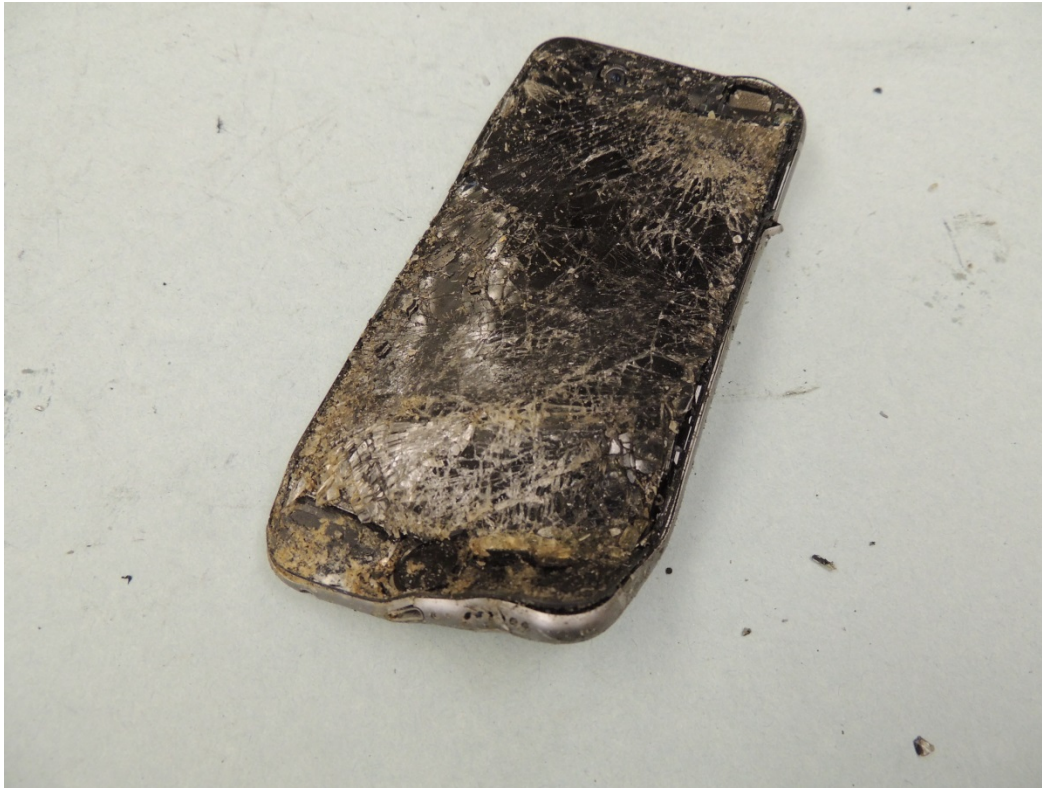
**Figure 1.** Apple iPhone 6+ as received

The iPhone 6+ (figure 1) is capable of storing data in the non-volatile memory (NVM)<sup>1</sup>. The extent of the damage sustained by the iPhone precluded normal recovery

procedures and additional attempts using surrogate units were unsuccessful in yielding data. Therefore, no data pertinent data were recovered.

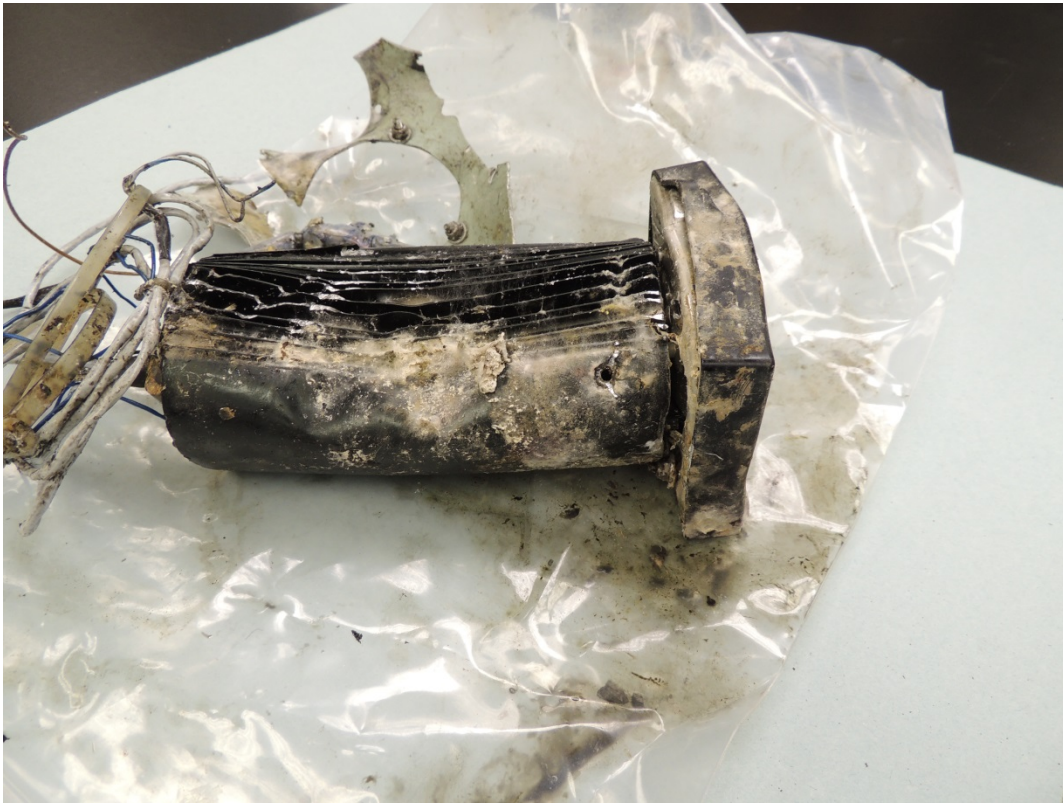
**Figure 2.** Dynon D-10A as received

The Dynon D-10A (figure 2) is capable of storing data in the NVM. An external examination determined the device received severe impact. The housing was removed and the internal memory chip containing the devices NVM was located and read out using laboratory equipment. A thorough analysis of the imaged data showed that no data was recorded to the device and no further work was performed.

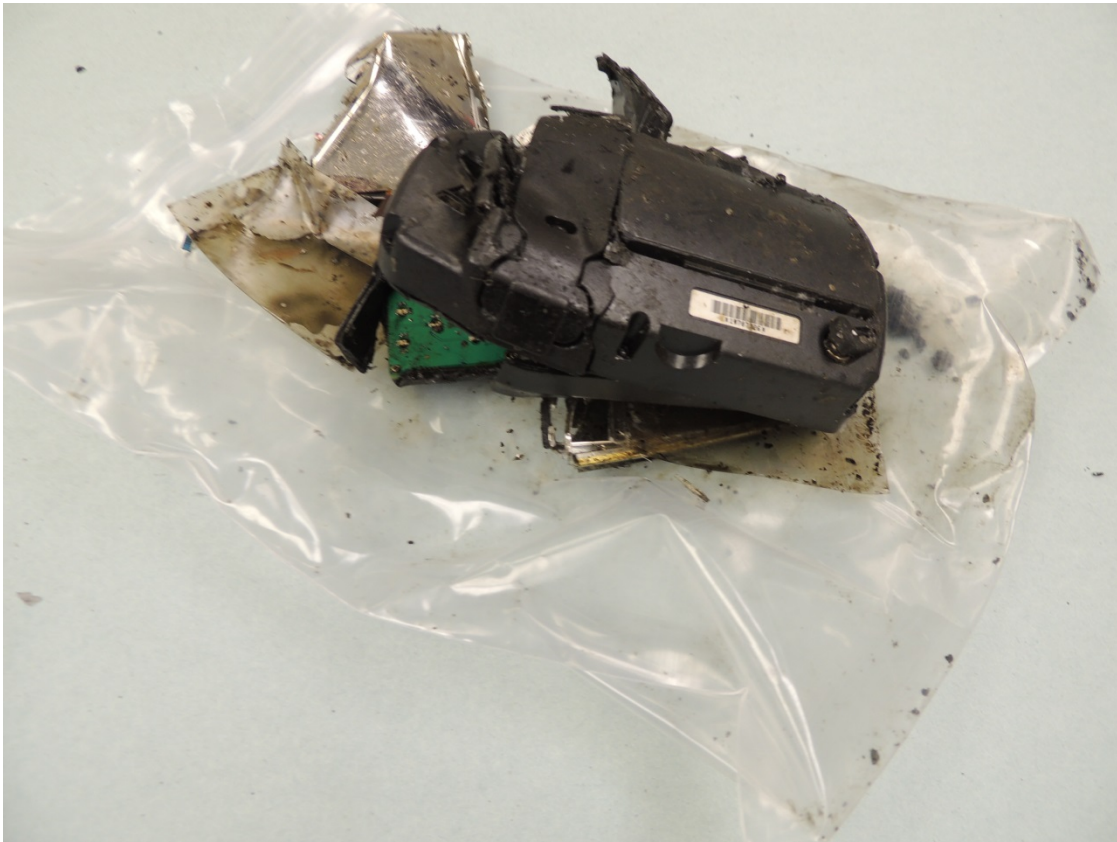
**Figure 3.** Garmin GPSMAP as received

Upon arrival at the Vehicle Recorder Division, an exterior examination revealed the unit had sustained significant damage (figure 3). The circuit board containing the unit's nvm was located and the memory chip was removed and read out using laboratory equipment. The data was successfully recovered using forensic software.

The accident flight was not identified in the 65 recorded sessions from June 1, 2014<sup>2</sup> through March 22, 2015. Ten flights were recorded in the calendar year. No additional pertinent information could be extracted from the device.
