**NATIONAL TRANSPORTATION SAFETY BOARD**  
Office of Research and Engineering  
Washington, D.C. 20594

## **Video Study**

**NTSB Case Number:**  
**CEN15FA311**

Location: Oshkosh, Wisconsin  
Date: July 22, 2015  
Time: 7:44 AM CDT  
Airplane: Piper PA-46-310P

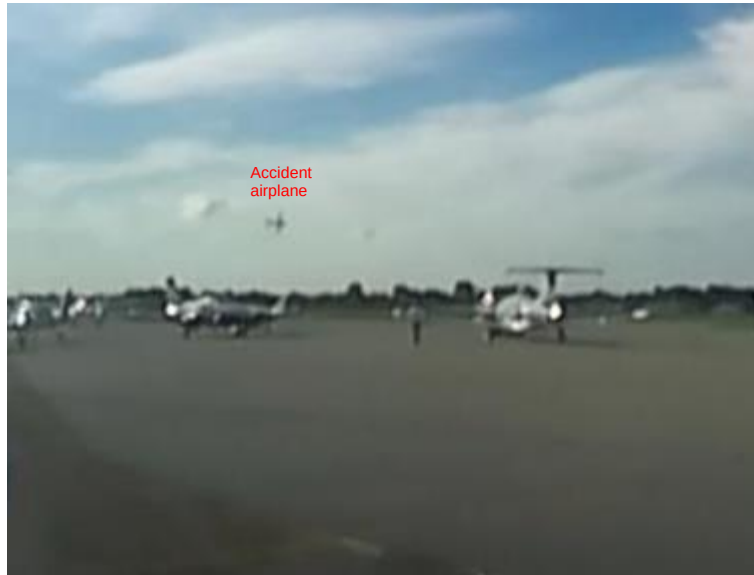
resolution of 1440x1440 and frame rate of 30 fps. The video was unfolded from polar to rectangular coordinates, resulting in 1280x720 resolution and 30 fps frame rate. The accident airplane was approximately 1500 ft from the camera and, because of the distance, its image in the video was only approximately 10 pixels long. Figure 1 is a detail from the video frame at time 17 seconds in which the accident airplane is visible shortly before it impacted ground.

Figure 1 Detail from a Video Frame Showing the Accident Airplane

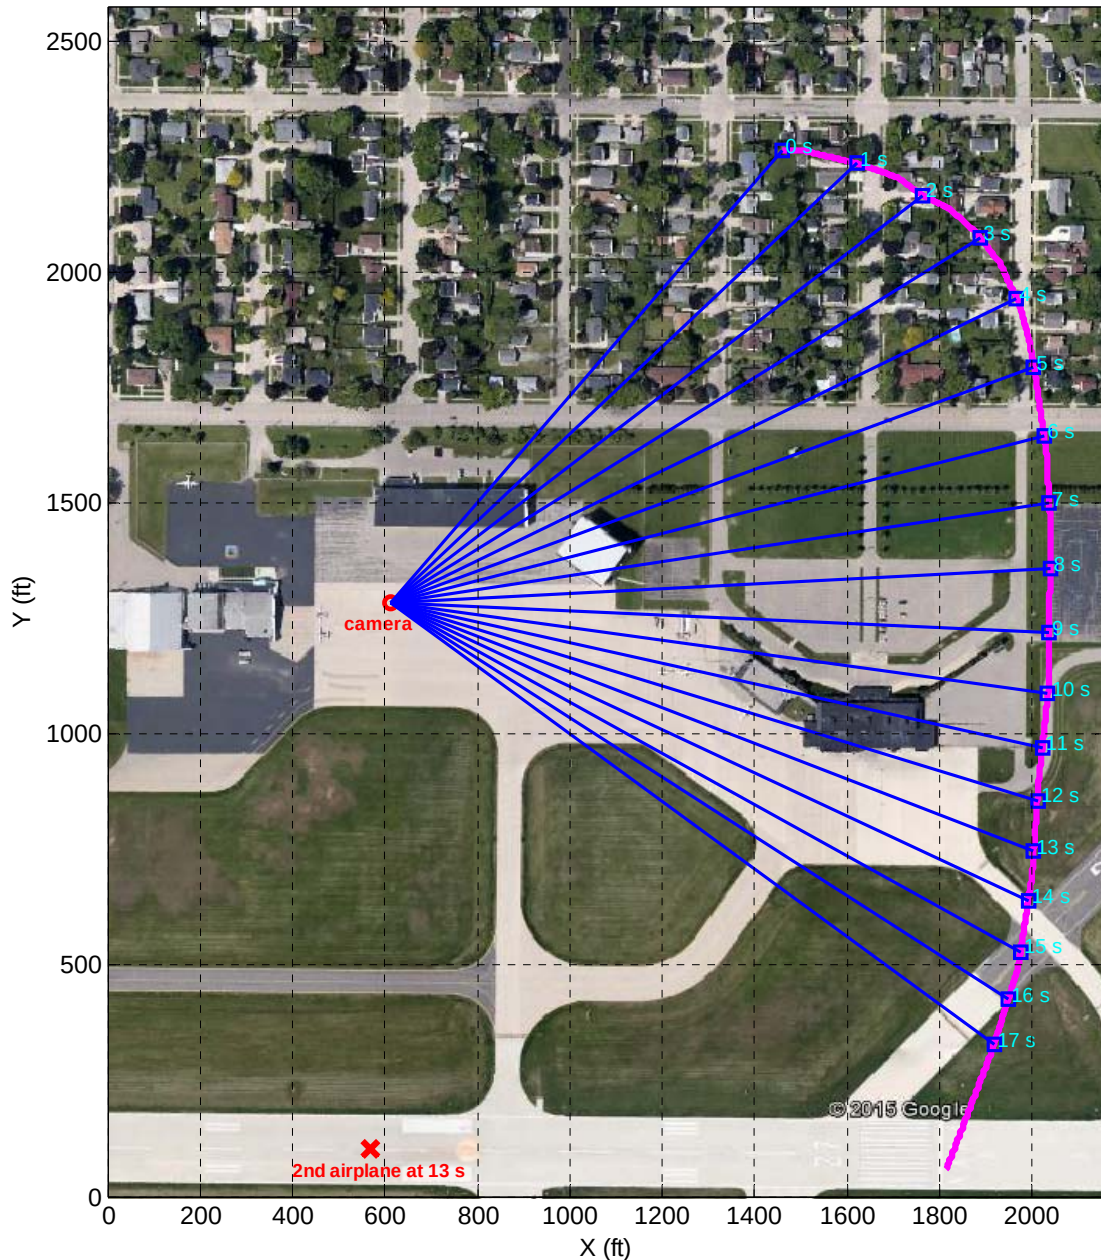
The camera-to-airplane yaw angles were measured in eighteen frames spaced by one second. The approximate location of the camera was known from an aerial photograph and from statement of the pilot of the camera airplane. More accurate camera location was estimated using the images of three airport buildings visible in the video. These buildings and the location of the crash, also visible in the video, were then used for aligning the yaw of the 360° panoramic camera view with north. Figure 2 shows eighteen lines, originating at the camera location, that point to the airplane image at the eighteen analyzed times. The time corresponding to each line is shown in the figure. Time was set to zero at the first analyzed point which was time 4:53 in the video recording.

Figure 2 Accident Airplane Ground Track and Eighteen Analyzed Trajectory Points

The estimated locations of the airplane in X-Y coordinates are at the intersection of the eighteen lines with the ground track of the airplane, which is shown in magenta in Figure 2. The ground track past time 7 seconds was estimated based on statement of the accident airplane pilot and on statements of witnesses on the ground. Between time 0 seconds and 7 seconds, ground track was estimated based on pilot's statement that he was flying at approximately 90 kts in west to east direction before turning south. The airplane speed at time 7 seconds was estimated based on the video as described below. The trajectory between time 0 seconds and time 7 seconds had to be smooth and the speed had to start at 90 kts and end at the video-based estimated speed at time

7 seconds. This resulted in the trajectory shown in Figure 2. The square markers in Figure 2 are the estimated ground track locations of the accident airplane at the eighteen analyzed times.

At time 5:06 in the video, corresponding to time 13 s in Figure 2, an object is seen moving east to west and is assumed to be a departing airplane on runway 27. It is only seen for a fraction of a second because the camera view is obstructed. Because the second airplane was on the ground and far from the camera, its image in the video is only a barely visible moving dot. Its location was estimated with the method used for analyzing the trajectory of the accident airplane. The location of the second airplane at time 13 s is shown by the red 'X' marker in Figure 2.

1. At time 13 s (see Figure 2), the airplane started a constant-radius 90° right turn that would bring it to the centerline of Runway 27.
2. The ground speed remained constant during the turn as it was at time 13 s (see Figure 4).
3. Wind speed is not taken into account.
4. Altitude is not taken into account.

The required radius of the turn is  $R=655$  ft (see Figure 2). The length of the  $\frac{1}{4}$  circle trajectory is  $(\pi/2)R=1029$  ft. The estimated speed at time 13 s was 109.7 ft/s. Therefore, the time required to complete the hypothetical  $\frac{1}{4}$  circle turn is  $1029/109.7=9.4$  seconds.

If the second airplane stayed at the location where it is shown in Figure 2, when the accident airplane completed its turn, the estimated distance between the airplanes would have been  $2000-570-655=775$  ft. However, the second airplane was departing and moving west. To keep the separation between the airplanes at 1500 ft when the accident airplane completed the turn, during the 9.4 seconds the second airplane would have to move west at the average speed of  $(1500-775)/9.4=77.1$  ft/s=45.7 kts.
