NATIONAL TRANSPORTATION SAFETY BOARD  
Vehicle Recorder Division  
Washington, D.C. 20594

### Specialist's Factual Report by Sean Payne

Location: Granbury, Texas  
Date: September 24, 2015  
Aircraft: Bushby Mustang II  
Registration: N929DS  
Operator: Private  
NTSB Number: CEN15FA422

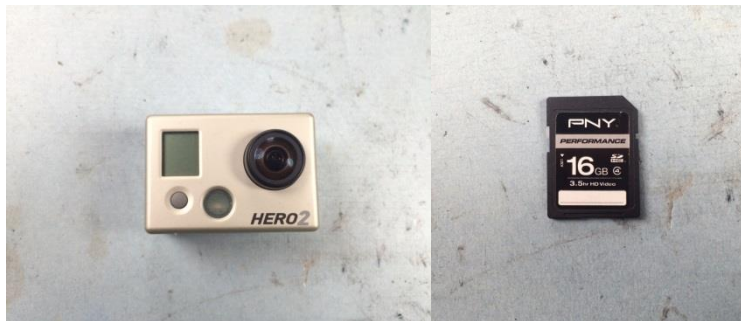
Upon arrival at the Vehicle Recorder Division, an exterior examination revealed the unit had not sustained any damage and image recording information was extracted the associated SD card via a PC. Additionally, a binary copy of the card was made and examined forensically for corrupted video files.<sup>6</sup> Figure 1 shows the GoPro Hero 2 and the associated SD card after being removed from the camera's protective case.

Figure 1. The GoPro Hero 2 and the associated SD card.

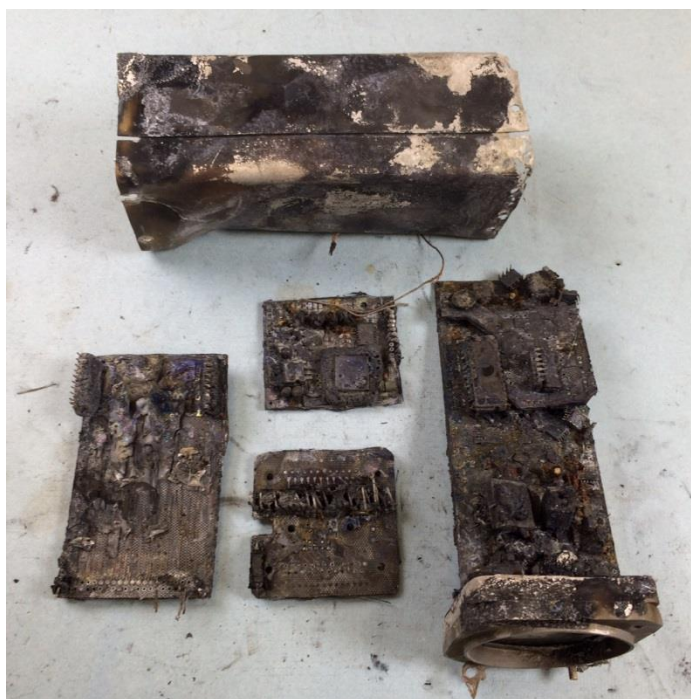
Upon arrival at the Vehicle Recorder Laboratory, an exterior examination revealed the unit had sustained significant impact and thermal damage. An internal examination revealed that circuitry and NVM associated with the device were destroyed by fire. Figure 2 shows the device after disassembly and inspection.

**Figure 2. The JPI EDM-700 after disassembly and inspection.**

No data was recovered from the JPI EDM-700.

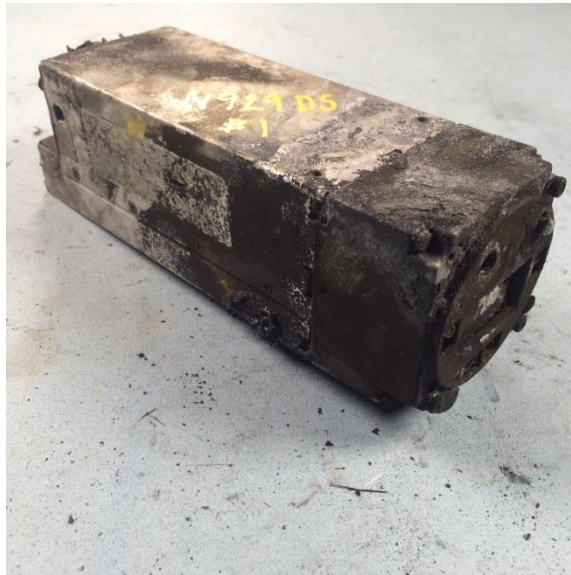
The Becker VHF AR-4201 did not record electronic data and was determined to have no added value to the investigation. Figure 3 shows the Becker VHF AR-4201 as received.

Figure 3. The Becker VHF AR-4201 as received.

No data was recovered from the Becker VHF AR-4201.

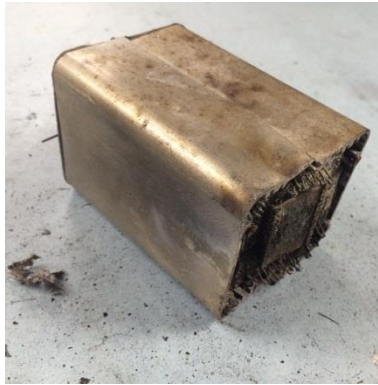
Upon arrival at the Vehicle Recorder Laboratory, an exterior examination revealed the unit had sustained significant impact and thermal damage. An internal examination

revealed that circuitry and non-volatile memory associated with the device were destroyed by fire. Figure 4 shows the device as received.

Figure 4. The Electronics International FL-2RA-12 as received.

No data was recovered from the E.I. FL-2RA-12.

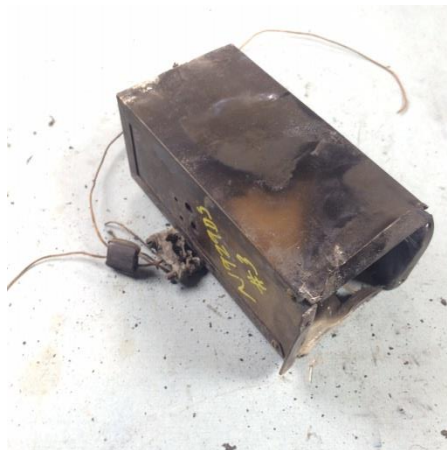
Figure 5 shows the 5<sup>th</sup> electronic device associated with the investigation. The device could not be identified with corresponding records or comparison to recorded video material. The device was damaged beyond potential data extraction and determined to have no value to the investigation.

Figure 5. The 5<sup>th</sup> device examined associated with the investigation.

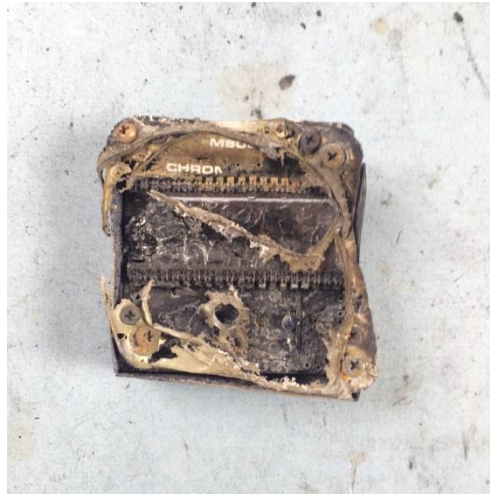
No data was recovered from the Davtron M800. Figure 6 shows the device as received by the laboratory.

Figure 6. The 6<sup>th</sup> device examined associated with the investigation.

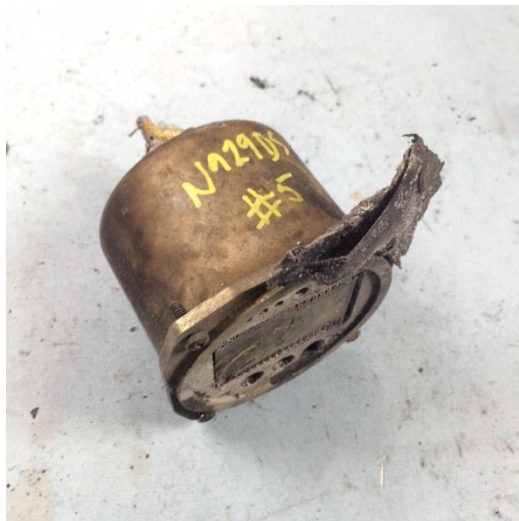
Figure 7. The 7<sup>th</sup> device examined associated with the investigation.

The unit was destroyed by fire and impact damage. The unit's internal NVM was also damaged and unreadable. No data was recovered from the device.
