**NATIONAL TRANSPORTATION SAFETY BOARD**  
Vehicle Recorder Division  
Office of Aviation Safety – Central Region

## Observations from Security Camera Video

**Tom Latson – NTSB investigator in charge**

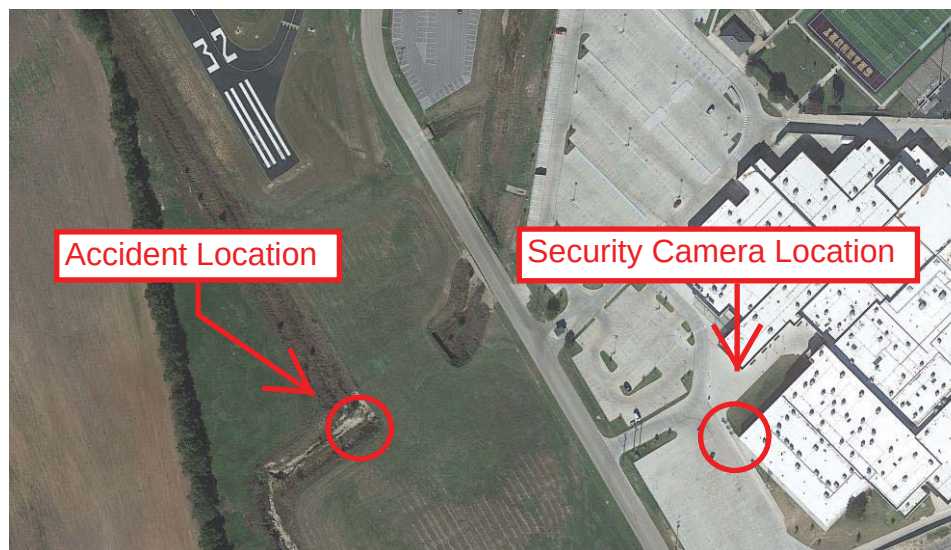
**Figure 1 – Showing the accident location and the security camera location**

The security camera was located on the west side of the Granbury High School, oriented generally to the west. Video images from a security camera time of 1907:50 through 1910:50 were reviewed by the investigator-in-charge. Several significant observations are summarized on the following pages.

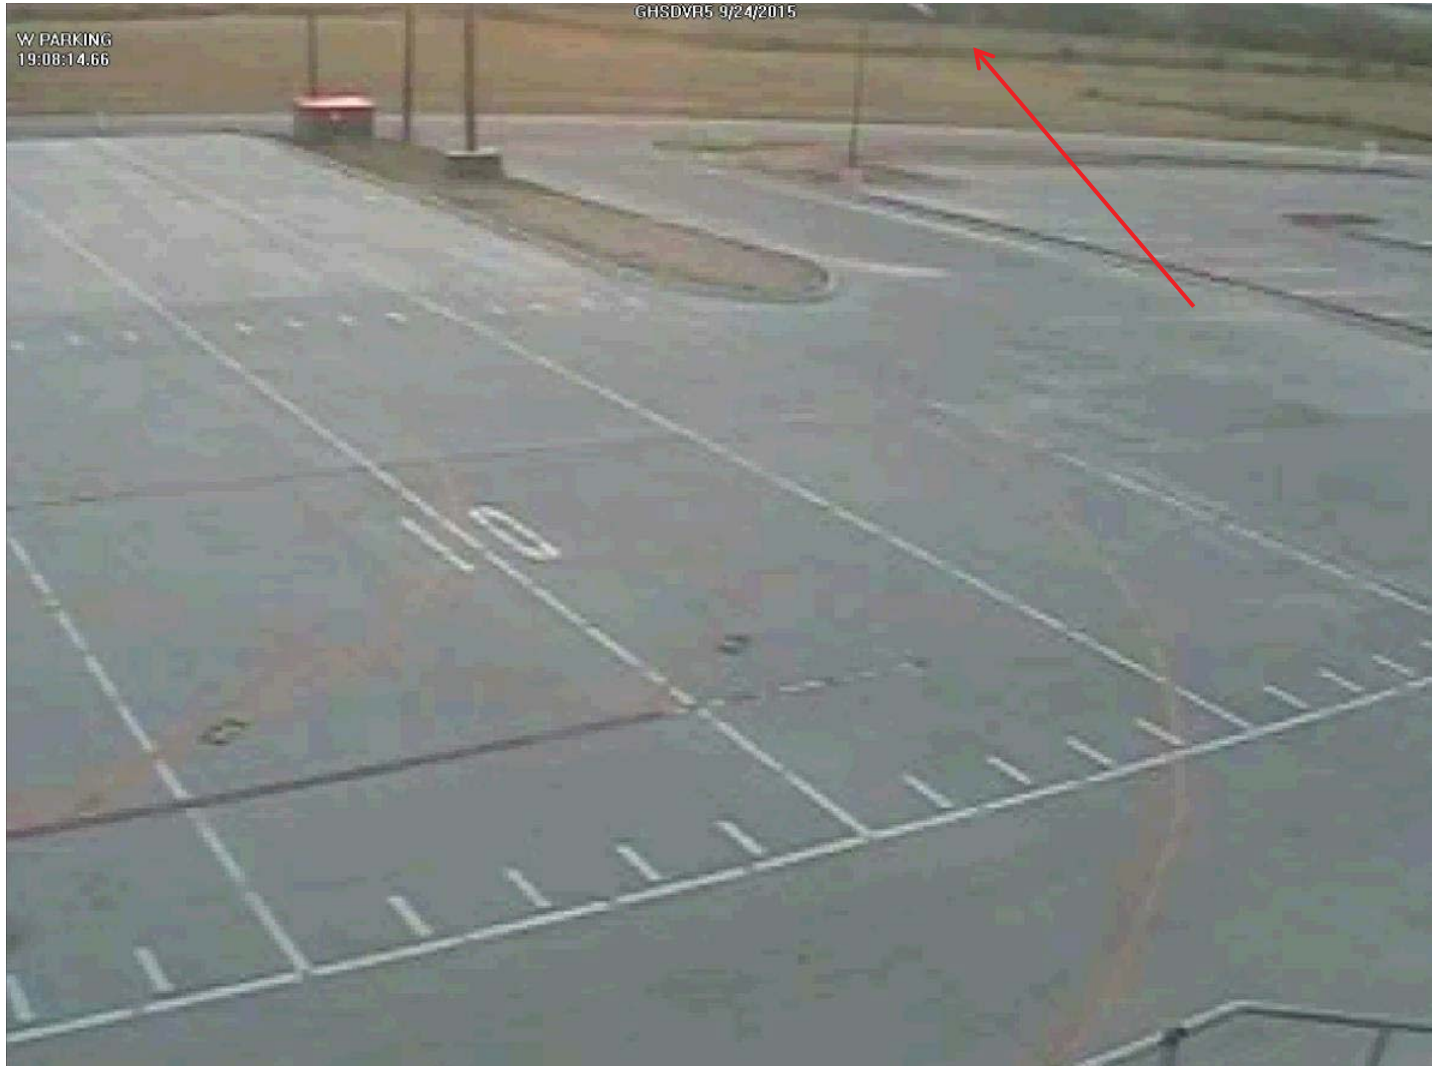
**1908:14.66 The airplane first appears in view on the top center, and is moving southbound, from right to left.**

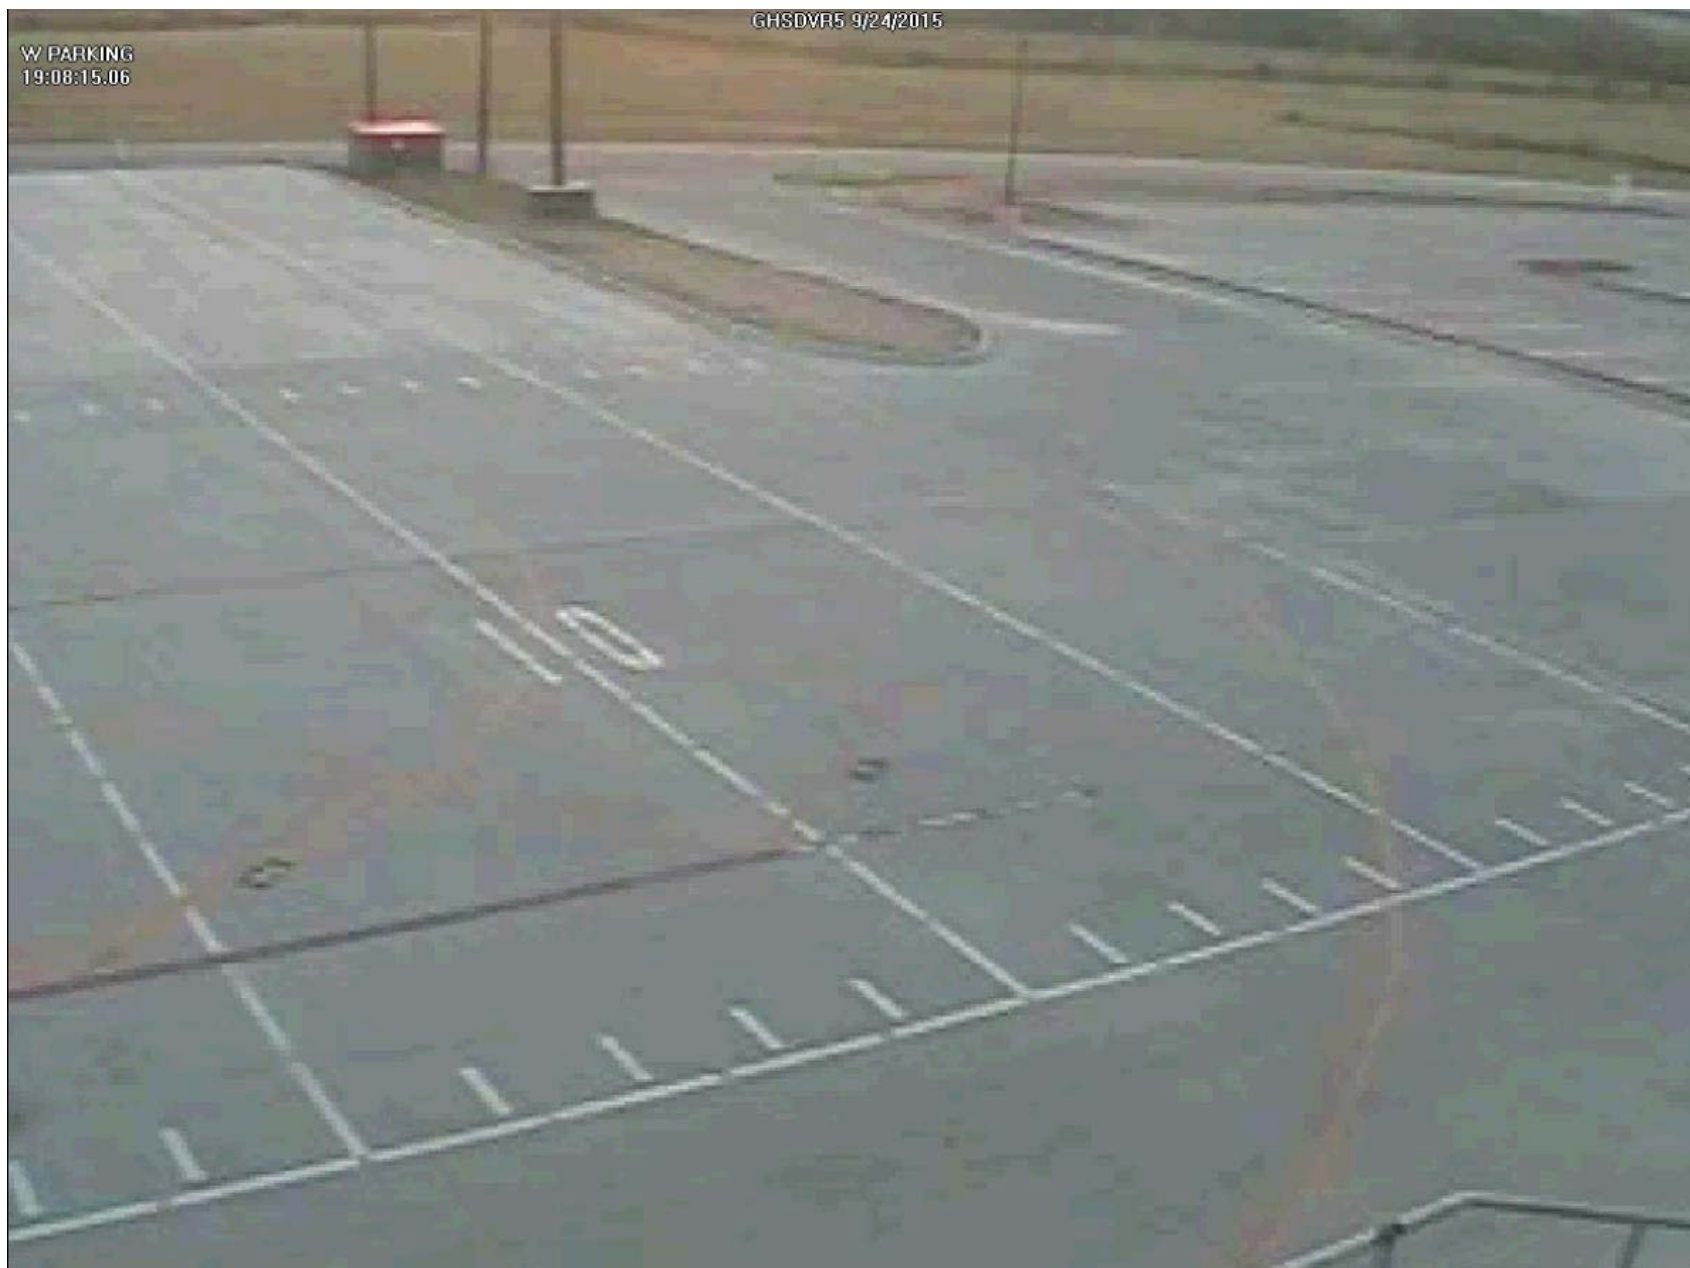
**1908:15.06 The southbound airplane has descended into the ditch and has briefly disappeared from view.**

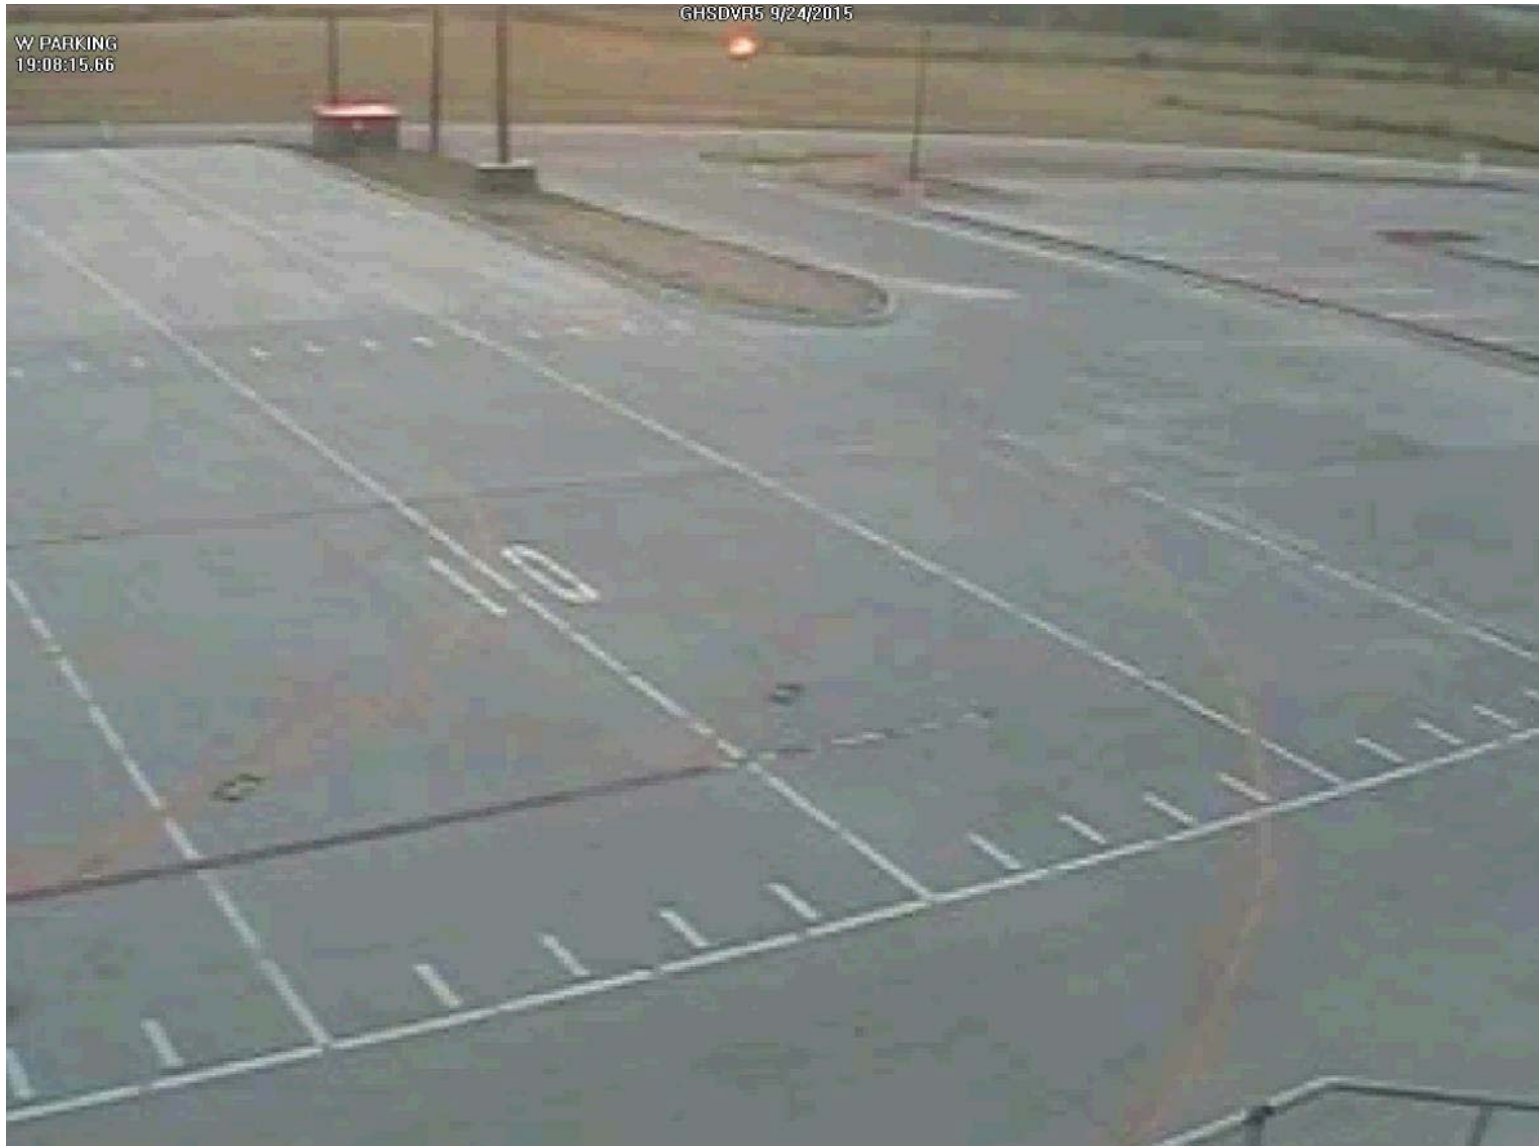
**1908:15.66 The airplane reappears in view and the first evidence of fire appears.**

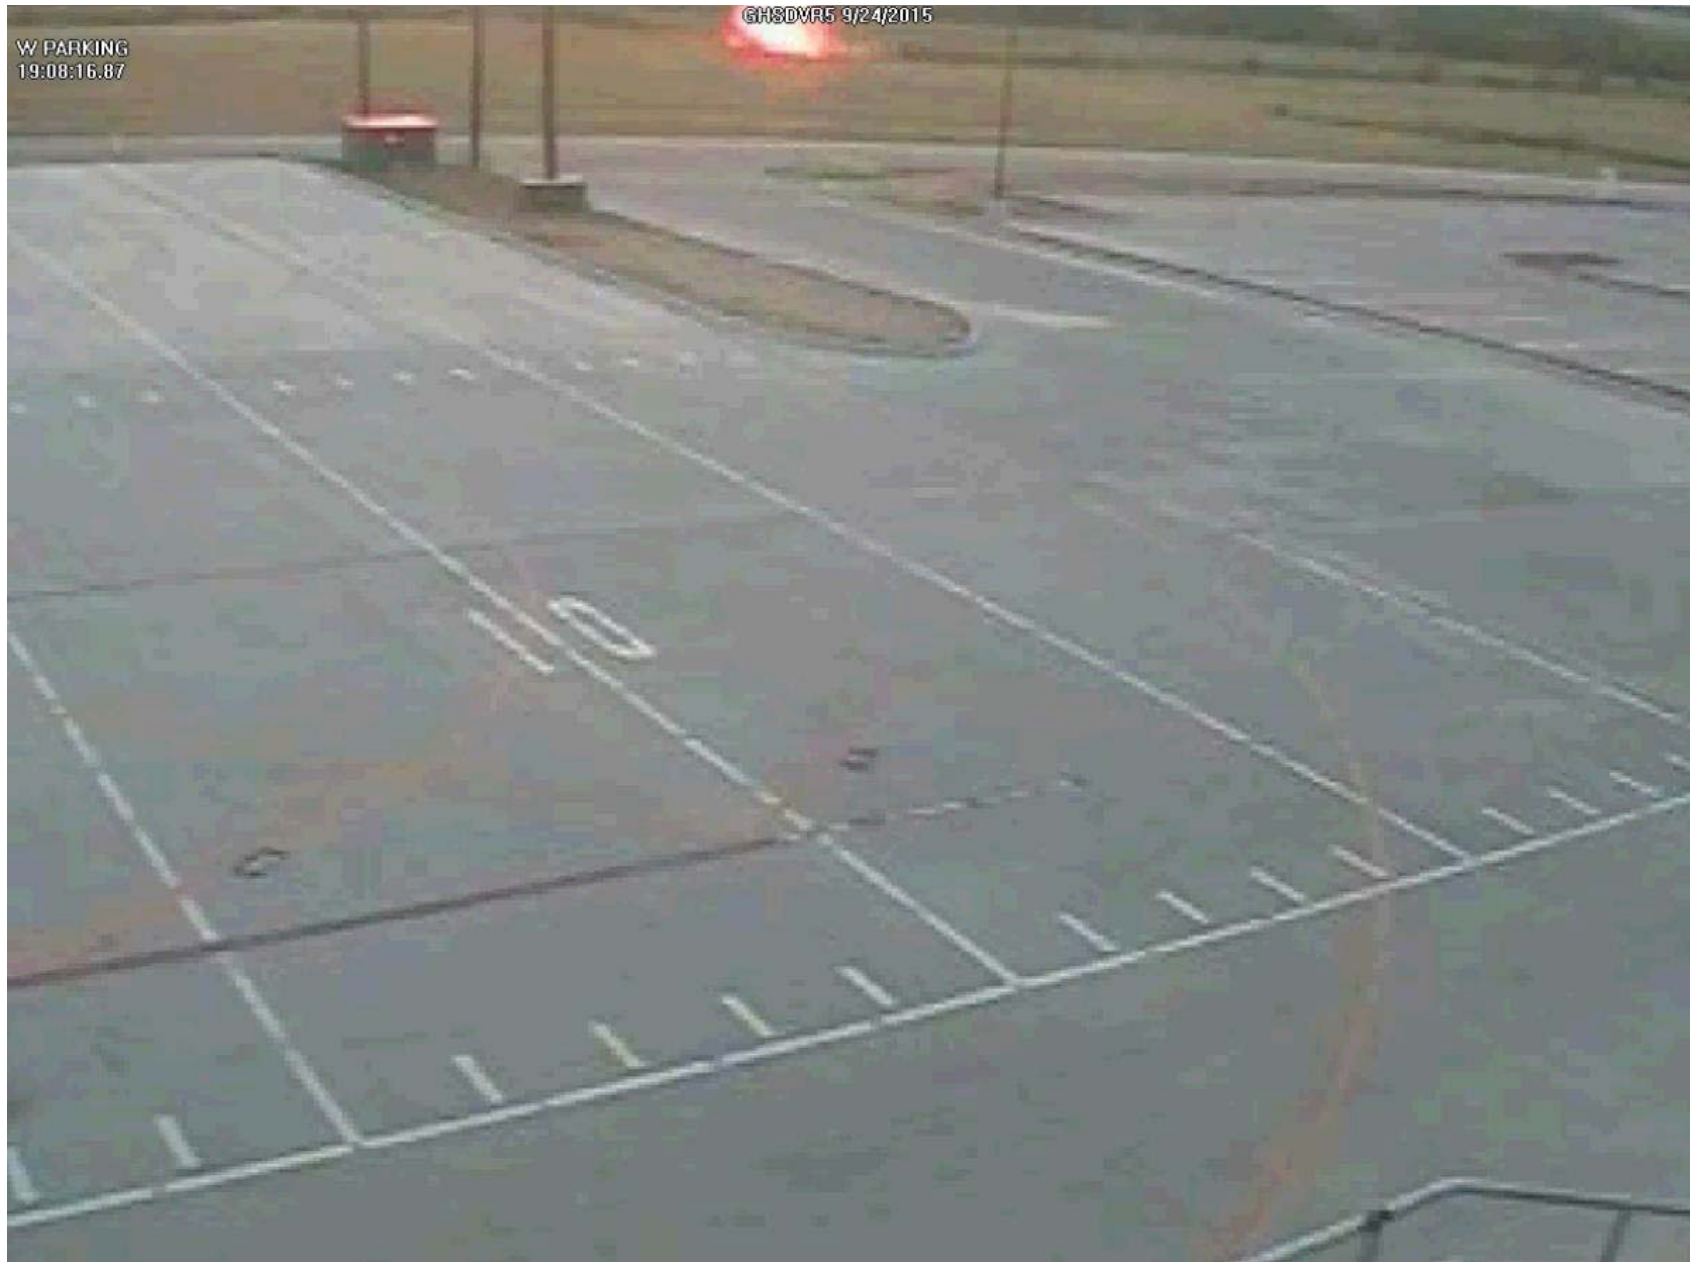
1908:18.87 The airplane is fully engulfed in fire.

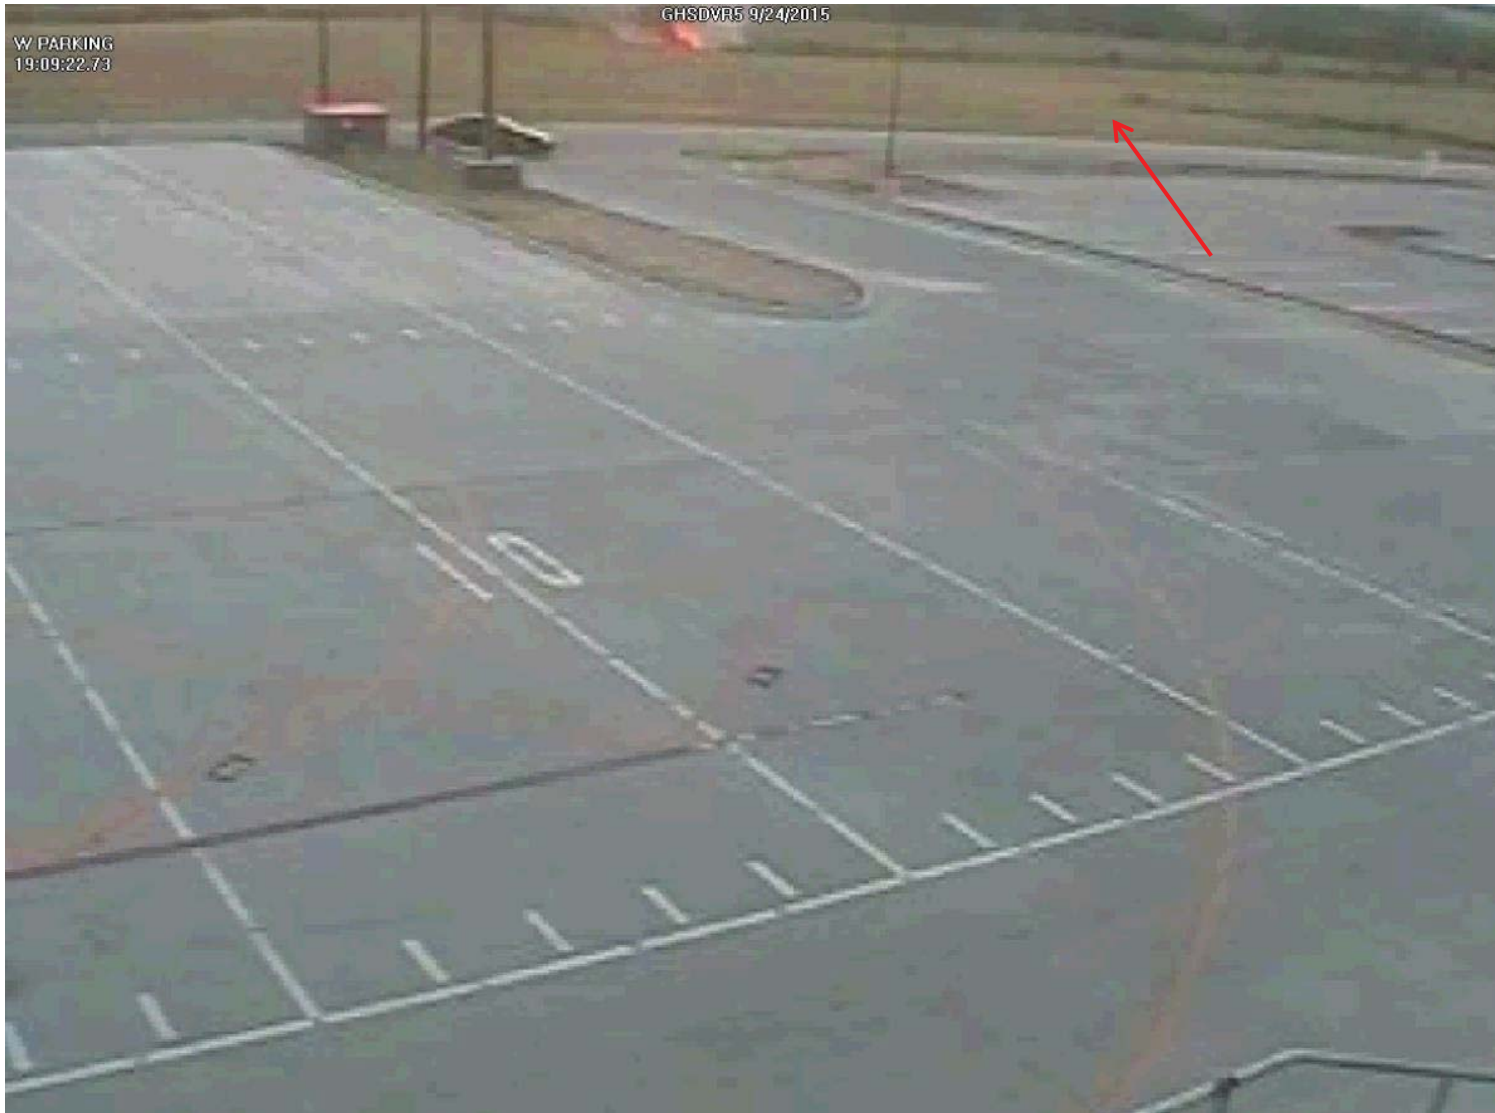
**1909:22.73 The fire continues to burn. One person can be faintly seen in the grassy area on the top right of the photo and is running toward the wreckage. An automobile has arrived and is stopped on the top left of the photo.**

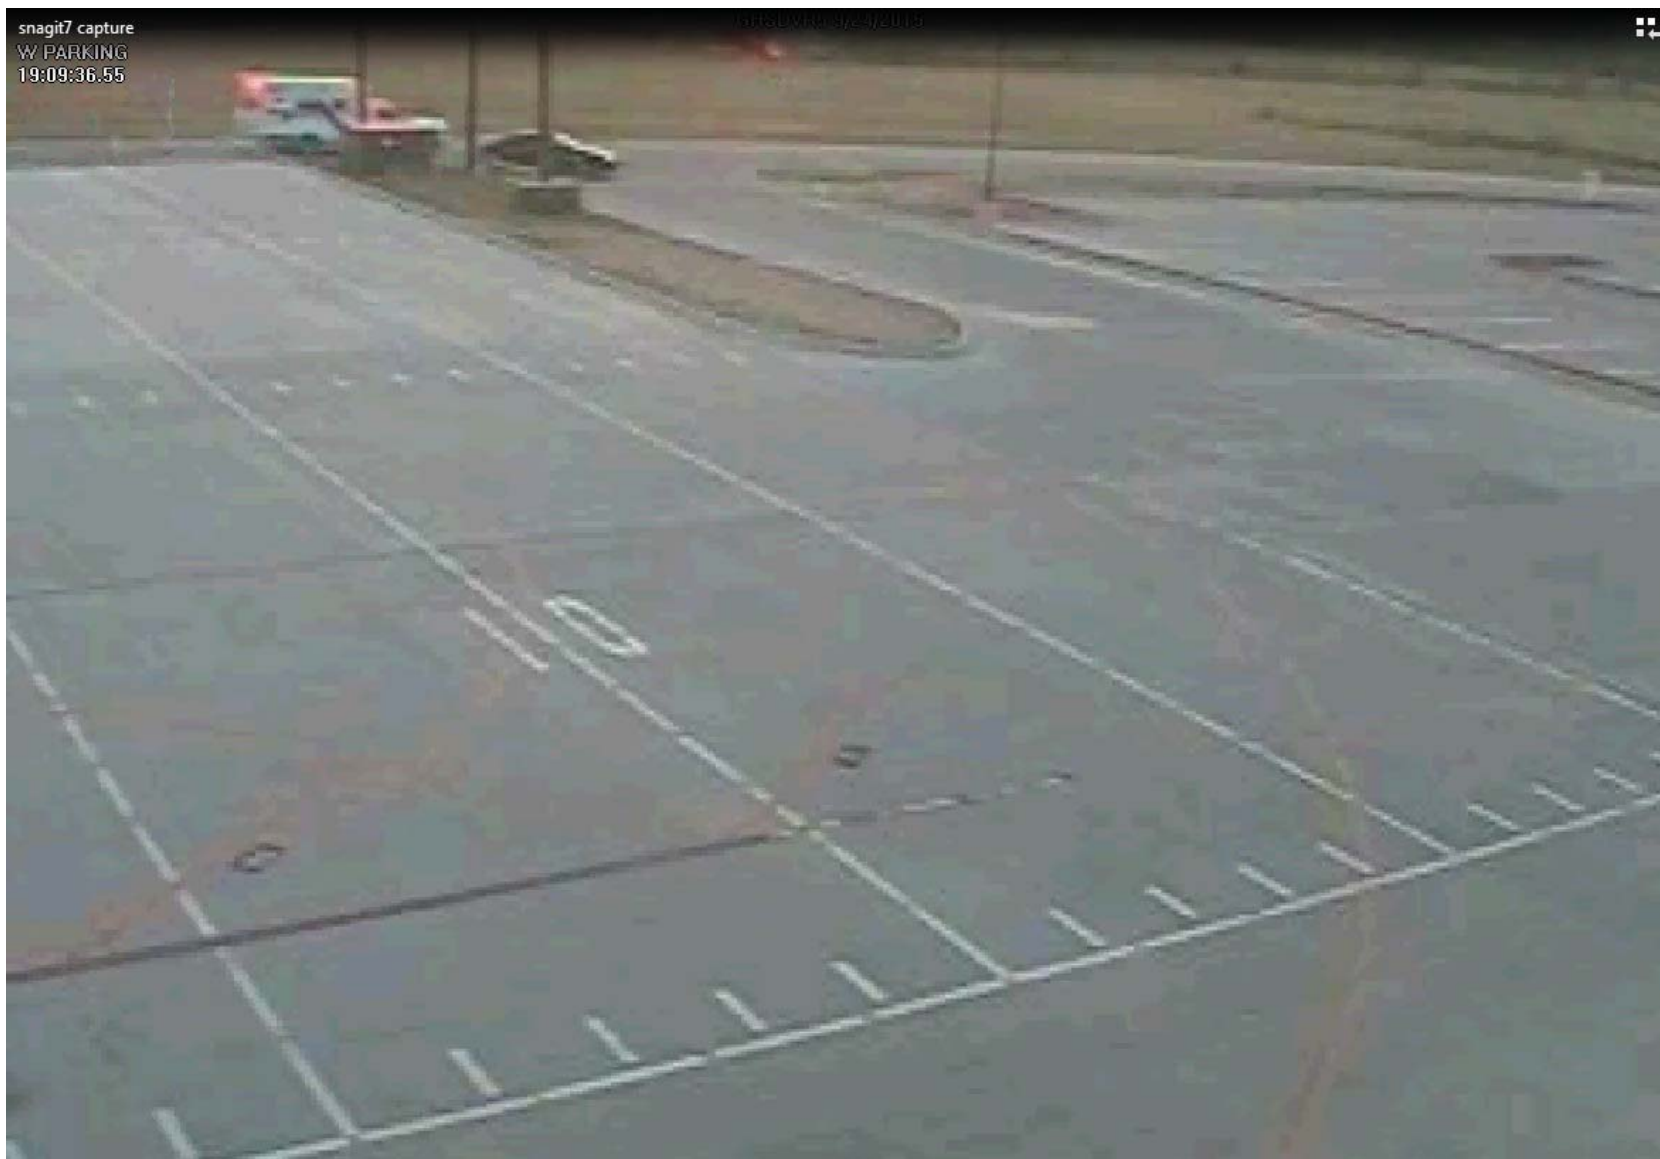
**1909:36.55** The first emergency vehicle appears in view on the top left, and is moving northbound, from left to right. Several persons are in the grassy area in the top right of the photo and are running toward the burning wreckage.
