# NATIONAL TRANSPORTATION SAFETY BOARD

## Global Positioning System Device

### Specialist's Factual Report

Location: Ama, Louisiana  
Date: September 26, 2015  
Aircraft: Zodiac CH-601-HD  
Registration: N401  
Operator: Private  
NTSB Number: CEN15FA426

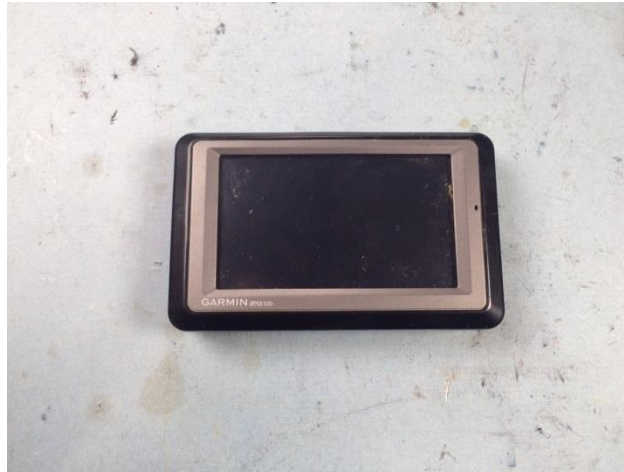
**Figure 1.** Front of Garmin Aera 500.

The device arrived with minimal damage and was in working condition. The device was connected to a PC via a USB cable and was downloaded normally using the manufacturer's recommended procedure and associated software. Figures 1 and 2 show the front and back of the device in the laboratory.

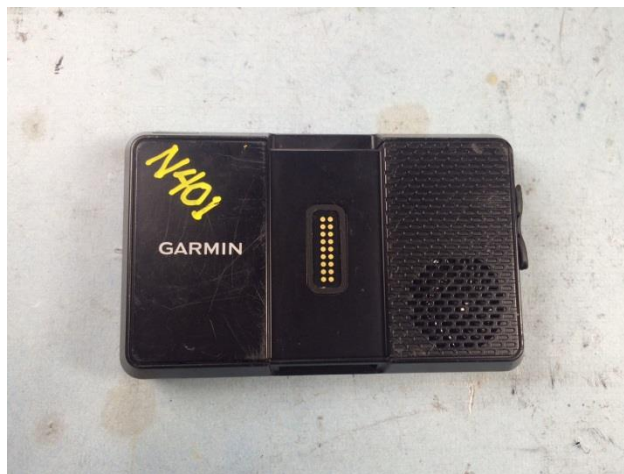
**Figure 2.** Rear of Garmin Aera 500.

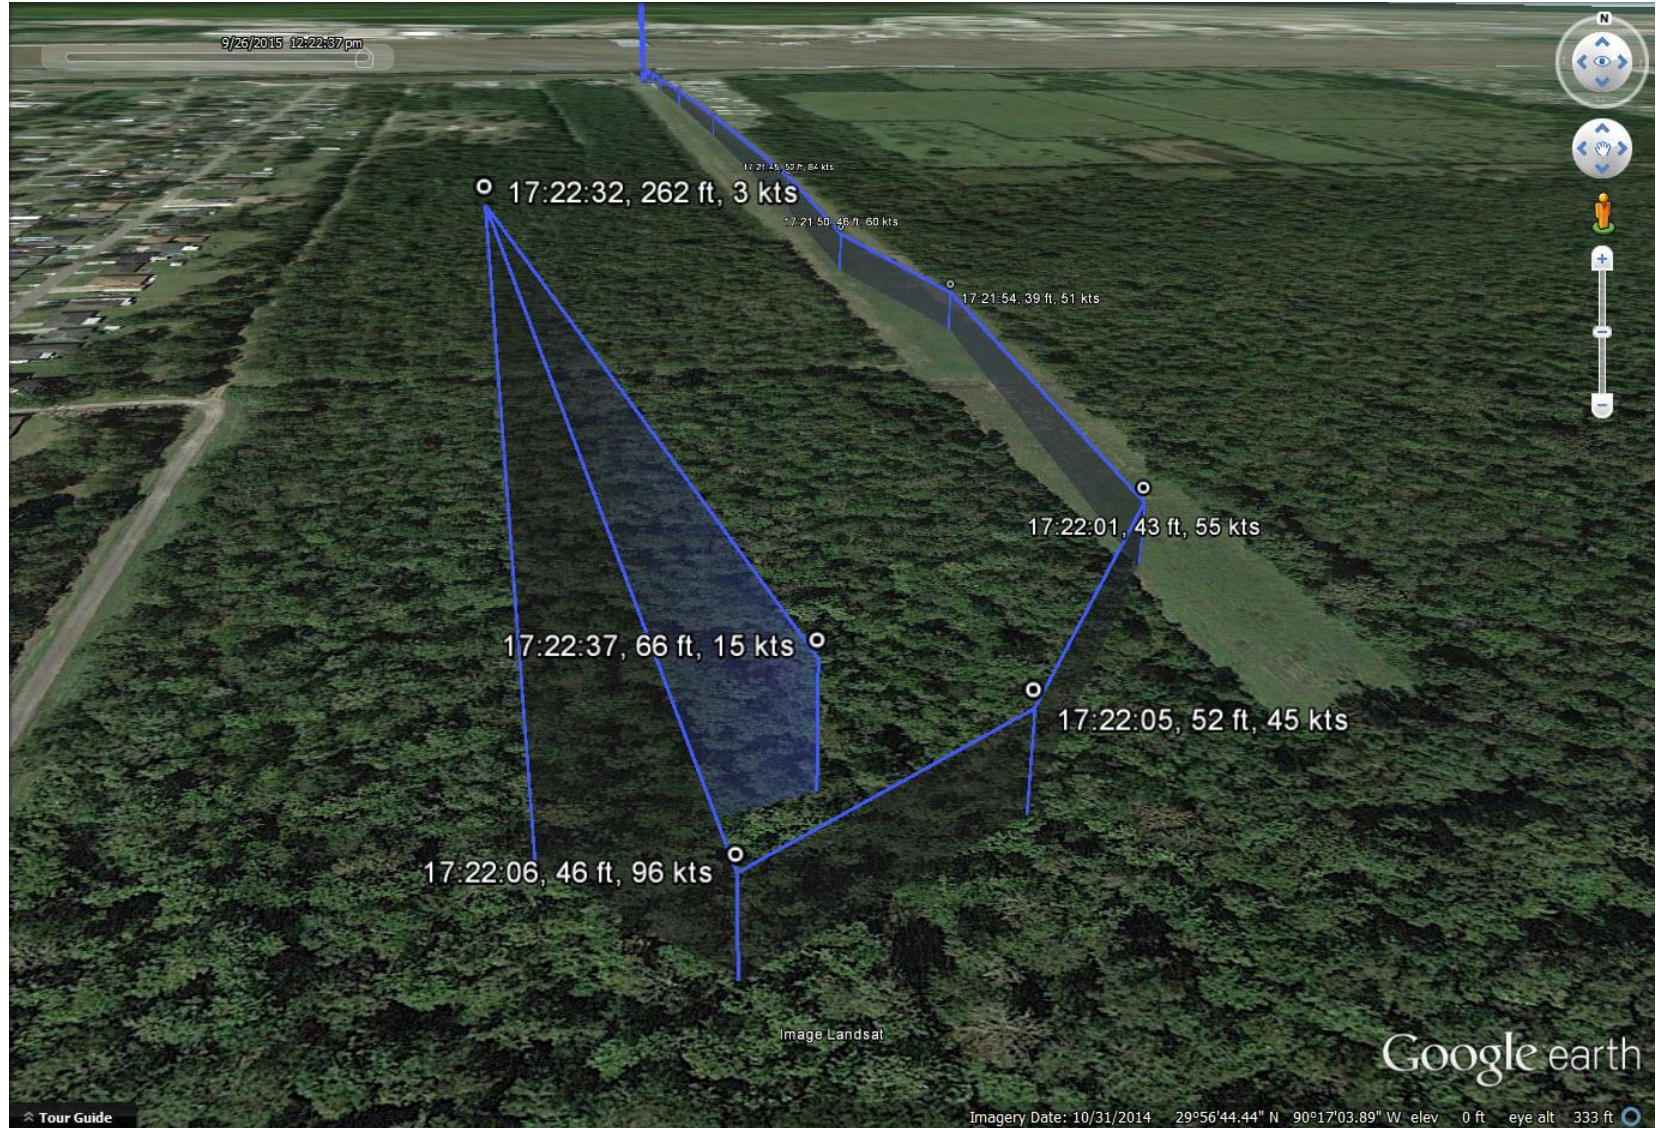
Figure 5 provides a 3 dimensional view of the accident recording looking down the aircraft's flightpath as it attempted a departure from LS40.

Figure 5. A 3 dimensional view of the accident tracklog from a perspective of the departure end of the runway.

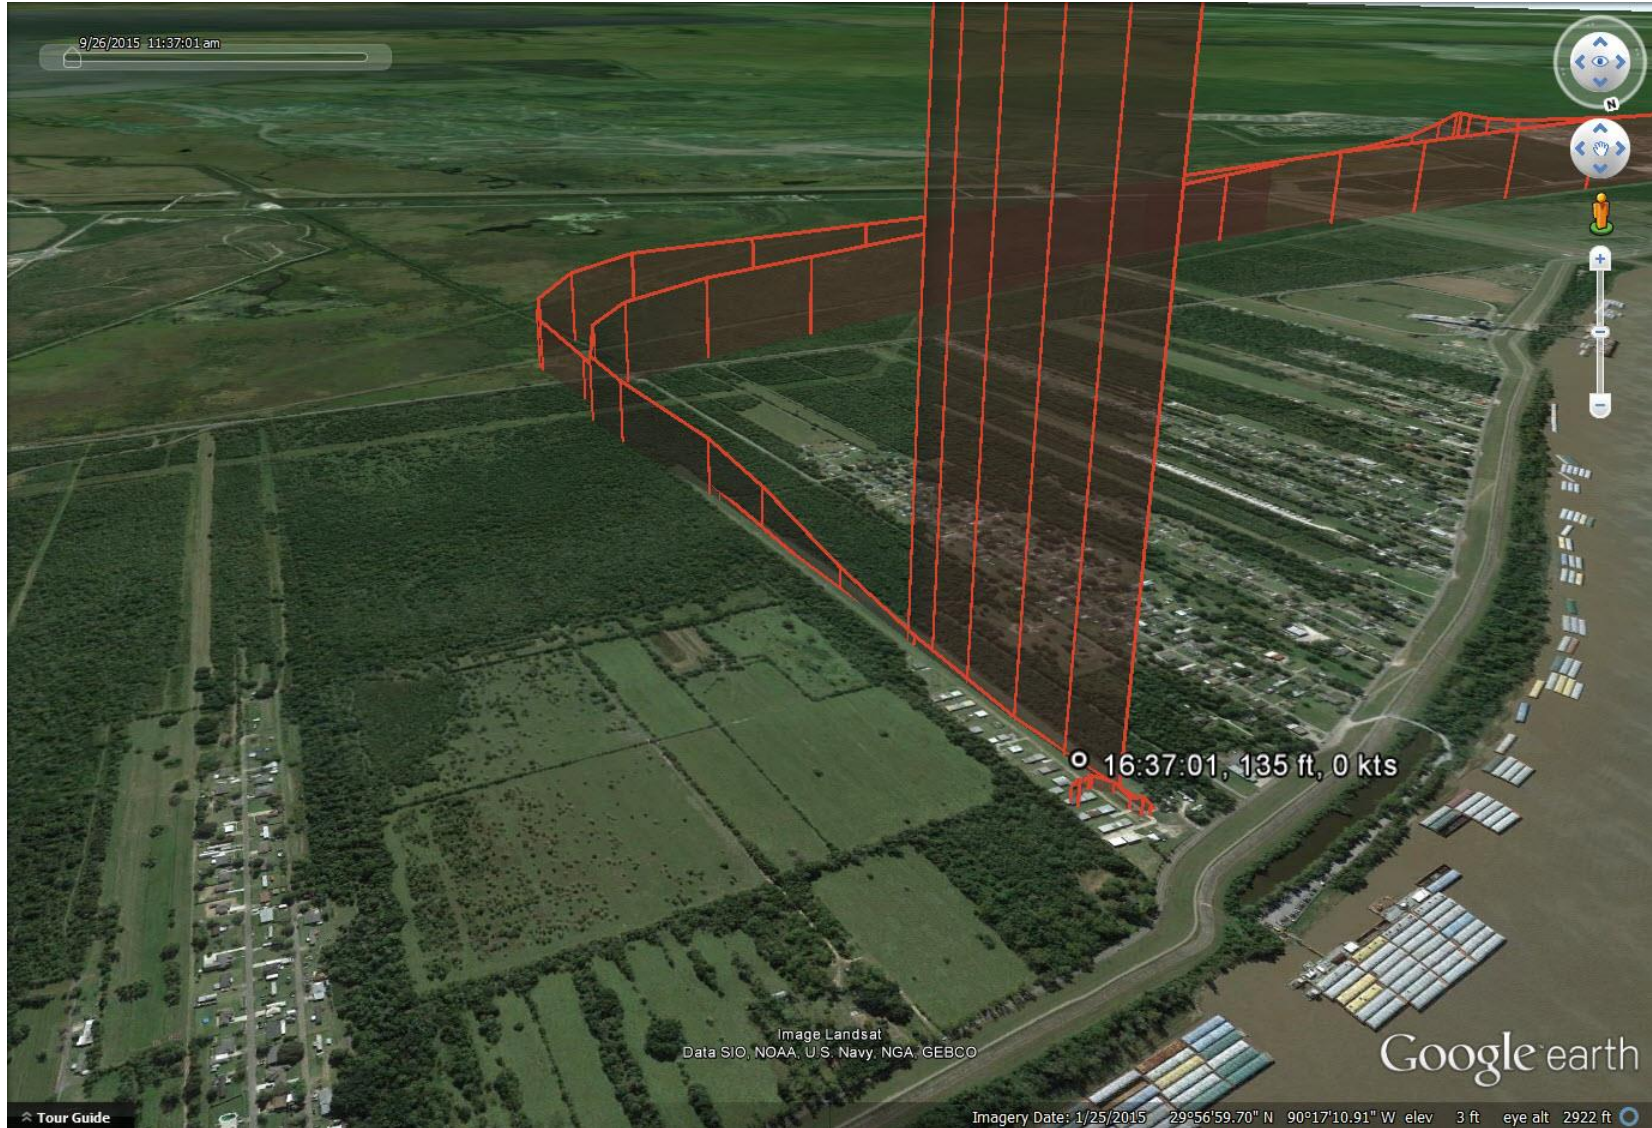
Figure 7 is a 3 dimensional view of the previous flight's departure and arrival sequence to and from LS40. The perspective is oriented in the south-southwesterly direction. The aircraft departed LS40 to the west and reversed course toward the east and made a landing in the opposite direction of its original departure.

Figure 7. A 3 dimensional view the departure and arrival leg of the previous flight. Perspective is toward the south-southwest. The first few recorded altitude positions were determined to be anomalous.

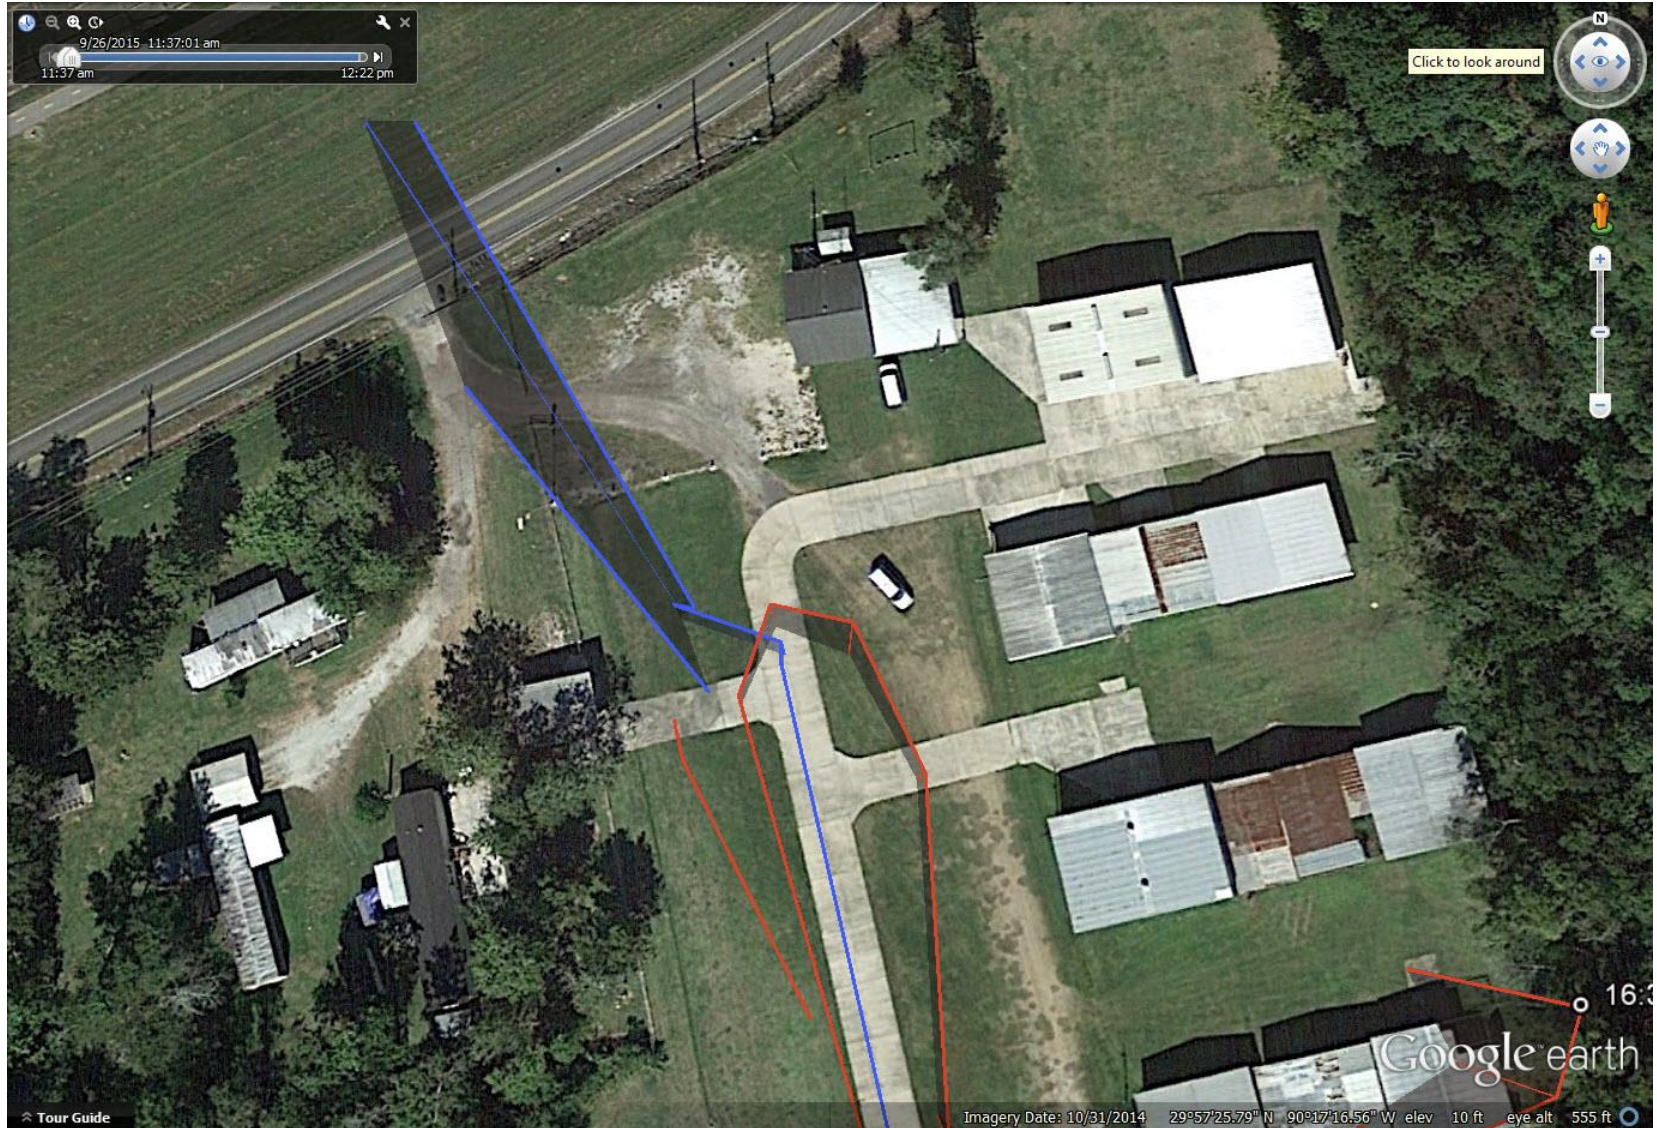
Figure 8 is a top down view of the both the tracklogs for the previous flight (red) and the accident flight's departure (blue). The previous flight tracklog shows the aircraft arrived in the opposite direction it departed. The previous flight tracklog ended a few feet west of the tenant occupied end of the runway at 16:53:39 and a new track log began at 17:19:02 in approximately the same position. Shortly thereafter, at 17:21:18, the aircraft departed LS40 on the accident flight.

**Figure 8. A north up, top down overview of both the previous flight's tracklog (red) and the accident flight's tracklog (blue). The two recordings show the previous tracklog ending and the accident flight tracklog beginning in the same area.**
