**NATIONAL TRANSPORTATION SAFETY BOARD**  
Vehicle Recorder Division  
Washington, DC 20594

## **Cockpit Displays – Recorded Flight Data**

**Specialist's Factual Report**  
**By George Haralampopoulos**

Location: Navasota, Texas  
Date: February 28, 2016  
Aircraft: Cirrus SR20  
Registration: N477TC  
Operator: Private  
NTSB Number: CEN16FA111

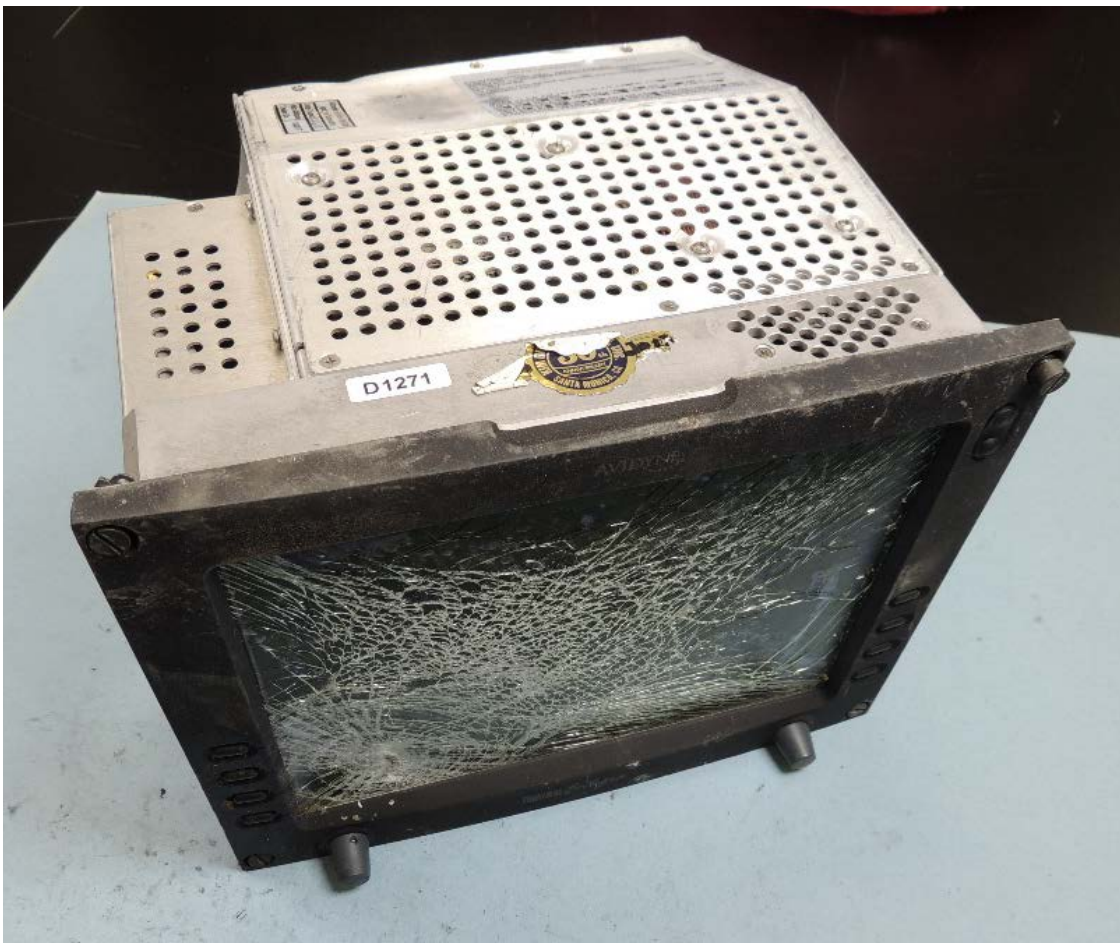
A visual inspection of the Avidyne PFD exterior revealed impact damage including a cracked screen (Figure 1). Additional effects of impact disabled the ability to read data from the PFD under normal procedures, so an extraction of the interior memory module was performed.

**Figure 1.** Avidyne PFD as received.

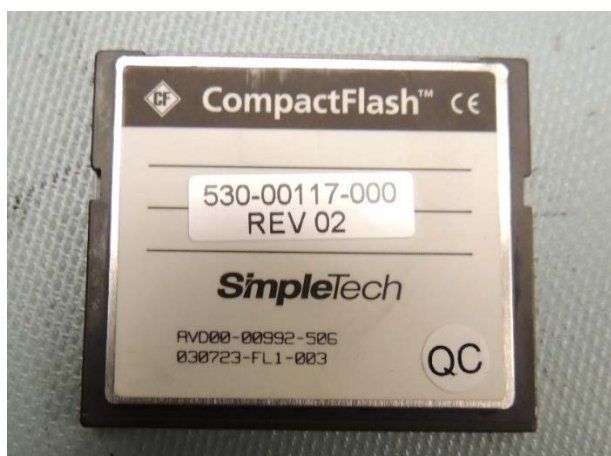
The internal CF memory card (Figure 3) from the Avidyne MFD had no exterior damage, however the memory card did not contain any data. While the MFD software included engine monitoring and recording capability, the aircraft was not equipped with an engine interface device.

**Figure 3.** Internal CF Card from Avidyne MFD.
