# Continental Motors

## ENGINE RUN REPORT

| ENGINE MODEL | IO-520-CB9 |
| FILE NUMBER | 15-438 |

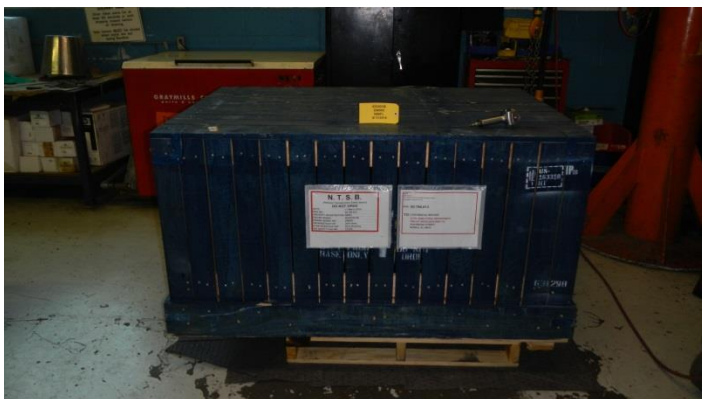
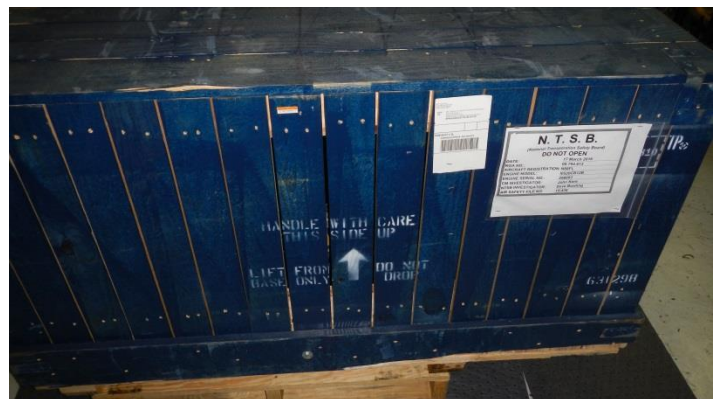
The crate was removed from the storage facility and it was apparent that oil had leaked from the bottom of the crate. The top of the crate was removed and the engine was documented. The engine was removed from the crate and the oil sump quick drain plug was found extended and residual oil was dripping from the plug. The oil dipstick registered only residual oil on the tip. No other external anomalies were observed with the engine components. The throttle body was covered with a bag and the oil seal retainer plates had been removed by the crating facility to facilitate crankshaft placement on a wooden crutch inside the crate.

The airframe components, such as the exhaust gas and cylinder head temperature probes/wires, airframe mount, and cooling baffles remained attached to the engine. The throttle body/fuel metering unit was removed to accommodate the removal of the airframe mount; however, no adjustments were made and the original components were reinstalled for the engine run. The throttle lever and mixture controls remained secured to their respective shafts.

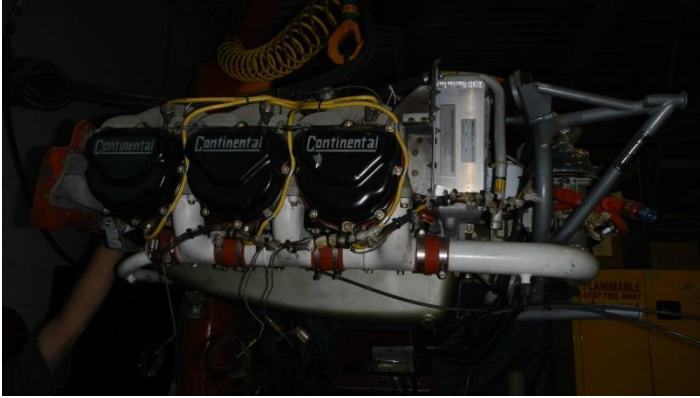
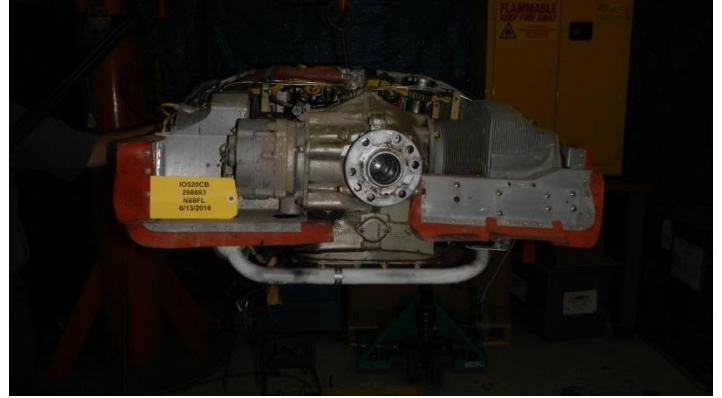
The top sparkplugs were removed from their respective cylinders and a lighted borescope was used to inspect and document the internal components. No pre-accident anomalies or signs of operational distress were noted on any of the components.

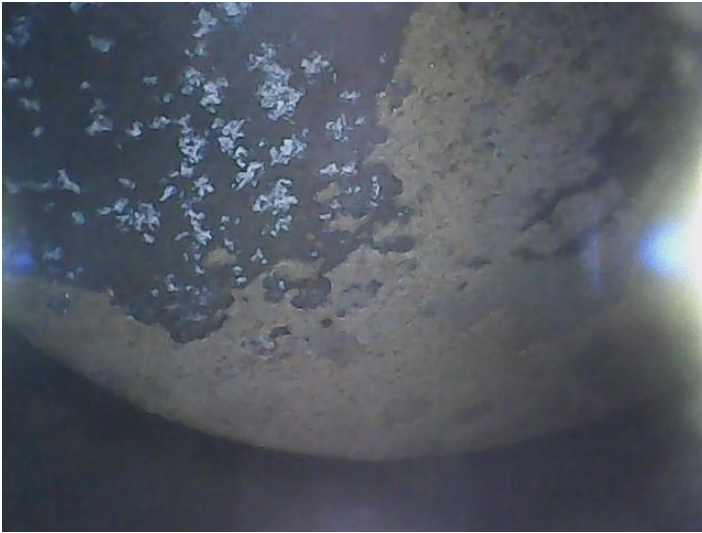
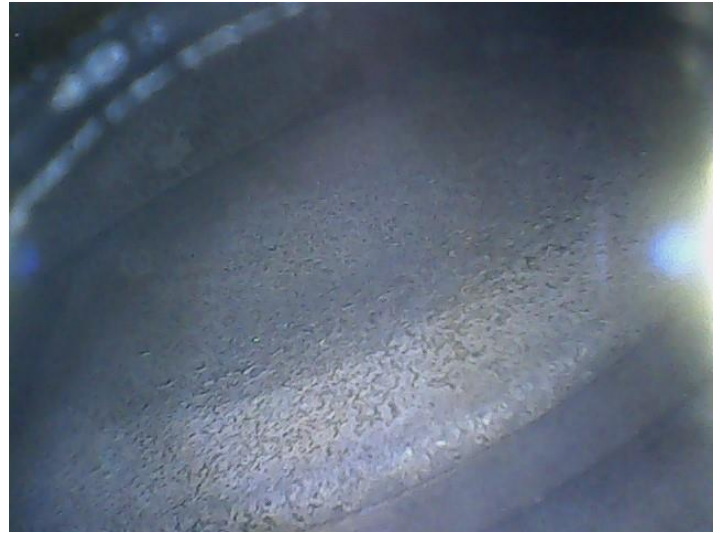
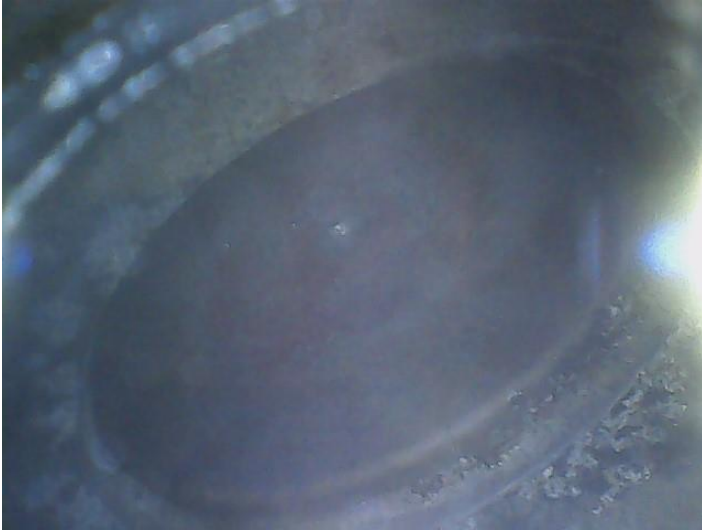
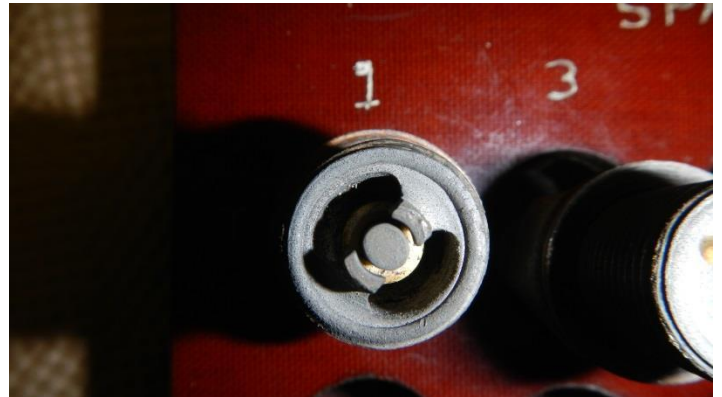
Cylinder #1

**NOTE:** The photos that follow the cylinder number represent that cylinder's piston, intake valve, exhaust valve, and top sparkplug, in that order, unless otherwise specified.

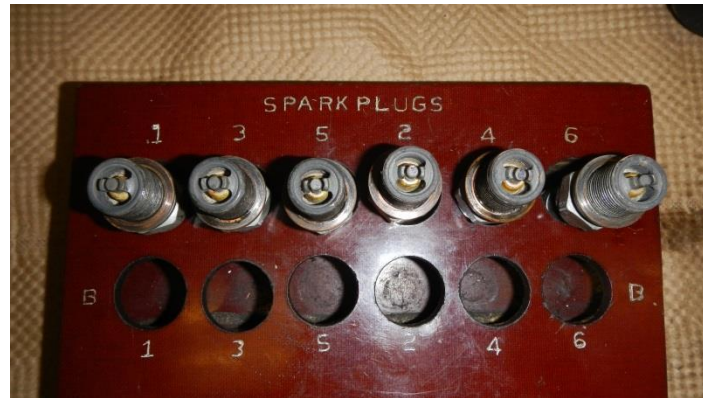
The sparkplugs were examined following the test run and no anomalies were noted.
