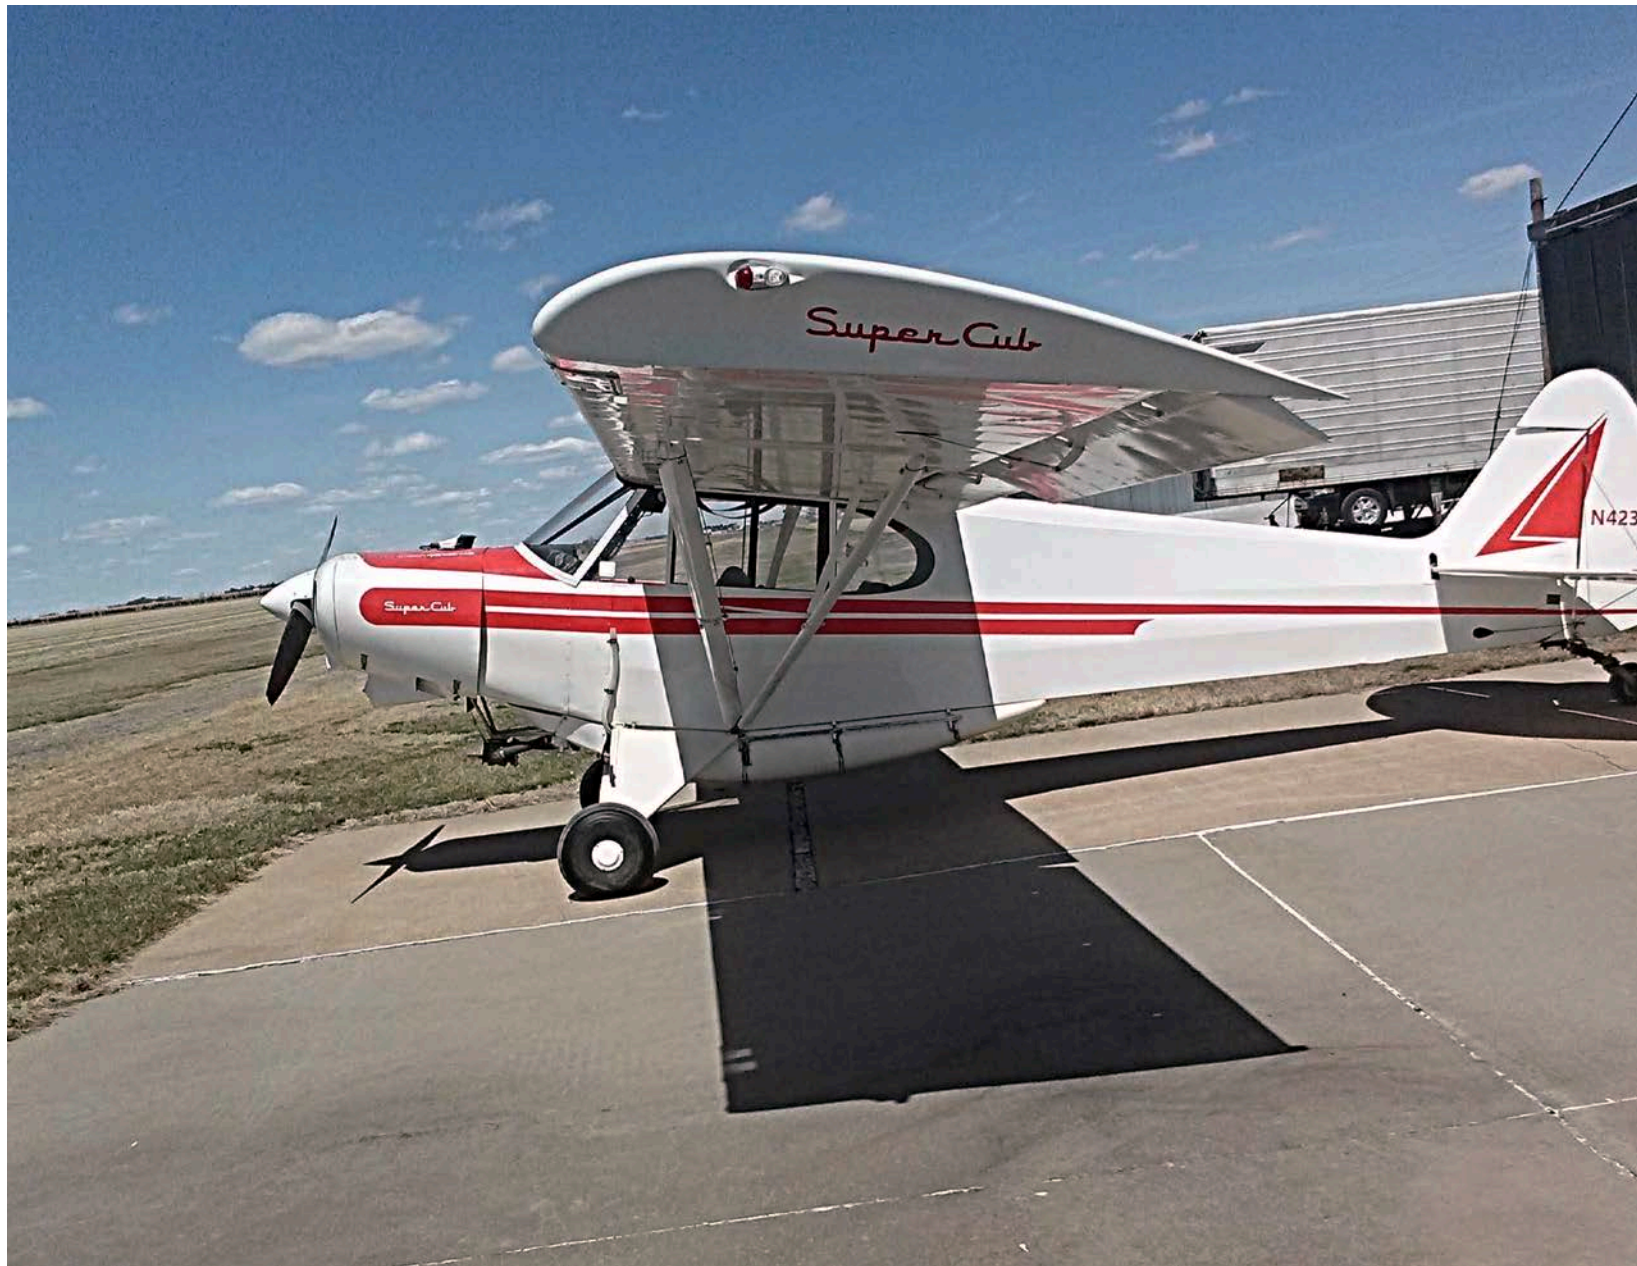
**Photo 1 – Pre-accident photograph of N4234Z, showing a 90-gallon Sorensen tank on bottom of fuselage. The front of the tank is about 2 inches aft of the front of the landing gear leg.**

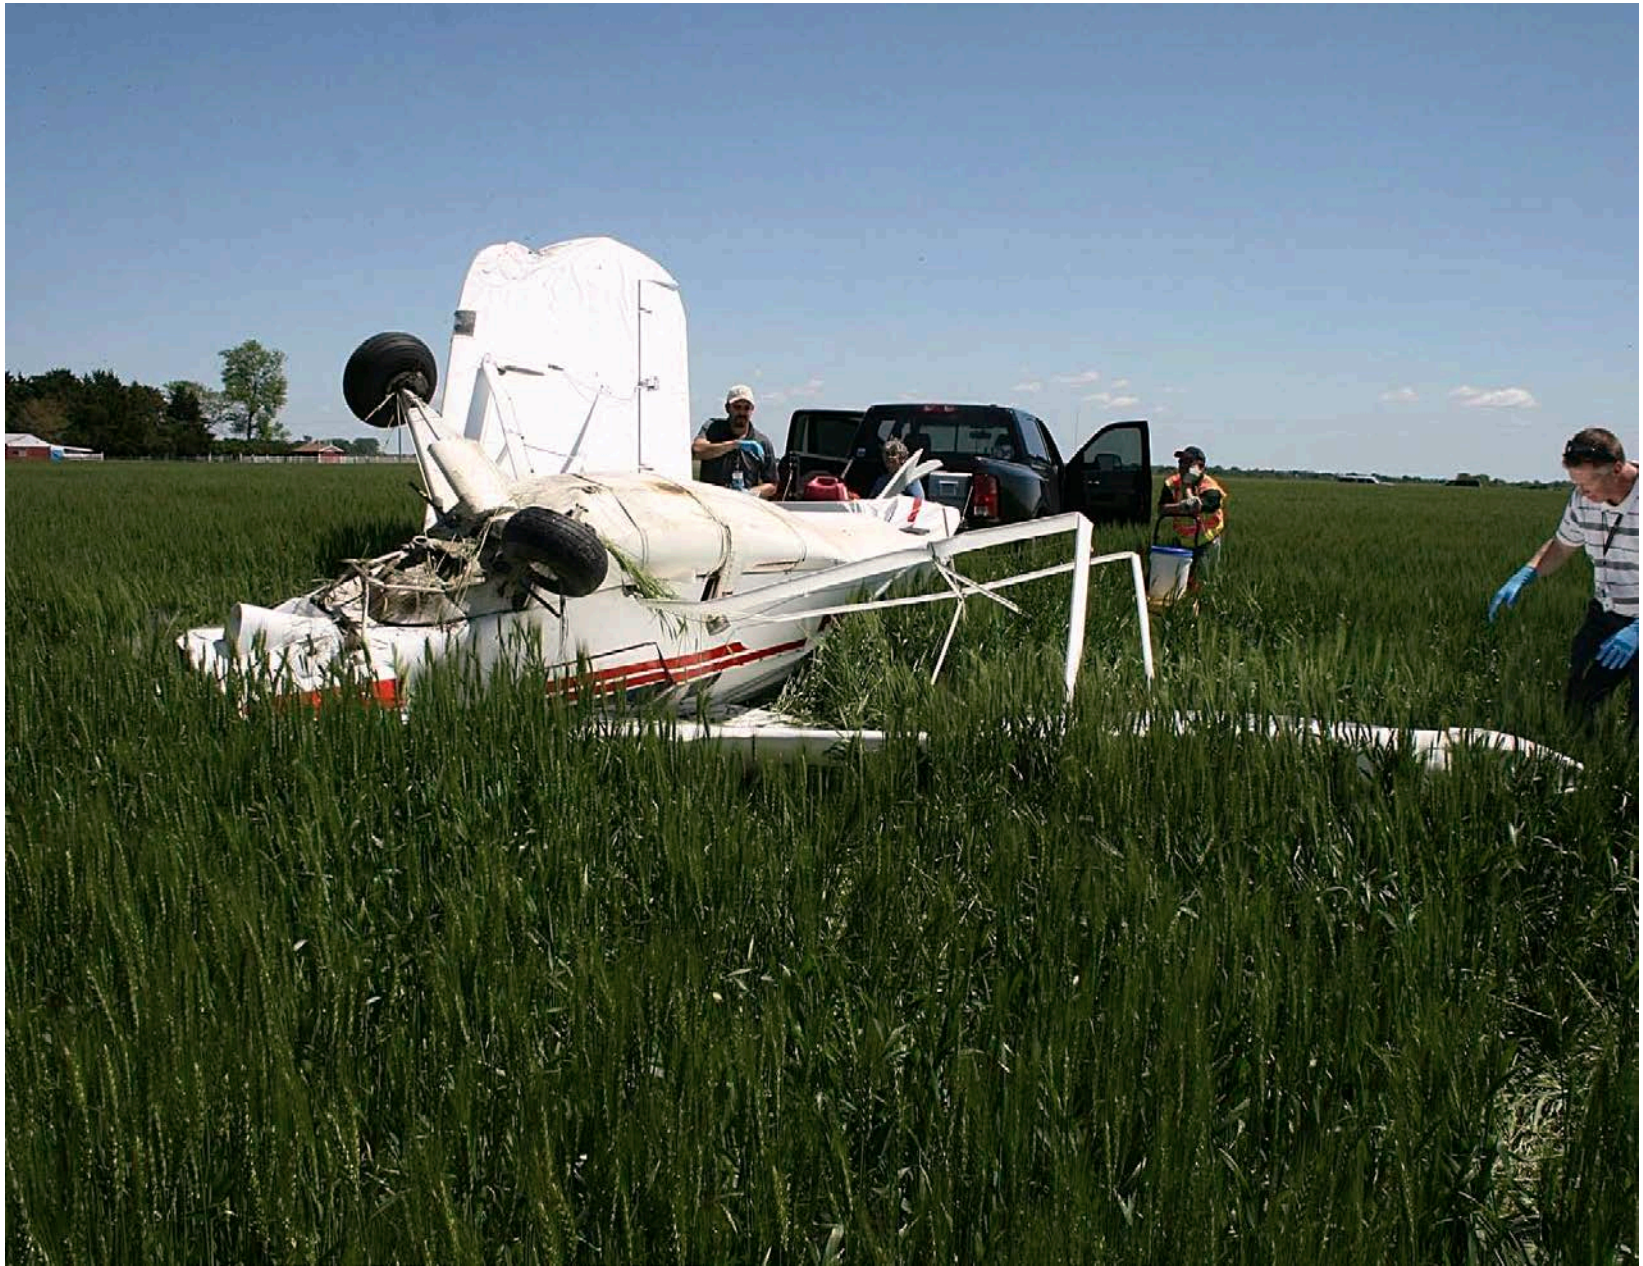
**Photo 2 – N4234Z at the accident site.**
