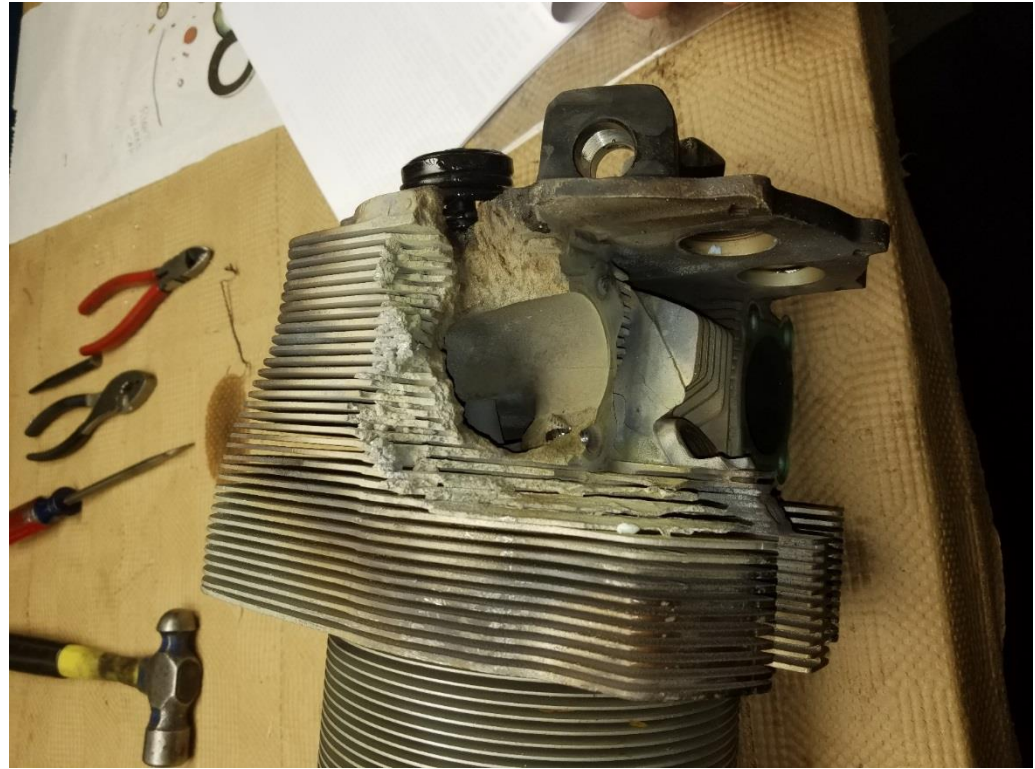
# Observed cylinder

The cylinder exhibited witness marks consistent with exhaust gas erosion.

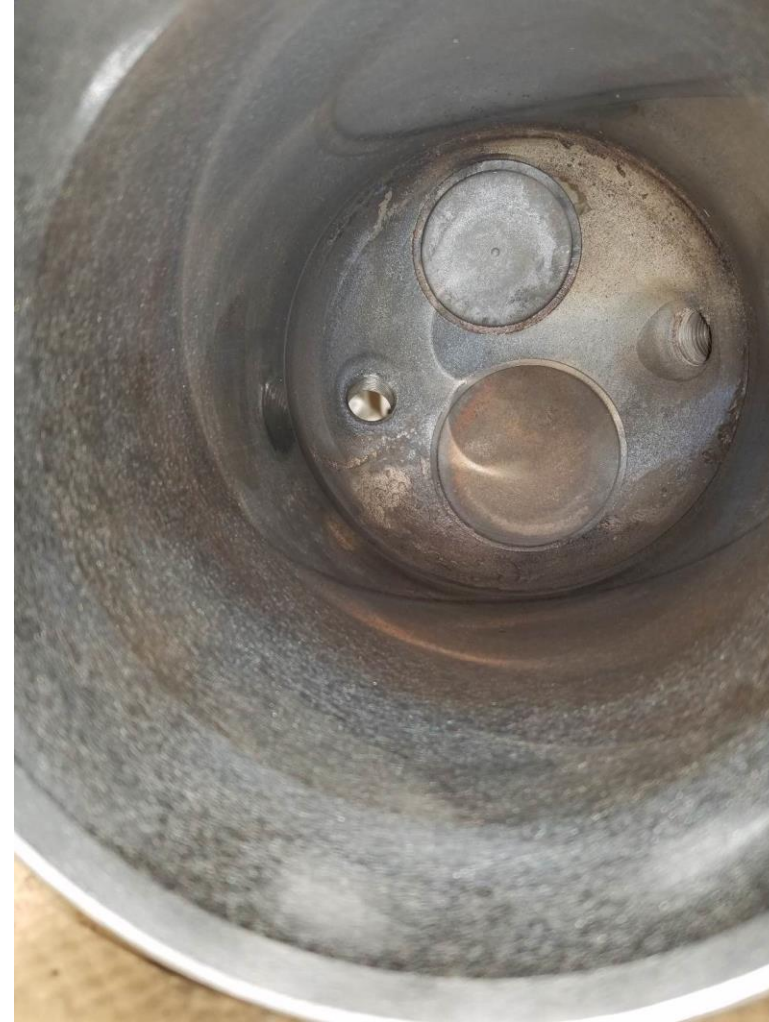
# Inside cylinder

No damage inside cylinder other than around valve. No hotspots on valves consistent with normal induction/combustion.

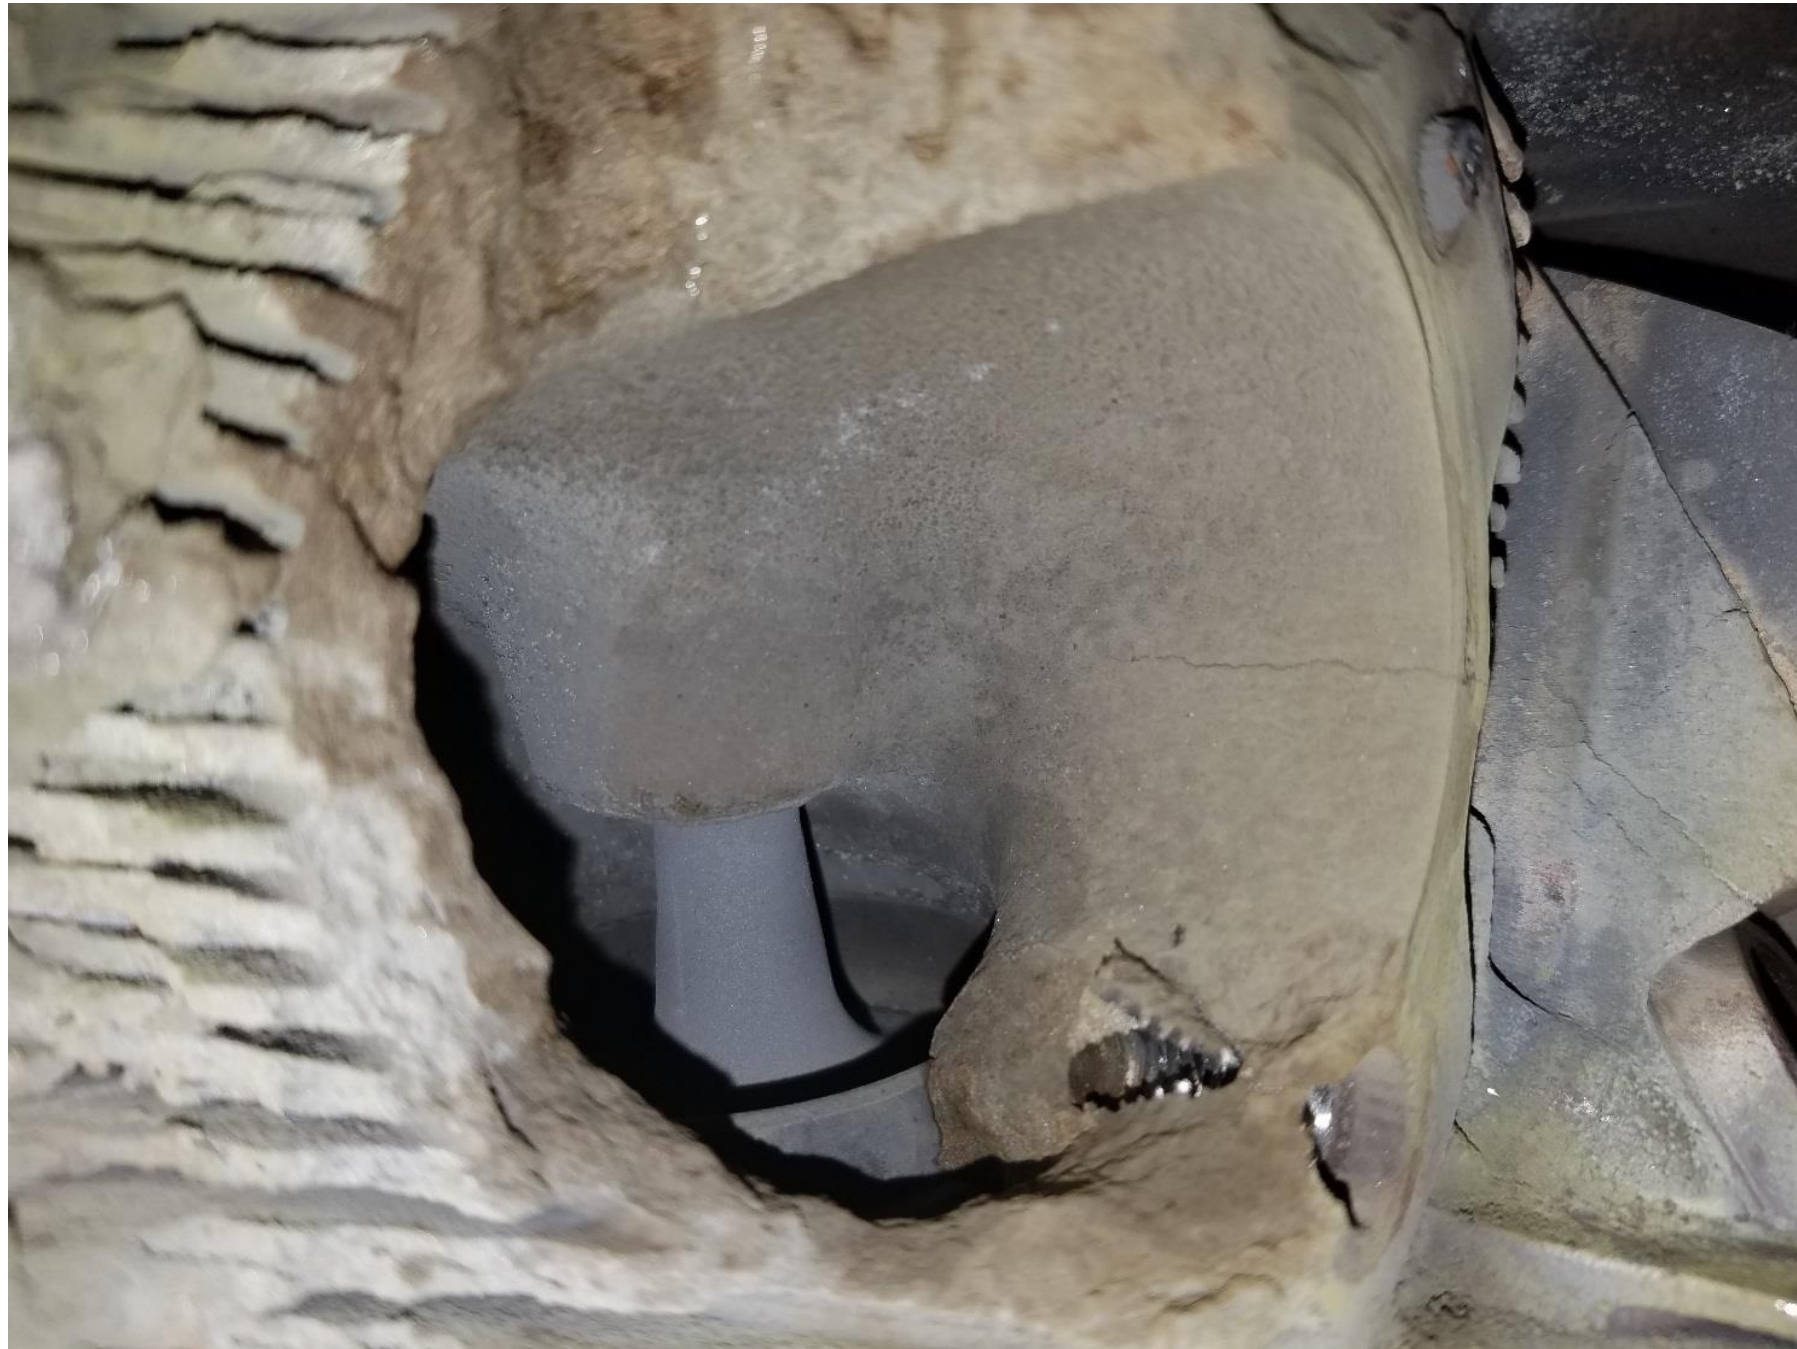
# Observed cracks

There was a crack present consistent with thermal shock cooling. Cracks at room temperature are hard to detect by dye penetrant methods. Cracks will open when applied power produces heat and exhaust gases subsequently erode through the softer aluminum that makes up the cylinder.
