**From:** SAM TABER [REDACTED]  
**Sent:** Thursday, July 21, 2016 9:20 AM  
**To:** Aguilera Jason  
**Subject:** Re: Corsair brake master pics

**From:** SAM TABER [REDACTED]  
**Sent:** Wednesday, July 20, 2016 4:53 PM  
**To:** Yank, Ray P (FAA)  
**Subject:** Corsair brake master pics

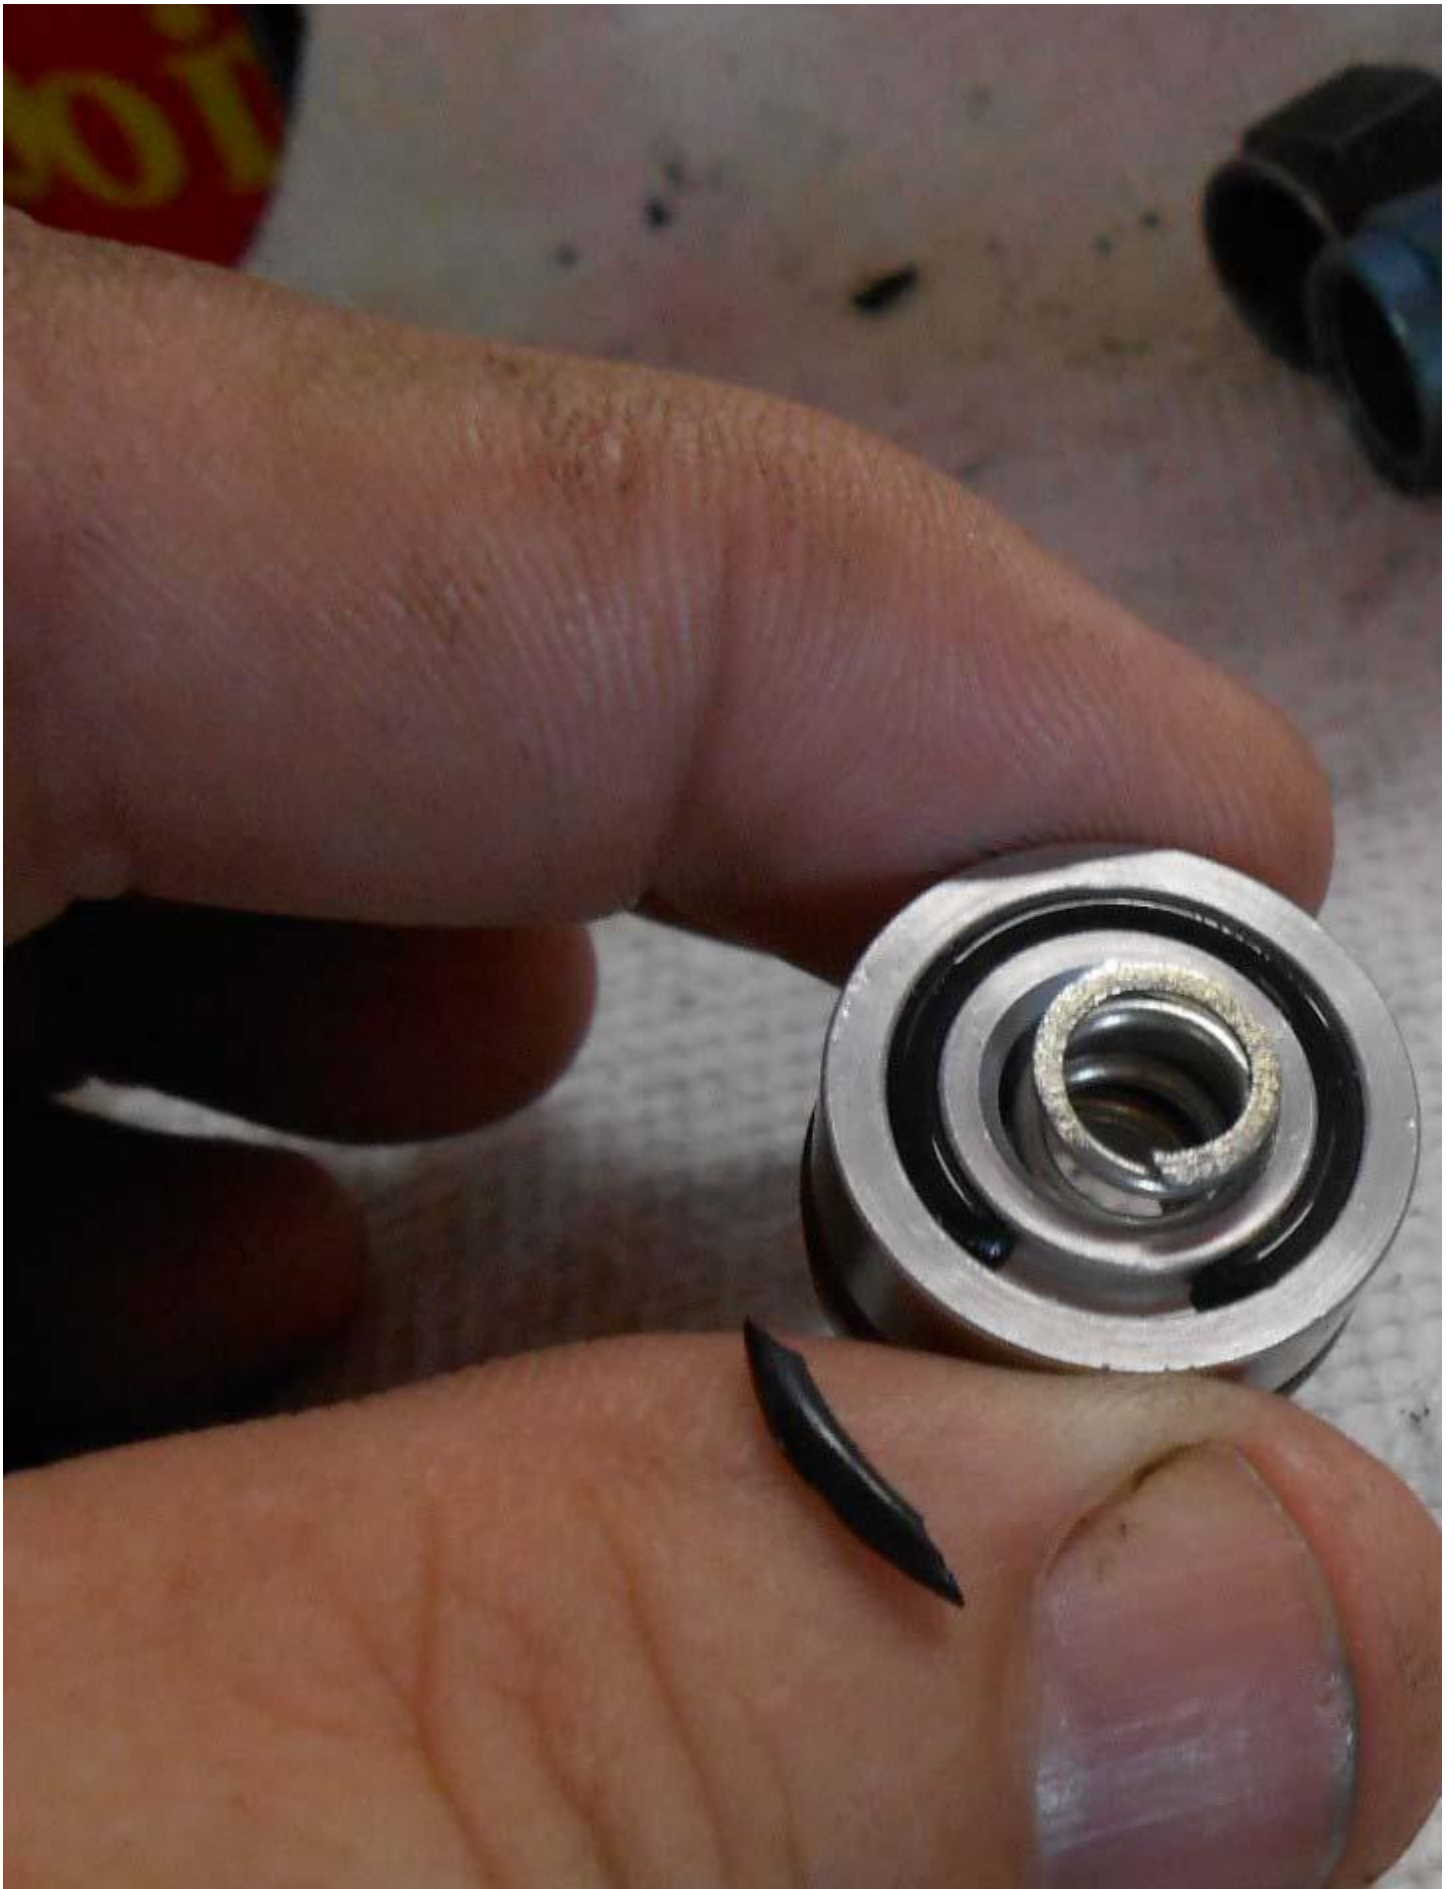
He described "loosing" the Left pedal pressure. The photos you have are of the Left master failure of that landing.

I will attach a photo which shows Both sheared o rings FYI.

Here is a photo of the brake problem. I am pinching the Left master piston assy. The black o ring is sheared and the shaved off part is sitting on my thumb.

I cannot say why this o ring failed the way it did but it had to happen by the o ring coming out of the groove for some reason and then getting pinched ( and cut) which would compromise the brake supply pressure by bypassing fluid ( pedal going down).

The brake builder informed me that the original 5606 will not work in the brake due to high operating temps of the brake and he wanted us to use Royco 782 High Temp synthetic fluid Mil PRF-83282. (Nice to know after the fact ! ST)

The system was drained and flushed per instructions and filled with Royco 782. Last Thurs 7/14 I taxied the aircraft about 8000' with "S" turn braking, crosswind taxi , high sped taxi to full stop and all normal ground operations . No issues or hesitation with the brakes at all. Note: I also did a full pressure pedal push to simulate a full locked brake to pressure test system prior to taxi tests.
