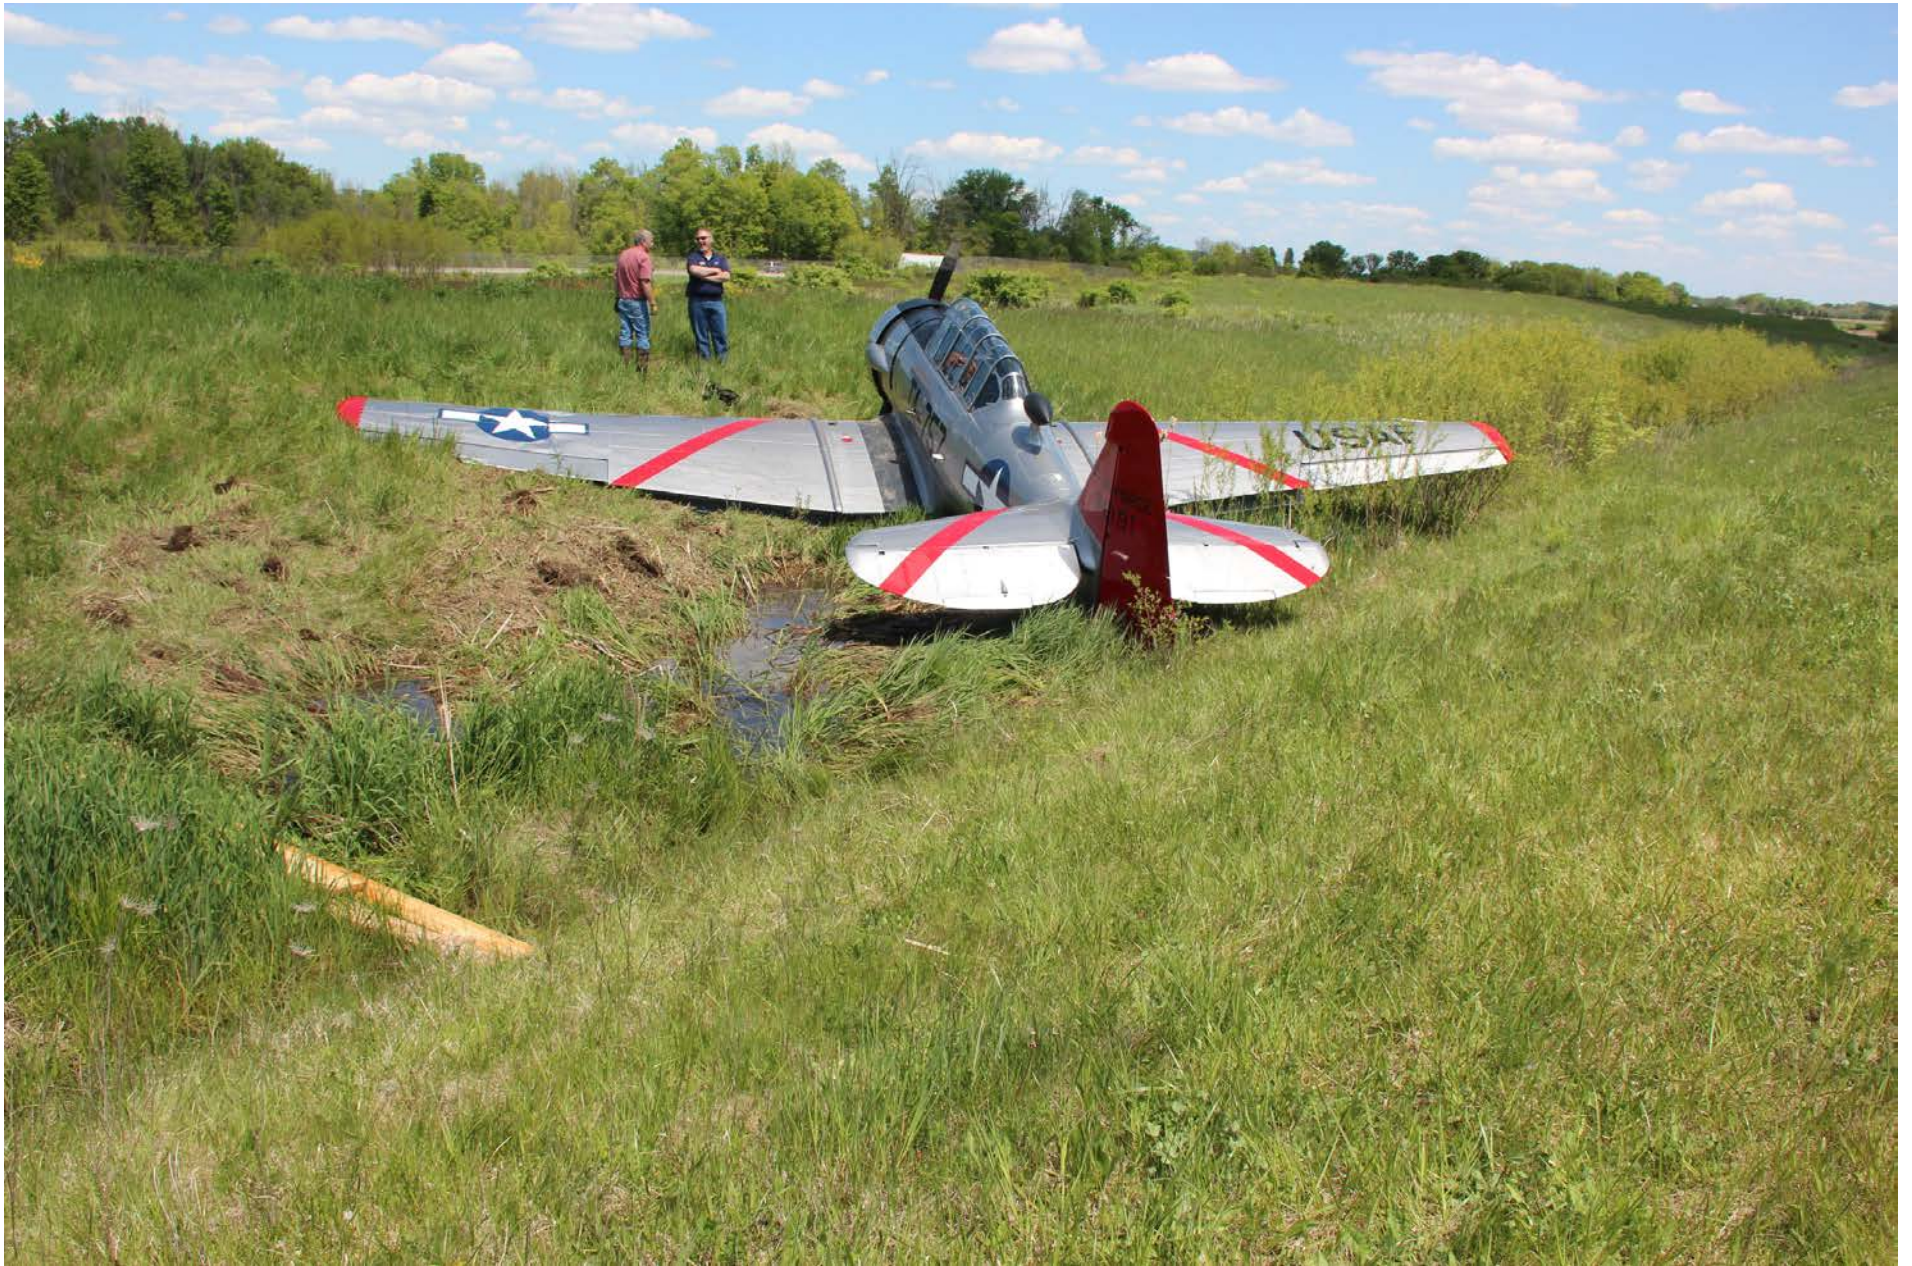
**Photo 1 – Accident airplane as it came to rest in ditch.**

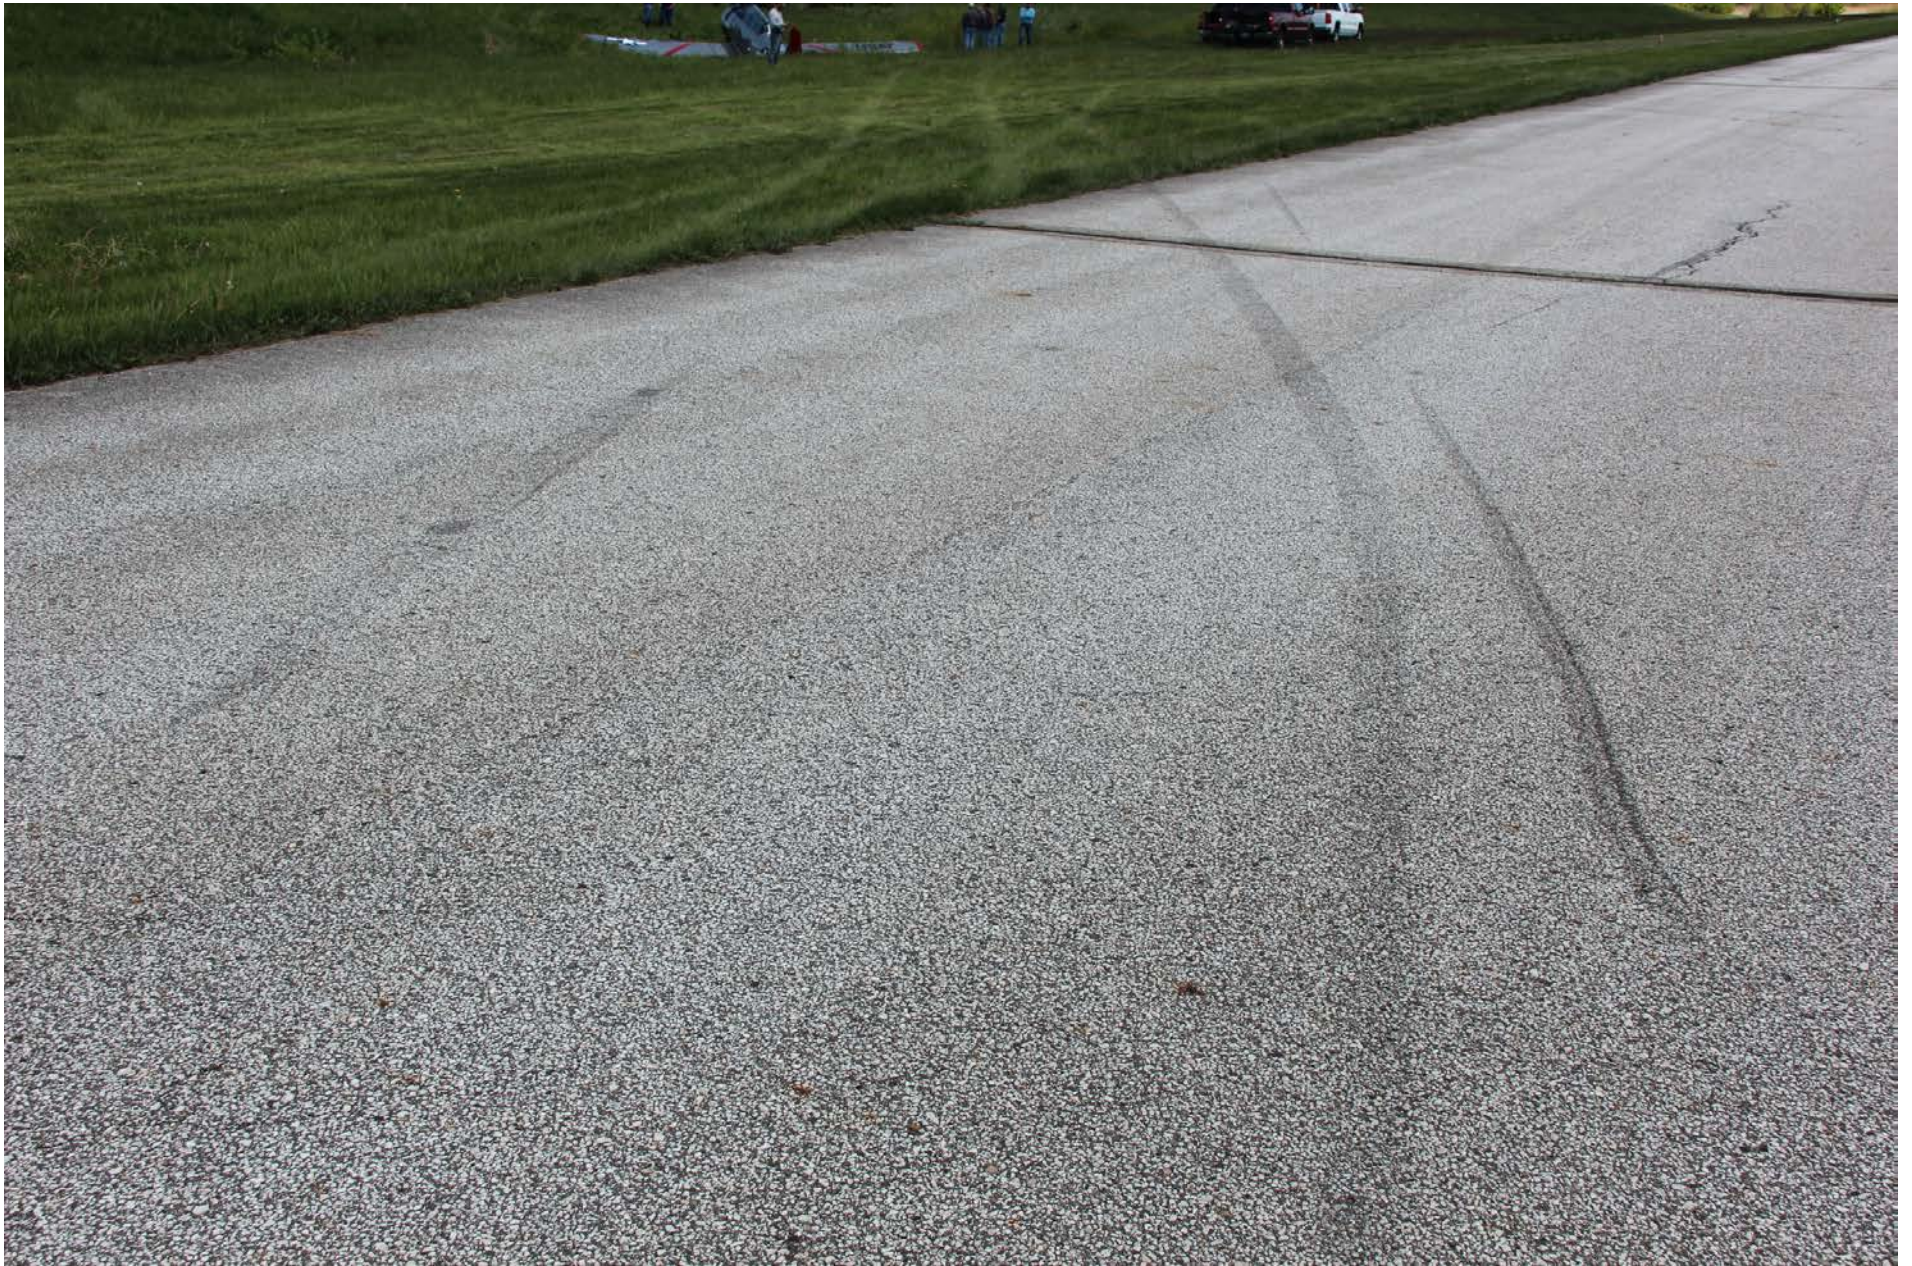
**Photo 2 – Tire markings on runway, leading into the grass off the runway surface to the location of the airplane.**

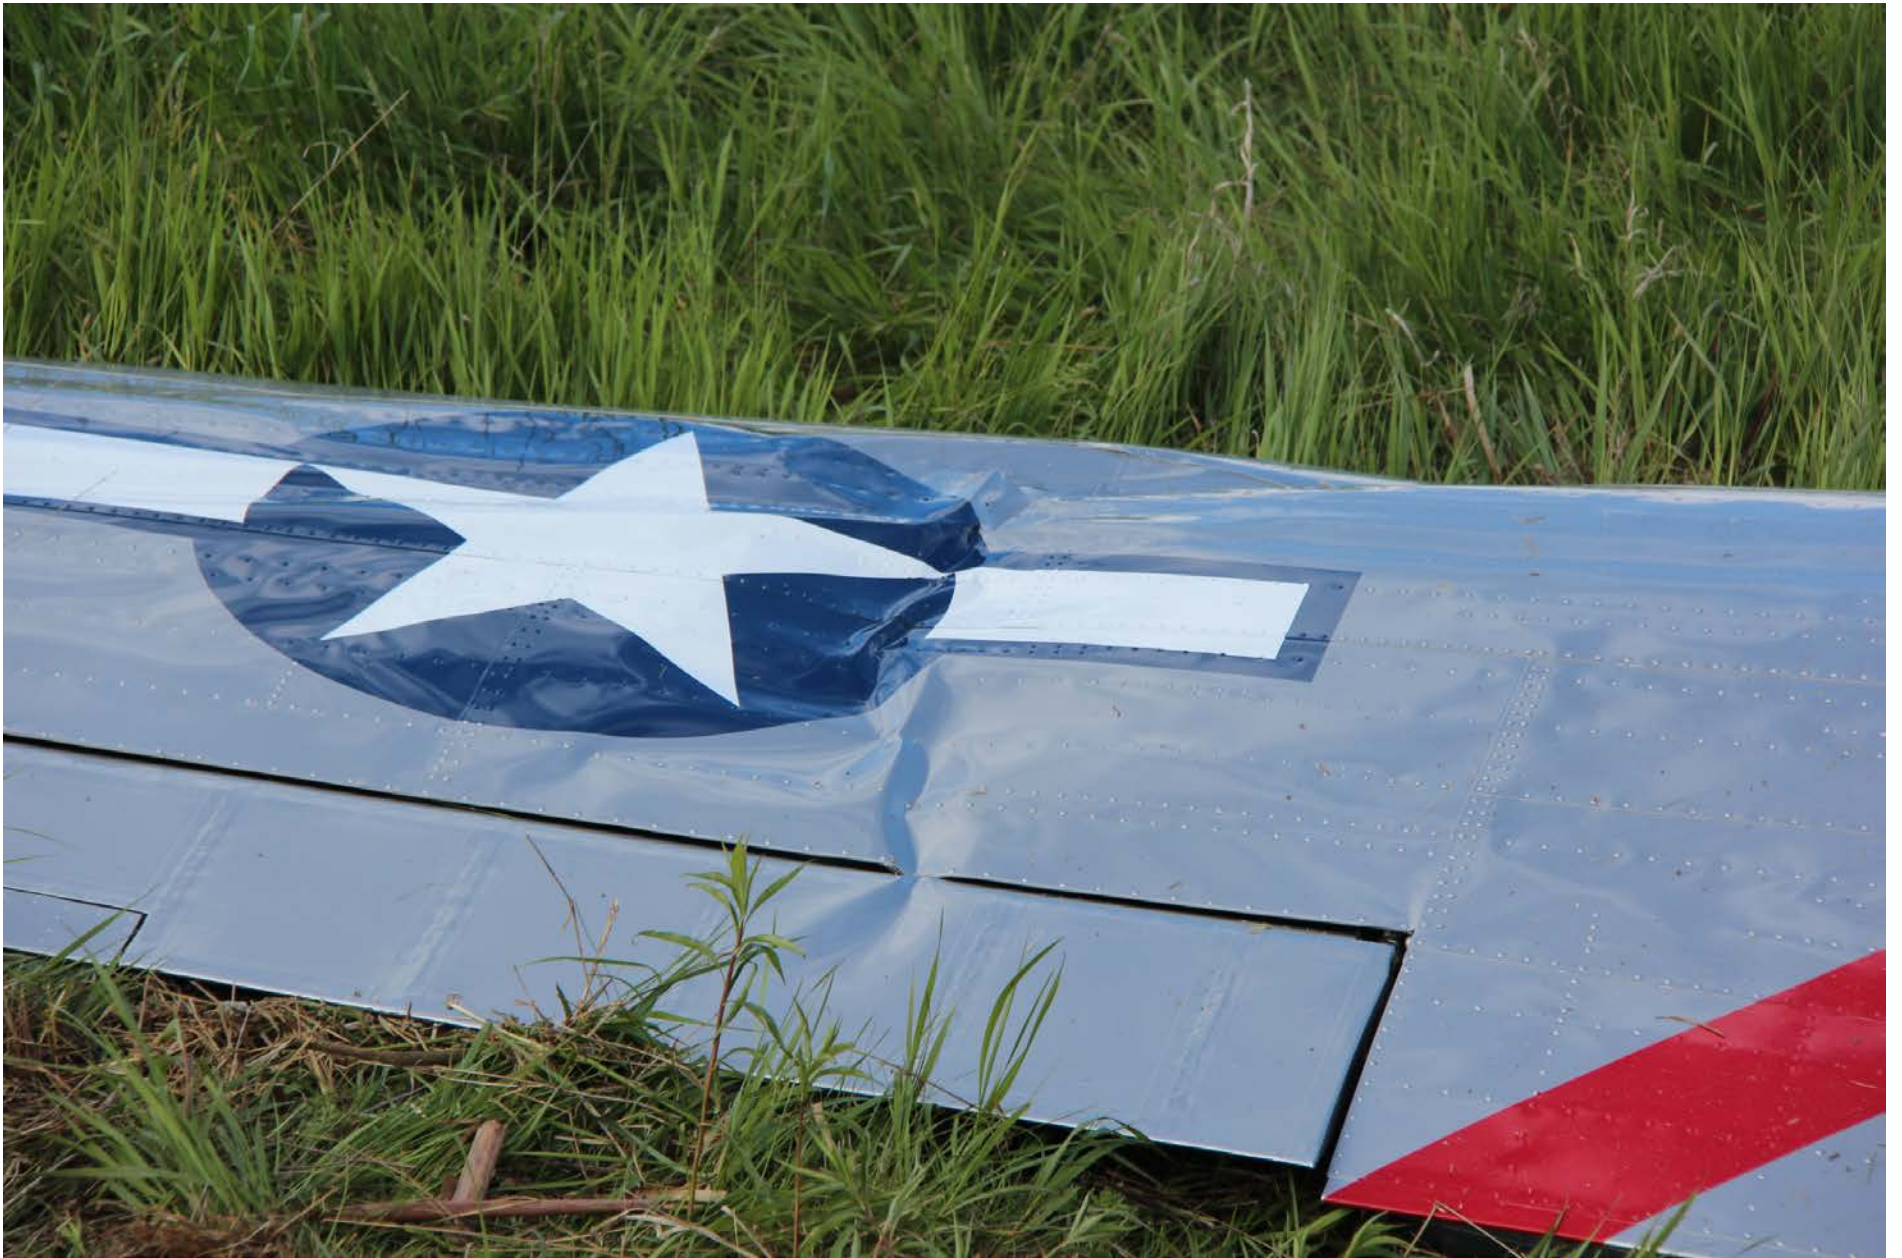
**Photo 3 - Close-up of damage to left wing.**
