# NATIONAL TRANSPORTATION SAFETY BOARD

## MATERIALS LABORATORY FACTUAL REPORT

Report No. 17-068

Place : Fargo, ND  
Date : 12/01/2016  
Vehicle : Cessna 340, N123KK  
NTSB No. : CEN17FA045  
Investigator : Arnold Scott

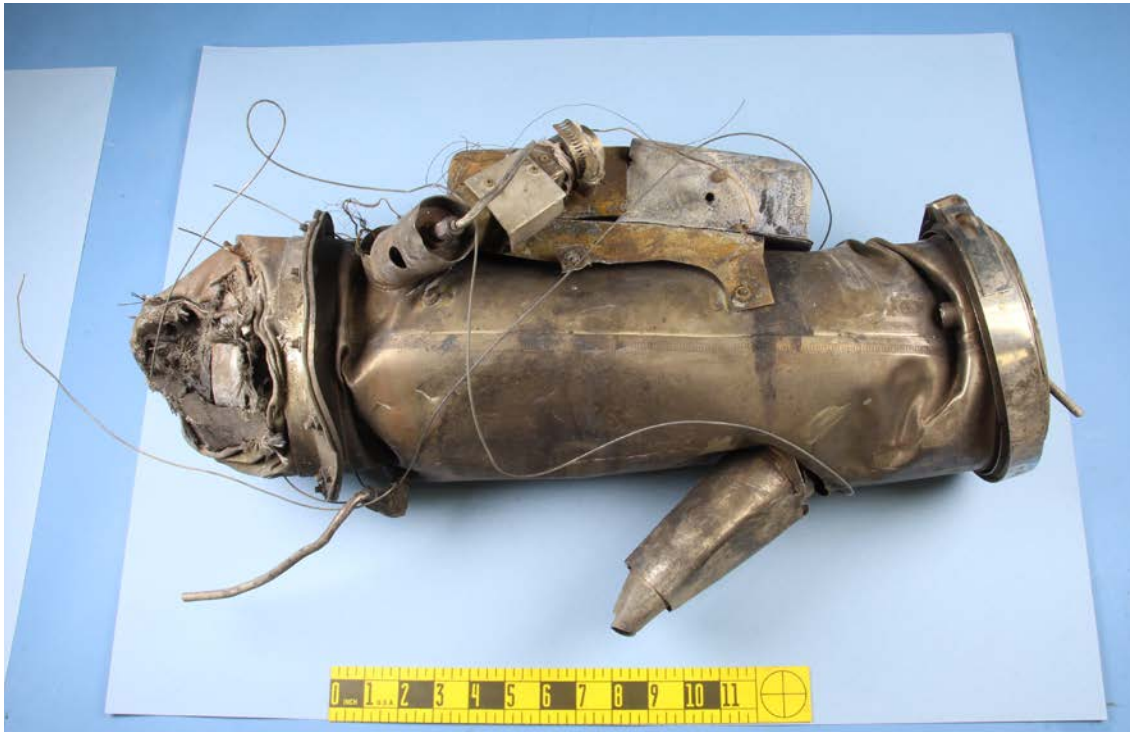
The combustion heater exhibited mechanical and thermal damage along its entirety (figures 1 - 4). The blower assembly (figure 5) for the combustion air had separated from the main body of the combustion heater assembly. The main body of the combustion heater exhibited multiple dents, folds and general distortion from its original cylindrical shape. Overall the body of the combustion heater exhibited thermal discoloration and soot staining consistent with exposure to a fire environment. No evidence of a fuel leak was observed on the exterior of the combustion heater's body. Examination of the fuel fittings on the combustion heater's body also did not reveal any evidence of a fuel leak. One of the fuel fittings on the combustion heater body was found to be loose. This fitting coincided with an area of mechanical deformation to the combustion heater's body (figure 6). The combustion air blower assembly exhibited some dents and punctures. There was a solenoid valve attached to the combustion air blower. This valve had fuel lines attached to it that exhibited secure connections and no evidence of fuel leakage.

Figure 1: Combustion heater body

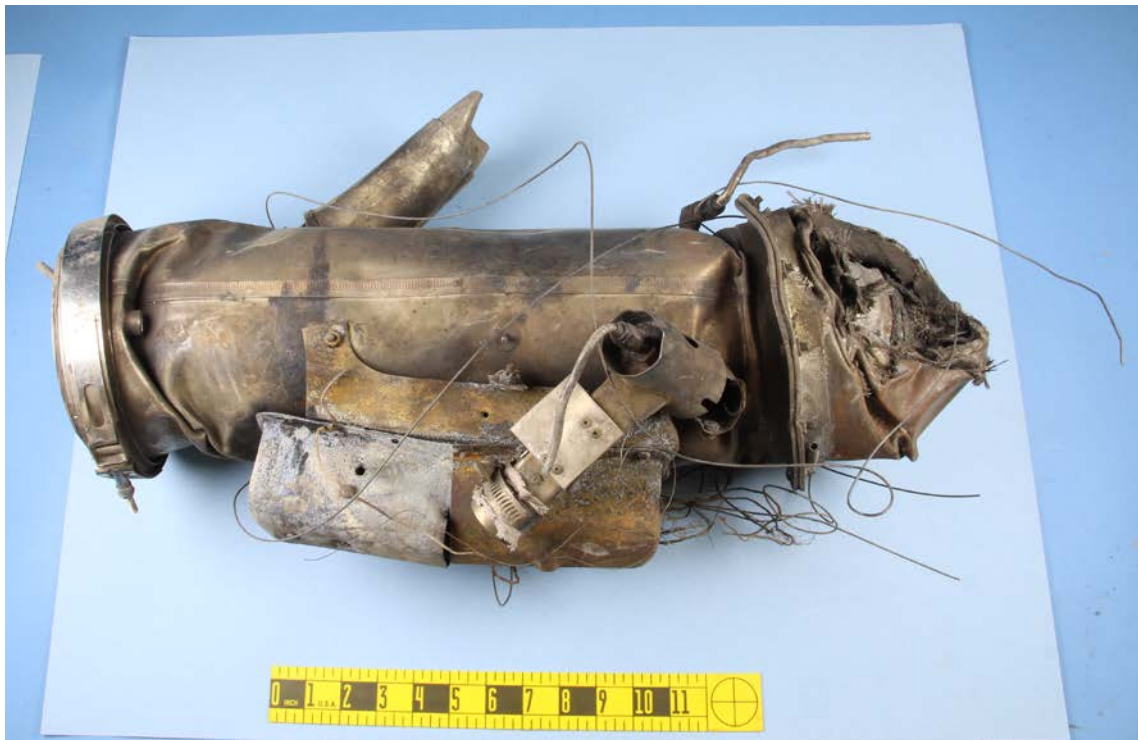
Figure 2: Combustion heater body

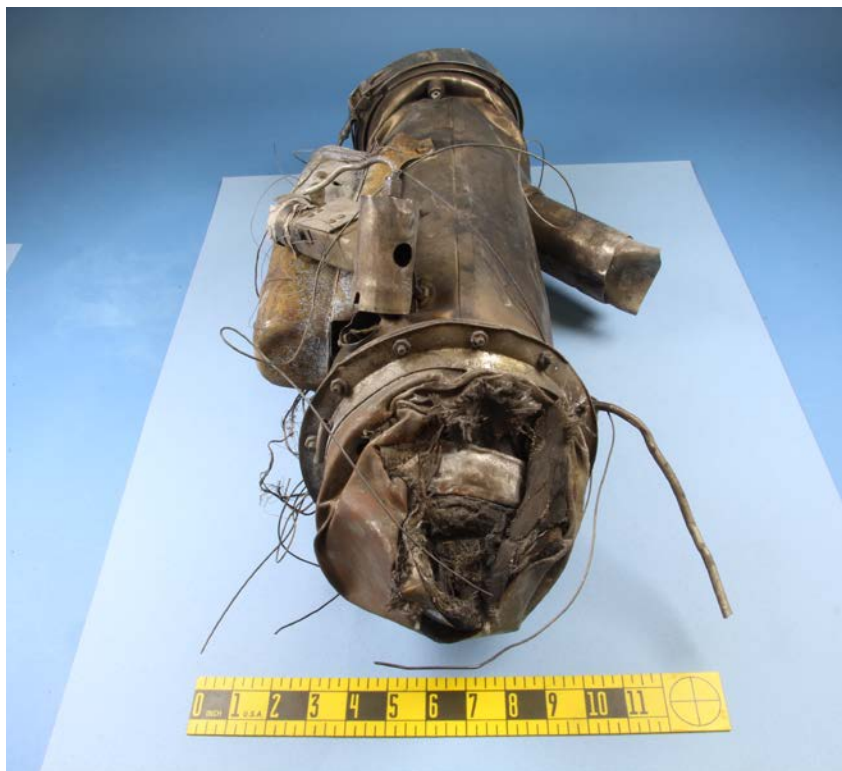
Figure 3: Combustion heater body, ventilation air inlet (cold) side.

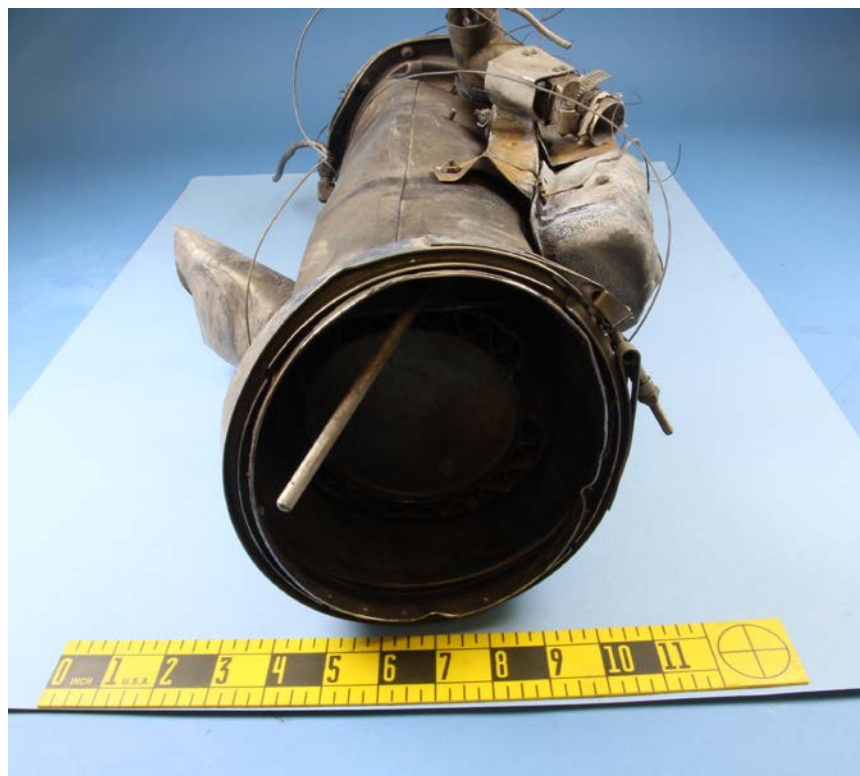
Figure 4: Combustion heater body, ventilation air outlet (hot) side.

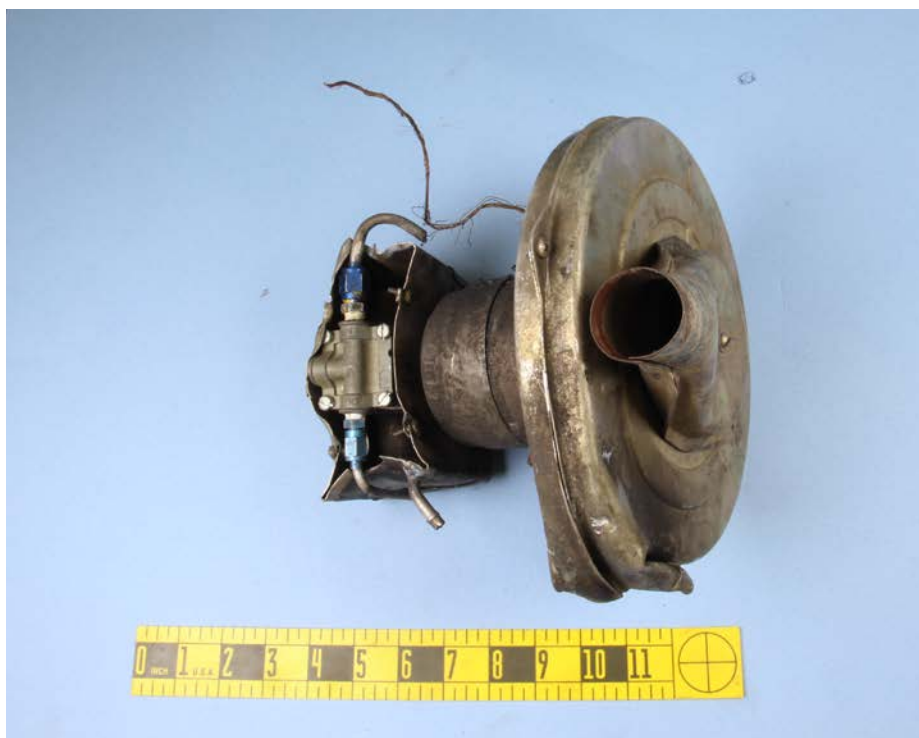
Figure 5: Combustion air blower.

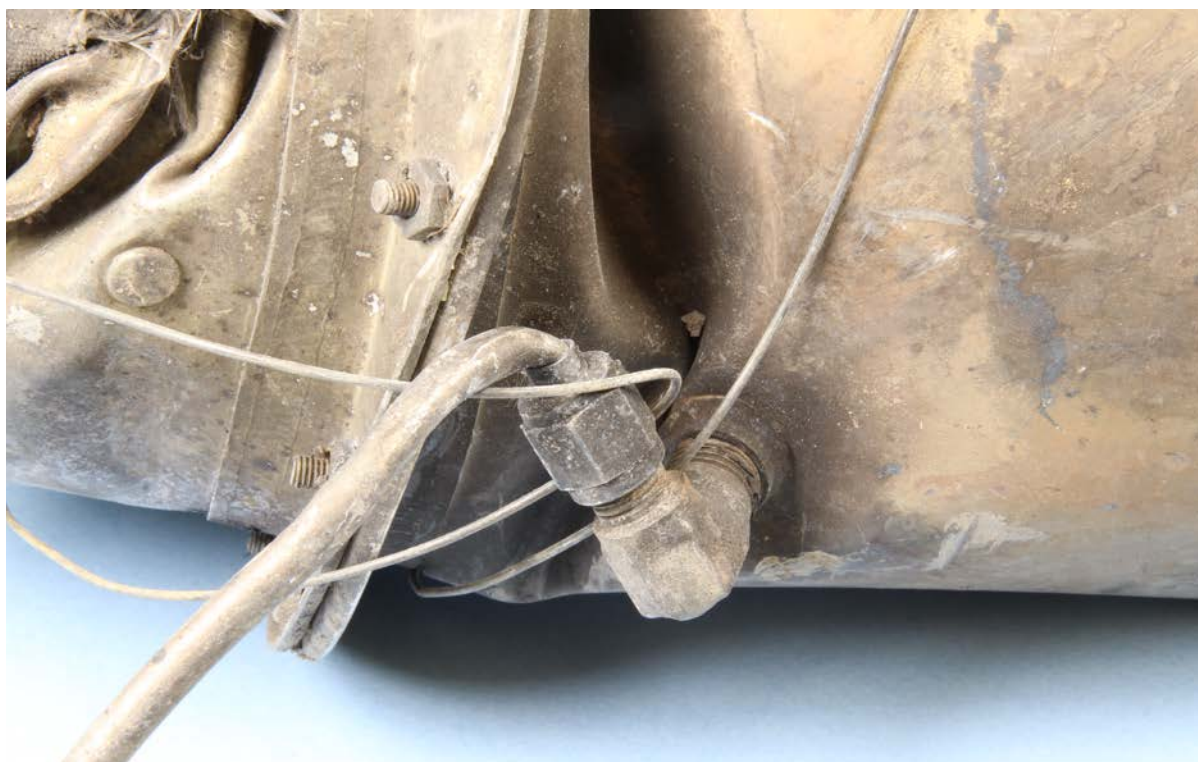
Figure 6: Loose fuel fitting near ventilation air inlet side of combustion heater body.
