## Airplane Performance Study

### **A. ACCIDENT**

| Airplane: | Cirrus SR22, Registration N401SC |
| NTSB Number: | CEN17FA084 |

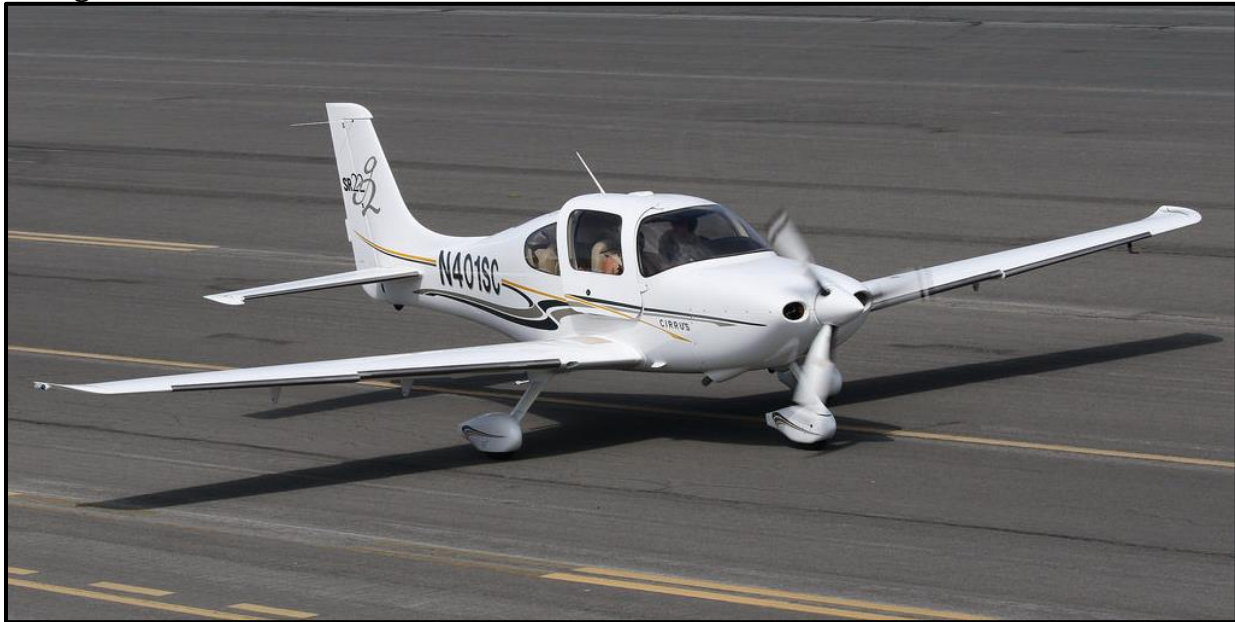
**Figure 1: Accident Airplane N401SC, a 2004 Cirrus Corporation SR22**

See Figures 1 and 2 for pictures of the accident airplane and the accident site, respectively.

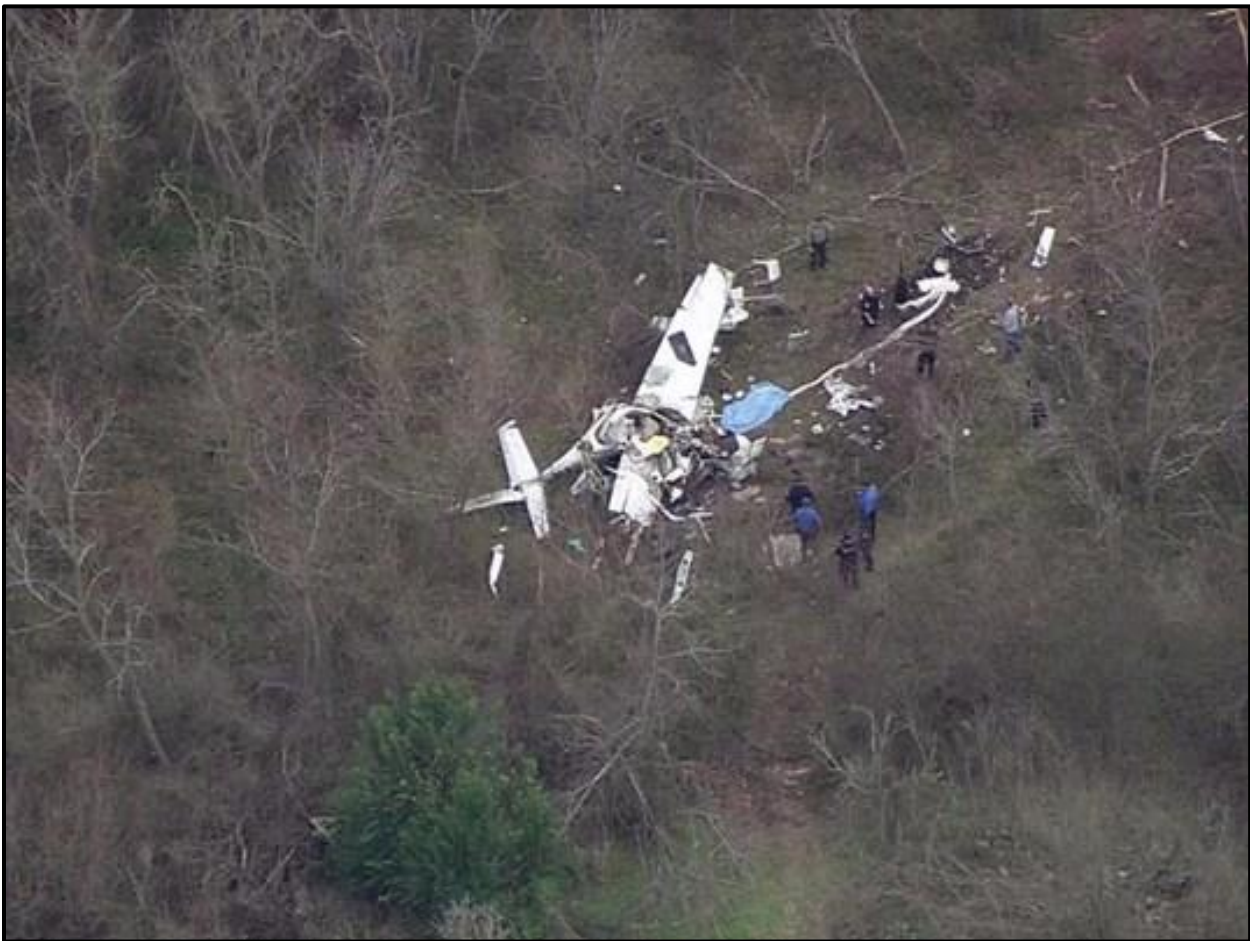
**Figure 2: Accident Site**

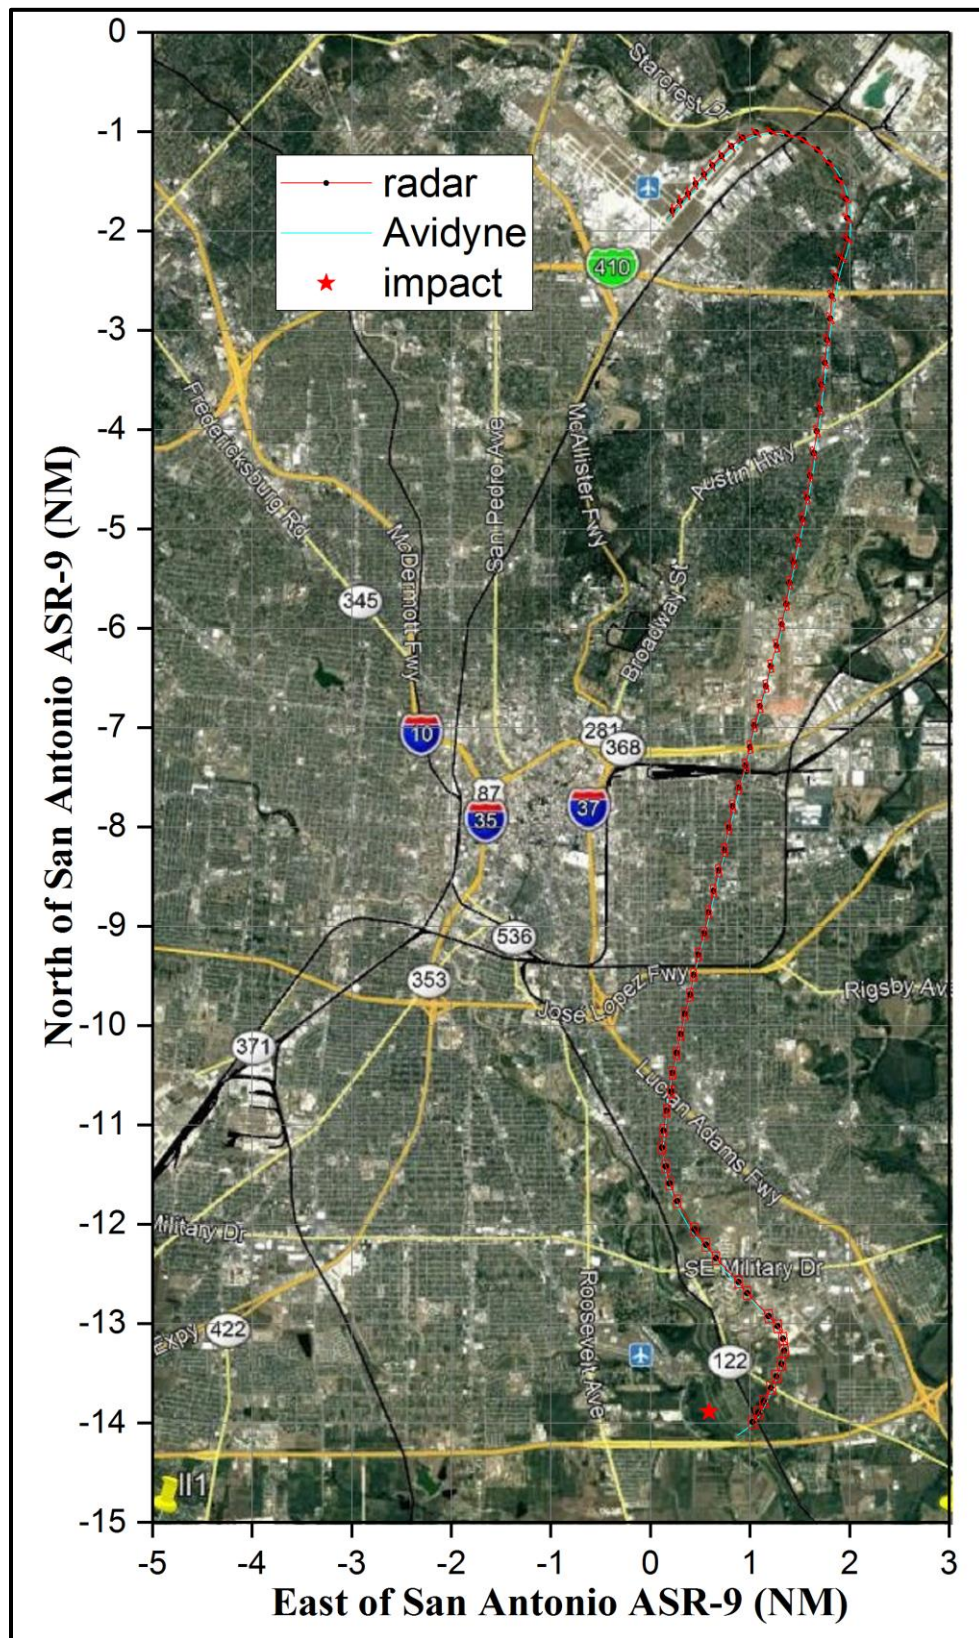
Figure 3: Ground Track for Flight from SAT

N401SC approached SSF from the north and entered a 45° leg to the right downwind for runway 32. (See Figures 3 and 4 for an overview of the ground track. The radar “points” in the figures are actually boxes shown in red. This is because of the uncertainty associated with the radar data mentioned earlier.) The airplane was at about 117 kt calibrated airspeed (KCAS) and 1,400 ft mean sea level (msl) when it entered a right downwind for runway 32. See Figure 5.

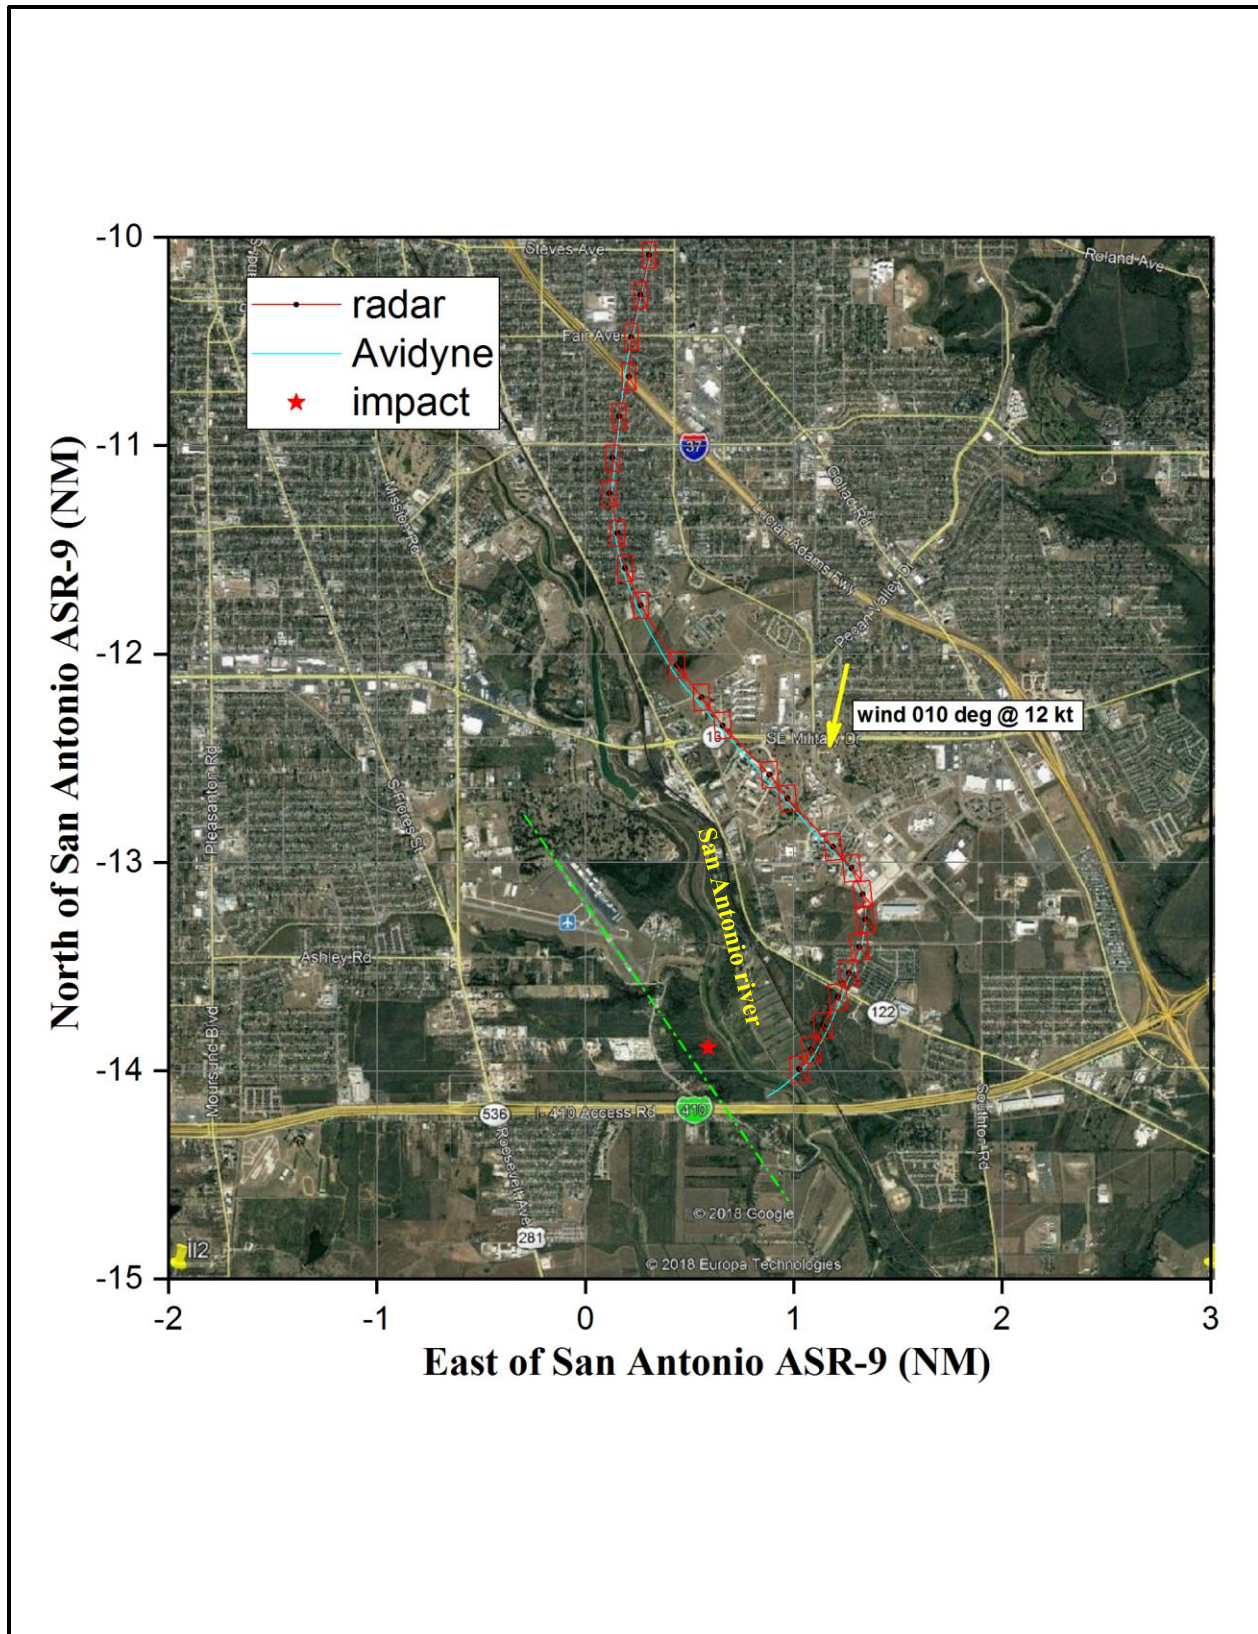
Figure 4: Ground Track Near Accident Site with Extended Runway Centerline

quickly approaching the extended runway centerline to runway 32 (denoted in green in Figure 4) at an airspeed of 103 KCAS, an altitude of 796 ft msl (219 ft above the airport), and in a right bank of about 48°. The wind from the northeast was pushing the airplane to the south as highlighted in Figure 4: this would increase the right bank angle/right aileron required to align and to stay aligned with the runway.

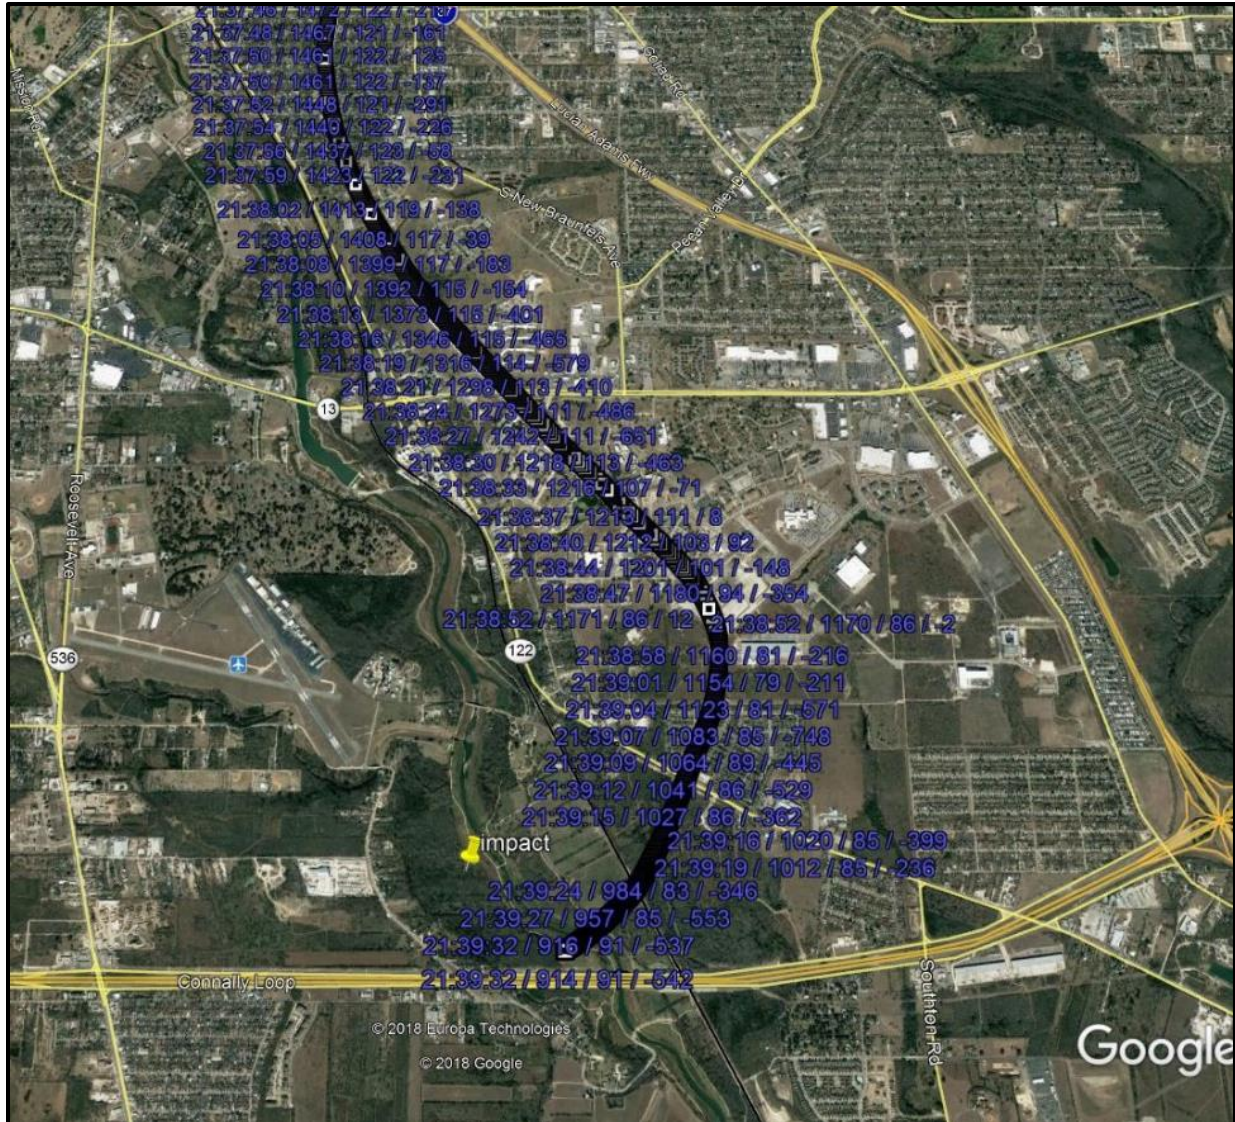
**Figure 5: Ground Track Near Accident Site with Time (GMT), Altitude (ft, msl), Estimated Airspeed (kt), and Rate of Climb (ft/min)**

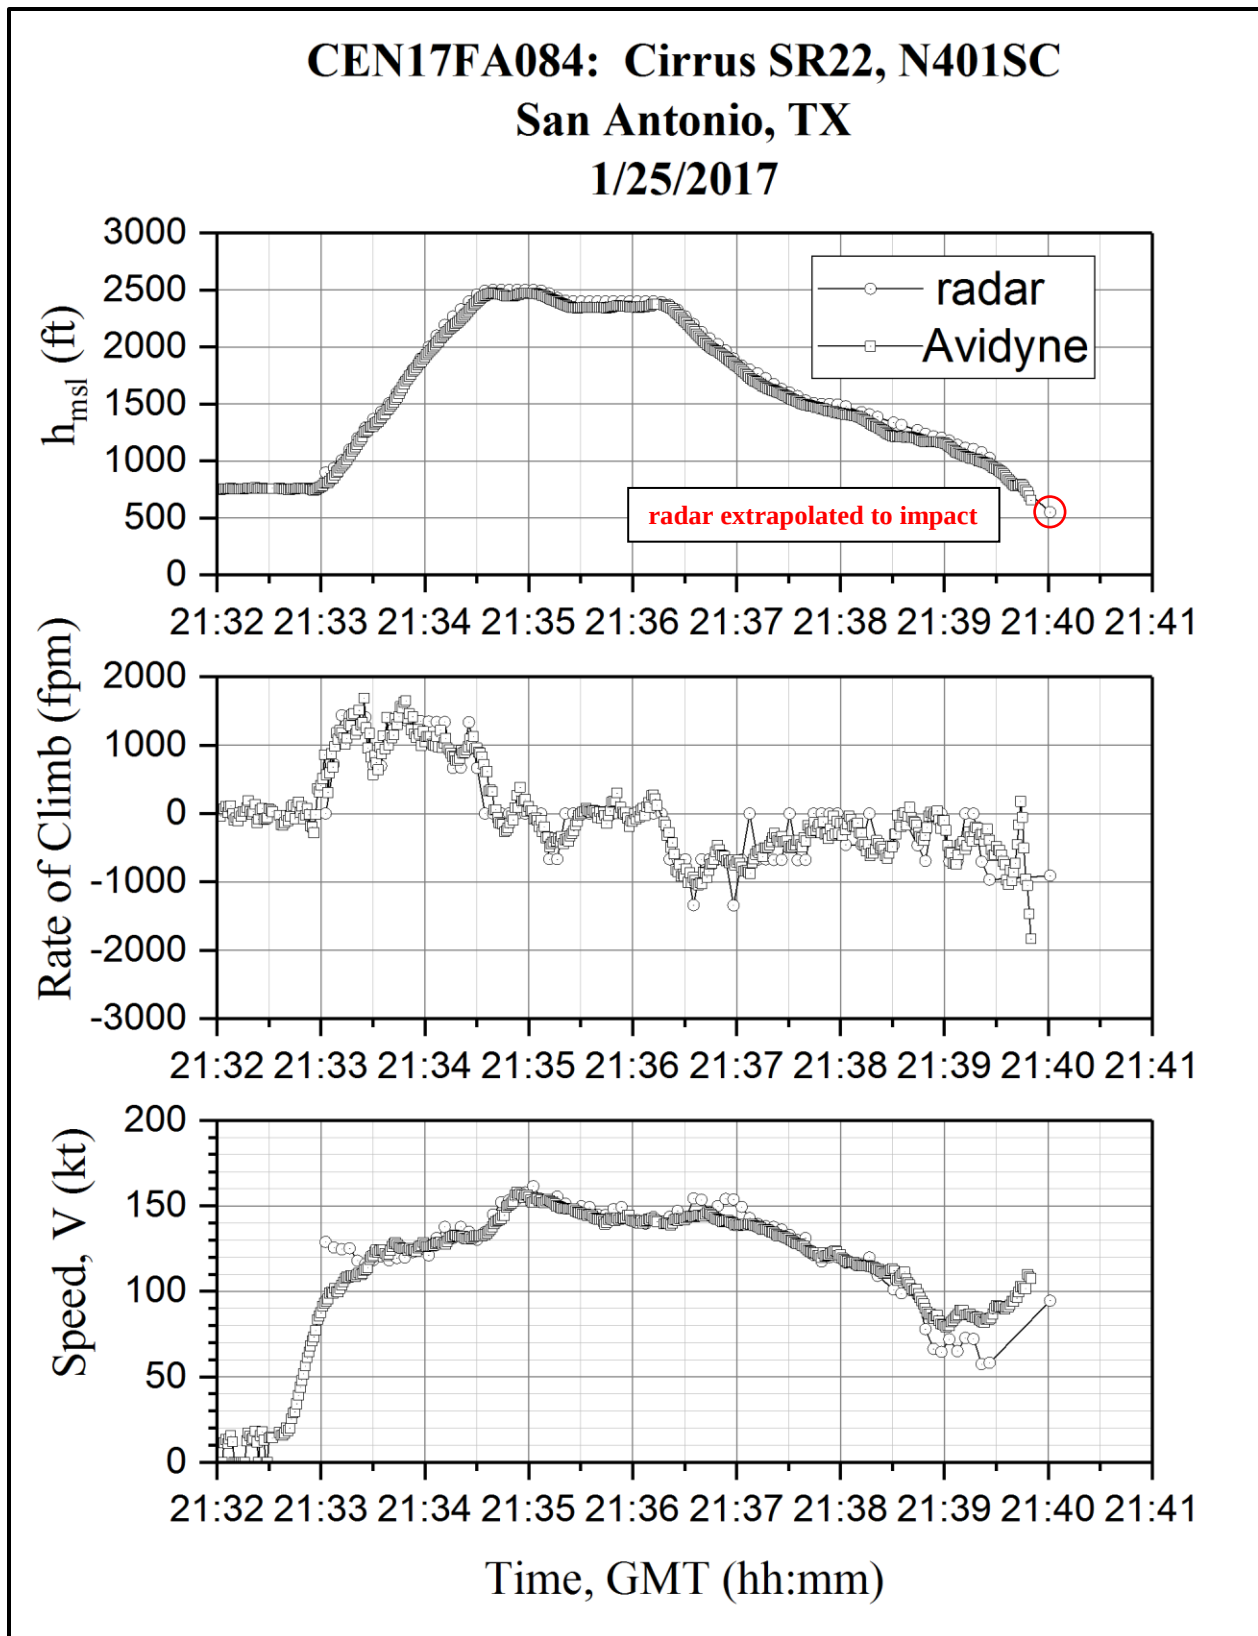
Figure 6: Altitude and Calibrated Airspeed Based on Avidyne and Radar Data

A second later, at 1539:45 CST, the airplane started to descend again, and six seconds later the airplane was descending at over 1,800 ft/min (fpm) with the right bank angle continuously increasing. Figures 6 and 7 include time histories of the airplane's altitude, speed, and attitude recorded on the Avidyne and estimated from radar during the eight-minute flight.

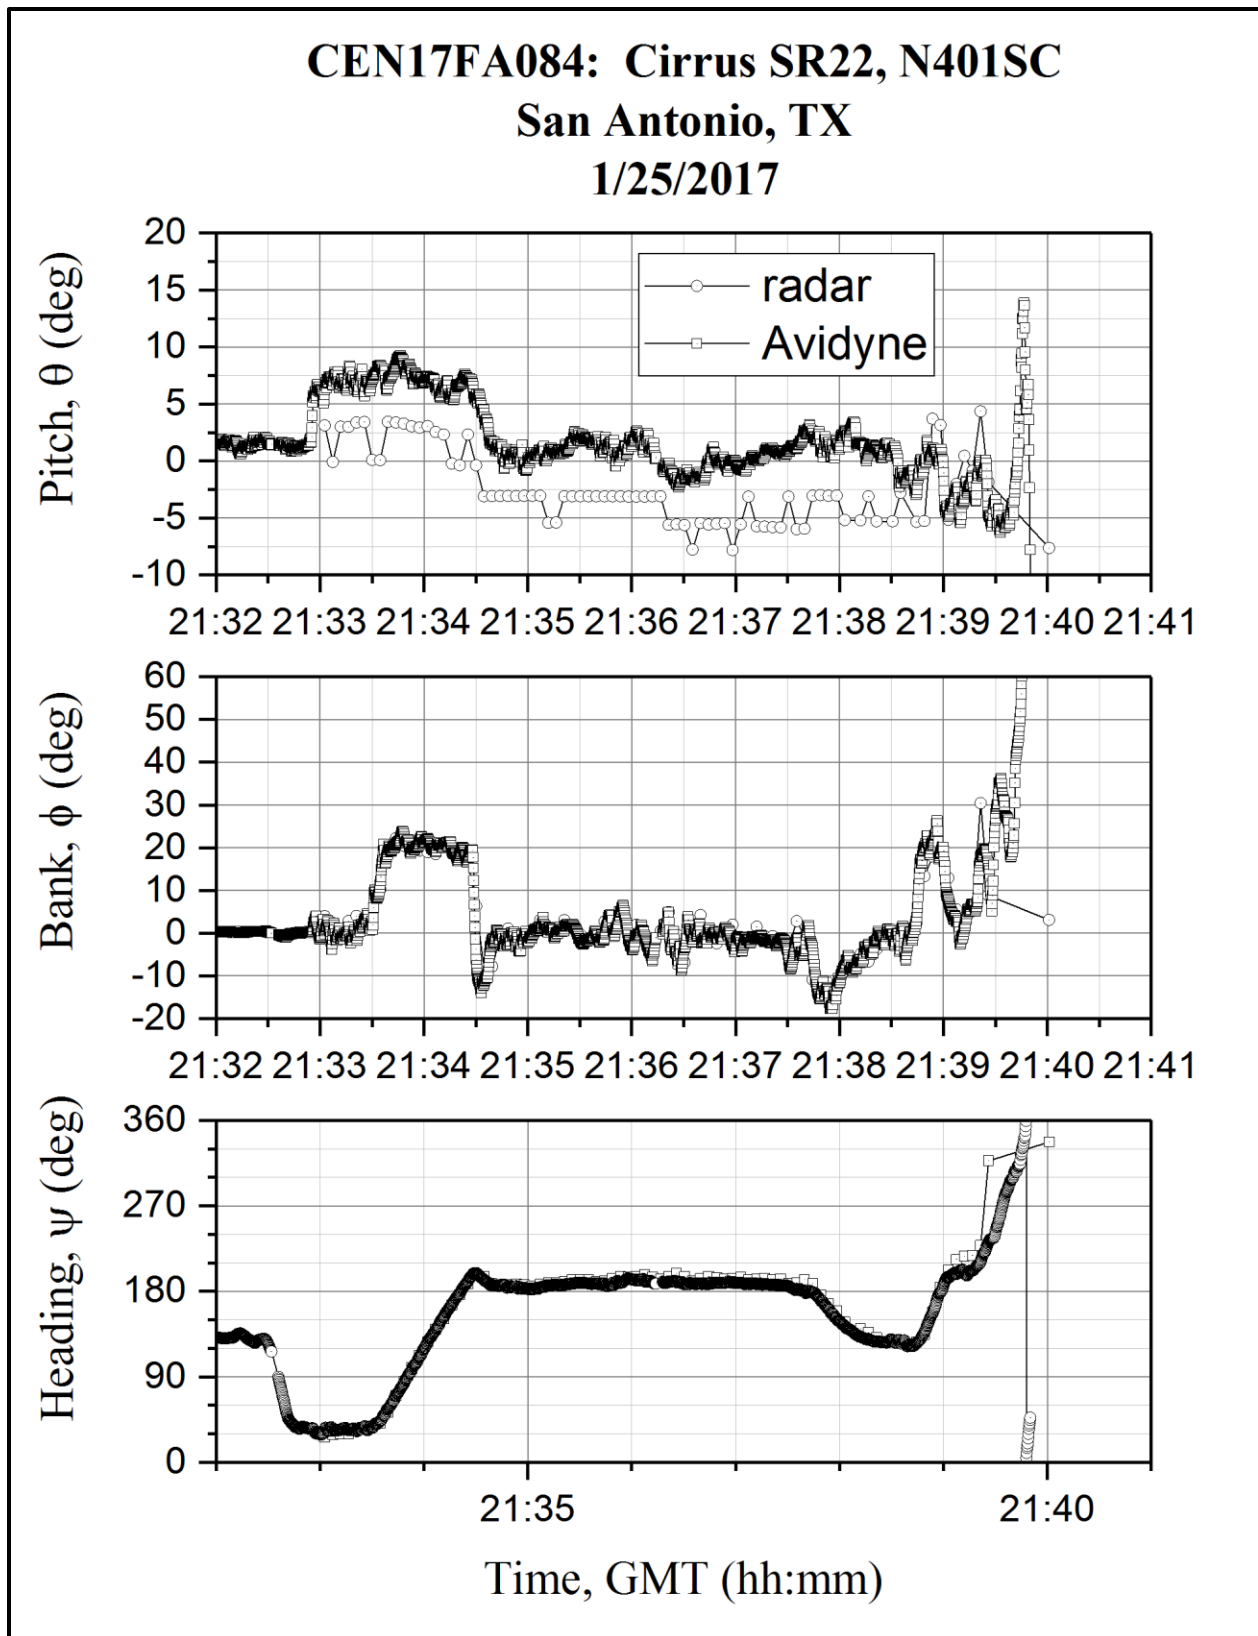
Figure 7: Pitch, Bank, and Heading Based on Avidyne and Radar Data

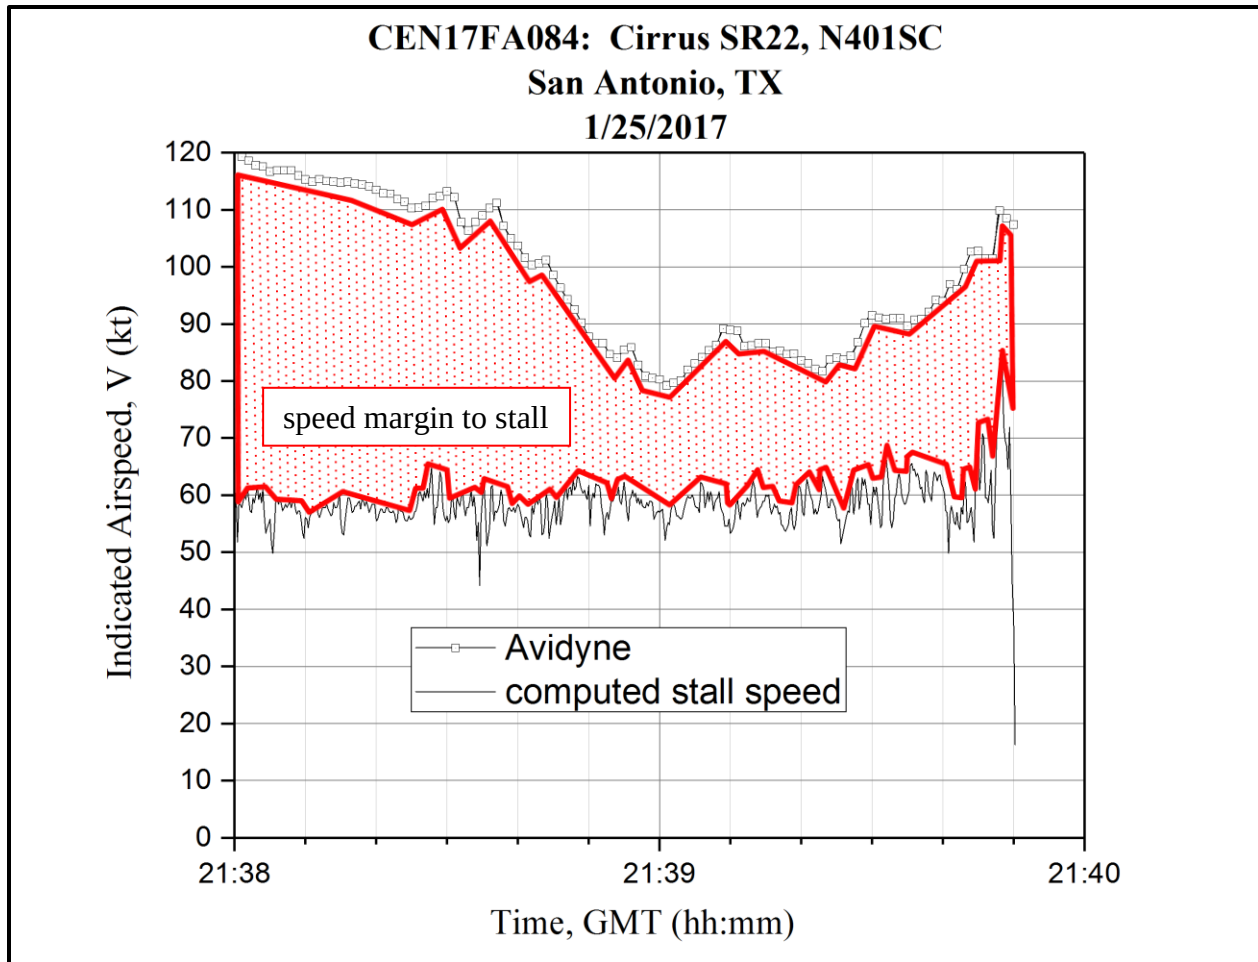
**Figure 8: Indicated Airspeed vs. Computed Stall Speed Based on Avidyne Data**

See Figure 8 for a comparison of the estimated stall speed from equation (1) to the indicated airspeed recorded on the Avidyne. The recorded airspeed was always about 20 kt faster than the estimated stall speed at the accident conditions, suggesting there was sufficient speed margin to stall on the turn to final approach.

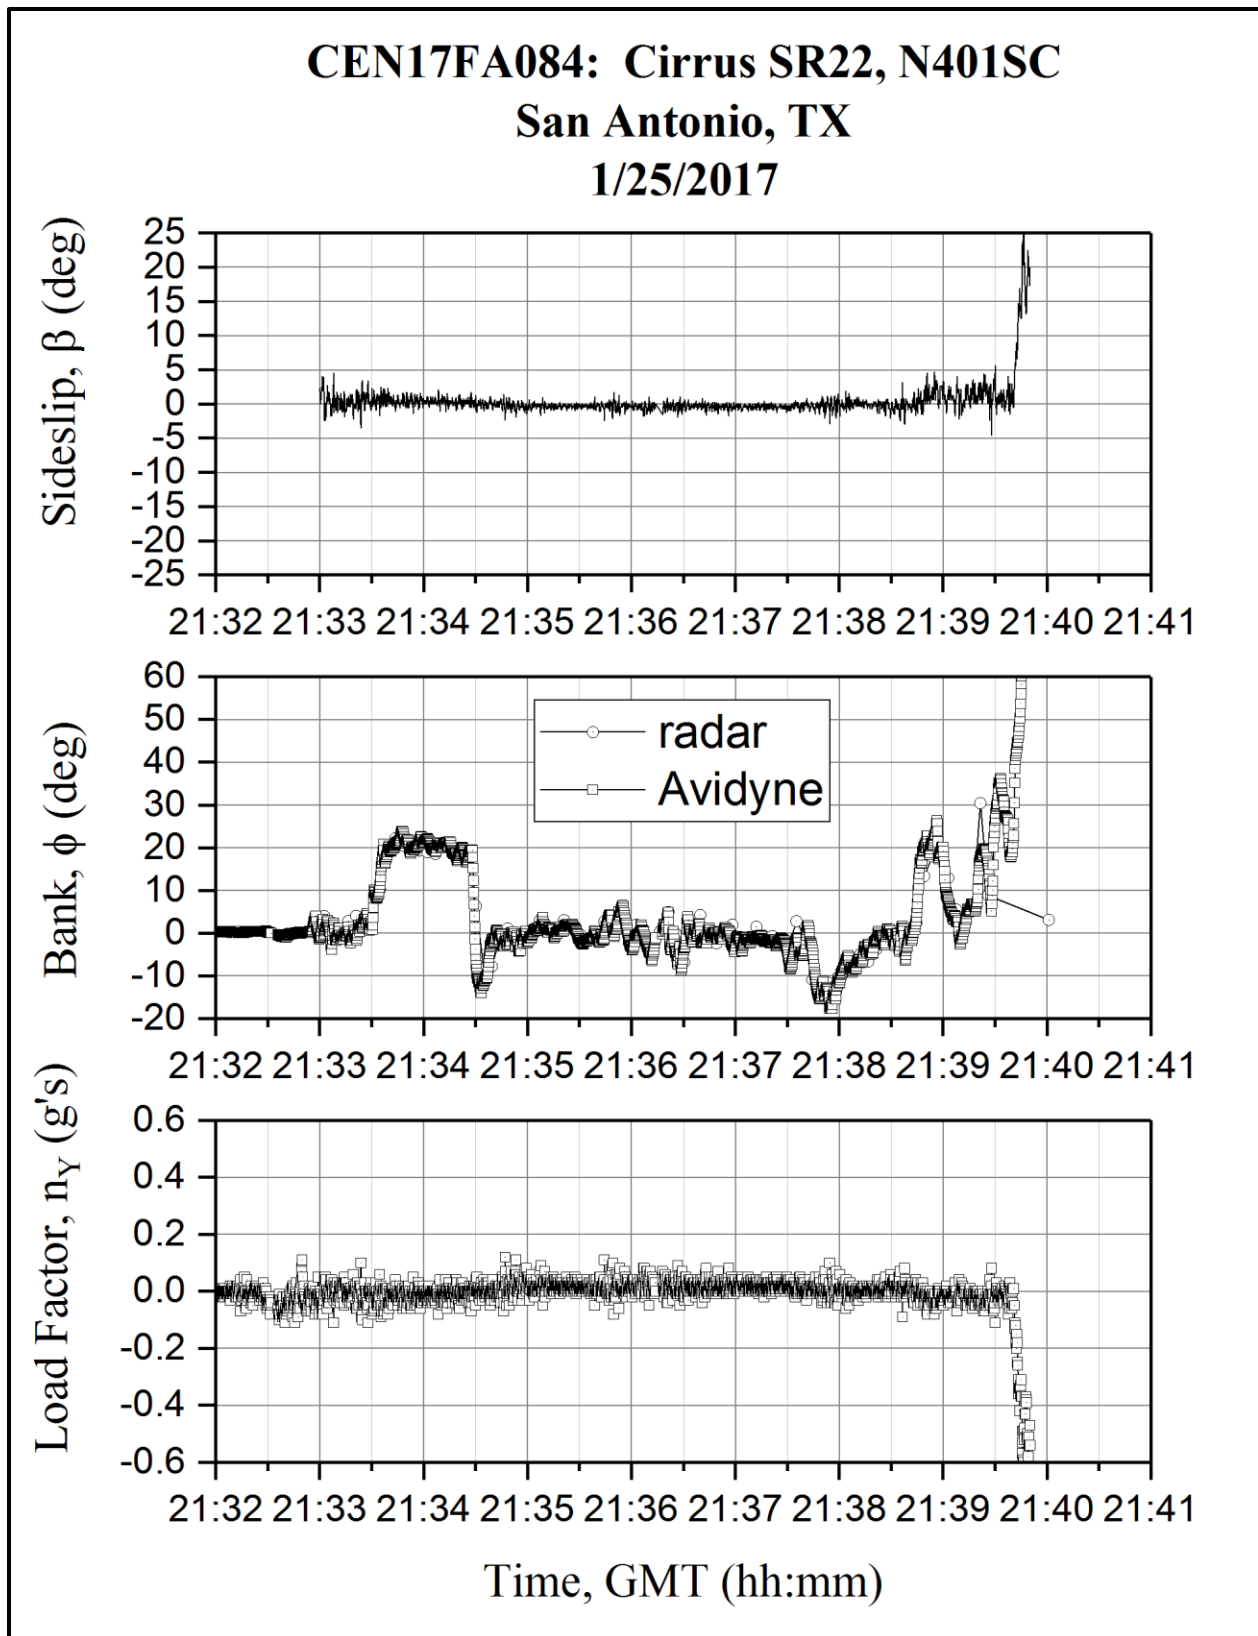
Figure 9: Estimated Sideslip, Bank Angle, and Lateral Load Factor Based on Avidyne and Radar Data

experiencing large sideslip angles during the circling turn to final at the end of the flight<sup>2</sup>. The sideslip was computed using Avidyne data and equation (4) below. The computed sideslip is shown in Figure 9. Note: Cirrus Corporation indicated that flight test data show that sideslip angles increase the stall speed<sup>3</sup> for the SR22.

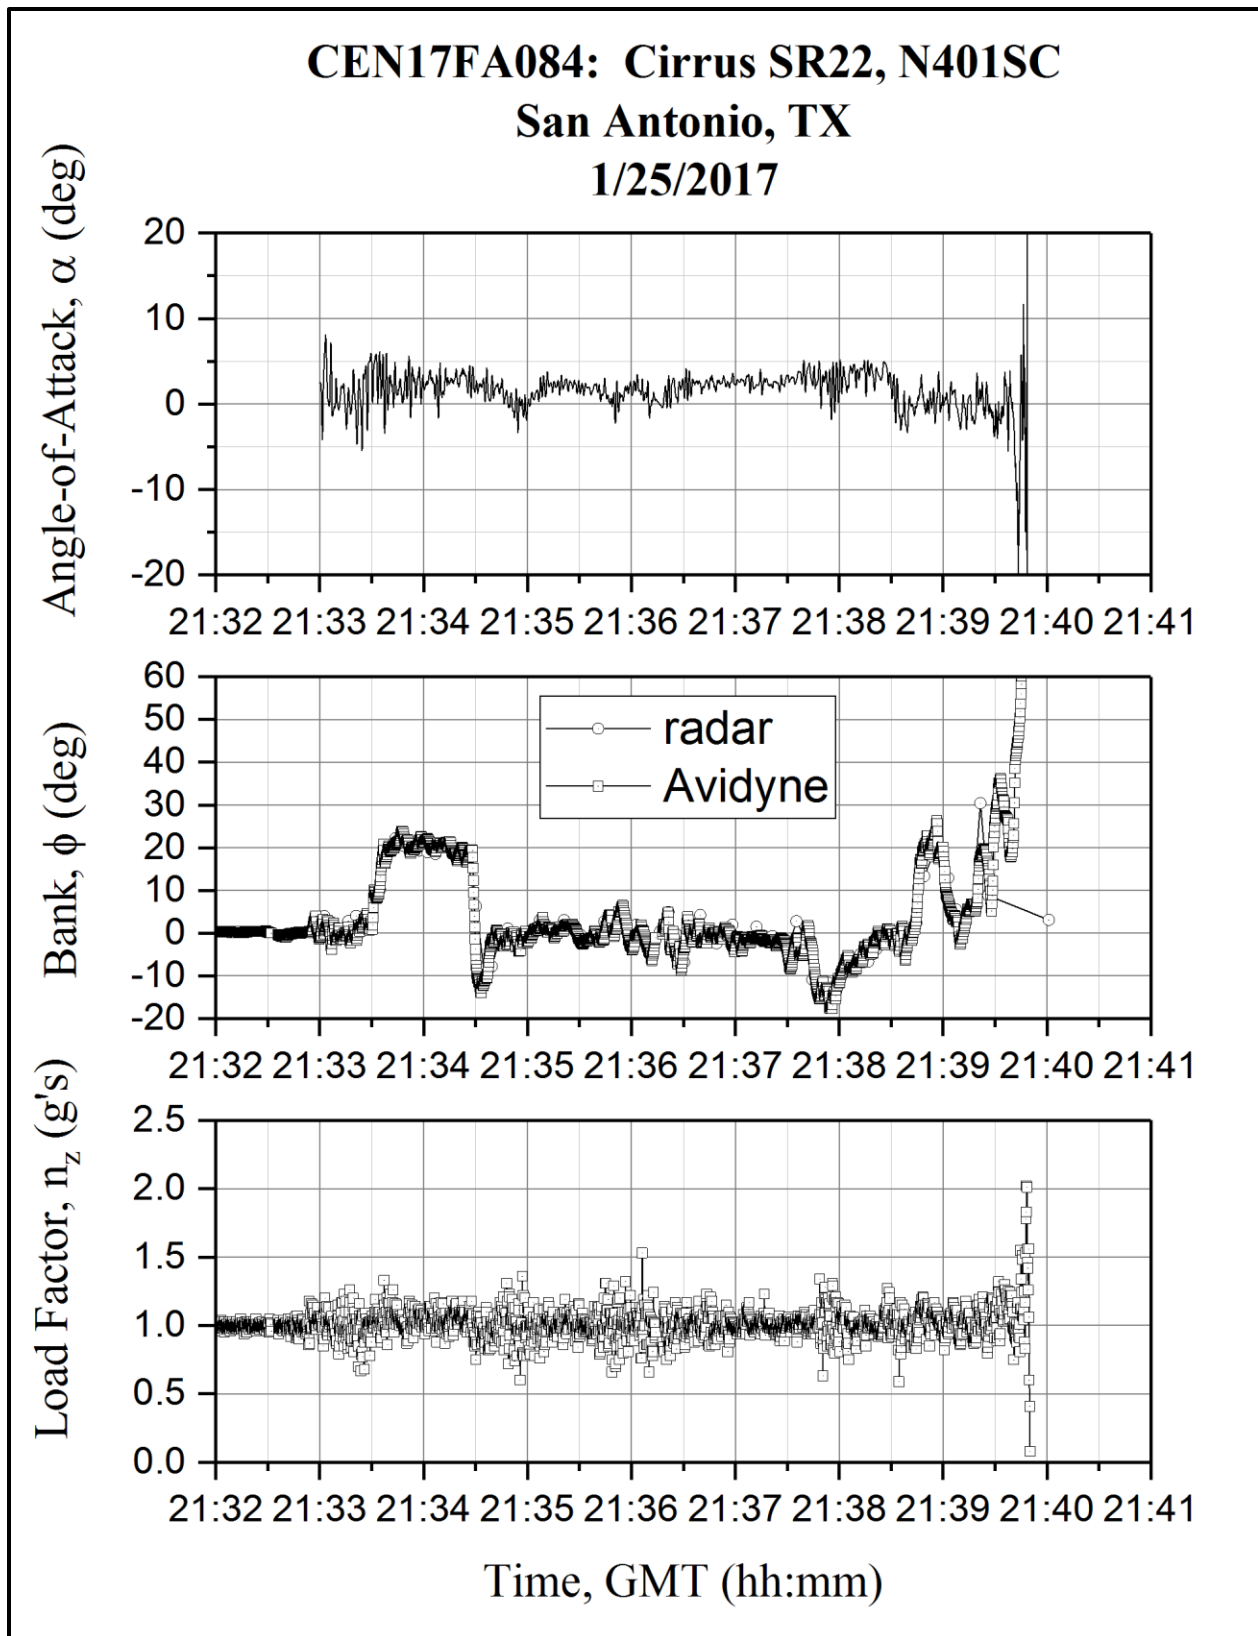
Figure 10: Estimated Angle-of-Attack, Bank Angle, and Normal Load Factor Based on Avidyne and Radar Data

AOA was estimated from parameters recorded on the Avidyne using equations (2), (3), and (4) and is shown in Figure 10.

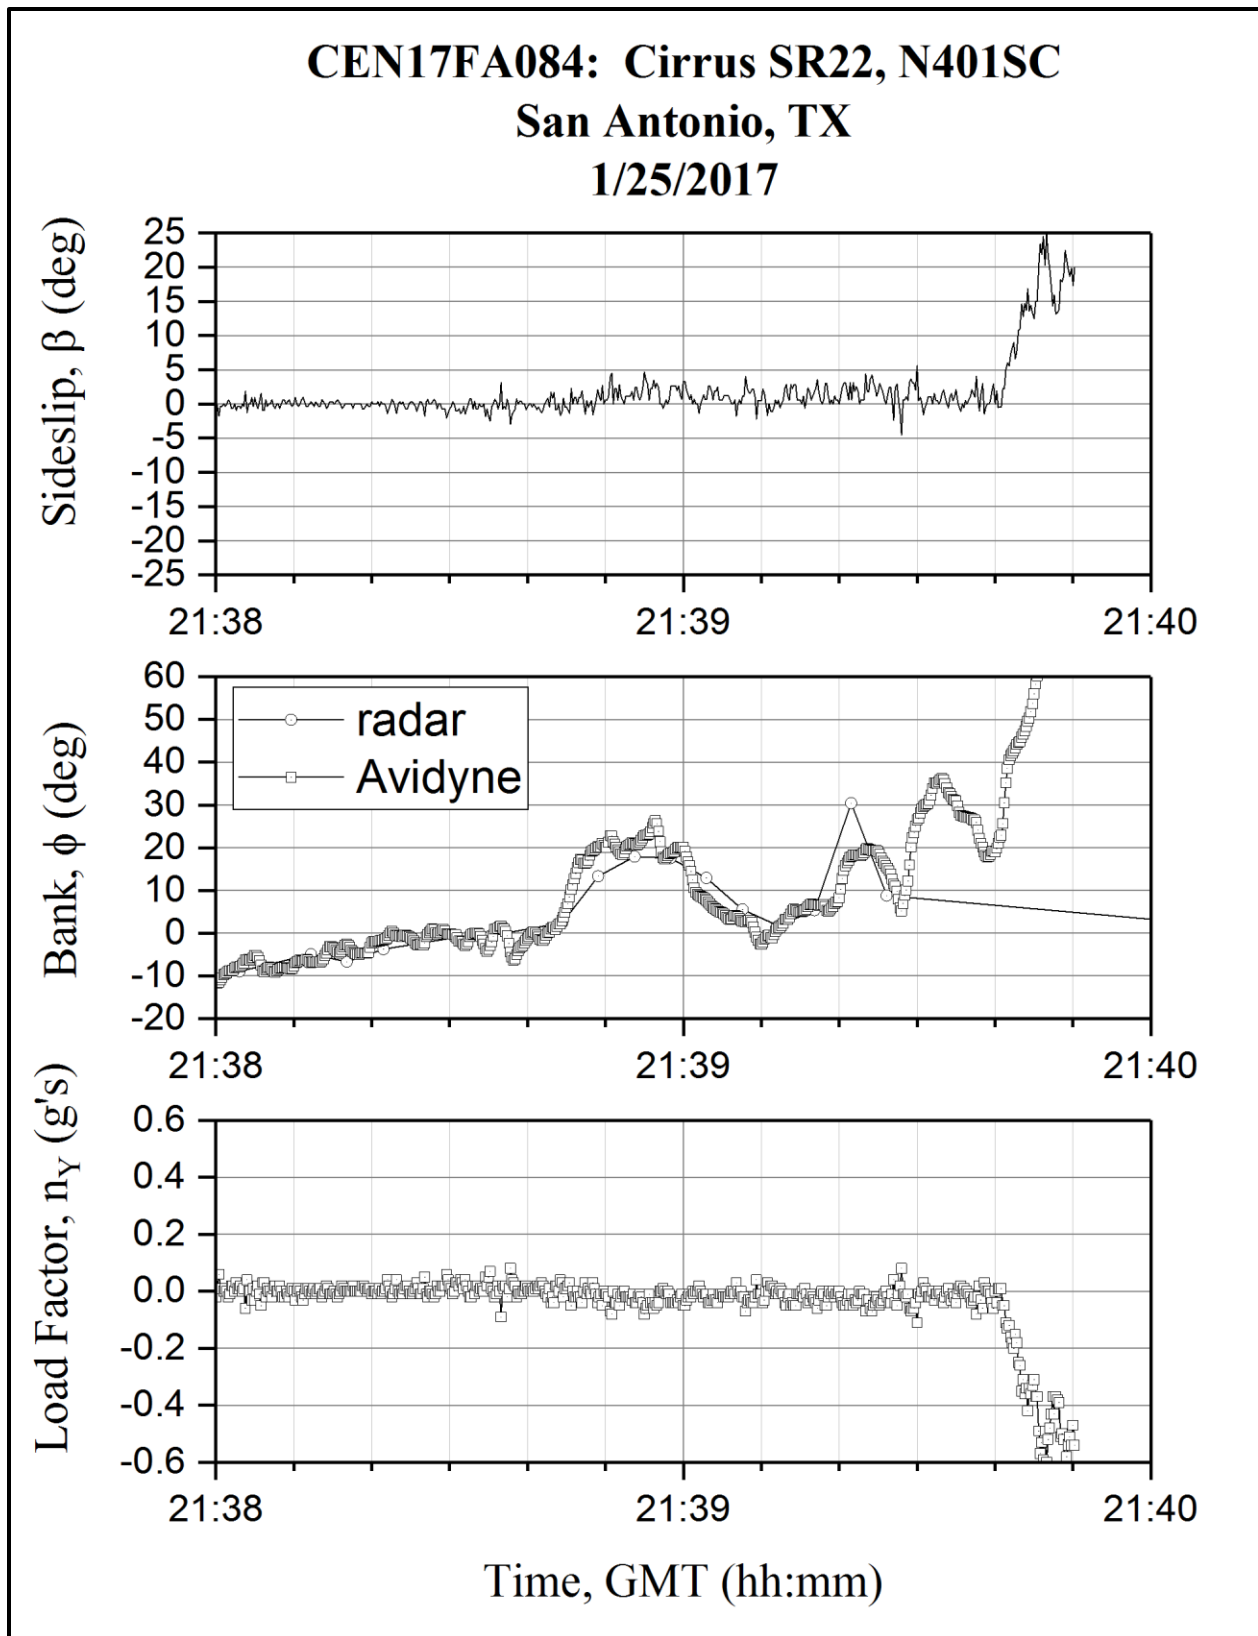
**Figure 11: Estimated Sideslip, Bank Angle, and Lateral Load Factor Based on Avidyne and Radar Data for the Final Minutes of Flight**

The estimated AOA exceeded the stall angle provided by Cirrus Corporation of about 24° at approximately 1539:48, two seconds before the Avidyne recorded a descent rate of over 1,800 fpm. Figures 11 and 12 show the sideslip angle and AOA, respectively, for the last two minutes of flight.

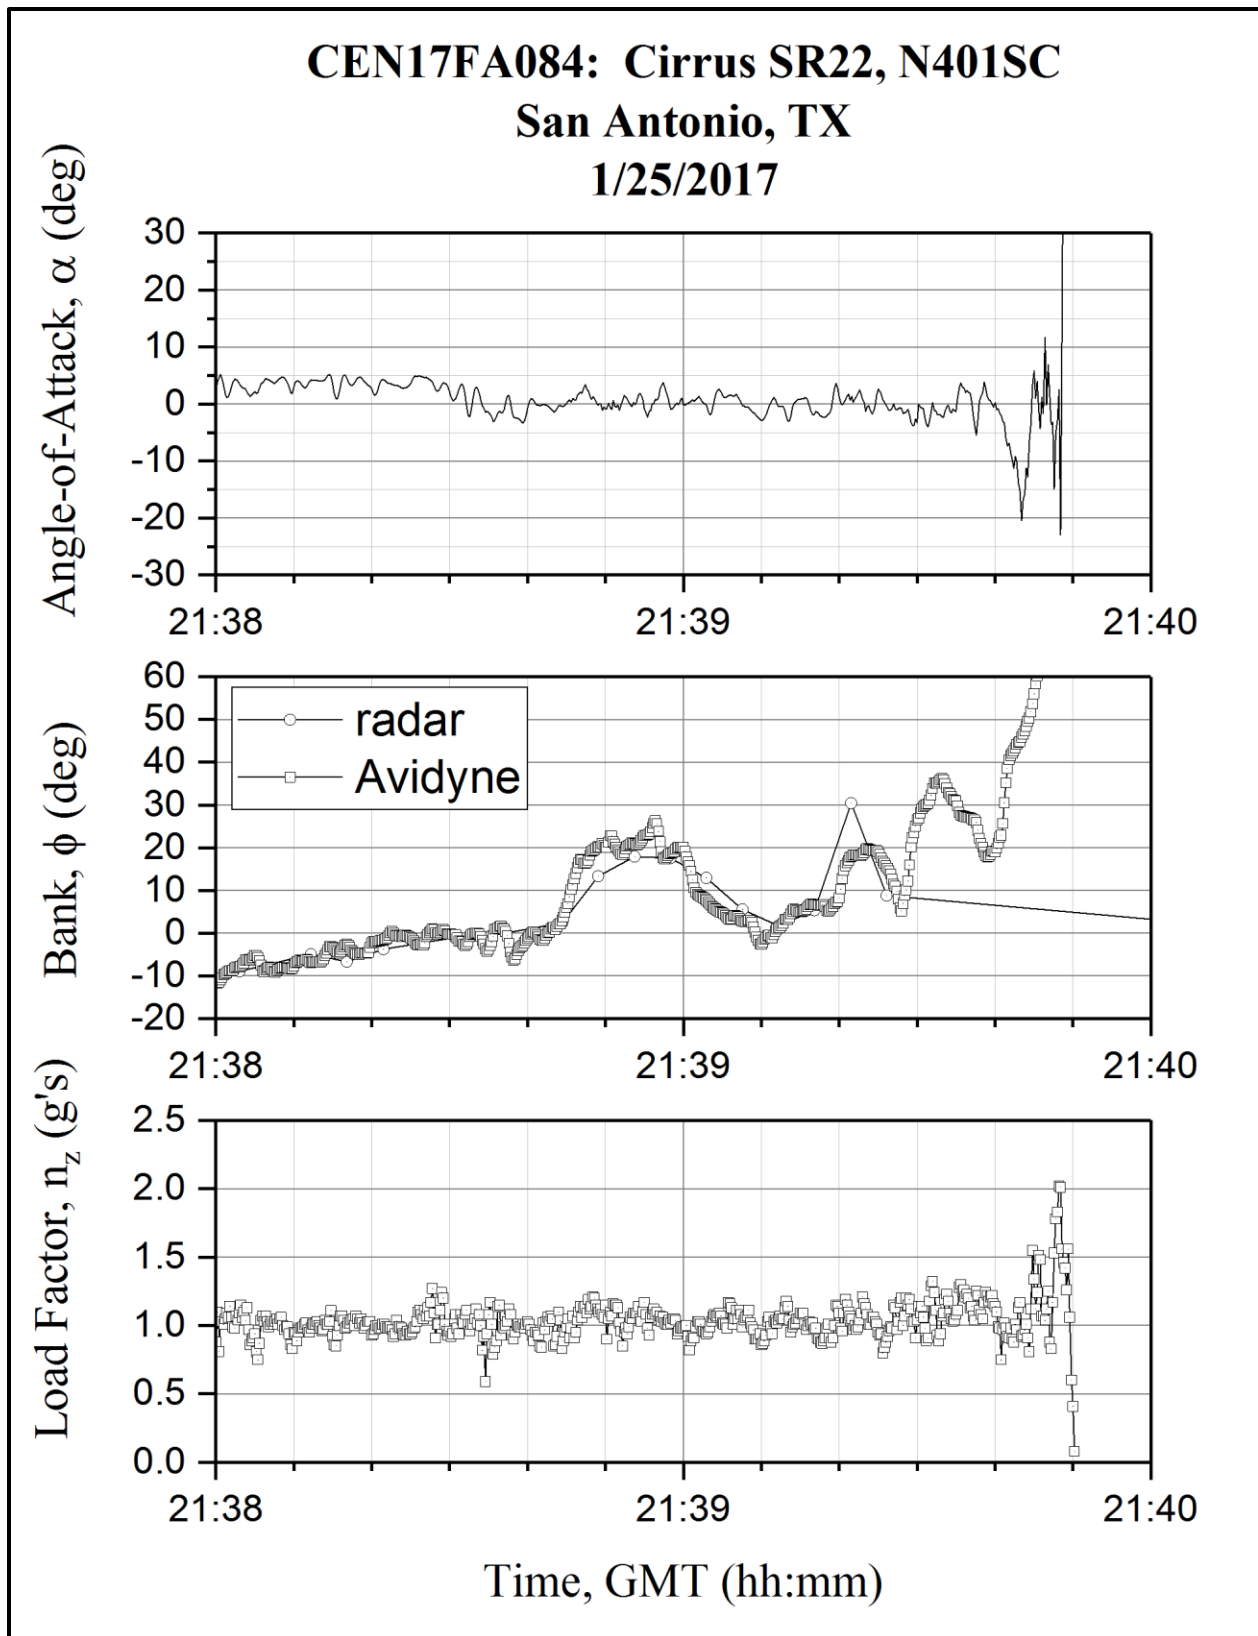
Figure 12: Estimated Angle-of-Attack, Bank Angle, and Normal Load Factor Based on Avidyne and Radar Data for the Final Minutes of Flight

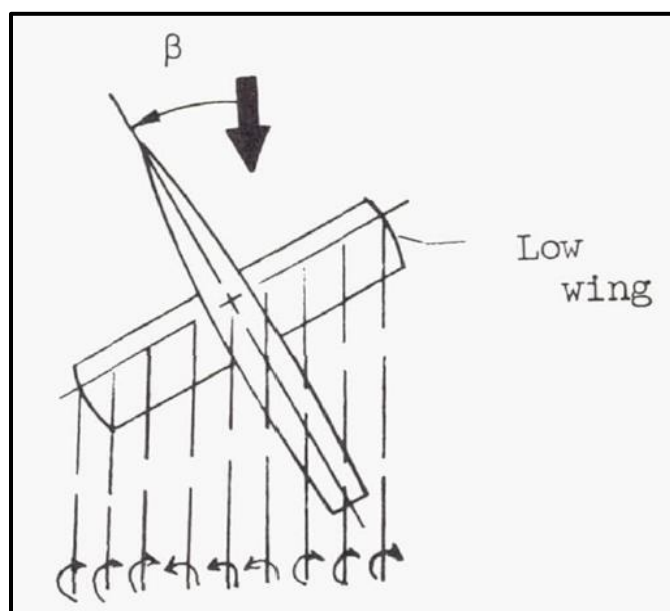
Figure 13: The Effect of Sideslip,  $\beta$ , on Chordwise Flow

<sup>3</sup> This is most likely due to the reduced chordwise flow and reduced dynamic pressure at the wing. See Figure 13.

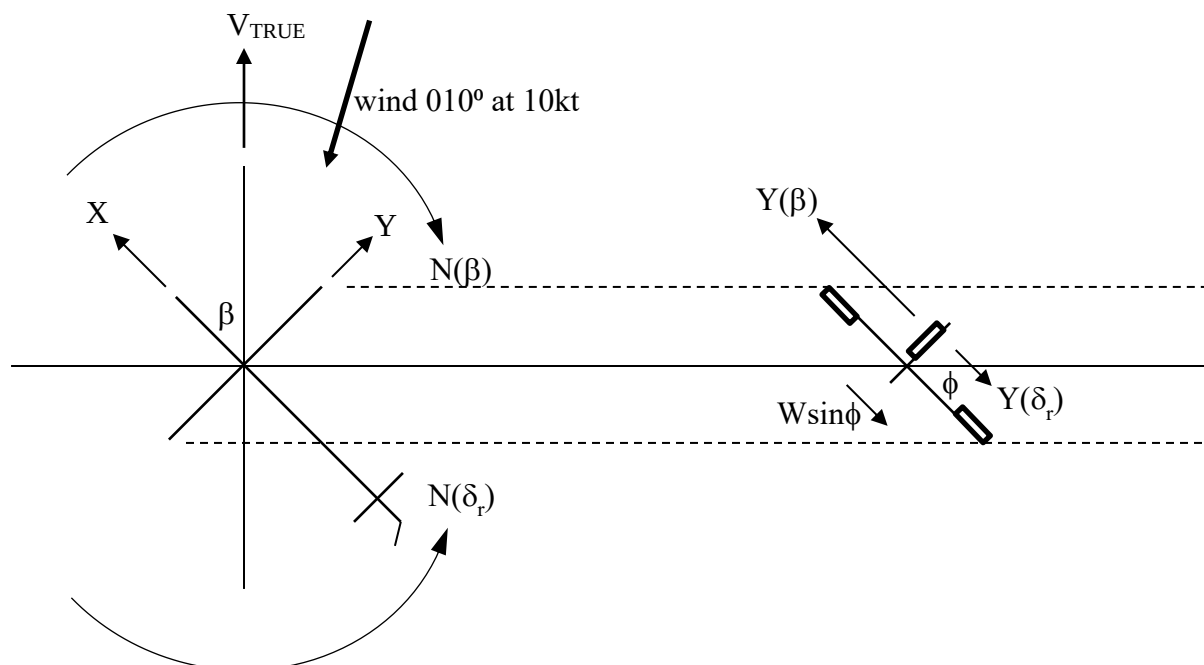
**Figure 15: Recorded Data Indicate that the Pilot May have Performed a Sideslip Maneuver to Avoid Overshooting the Runway Centerline**

It is possible that the pilot may have been performing a sideslip maneuver while turning base to avoid overshooting the runway centerline as drawn in Figure 15. An intentional slip can be used to adjust airplane ground track during an approach and is often used when a crosswind is present. A sideslip is a combination of forward movement and sideward movement (toward the low wing). In the case of the accident, the right crosswind would have required a sideward movement to the right and exacerbated the right bank angle required in the turn as shown in Figure 15.
