# NATIONAL TRANSPORTATION SAFETY BOARD

## Global Positioning System Device

### Specialist's Factual Report

Location: Price, Texas  
Date: January 31, 2017  
Aircraft/ID: Cessna 177  
Registration: N2810X  
Operator: Private  
NTSB Number: CEN17FA095

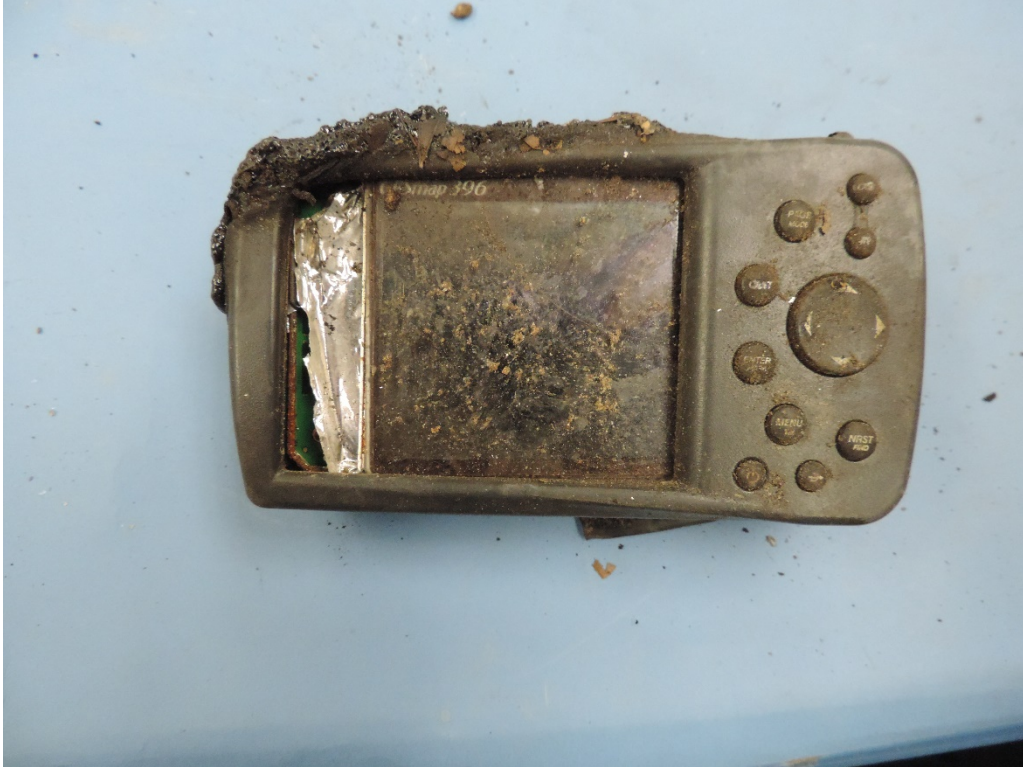
Figures 1 and 2 show the condition of the device as it arrived in the laboratory. The device exhibited substantial damage due to impact forces and fire. The device's internal memory component was removed, imaged, and decoded using laboratory hardware and software.

**Figure 1.** Photo of Garmin GPSMAP 396 (Front)

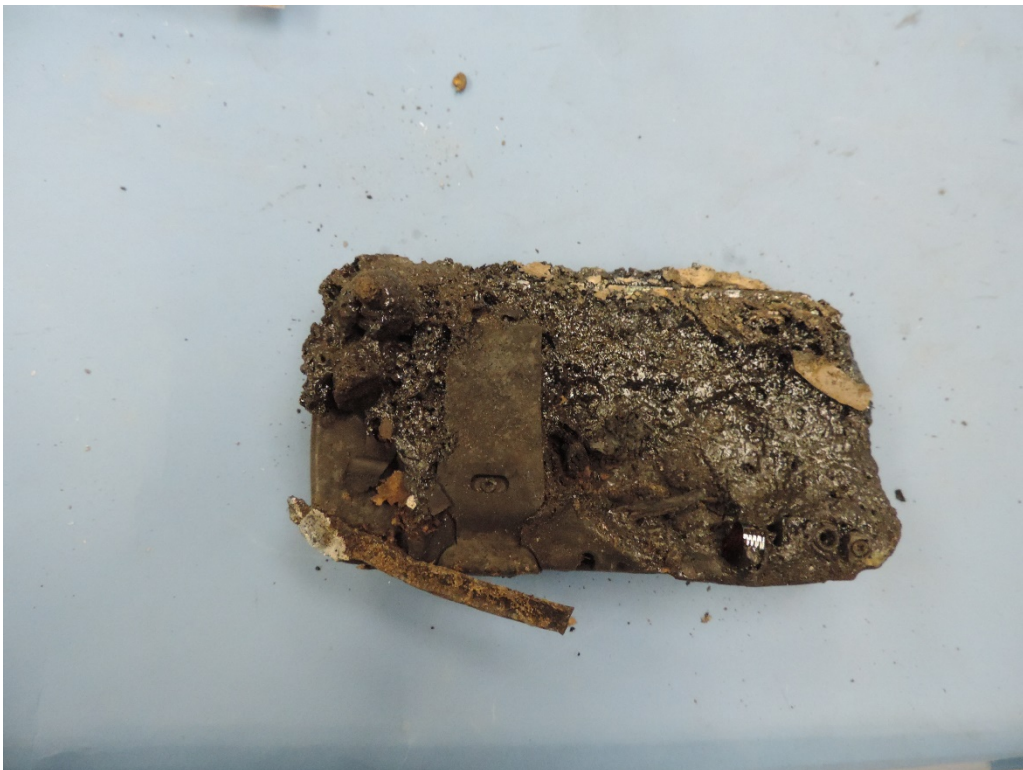
**Figure 2.** Photo of Garmin GPSMAP 396 (Back)

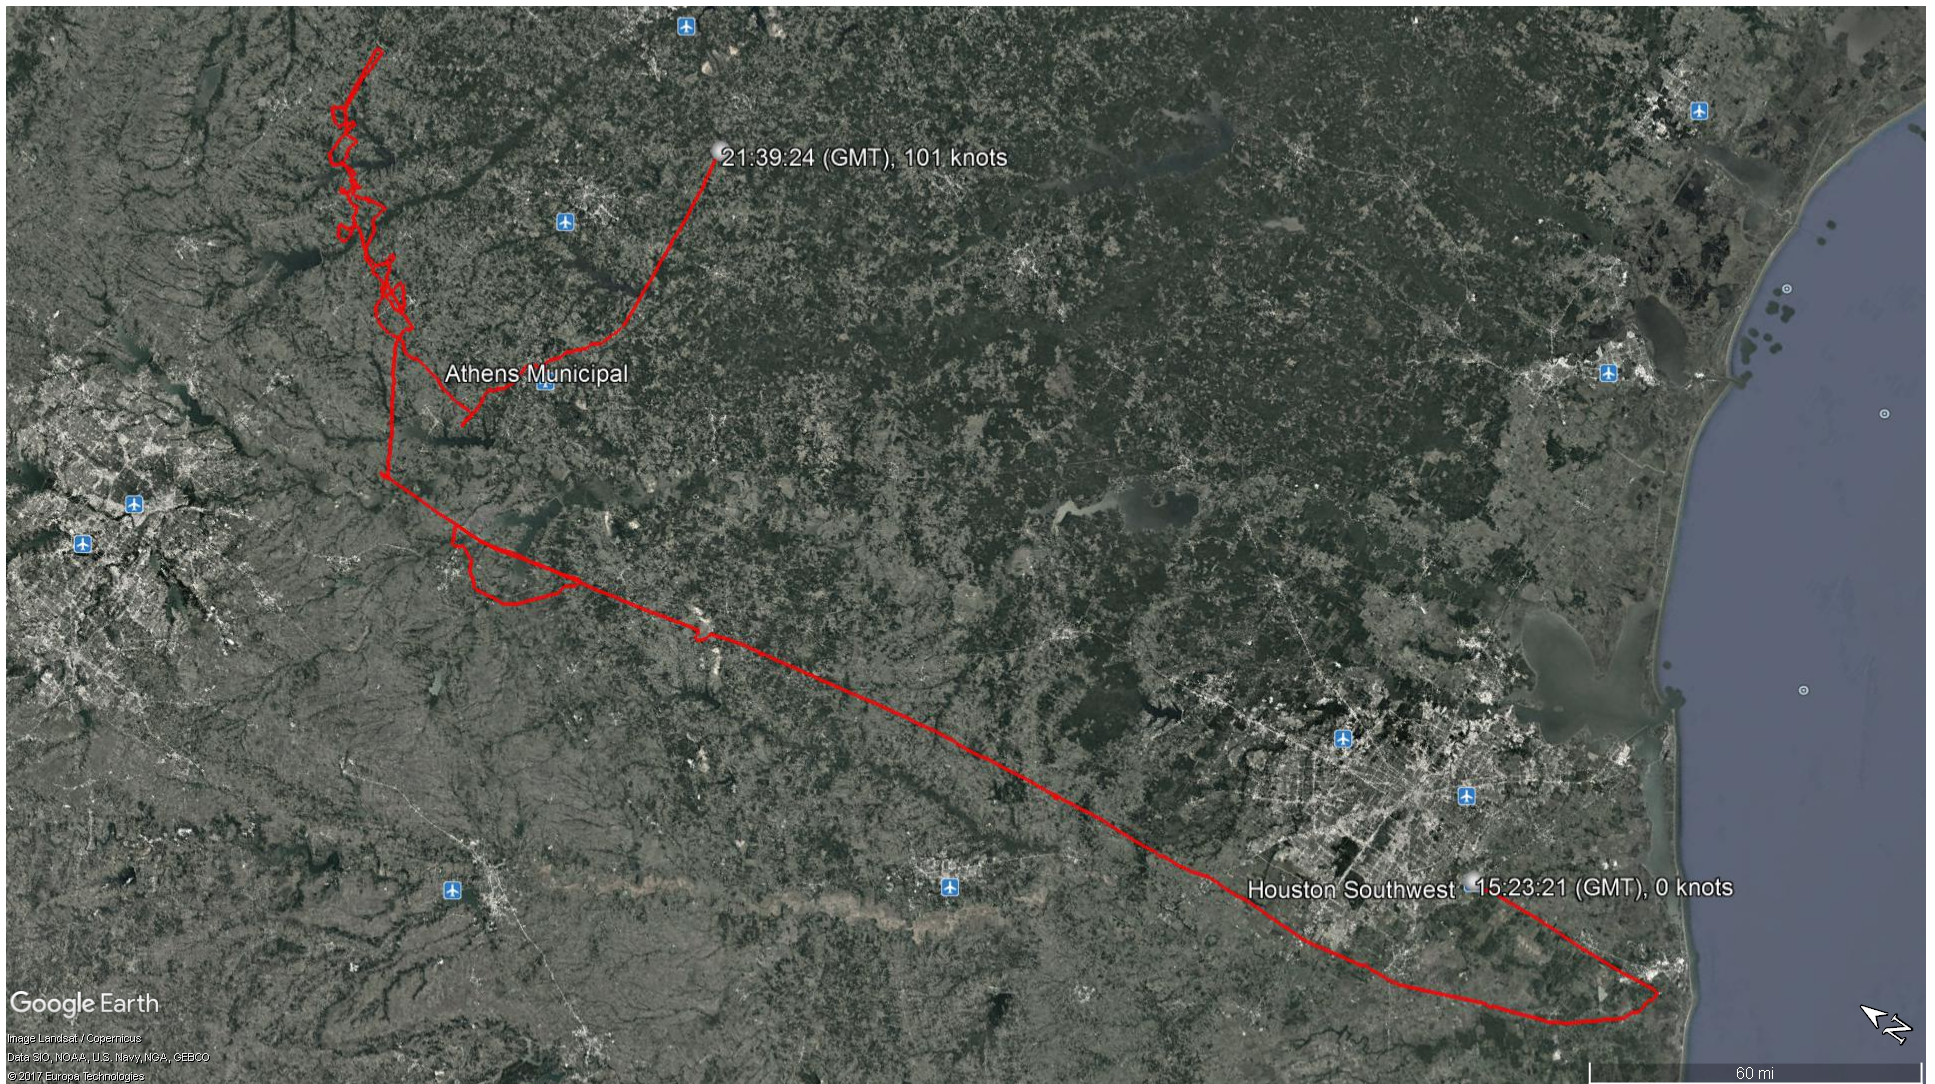
The session recorded begins at 15:23:21 UTC with the aircraft located at Houston Southwest Airport (AXH). The aircraft proceeds to and lands at Athens Municipal Airport (F44) where it remains from approximately 20:49 UTC to 21:09 UTC. The aircraft then takes off and proceeds northeast until the recording ends at 21:39:24 UTC. The total duration of the recording was 6 hours, 16 minutes, 3 seconds.

Figures 3 and 4 are graphical overlays generated using Google Earth showing, respectively, an overview of and the end of the recorded session.

**Figure 3.** Overview of the recorded session on January 31, 2017

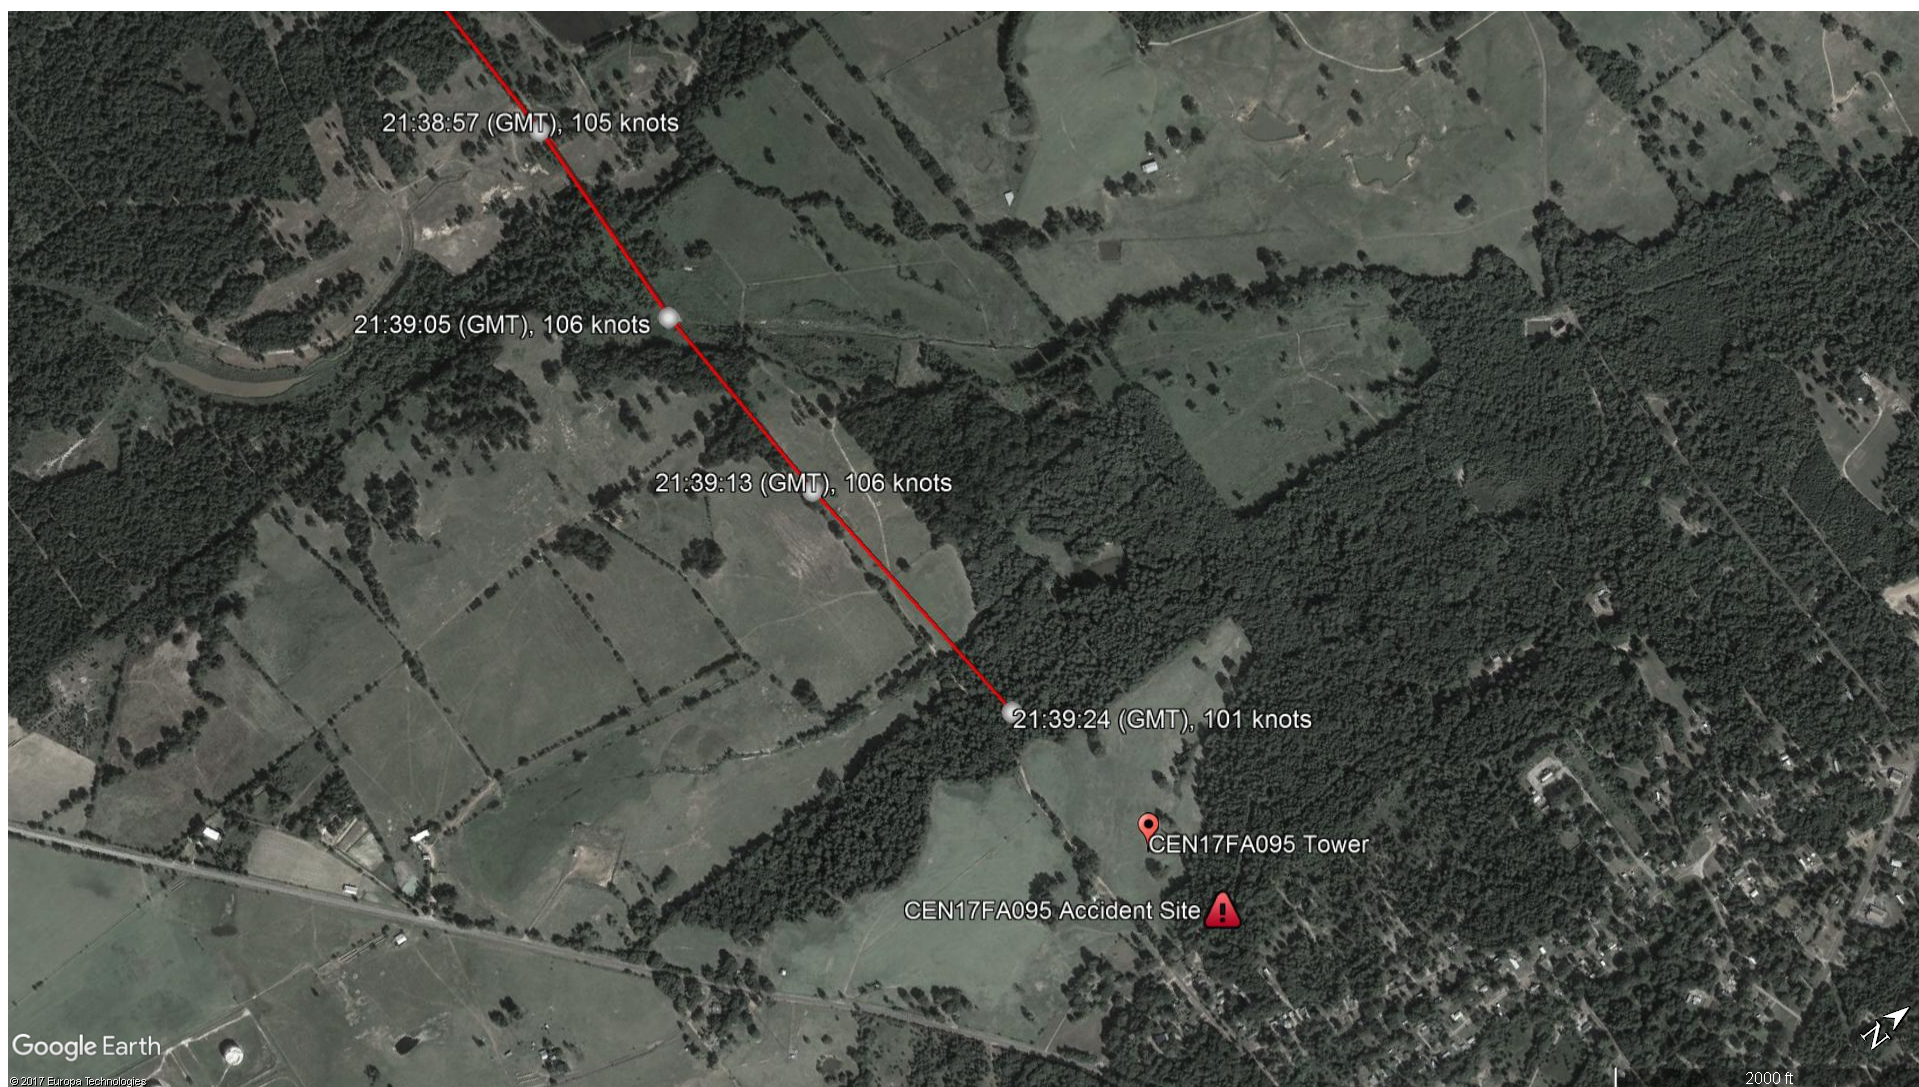
**Figure 4.** Detail view of the end of the recorded session, including locations for the cellular tower and the accident wreckage
