**NATIONAL TRANSPORTATION SAFETY BOARD**  
Office of Research and Engineering  
Washington, D.C. 20594

## **Video Study**

**NTSB Case Number:**  
**CEN17FA170**

Location: Hollis, Oklahoma  
Date: April 28, 2017  
Time: 1300 CDT  
Aircraft: Air Tractor AT-602

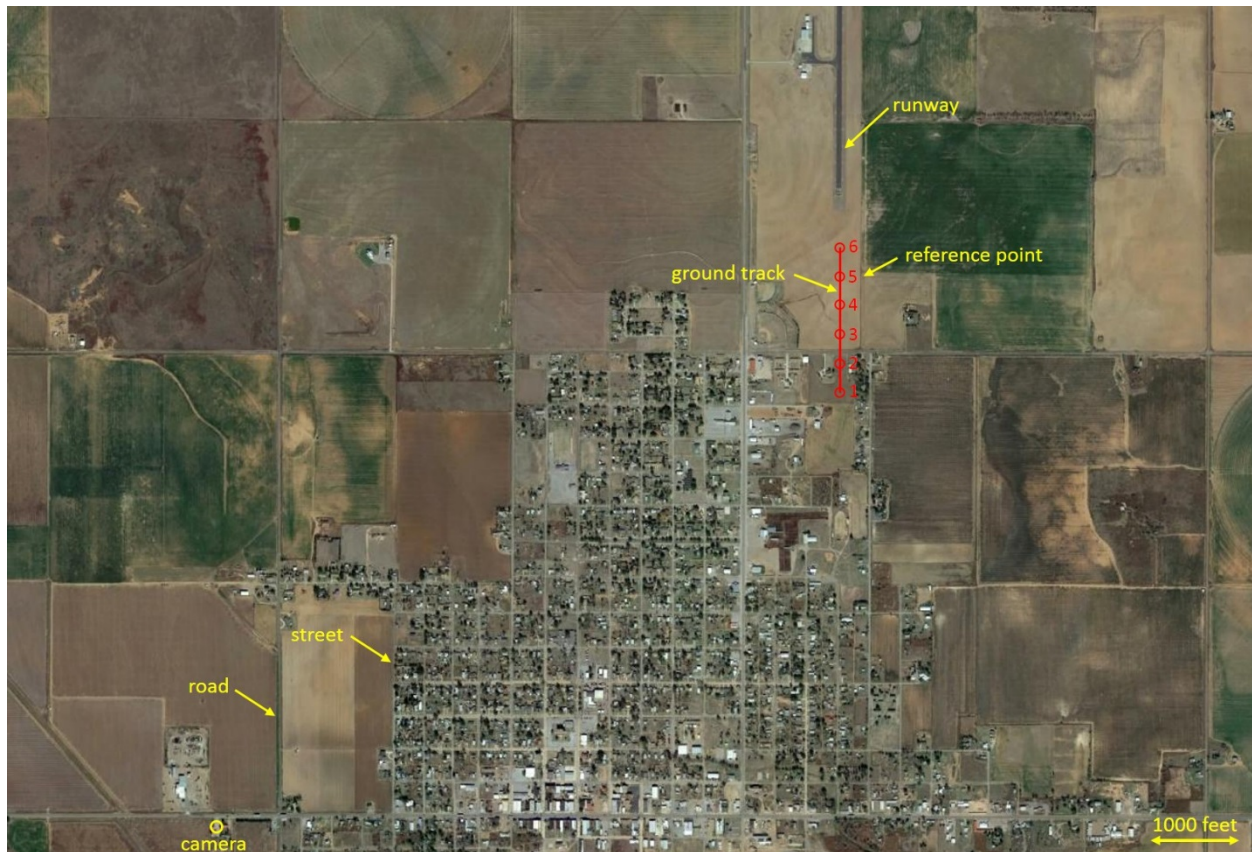
**Figure 1. Aerial Image of the Accident Area**

Figure 1 is an aerial view that shows the location of the camera and the location of the runway. Also shown in Figure 1 are a road and a street. Figure 2 is a frame from the

Figure 1 shows in red the assumed ground track of the airplane as it was approaching runway 35. Six reference points, spaced by 100 meters, are marked on the

ground track. The airplane impacted ground north of reference point No. 6 and before reaching the runway.

The analysis of the video was based on a mathematical model of the camera optics. Parameters of a camera optics model are the 3D location and 3D orientation of the camera and the horizontal field of view (HFOV) angle of the camera lens. The location of the camera was known. As can be appreciated in Figure 2, the camera, which was suspended on a tree, had significant roll and pitch angles with respect to the ground. The road seen in the frame in Figure 2 was the main reference for estimating the roll and pitch angles of the camera with respect to the ground. Reference points A, B, C and D were used for estimating the yaw of the camera and its HFOV. Once all camera parameters were estimated, the camera model could accurately map points seen in Figure 1 onto their images seen in the video frame in Figure 2.

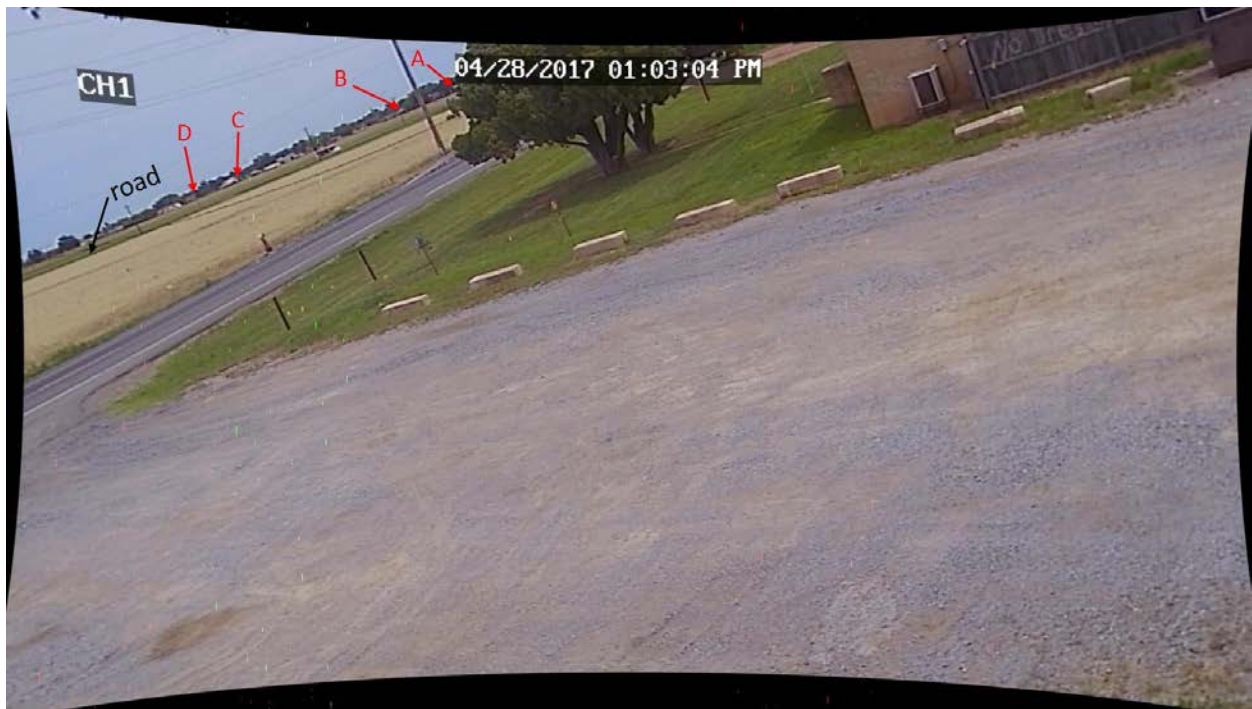
Figure 2. Video Frame (after barrel distortion corrected)

video. The original video frame had significant barrel distortion because of the wide-angle lens of the camera. Figure 2 shows the frame after the barrel distortion was mathematically corrected. The black areas near the edges of the frame correspond to areas that were outside of the original distorted image. The road marked in Figure 2 is the same road that is marked in Figure 1. Arrows A, B, C and D point to walls of buildings located along the street marked in Figure 1.

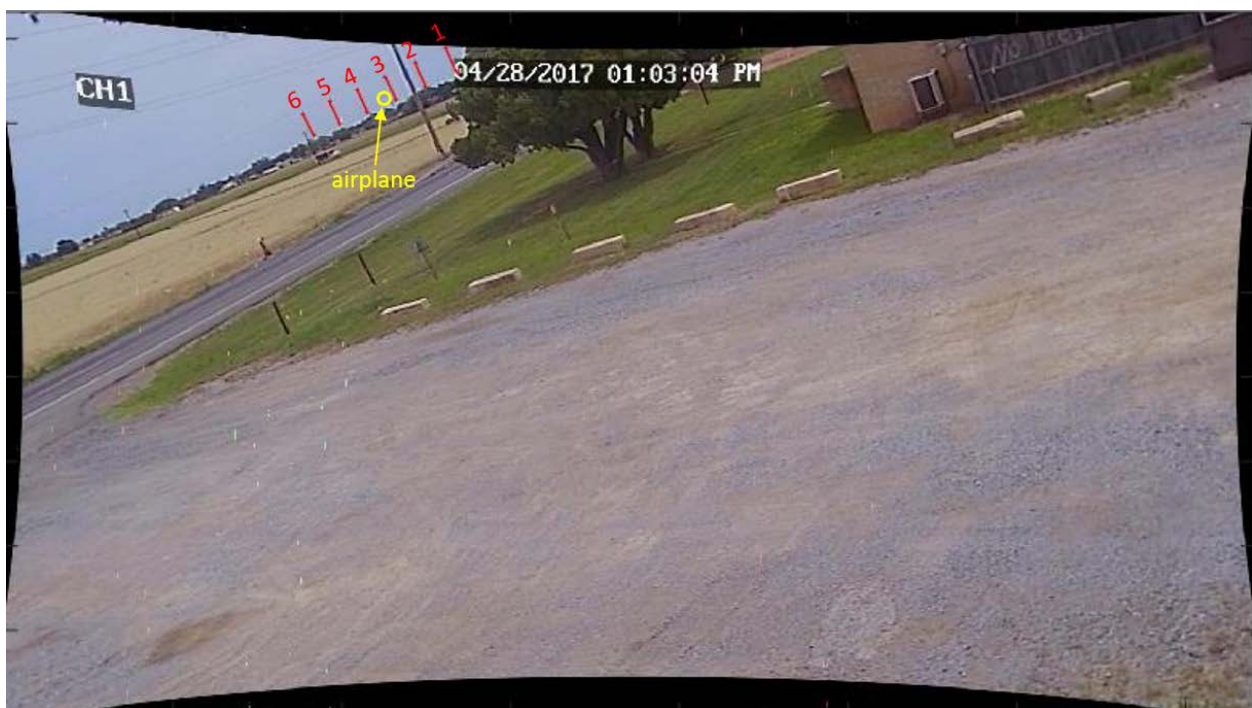
Figure 3. Video Frame Showing Reference Lines and the Airplane

Figure 3 shows the frame from Figure 2 onto which six reference lines were mapped by the camera model. These lines are located at the six reference points seen in Figure 1 and they extend from 30 meters to 90 meters above ground. Also shown in Figure 3 is the location of the airplane when it was between reference lines No. 3 and 4. Because of the 10,000 feet distance from the camera, the airplane is barely visible. However, by stepping through the video frame-by-frame, the location of the airplane with respect to the reference lines can be measured.

Once the airplane was past reference line No. 6, its altitude decreased rapidly at the rate of about 80 ft/s. One second after crossing reference line No. 6, the airplane was behind the trees seen in Figure 3 and no longer visible. About 3.5 seconds after the airplane disappeared from view, smoke resulting from a post-crash fire became visible in the video.
