**NATIONAL TRANSPORTATION SAFETY BOARD**  
Vehicle Recorder Division  
Washington, D.C. 20594

## **Cockpit Displays – Recorded Flight Data**

**Specialist's Factual Report**  
**By Sean Payne**

Location: Fishers, Indiana  
Date: August 31, 2017  
Aircraft: Vans Aircraft RV-12  
Registration: N212ZF  
Operator: Private  
NTSB Number: CEN17FA334

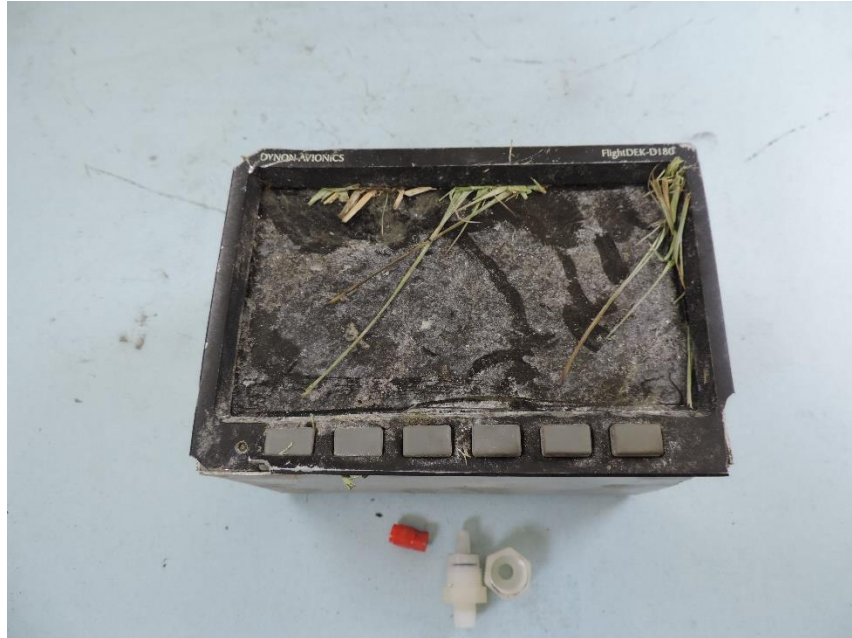
**Figure 1. Damaged exterior of Dynon FlightDEK-D180.**

The recorder was damaged in the event. The extent of the damage is shown in figure 1. The data were extracted by identifying the non-volatile memory<sup>1</sup> (NVM) chip inside the device, removing it via a de-soldering process, and reading the NVM's binary contents in a forensic reader. The binary contents were then converted to engineering units using documentation supplied by the manufacturer with the assistance of NTSB laboratory software.

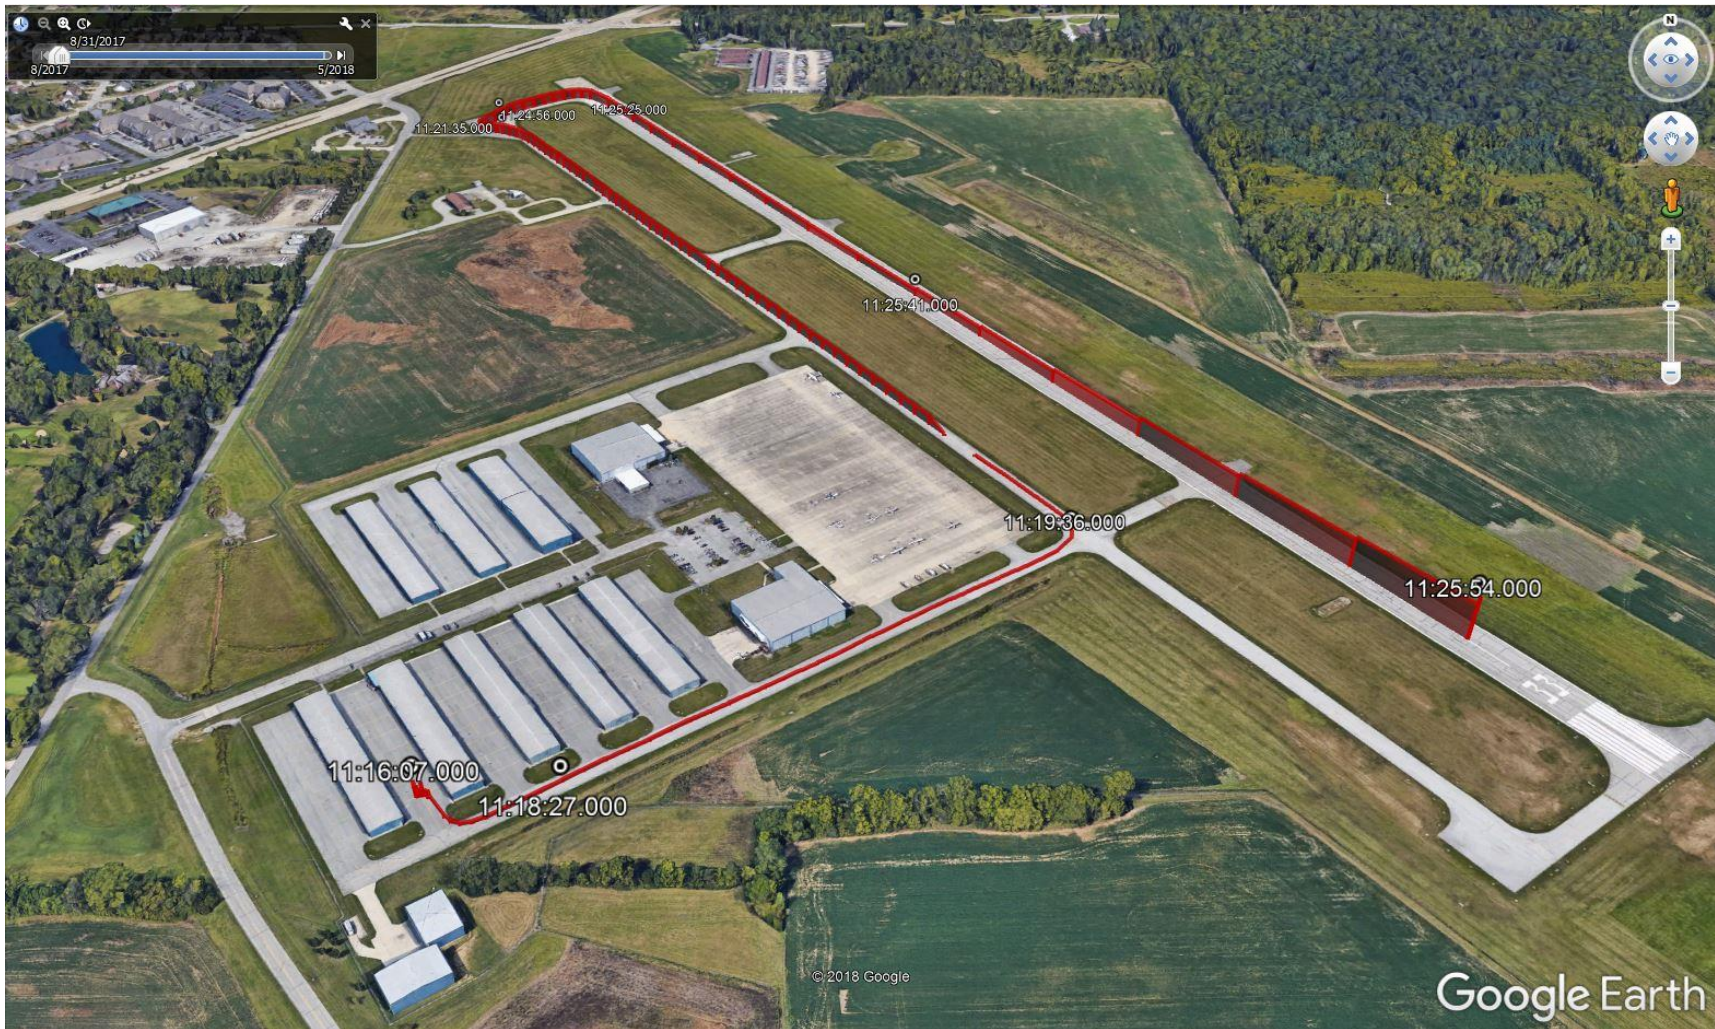
Figure 7. A Google Earth overlay of the entire accident flight recording.

Figure 7 is a Google Earth overlay showing the entire recorded tracklog points for the accident flight.

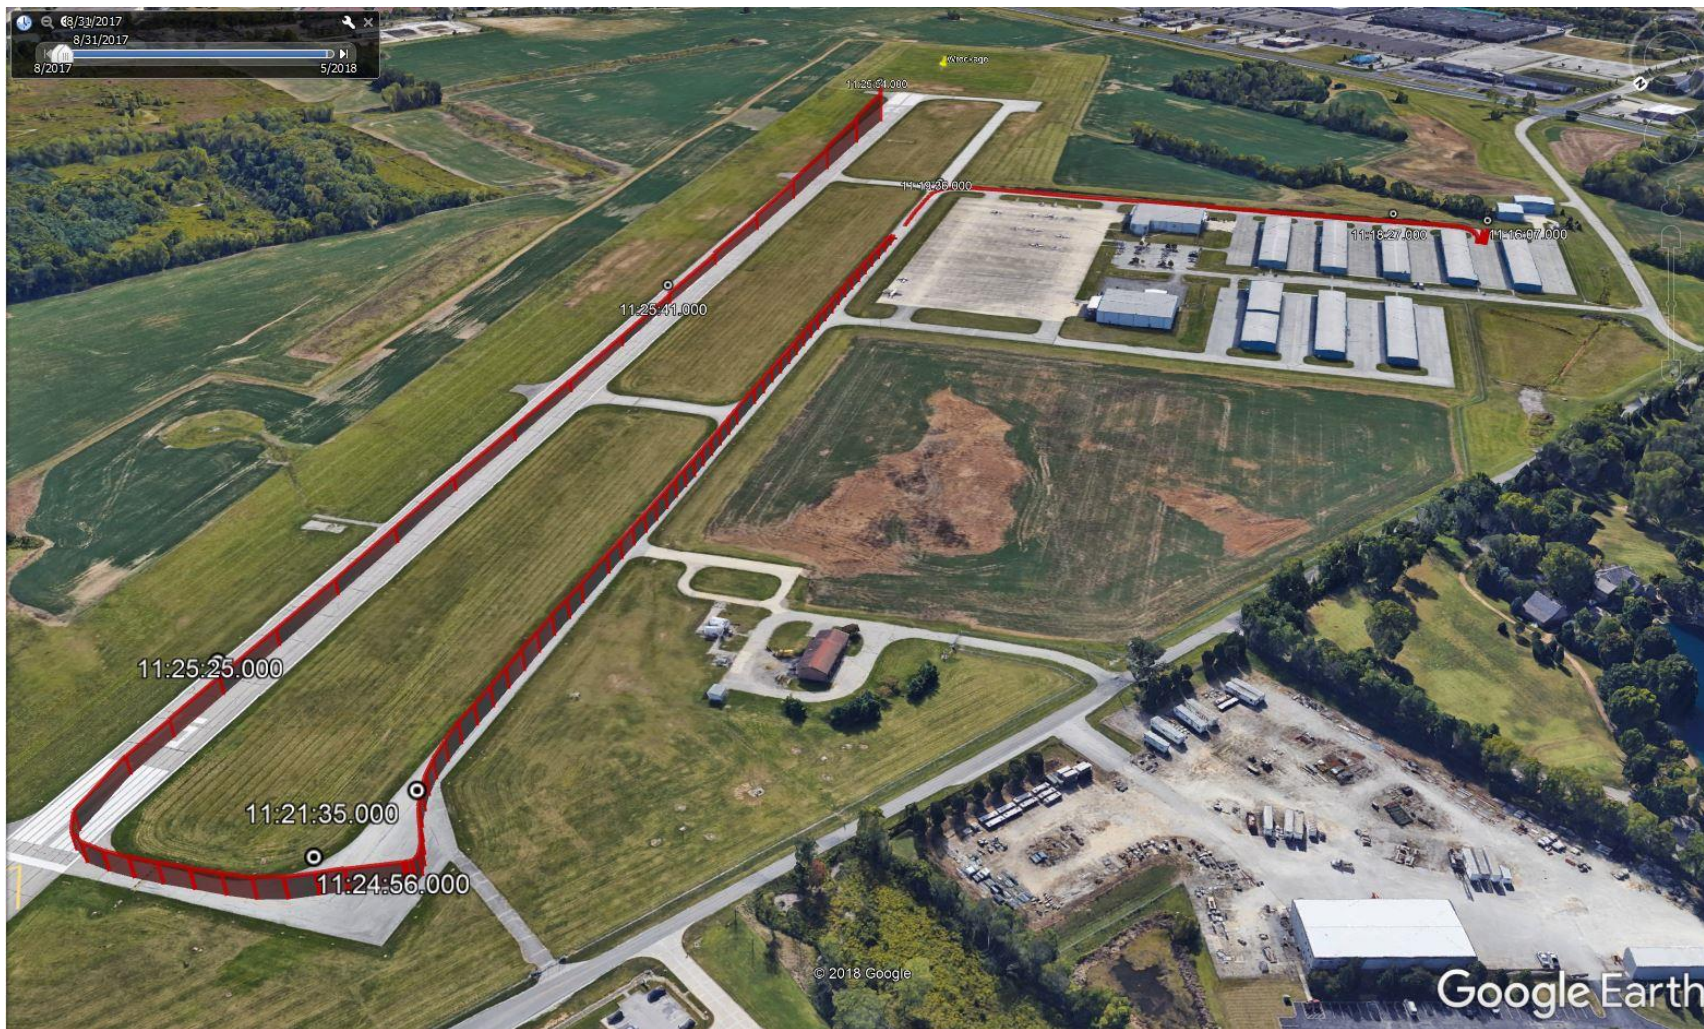
Figure 8. A Google Earth overlay of the accident recording in relation to the wreckage location.

Figure 8 is a Google Earth overlay oriented to show the entire recorded tracklog points for the accident flight in relation to the wreckage location which is displayed as a yellow pushpin near the departure end of the runway.
