**NATIONAL TRANSPORTATION SAFETY BOARD**

## **Electronic Devices**

### **Specialist's Factual Report By Sean Payne**

Location: Glenwood Springs, Colorado  
Date: September 15, 2017  
Aircraft: Cirrus SR22  
Registration: N462SR  
Operator: Private  
NTSB Number: CEN17FA354

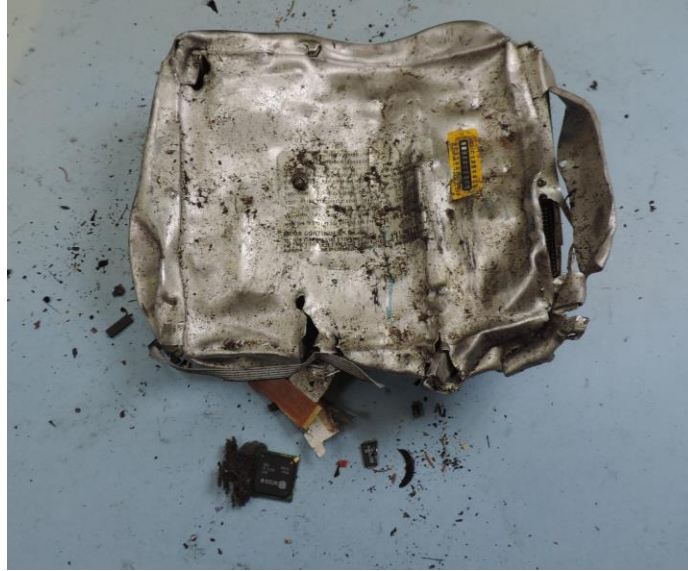
Upon arrival at the Vehicle Recorder Laboratory, an examination revealed the unit had sustained damage. The extent of the damage is shown in figure 1. A compact flash (CF) card was recovered from inside the unit. The CF card is picture in figure 2. The CF card was cracked and was missing internal memory components. The internal memory components could not be found in the wreckage.

**Figure 1.** Photo of damaged MFD.

This device is capable of storing data in the non-volatile memory (NVM).<sup>1</sup> The extent of the damage precluded normal recovery procedures and additional attempts were unsuccessful in yielding usable data. Therefore, no data pertinent to the event were recovered.

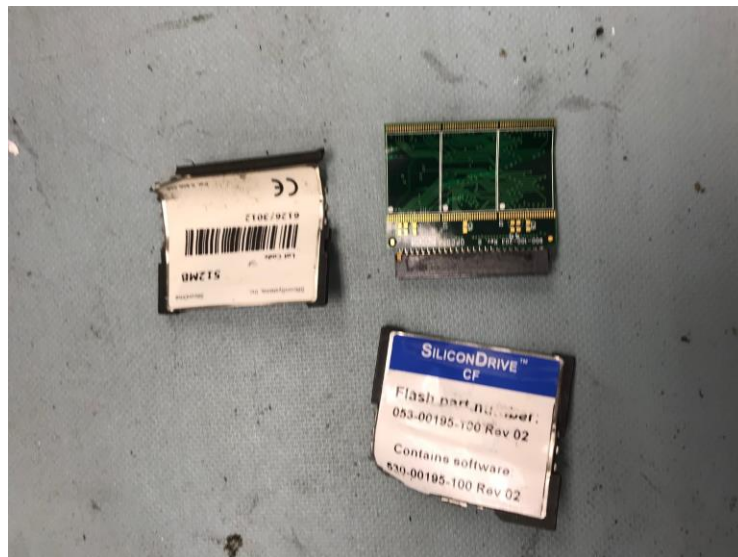
**Figure 2.** Photo of damaged CF card.

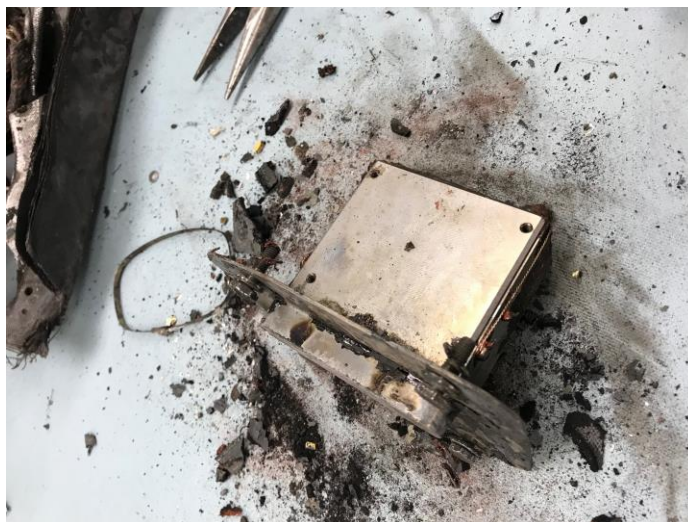
Upon arrival at the Vehicle Recorder Laboratory, an examination revealed the unit had sustained damage. The extent of the damage is shown in figure 3. The unit had sustained heavy fire damage. The RDM was exposed from the composite material and opened. Figure 4 shows the internal board of the RDM. The components on the internal board were destroyed by fire. Figure 5 shows the CF card that was recovered from the unit. The CF card has sustained heat damage. Figure 6 is an x-ray image of the CF card, component damaged is circled in yellow. Figure 7 is the CF card exposed, high temperature fire damage was prevalent. The damaged card was unable to be read using

**Figure 3.** Photo of damaged RDM.

This device is capable of storing data in the non-volatile memory (NVM). The extent of the damage precluded normal recovery procedures and additional attempts were unsuccessful in yielding usable data. Therefore, no data pertinent to the event were recovered.

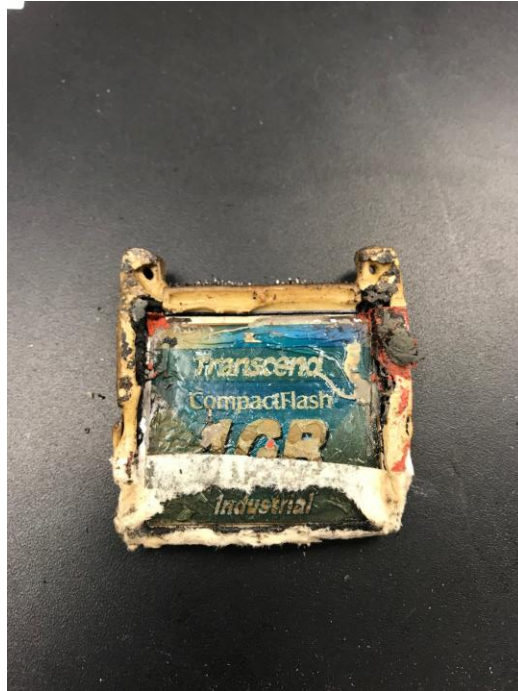
a card reader. The design of the CF card precluded efforts to read data directly from the chip. No data was recovered from the CF card.

**Figure 5.** Photo of damaged CF card recovered from RDM.

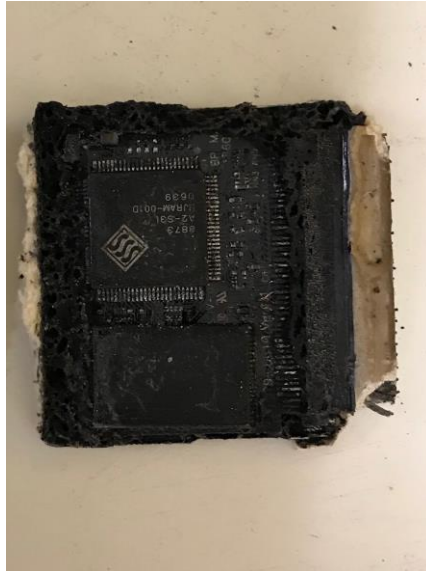
**Figure 7.** Photo of damaged CF card after being opened and inspected. Heavy fire damage was found.
