# NATIONAL TRANSPORTATION SAFETY BOARD

## Autopilot Data

### Specialist's Factual Report By Sean Payne

Location: Glenwood Springs, Colorado  
Date: September 15, 2017  
Aircraft: Cirrus SR22  
Registration: N462SR  
Operator: Private  
NTSB Number: CEN17FA354

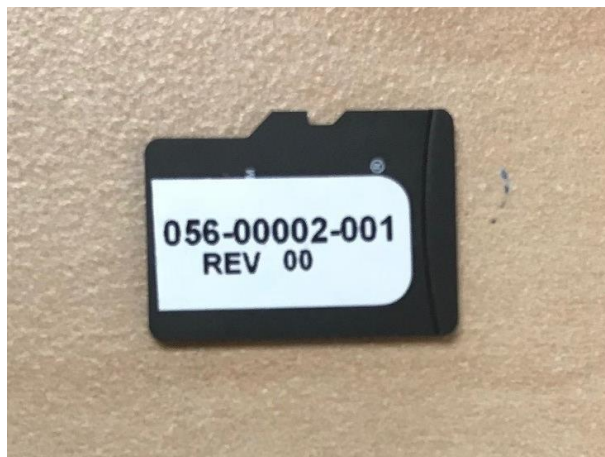
and inspected. No visible damage was found on the memory card. The card is shown in figure 2.

**Figure 2. The micro SD card removed from the card chassis.**

The card was attempted to be read via PC via a forensic write blocker, which is a device that prevents accidental modification or erasure of the memory card's data. The card became hot when powered in the chassis.

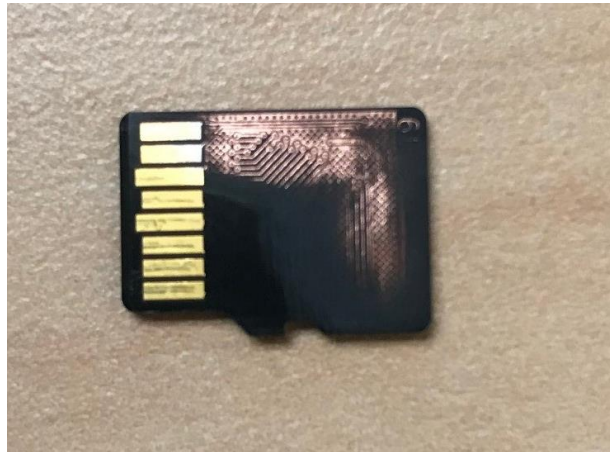
The card was sent to a third-party data recovery laboratory. The third-party data recovery laboratory used a method in which the card's plastic packaging is removed via sanding to expose wire leads. Once the wire leads are exposed, it may be possible to access the card's silicon chip via a micro-soldering technique. The third-party lab removed the plastic packaging in an area of the card and determined that data would not be recoverable via the micro-soldering method. The card, with the plastic packaging removed is shown in figure 3.

**Figure 3. The micro SD card with the plastic packaging removed via sanding.**

This device is capable of storing data in the non-volatile memory (NVM)<sup>1</sup>. The extent of the damage precluded normal recovery procedures and additional attempts were unsuccessful in yielding usable data. Therefore, no data pertinent to the event were recovered.
