# **NATIONAL TRANSPORTATION SAFETY BOARD**

## **Global Positioning System**

### **Specialist's Factual Report by Alice Park**

Location: Thief River Falls, Minnesota  
Date: September 23, 2017  
Aircraft: Cessna TR182  
Registration: N4777T  
Operator: Private  
NTSB Number: CEN17FA361

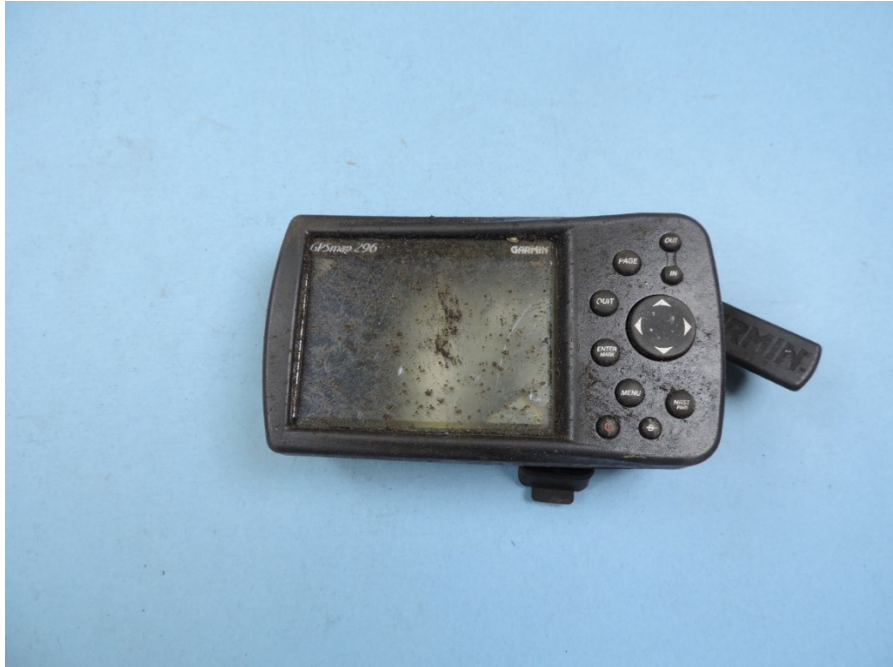
**Figure 1. External view of the Garmin GPSMAP 296 - front (s/n 67017031).**

Upon arrival at the Vehicle Recorder Laboratory, an exterior examination revealed that the unit had sustained impact damage during the accident and would not power on (Figure 1 and 2). It was disassembled for further examination.

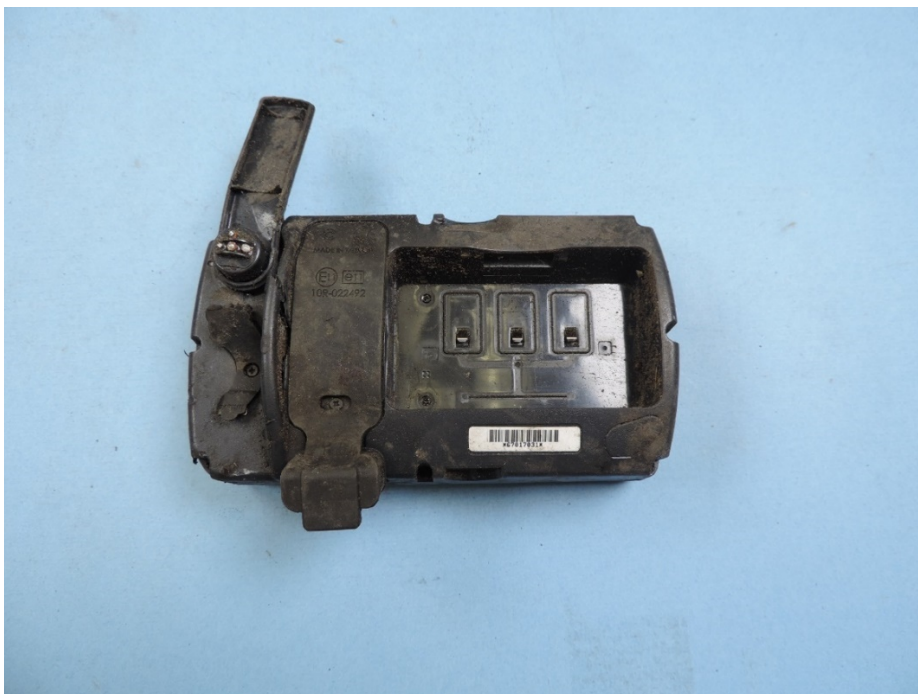
**Figure 2. External view of the Garmin GPSMAP 296 - back (s/n 67017031).**

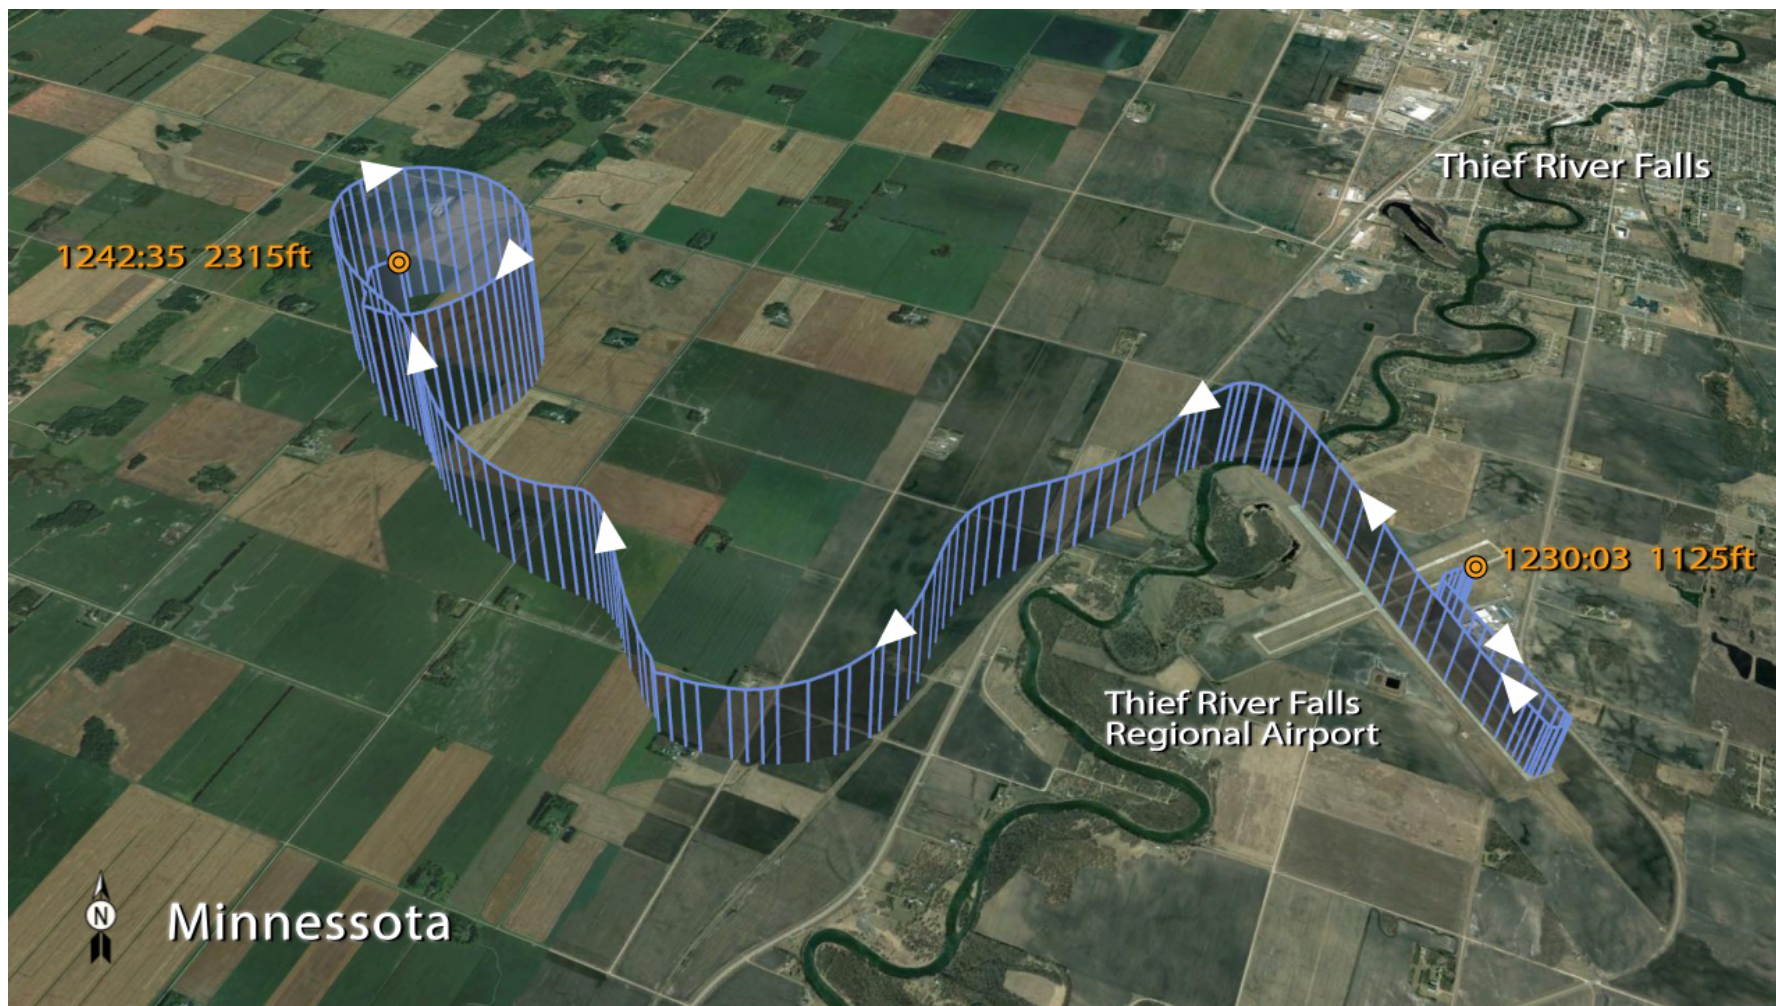
**Figure 4. Google Earth overlay of the accident flight**

(The direction of the flight is marked by white triangles and the first and final positions of the accident flight are marked with time and altitude.)

The most recently recorded track log began at 1230:03 Universal Time Coordinated (UTC) on September 23, 2017, departing at Thief River Falls Regional Airport. The accident flight flew to northwest direction from the departing airport and the final position was recorded at 1242:35 UTC with an altitude about 2315 feet. Figure 4 shows an oblique overhead view of the entire flight.
