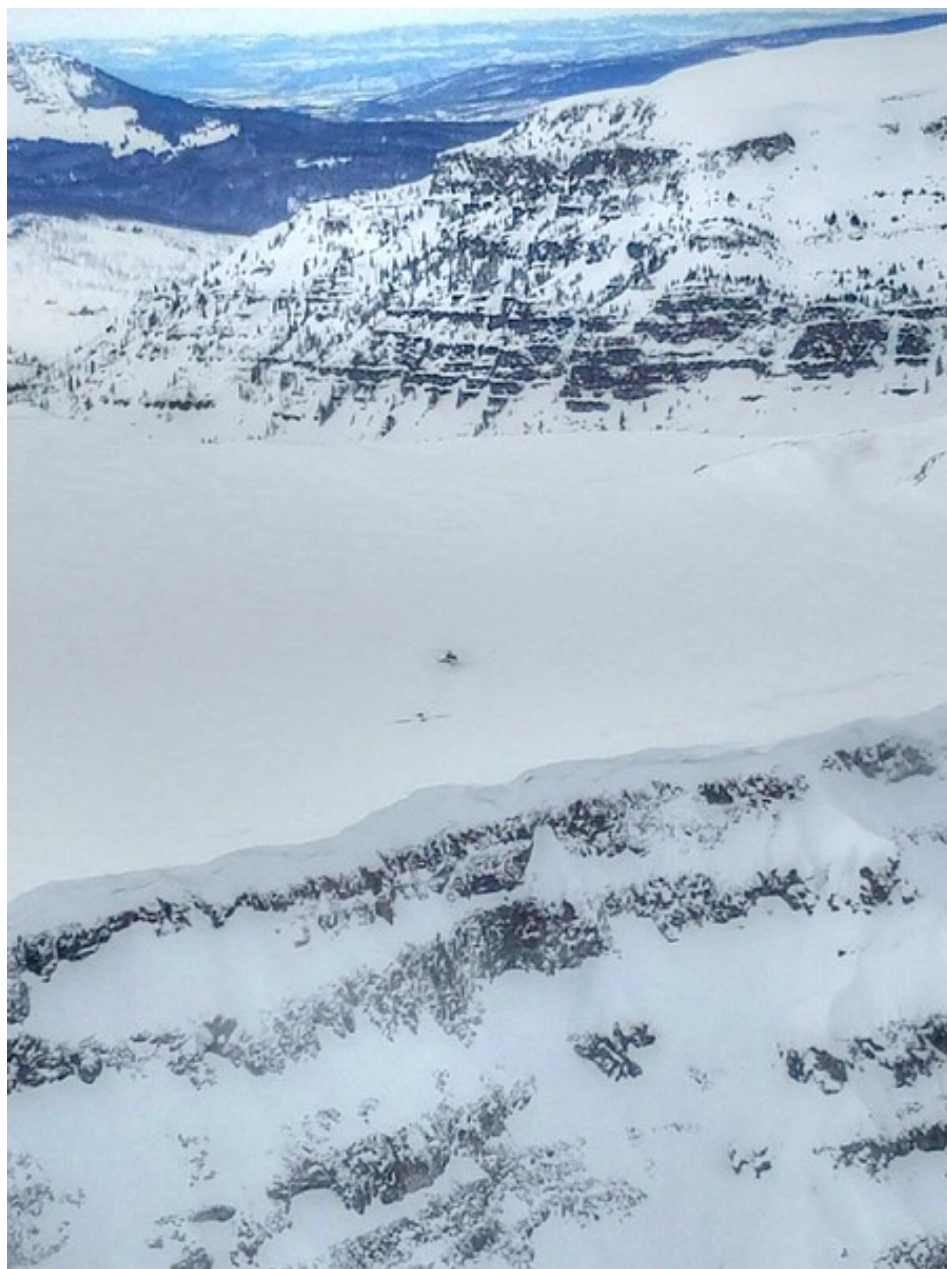
**Photo 1 – N5VK near the edge of the plateau. Rescue helicopter is in background.**

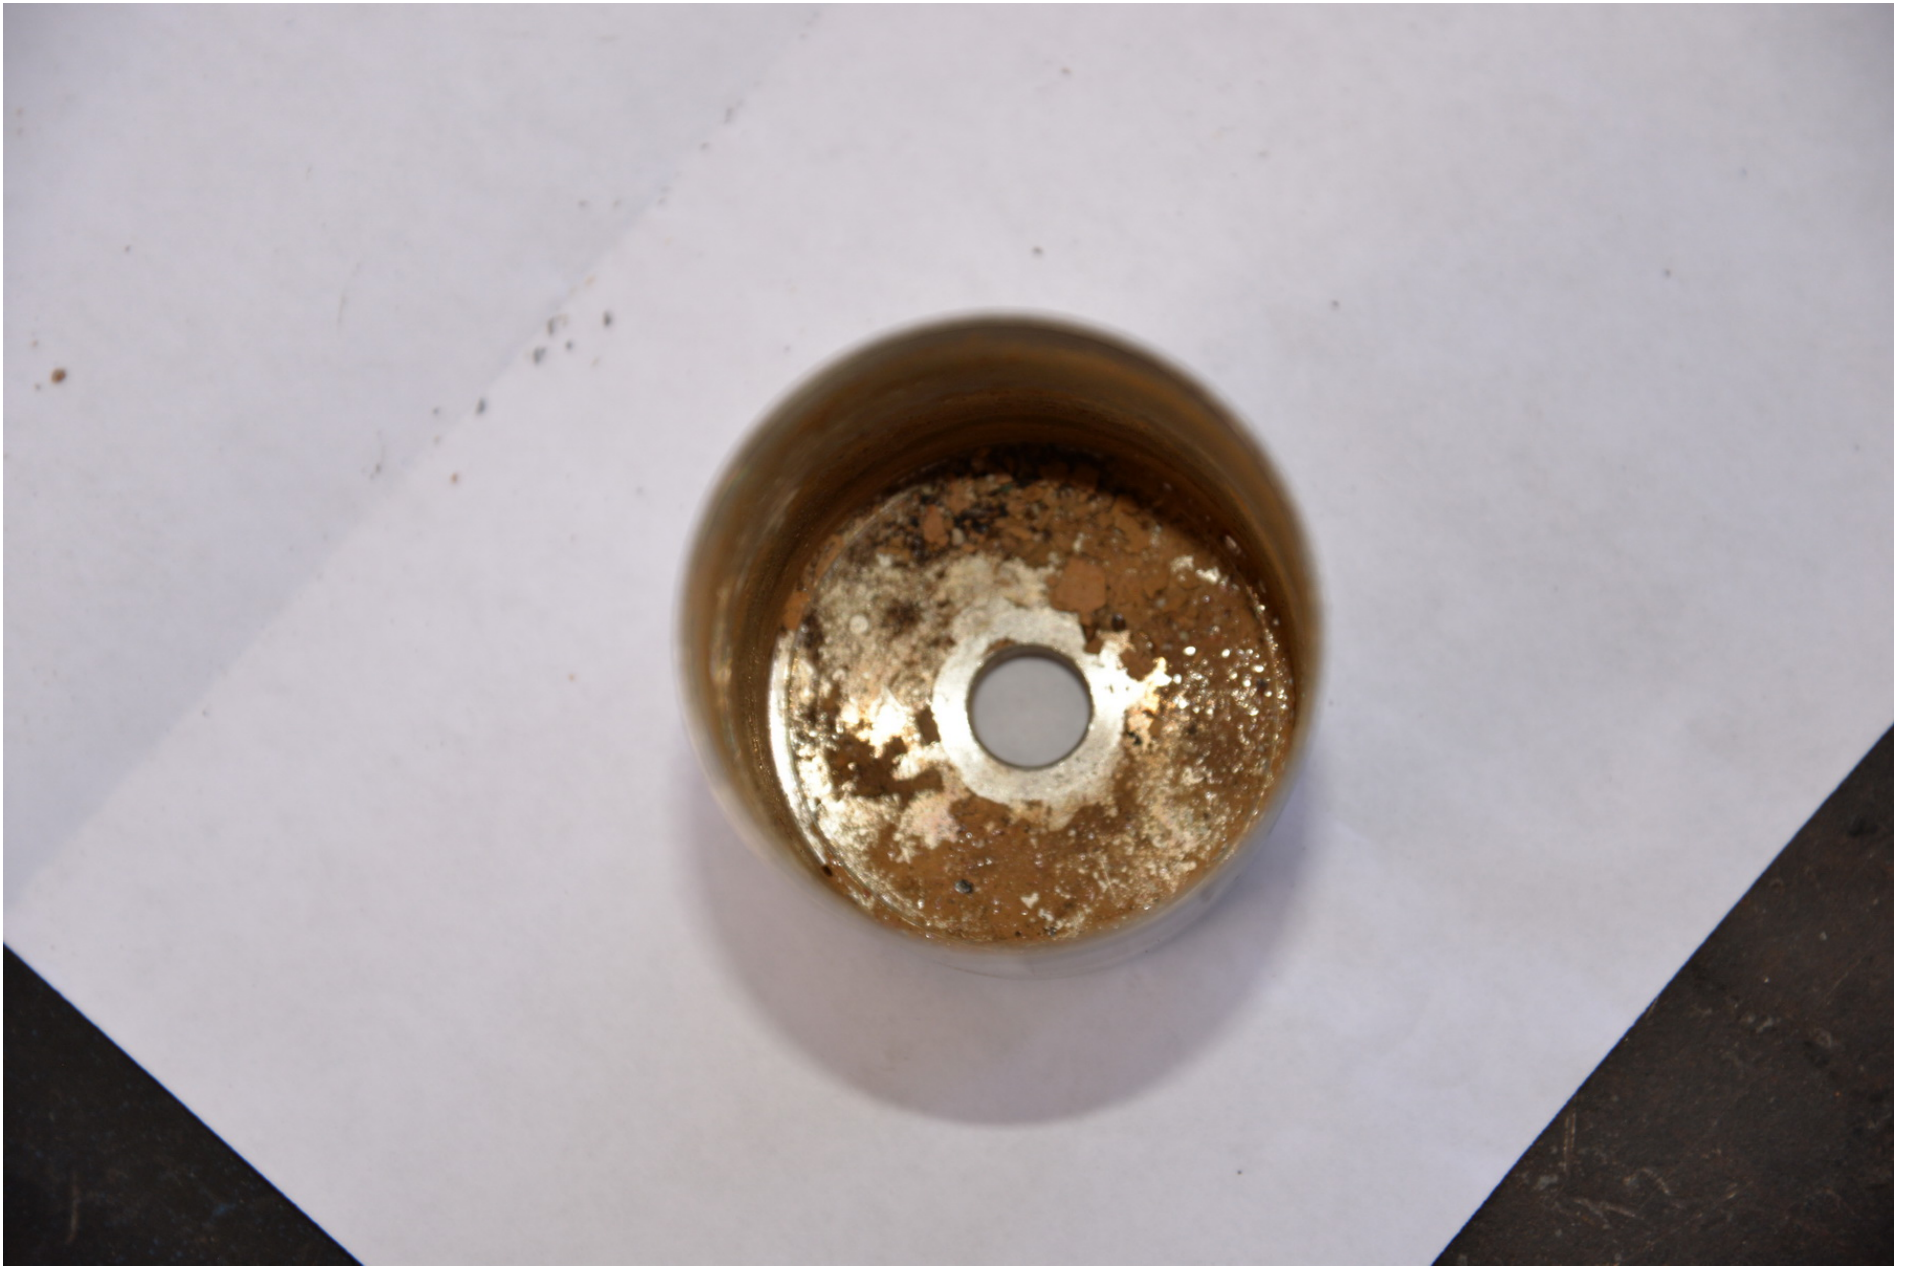
**Photo 2 – Gascolator contained rust and debris.**

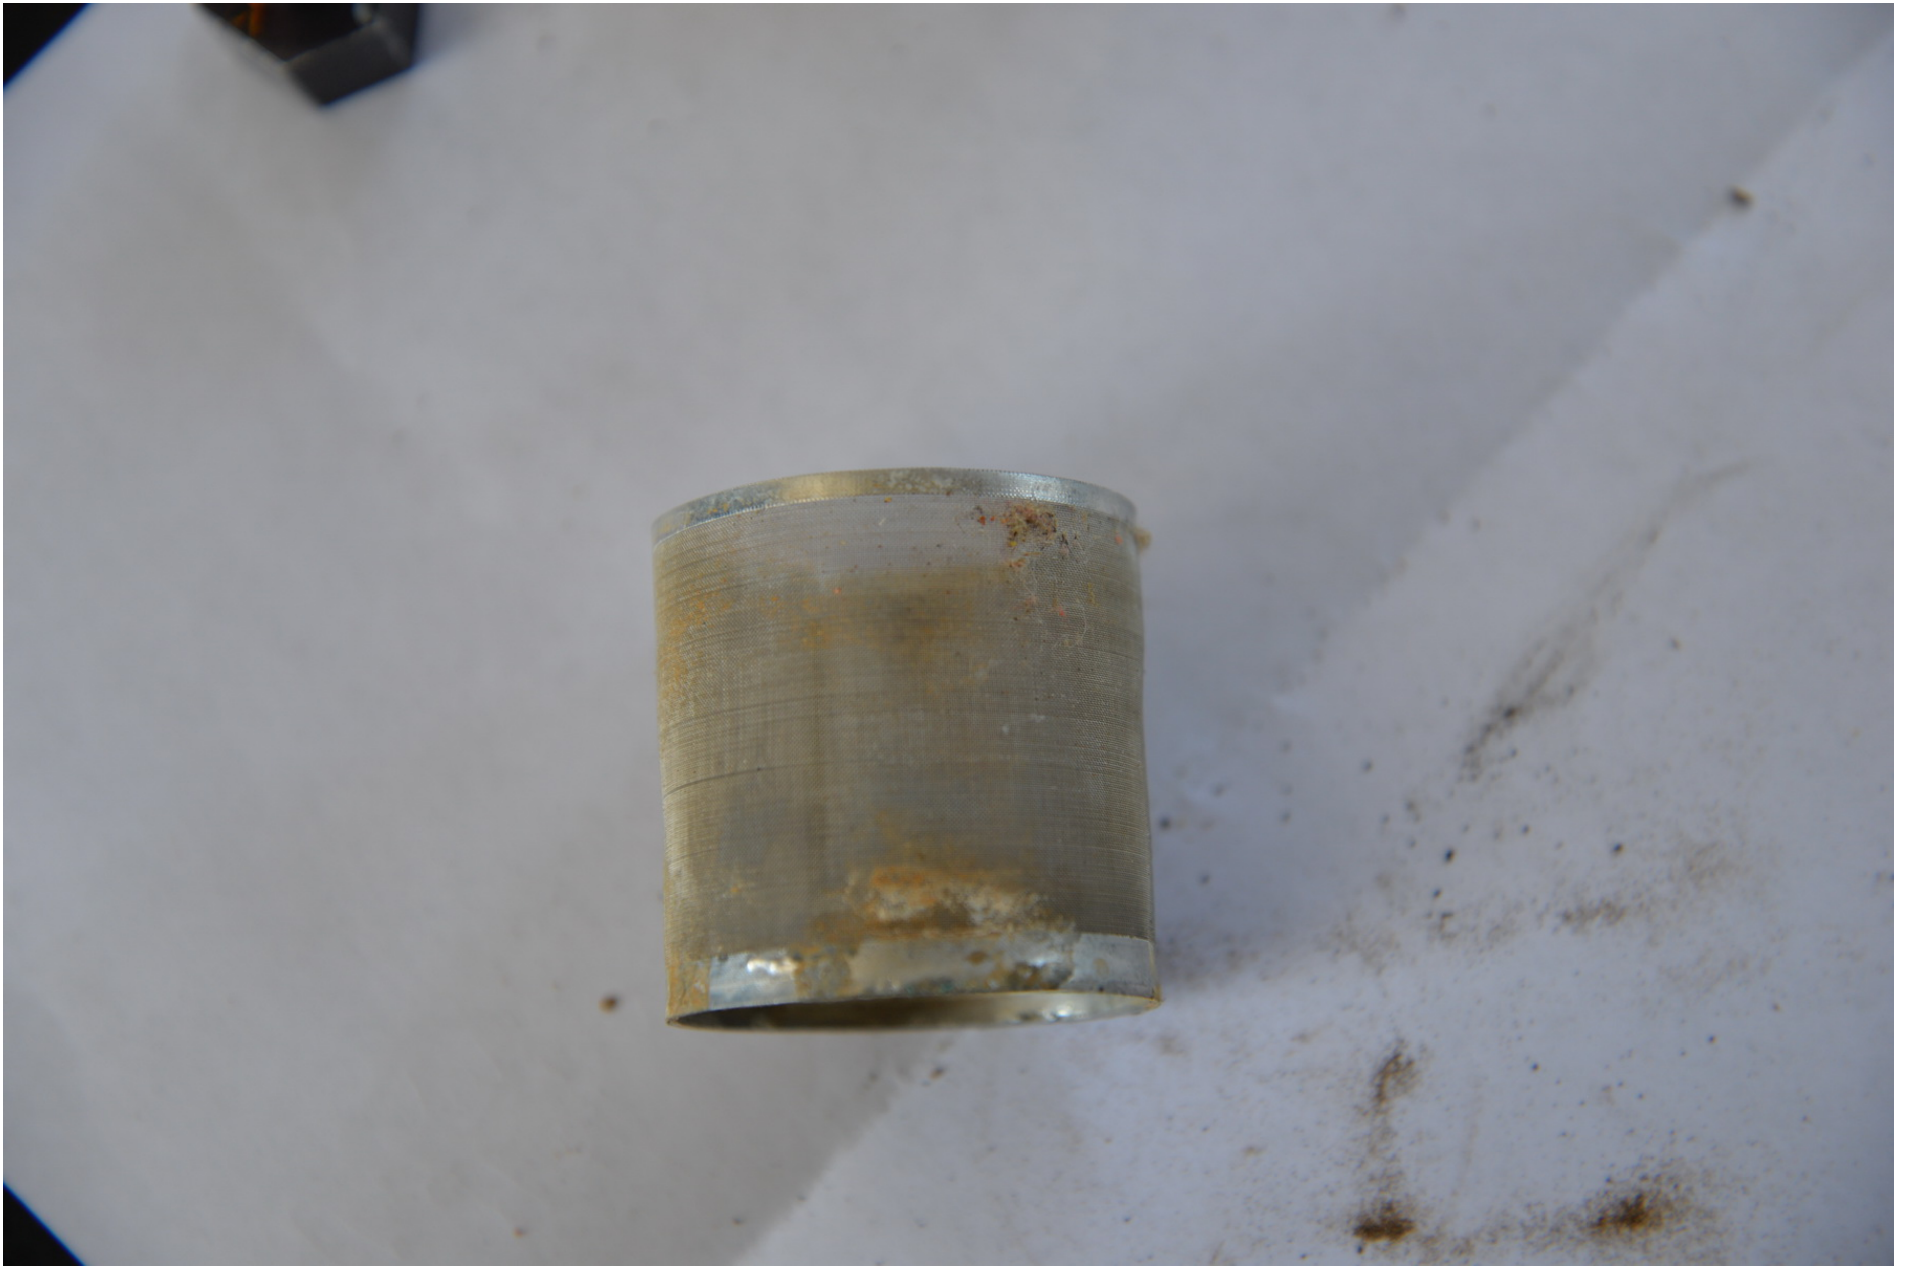
**Photo 3 – Fuel filter also contained rust and debris.**

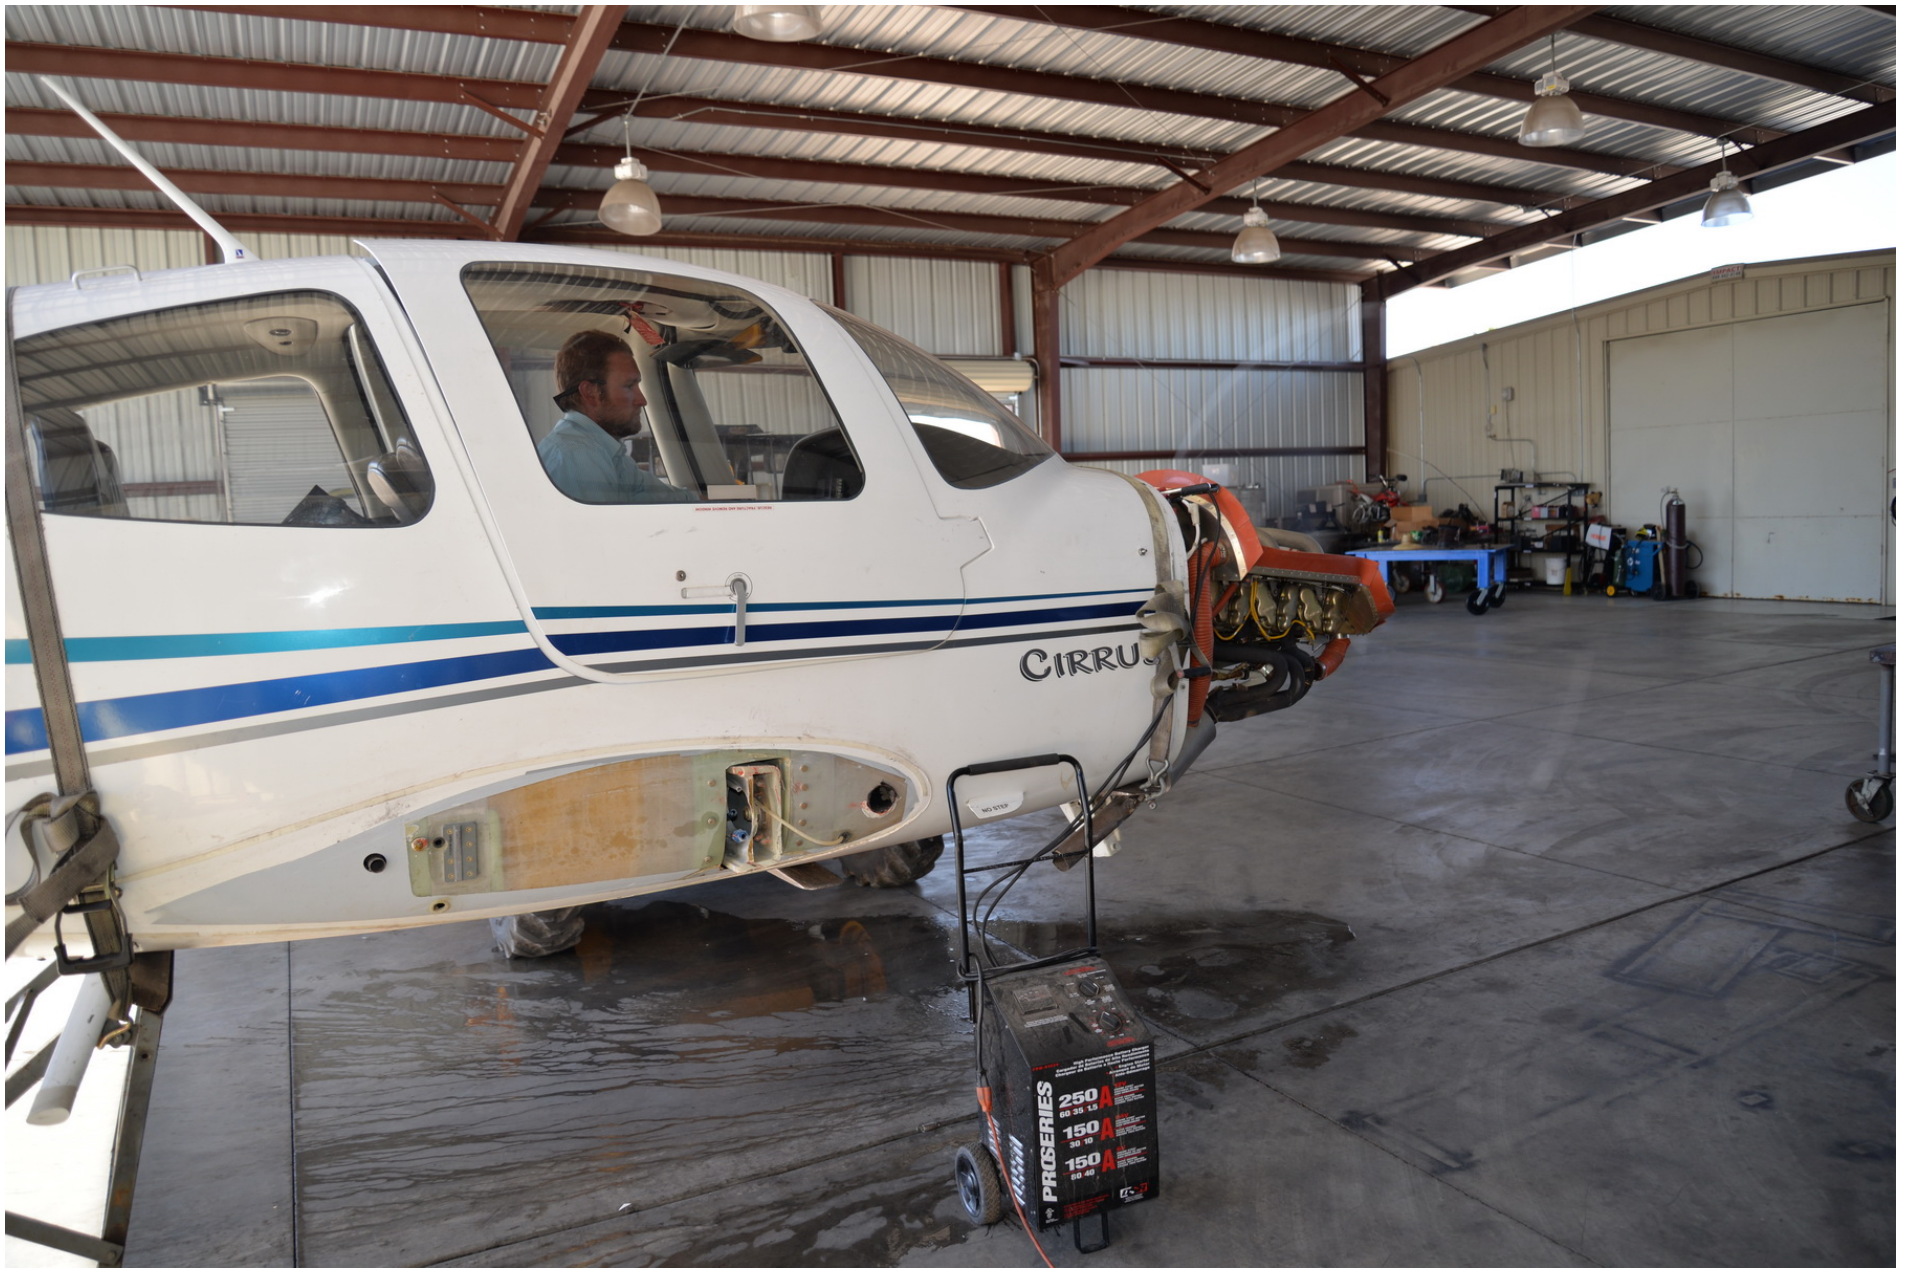
**Photo 4 – Engine being functionally tested.**

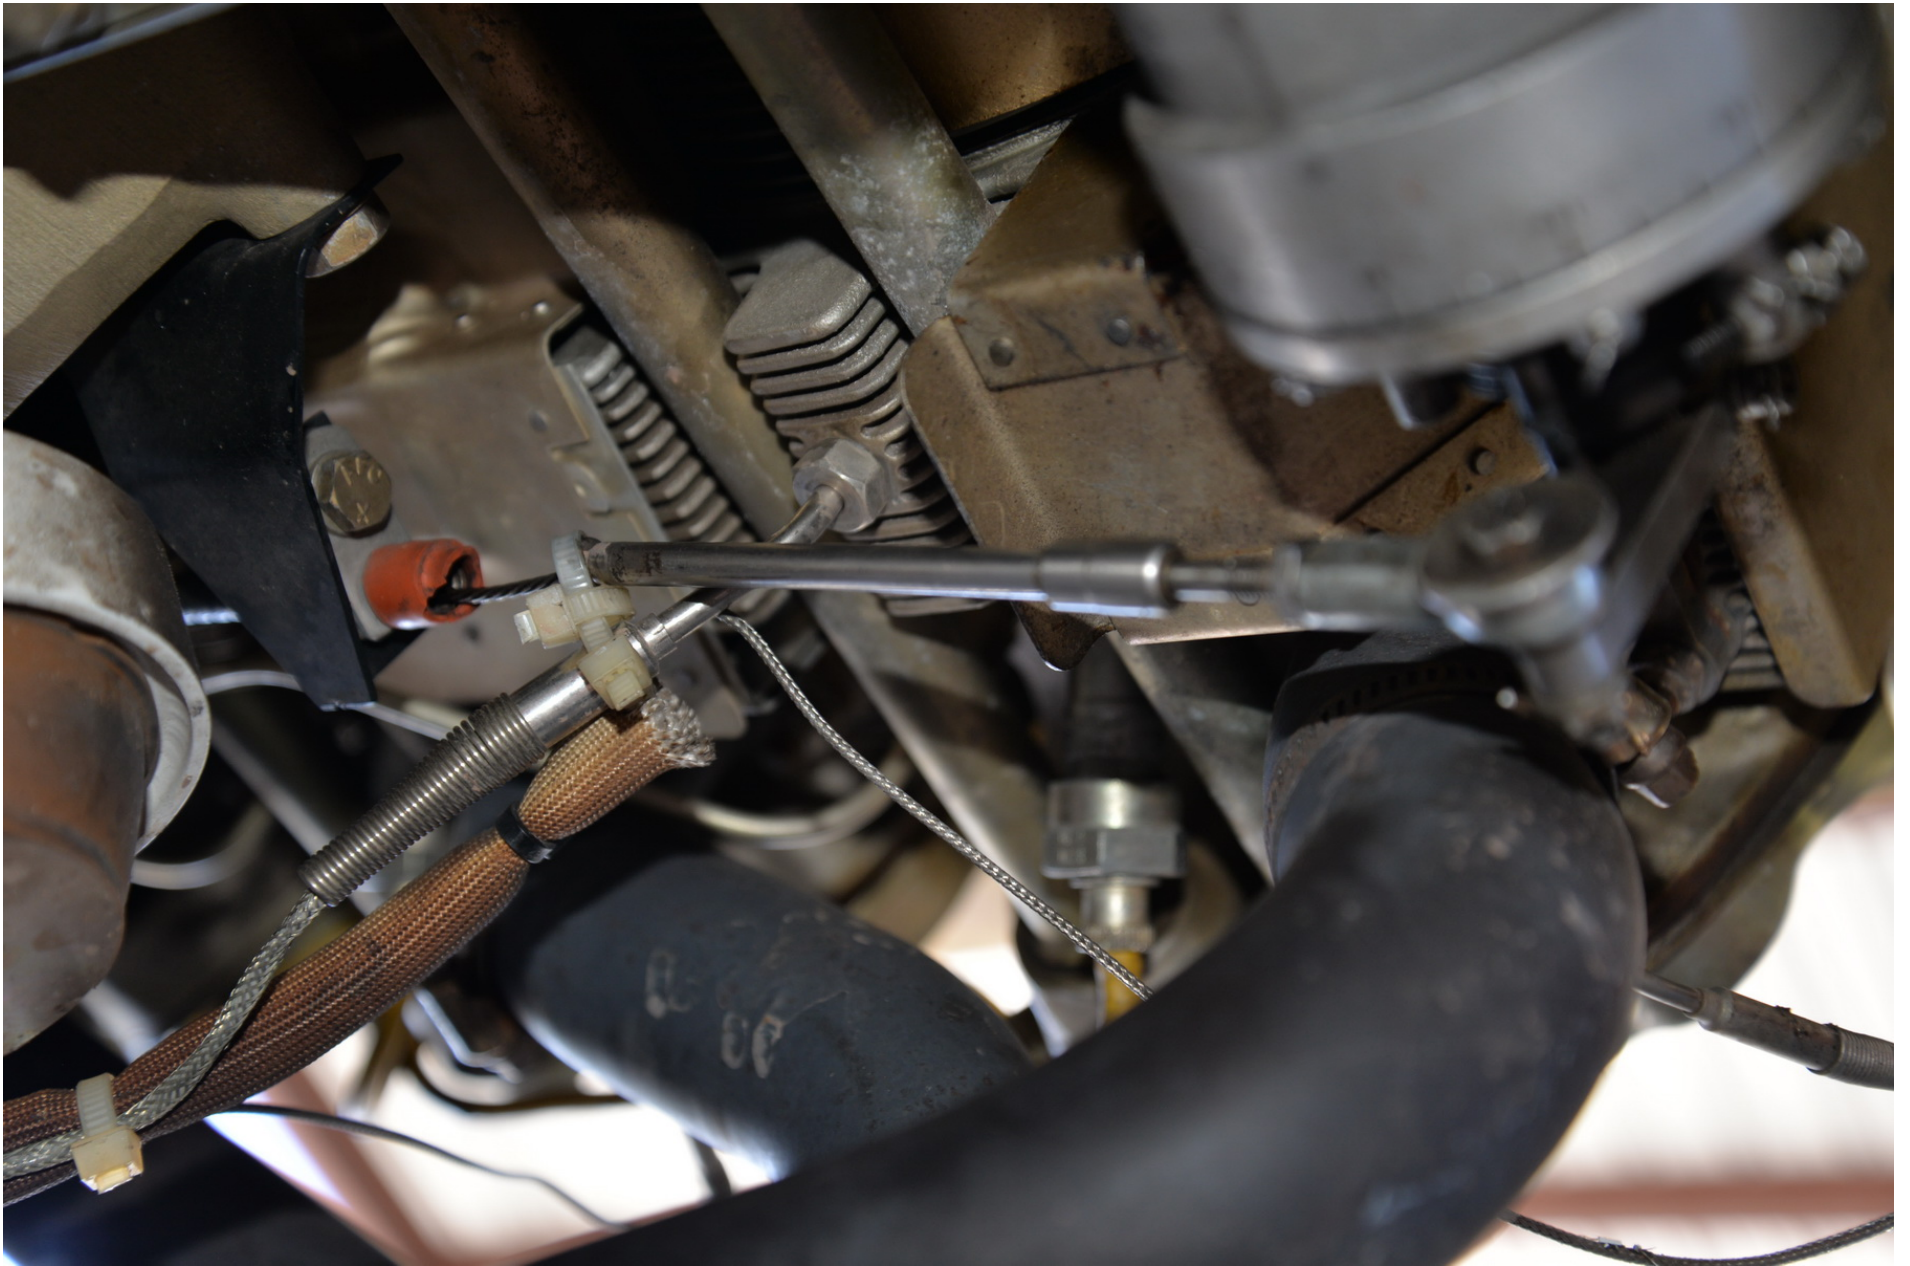
**Photo 5 – Damaged propeller governor cable.**
