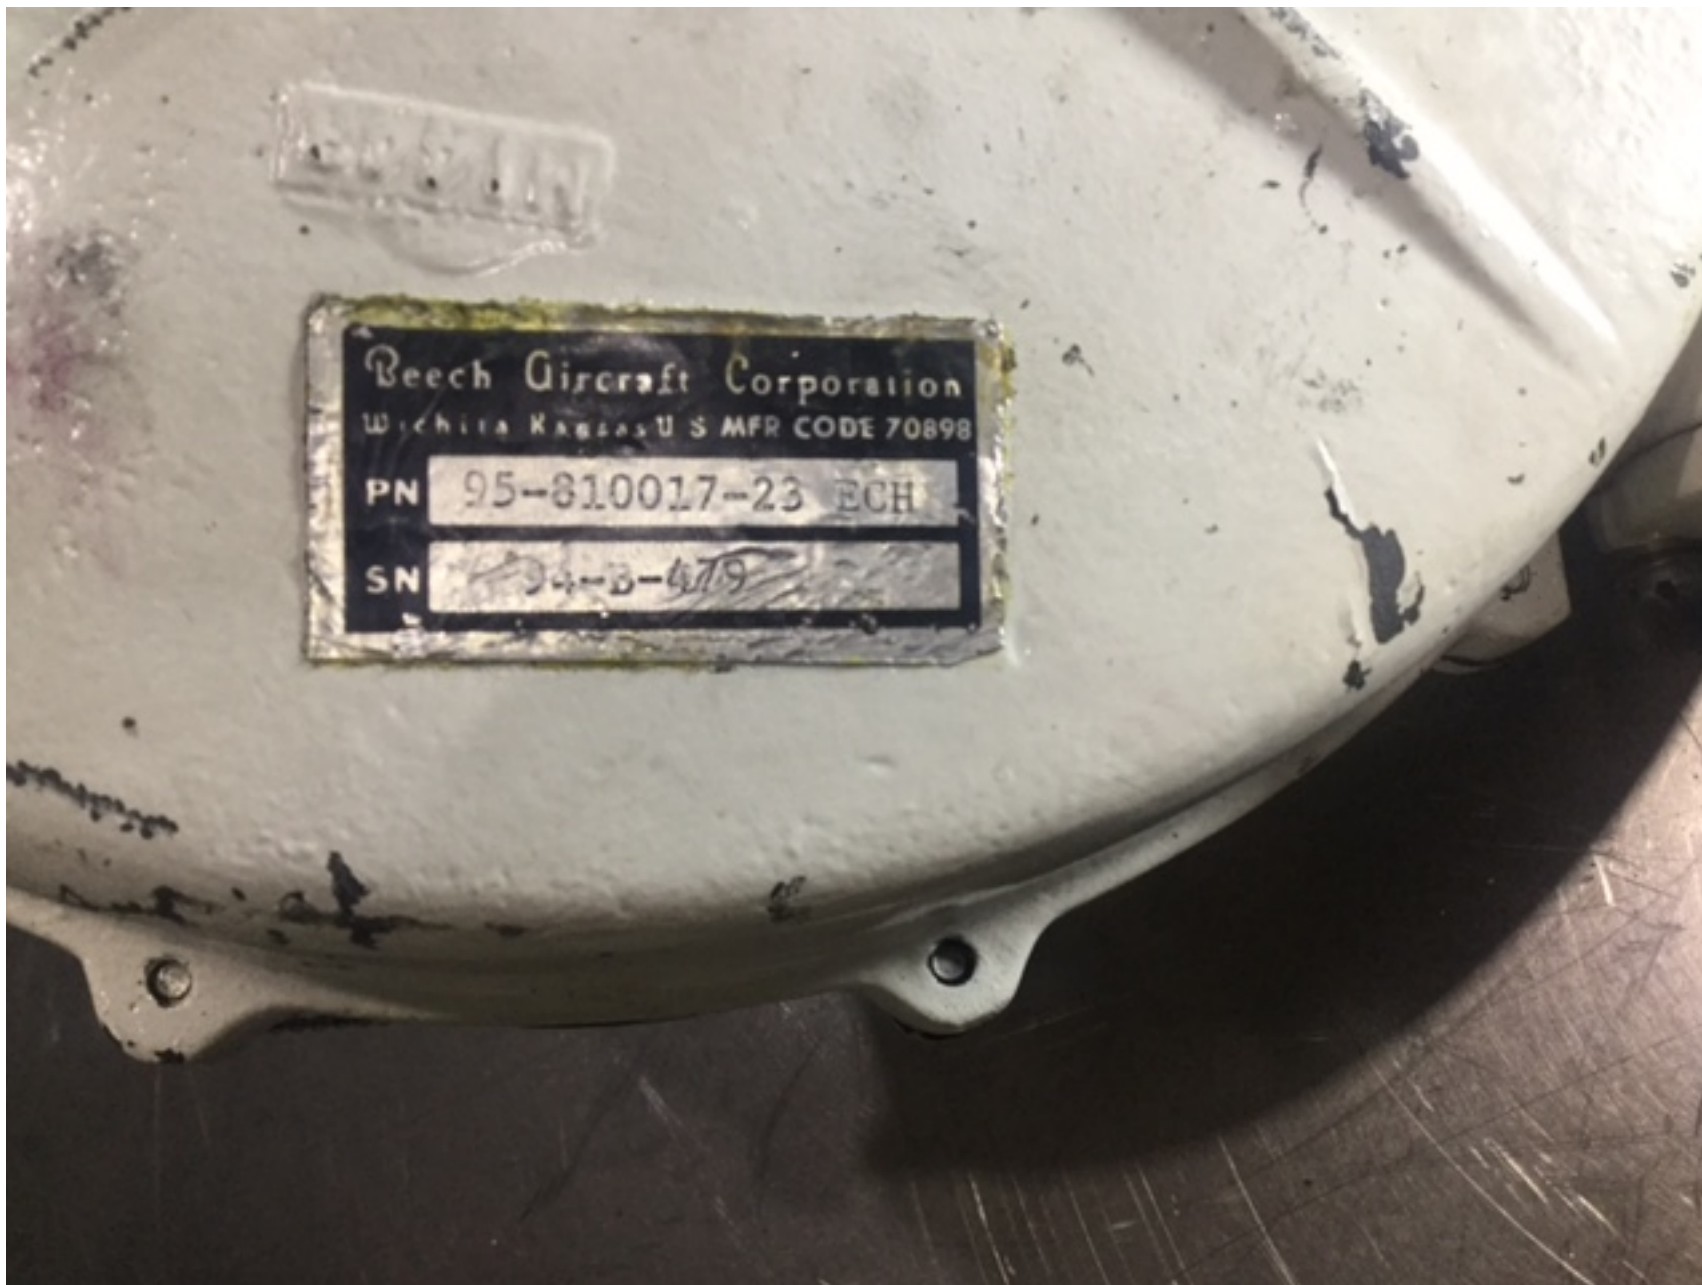
**Figure 1: Photo of a “Beech Aircraft Corporation” label with part number “95-810017-23 ECH,” serial number “94-B-479”.**

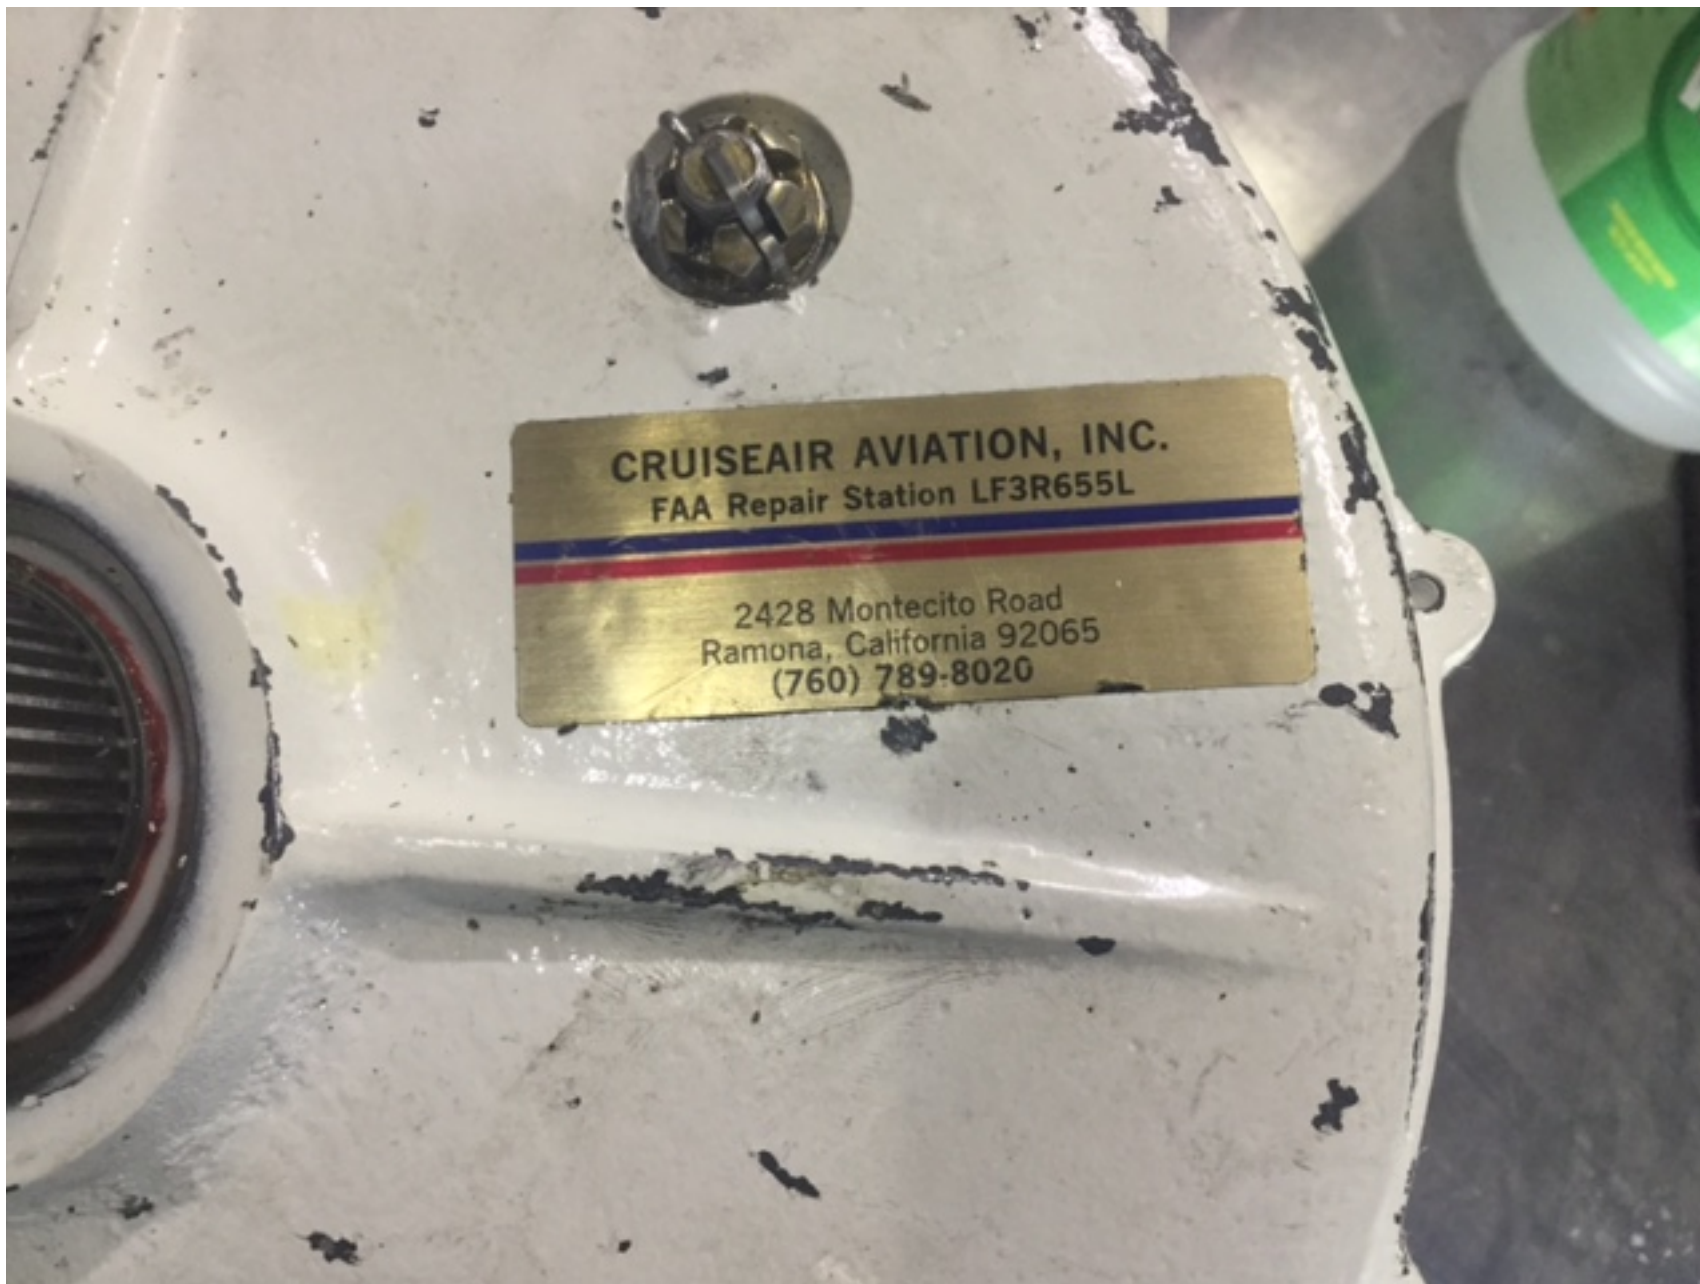
**Figure 2 – Photo of a “Cruiseair Aviation, Inc.” label with no part or serial number annotated.**

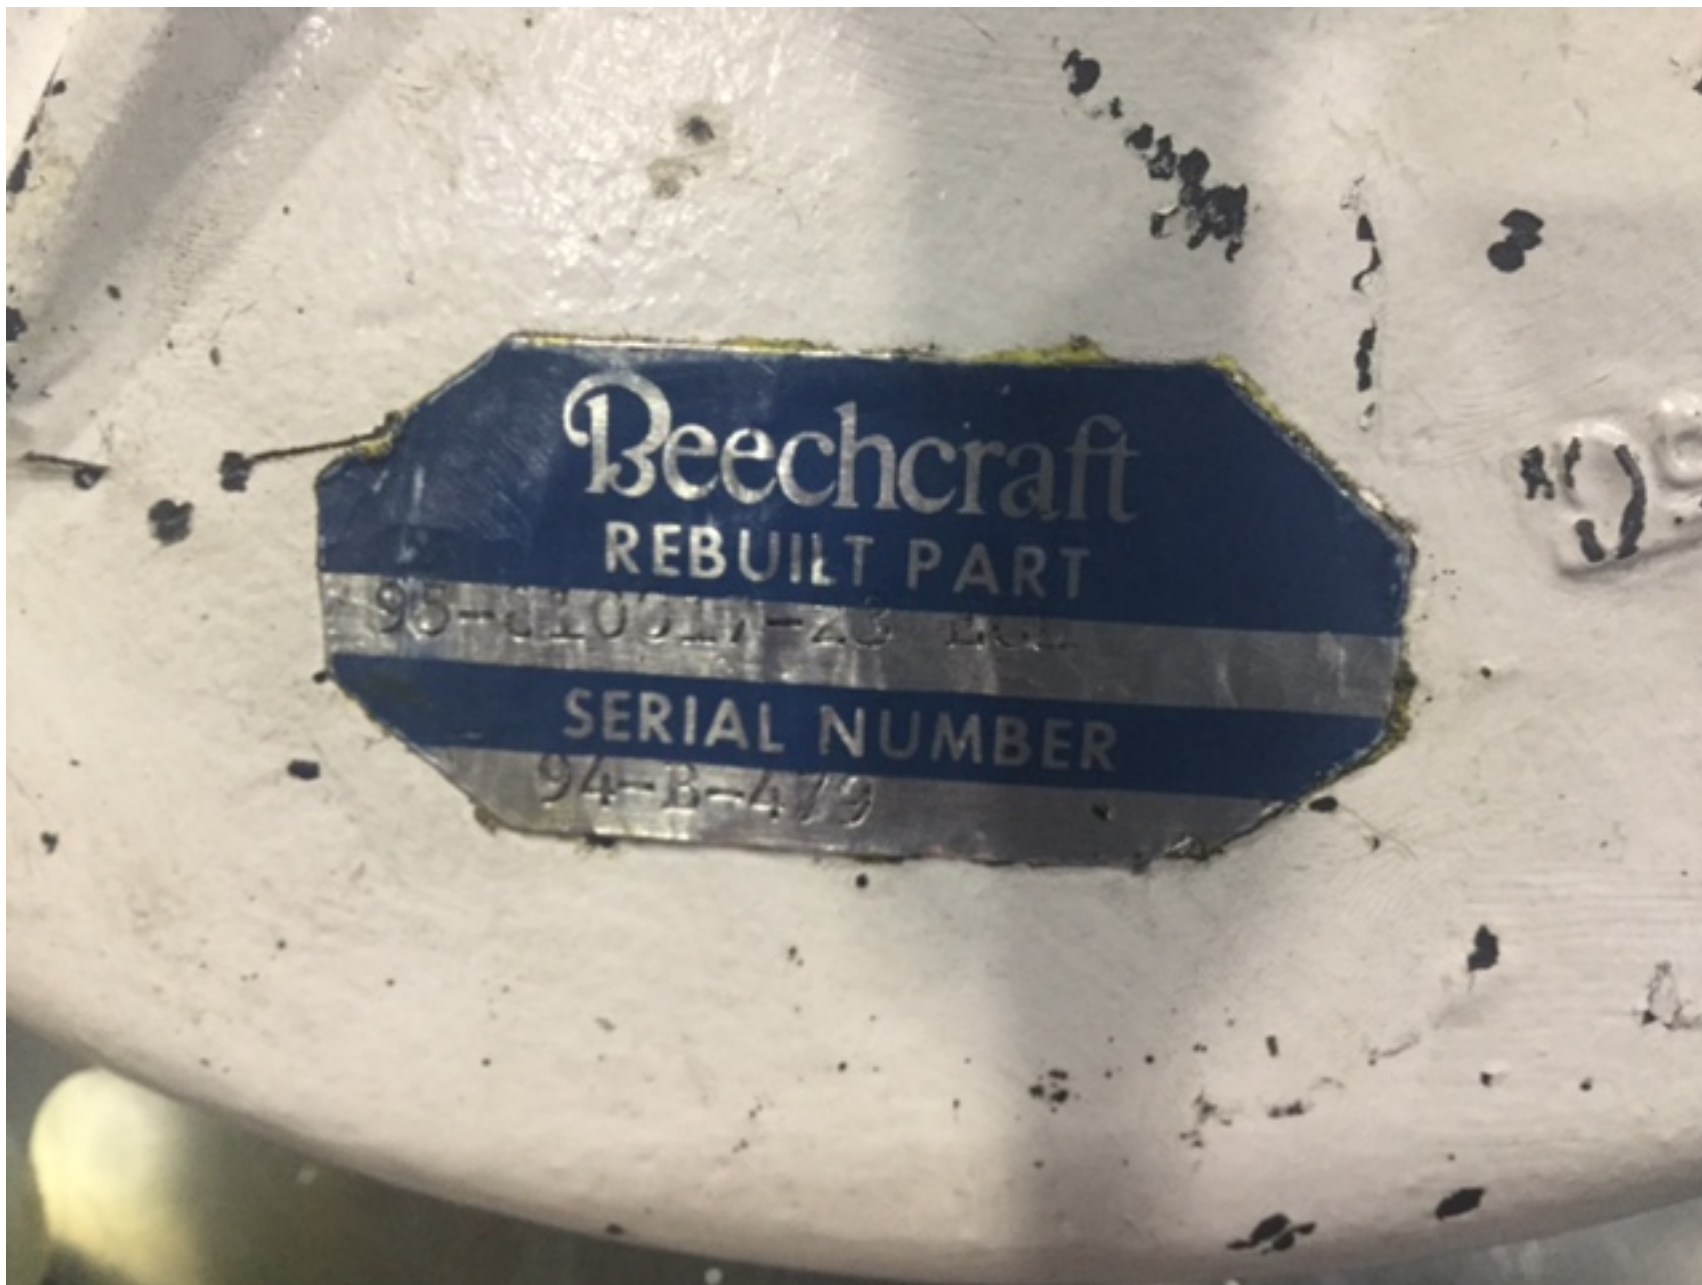
**Figure 3 – Photo of a “Beechcraft Rebuilt Part” label with part number “95-810017-23 ECH,” serial number “94-B-479”.**

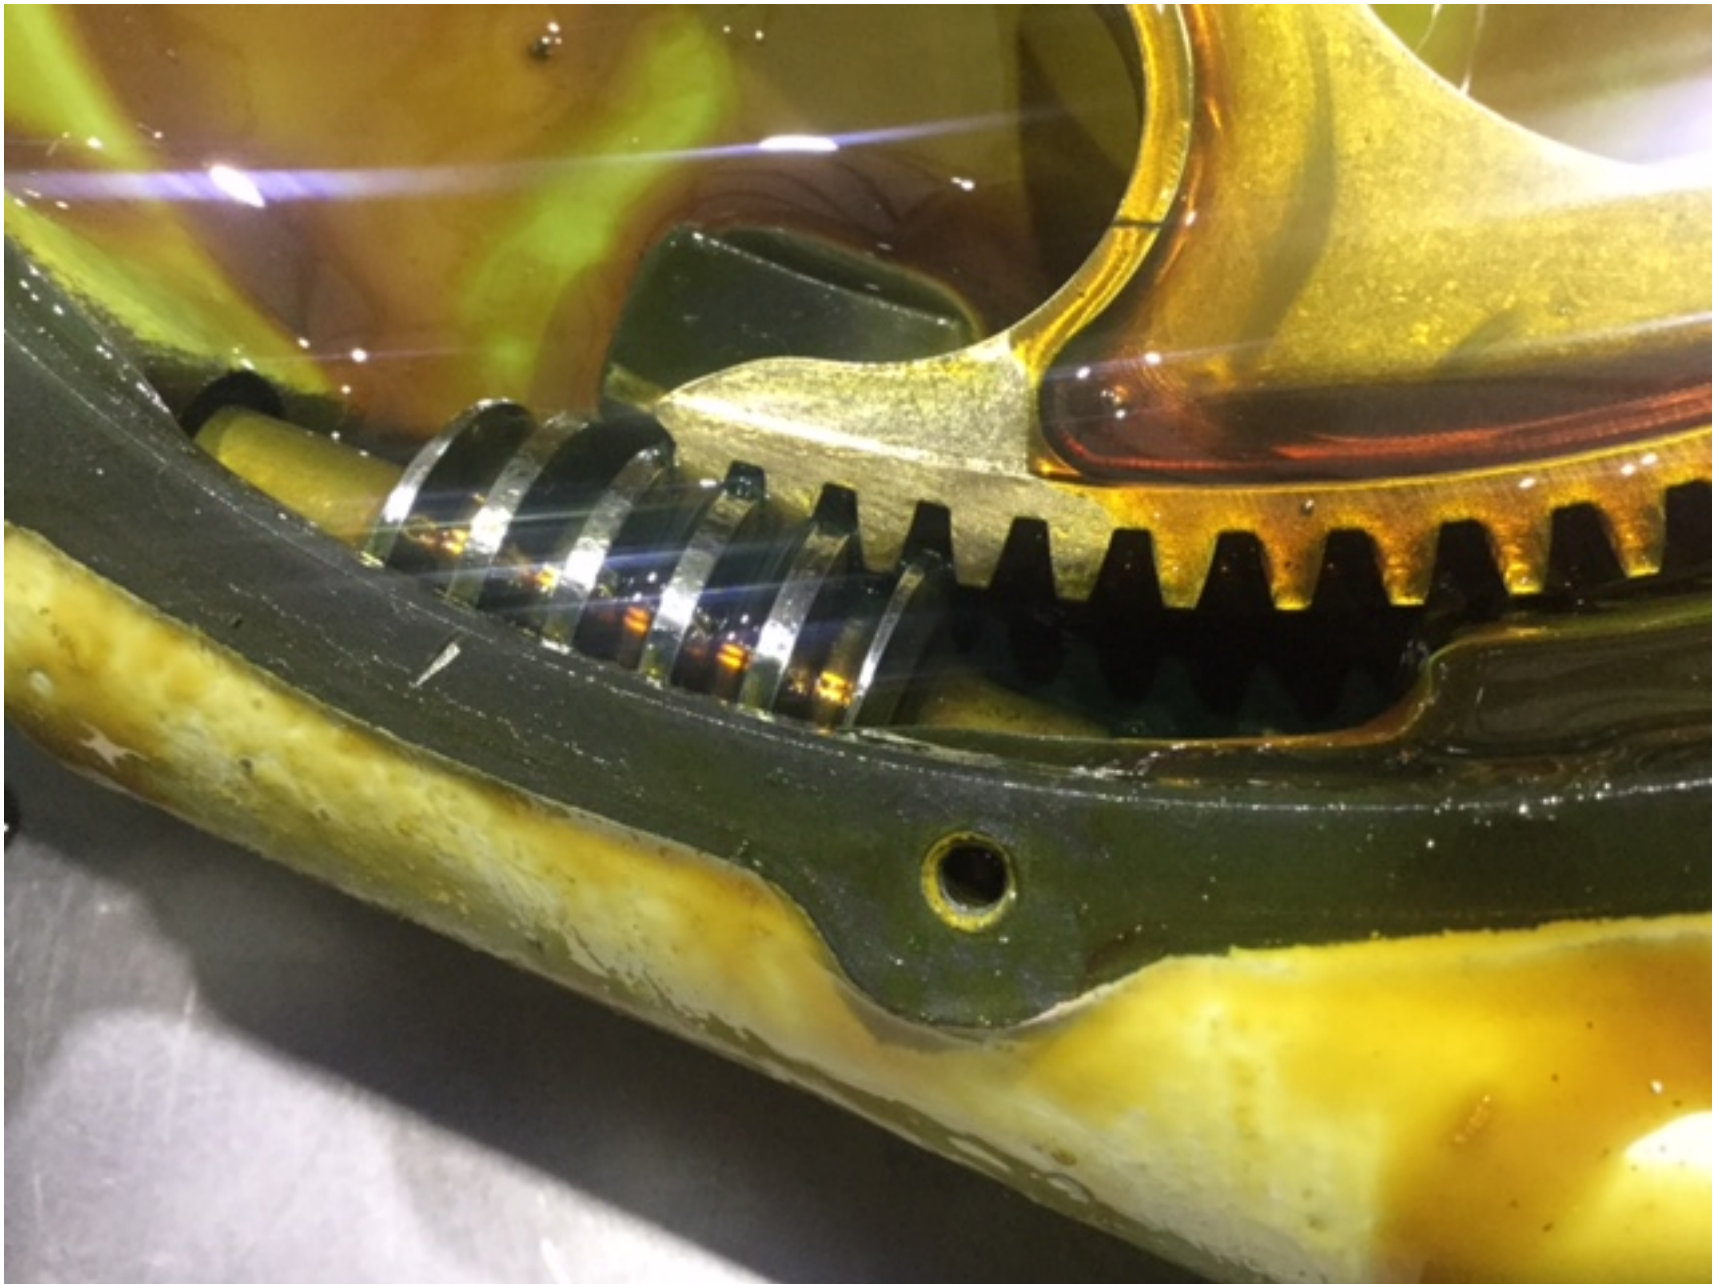
**Figure 4 - The sector gear teeth were partially sheared and were bound with worm gear teeth resulting in interference.**

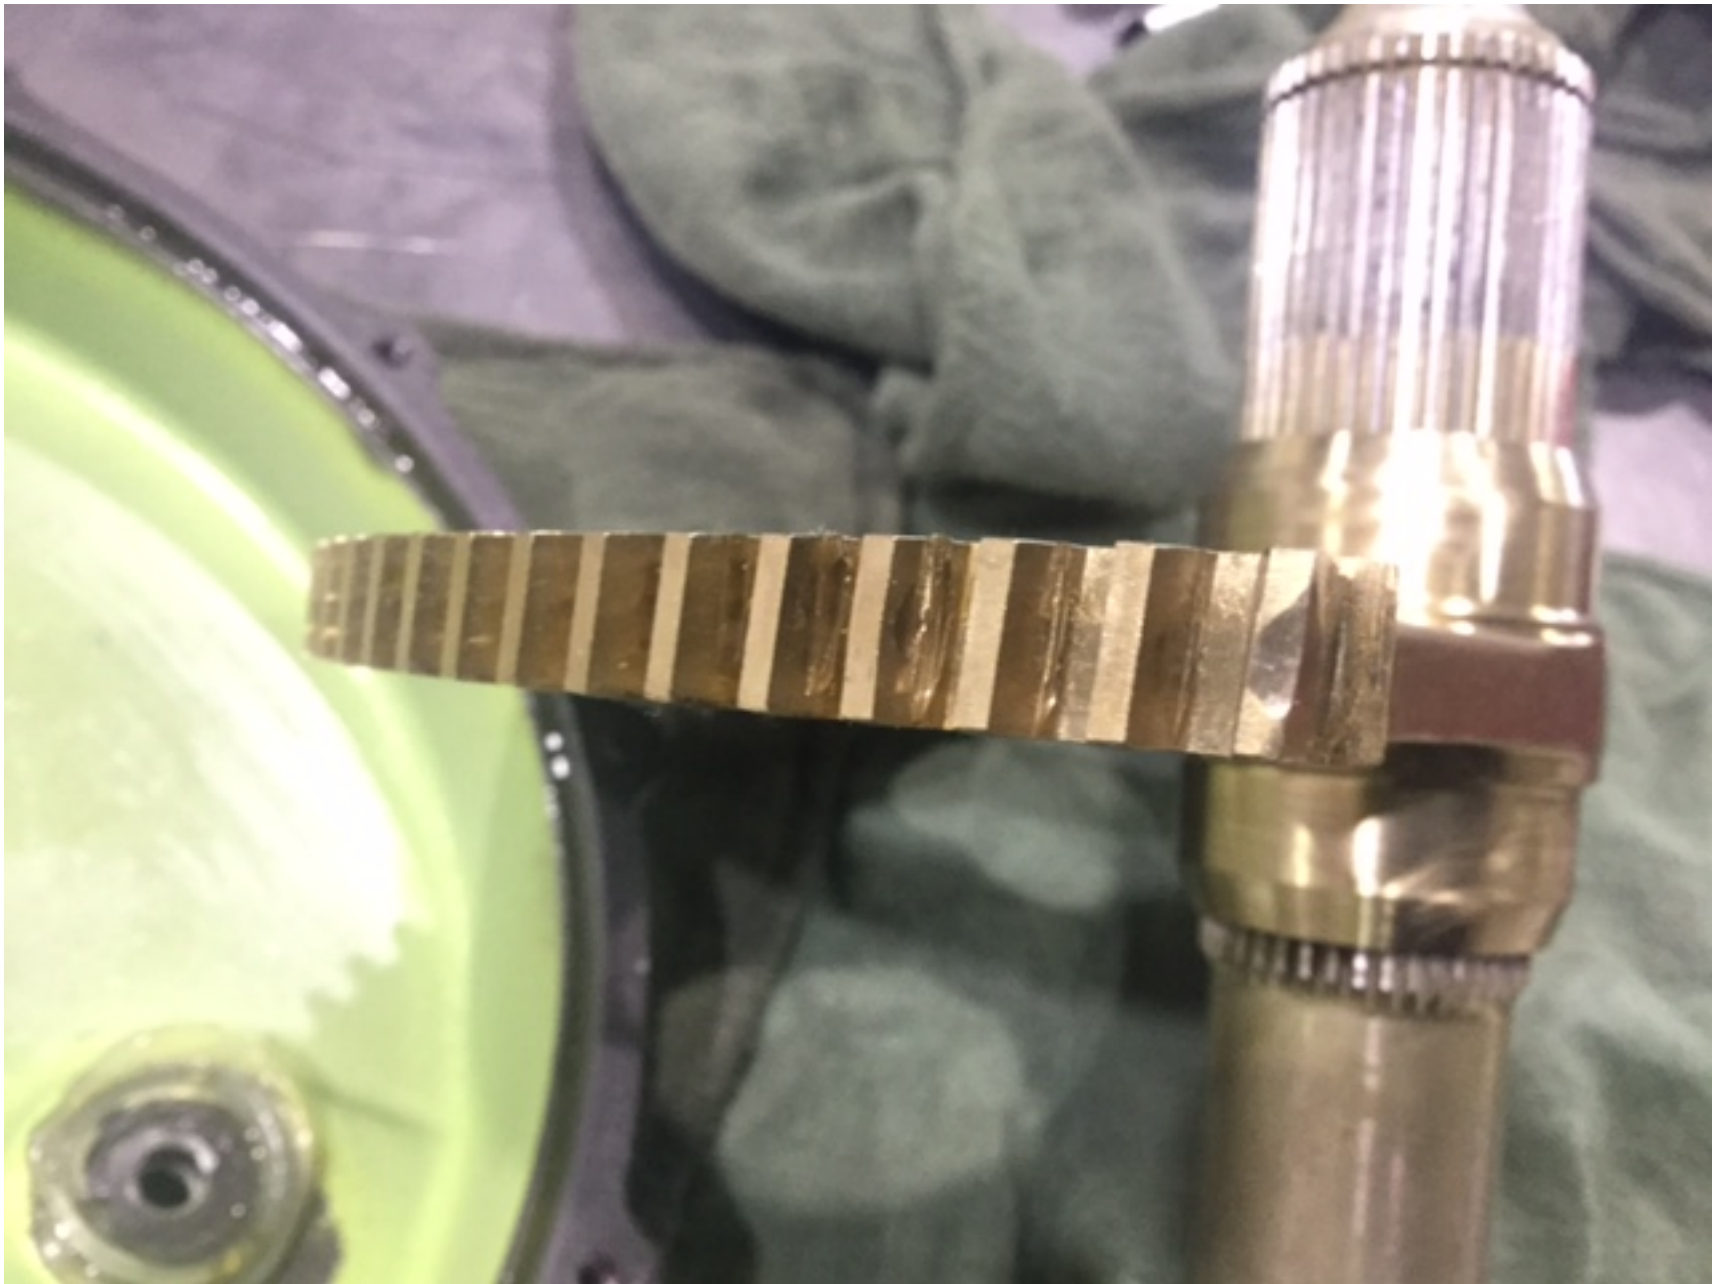
**Figure 5 - The photo depicts partial shearing of the sector gear teeth.**
