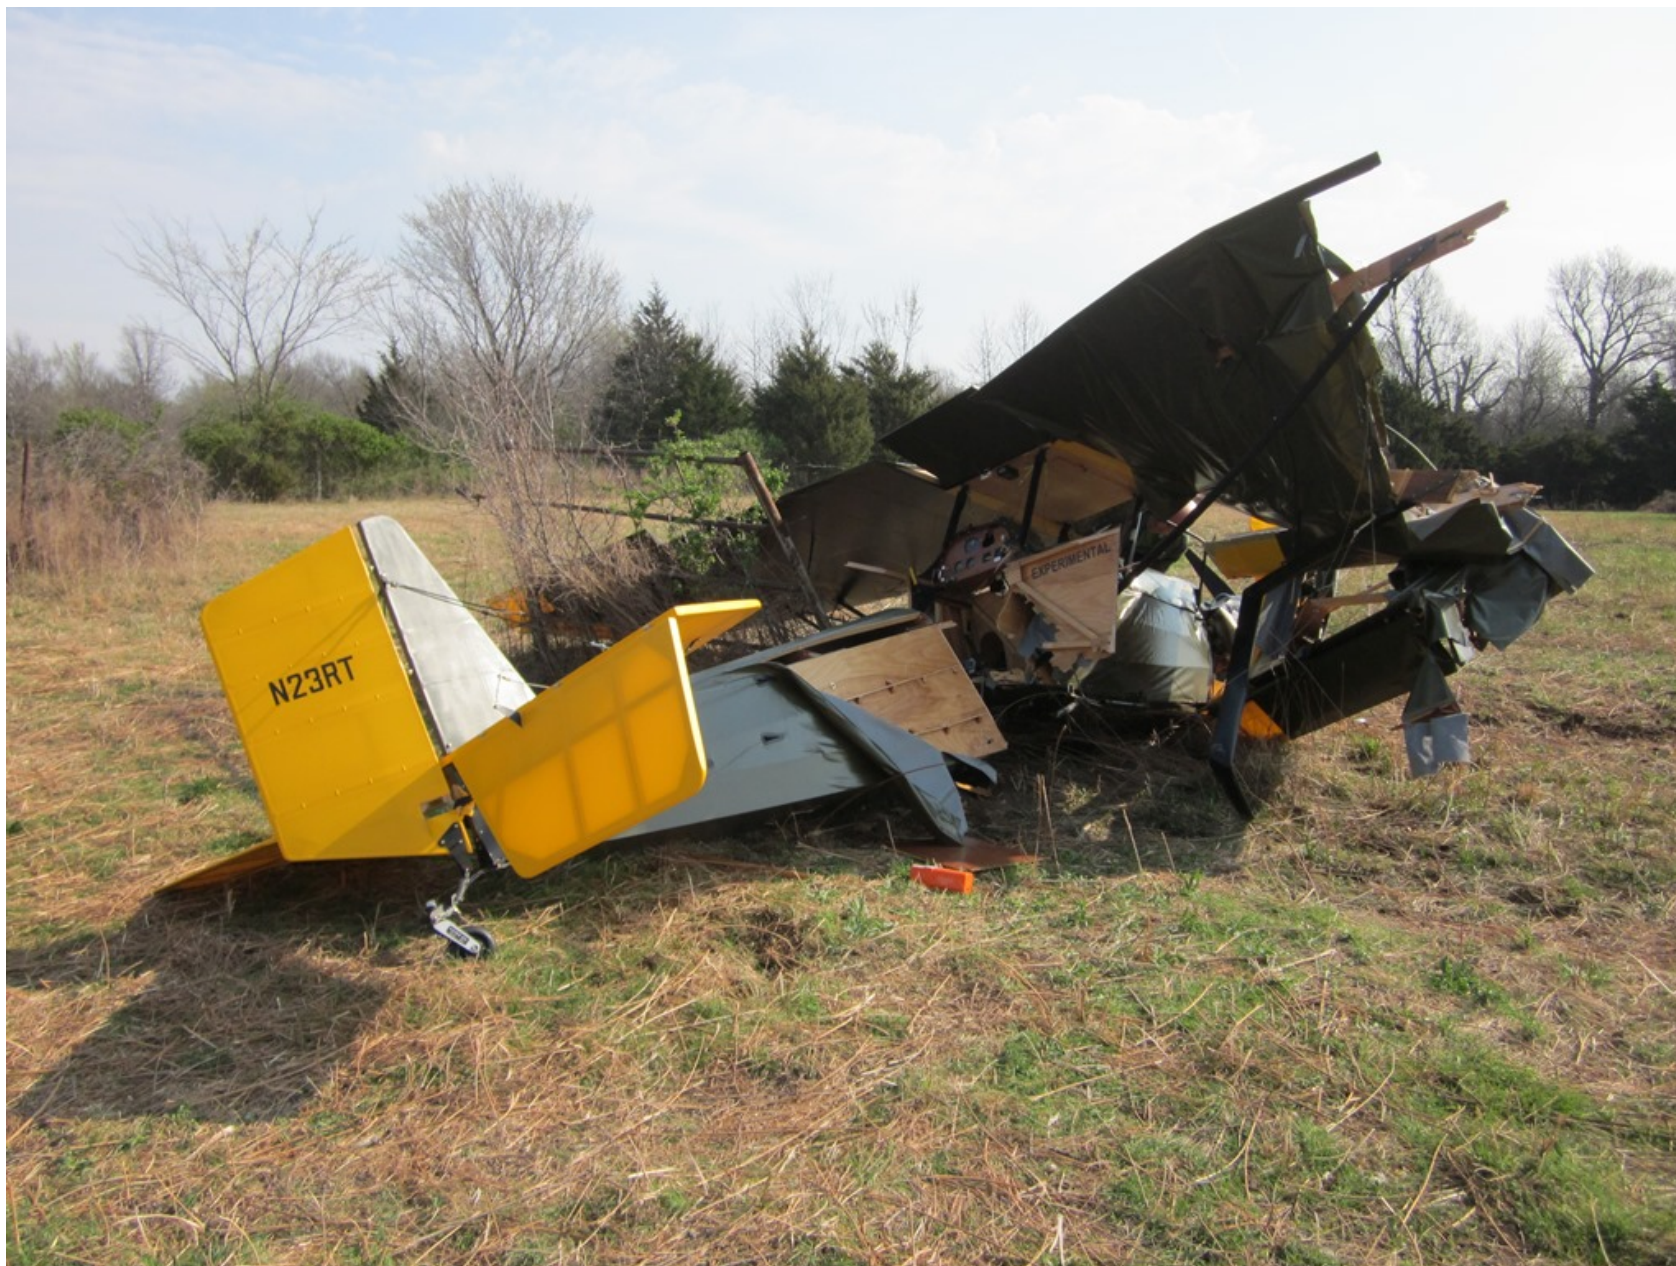
**Photo 1 – Airplane Wreckage at Accident Site**

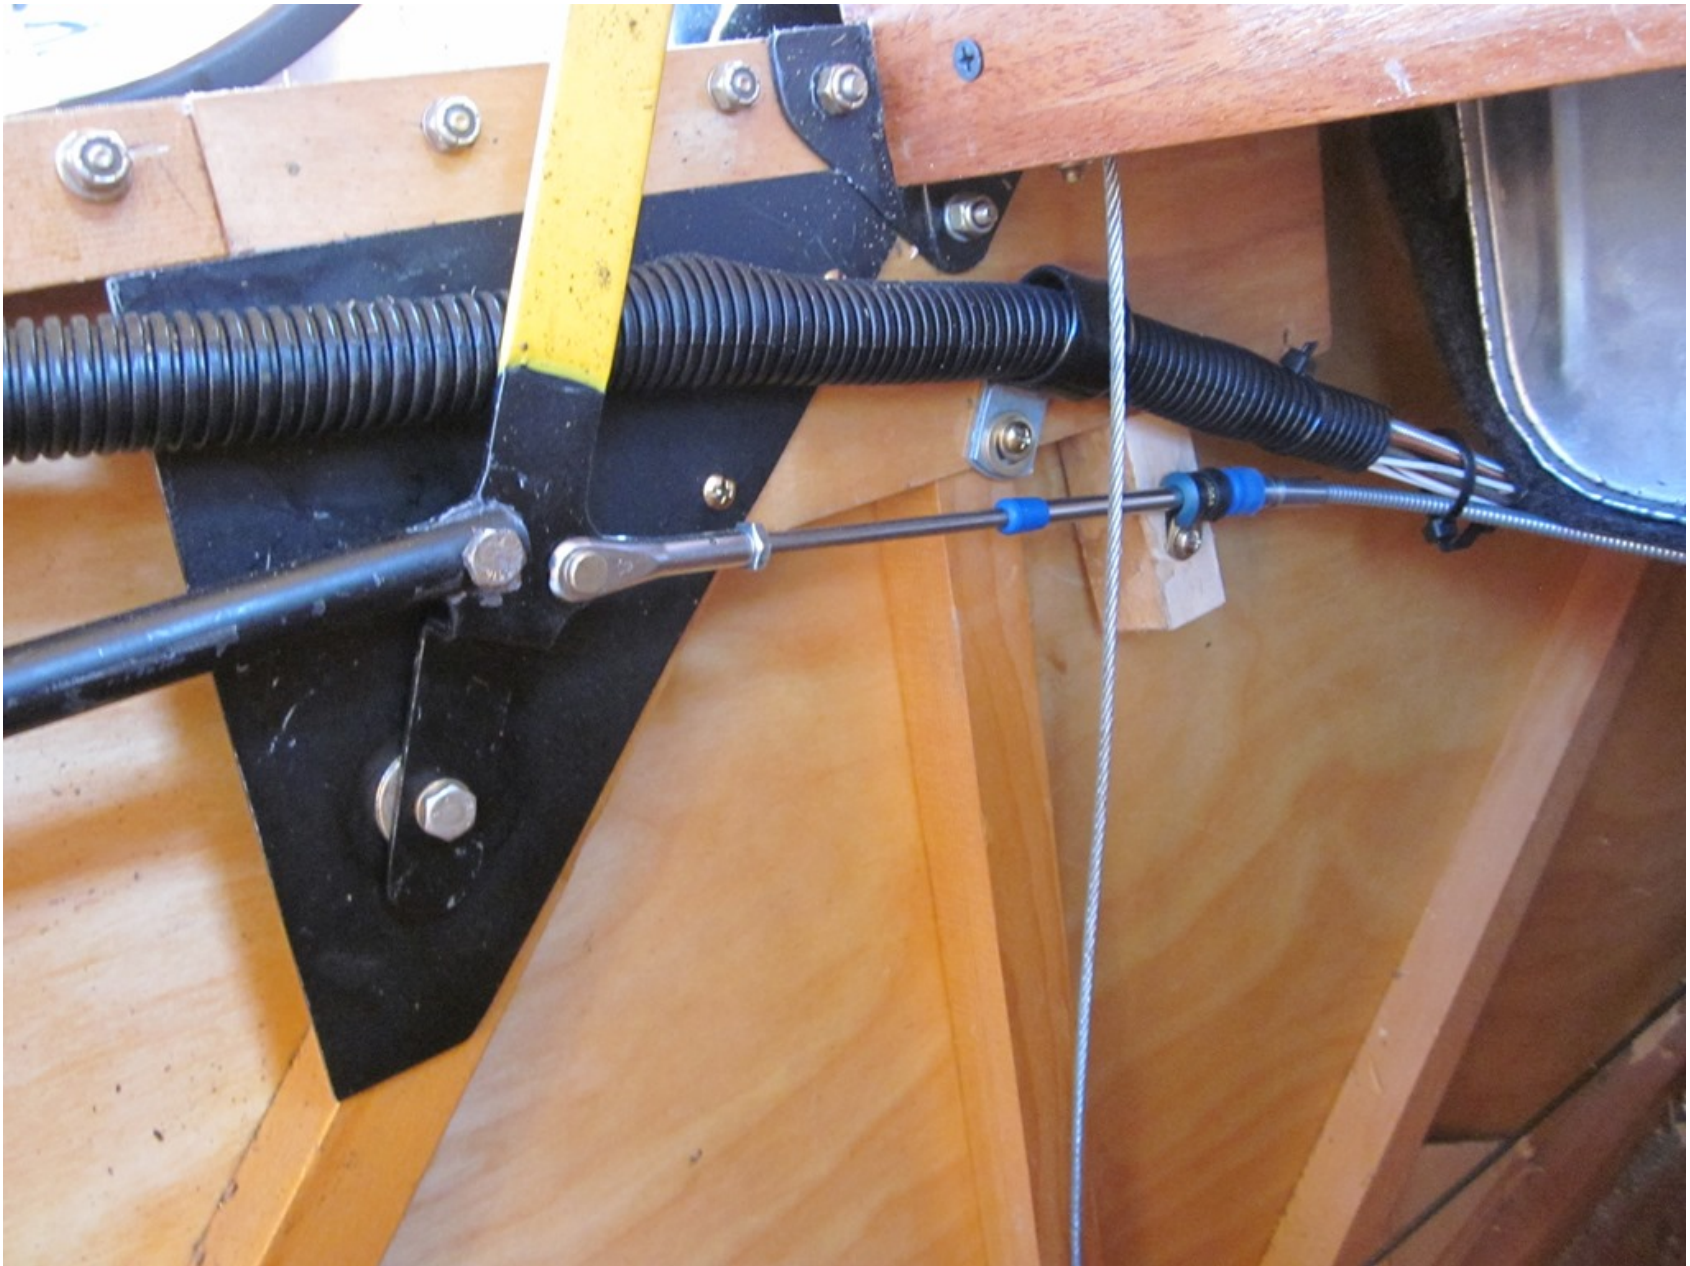
**Photo 2 – Throttle Cable Mounting Block Separated**

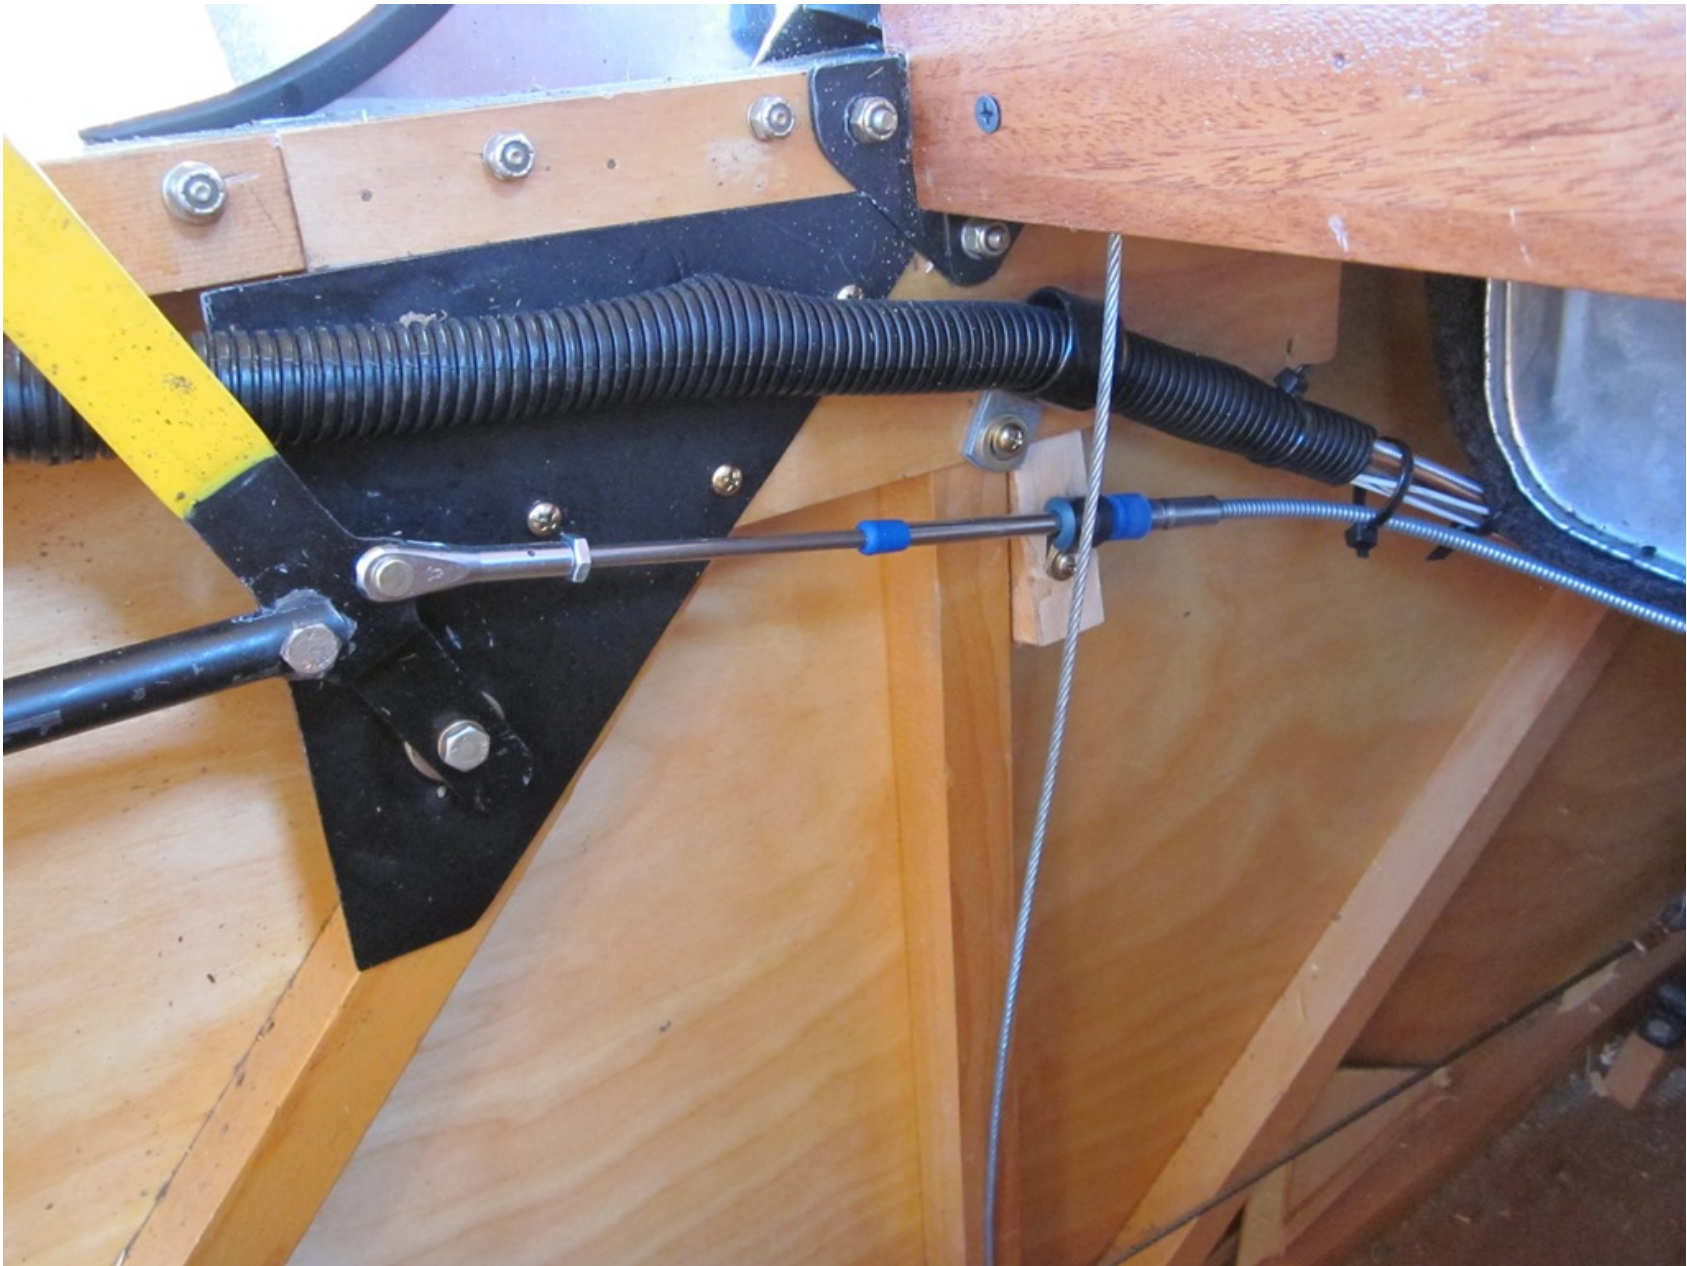
**Photo 3 – Throttle Cable Mounting Block Re-Positioned in Original Location**
