**Photo 1 – View of engine mounted on an engine stand for teardown examination**

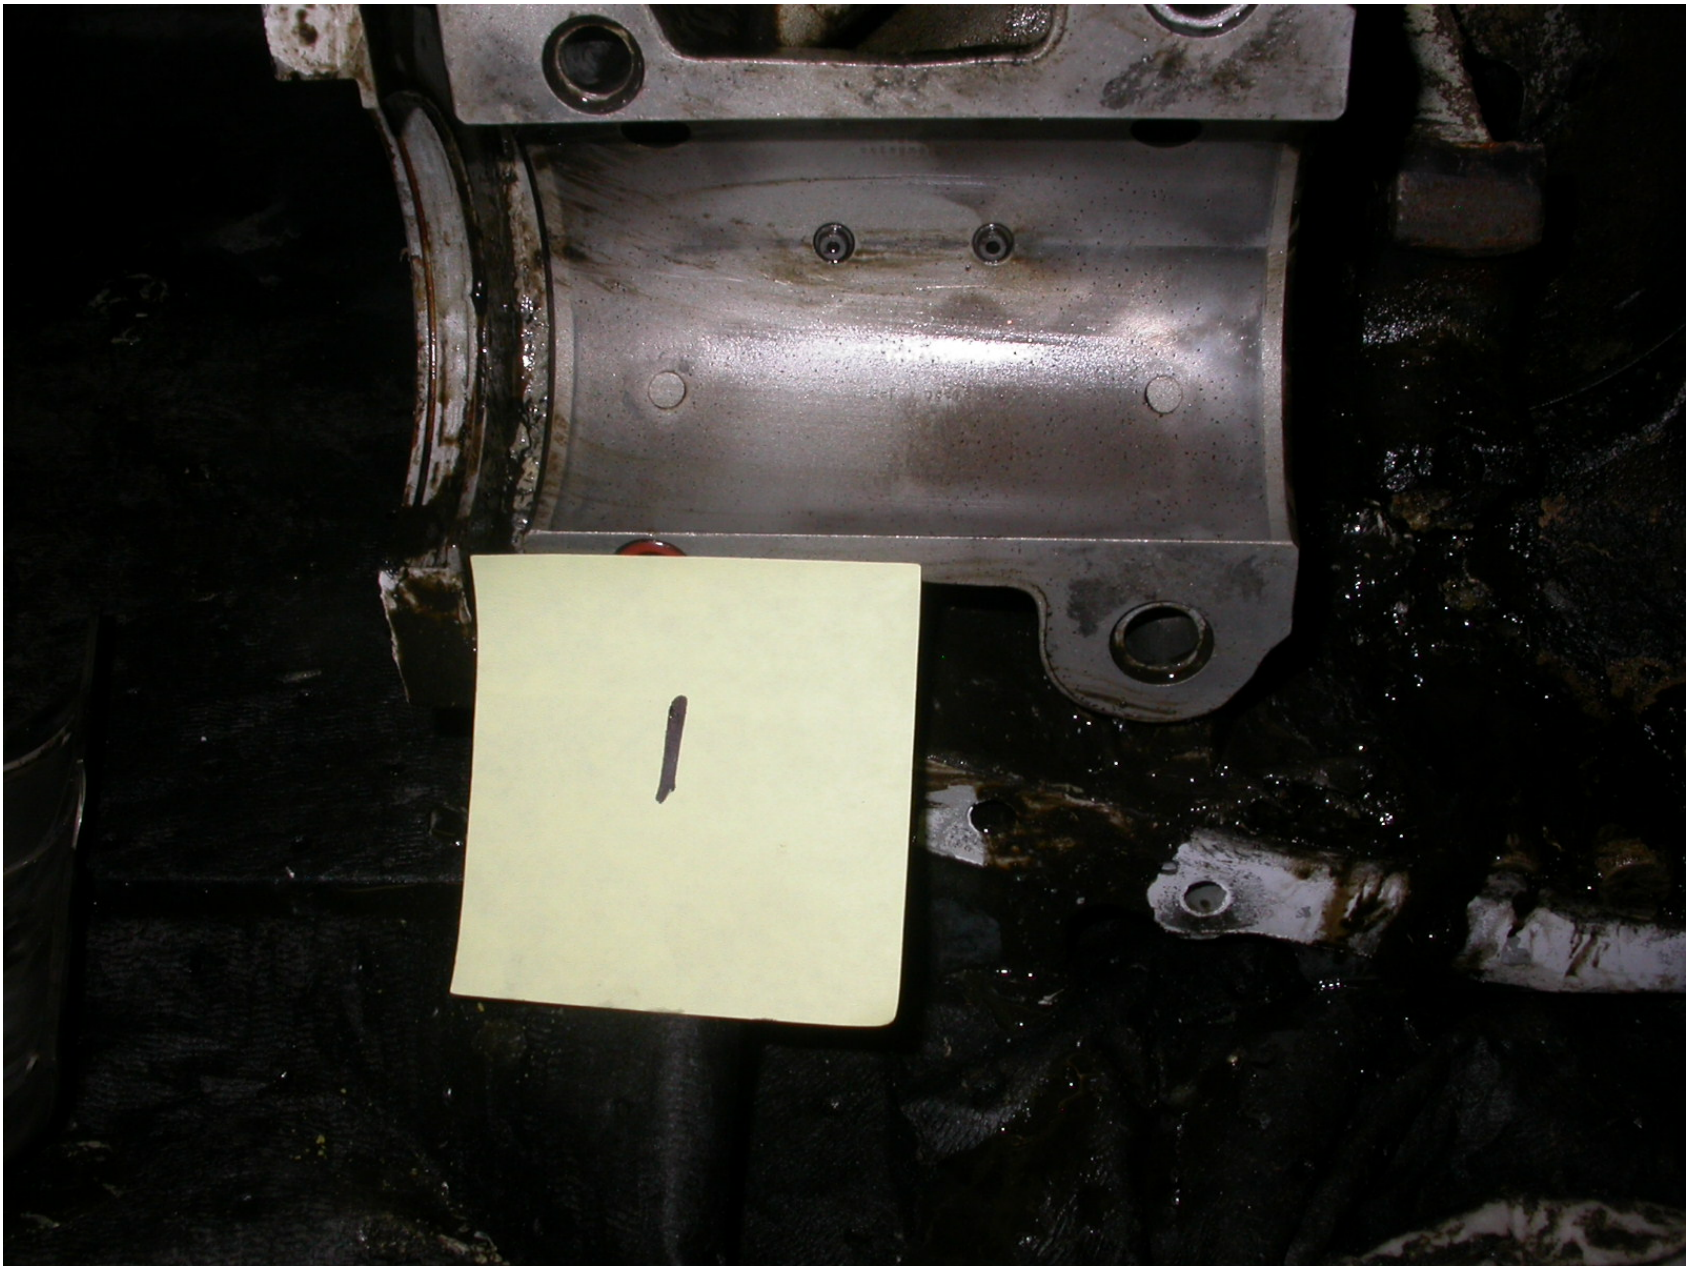
**Photo 5 – View of No. 1 main bearing journal**

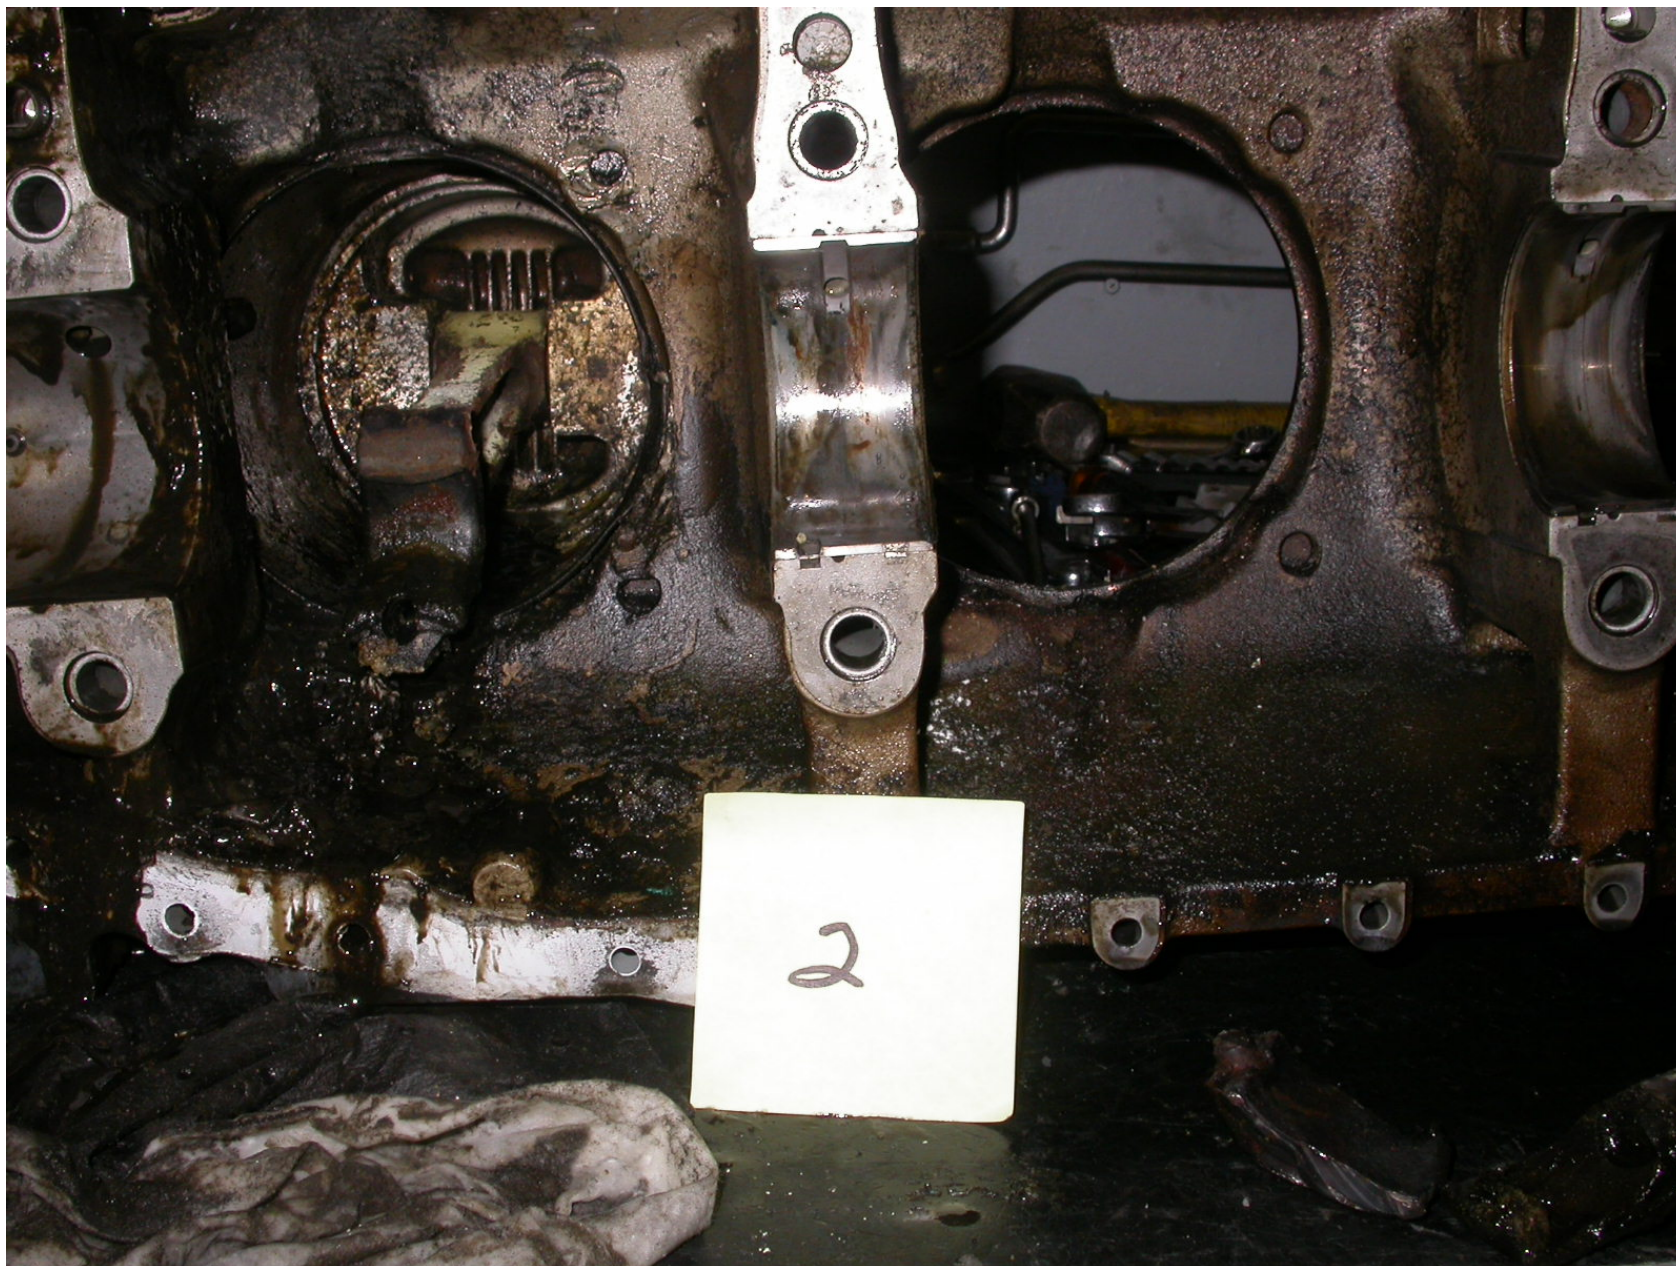
**Photo 6 - View of No. 2 main bearing journal**

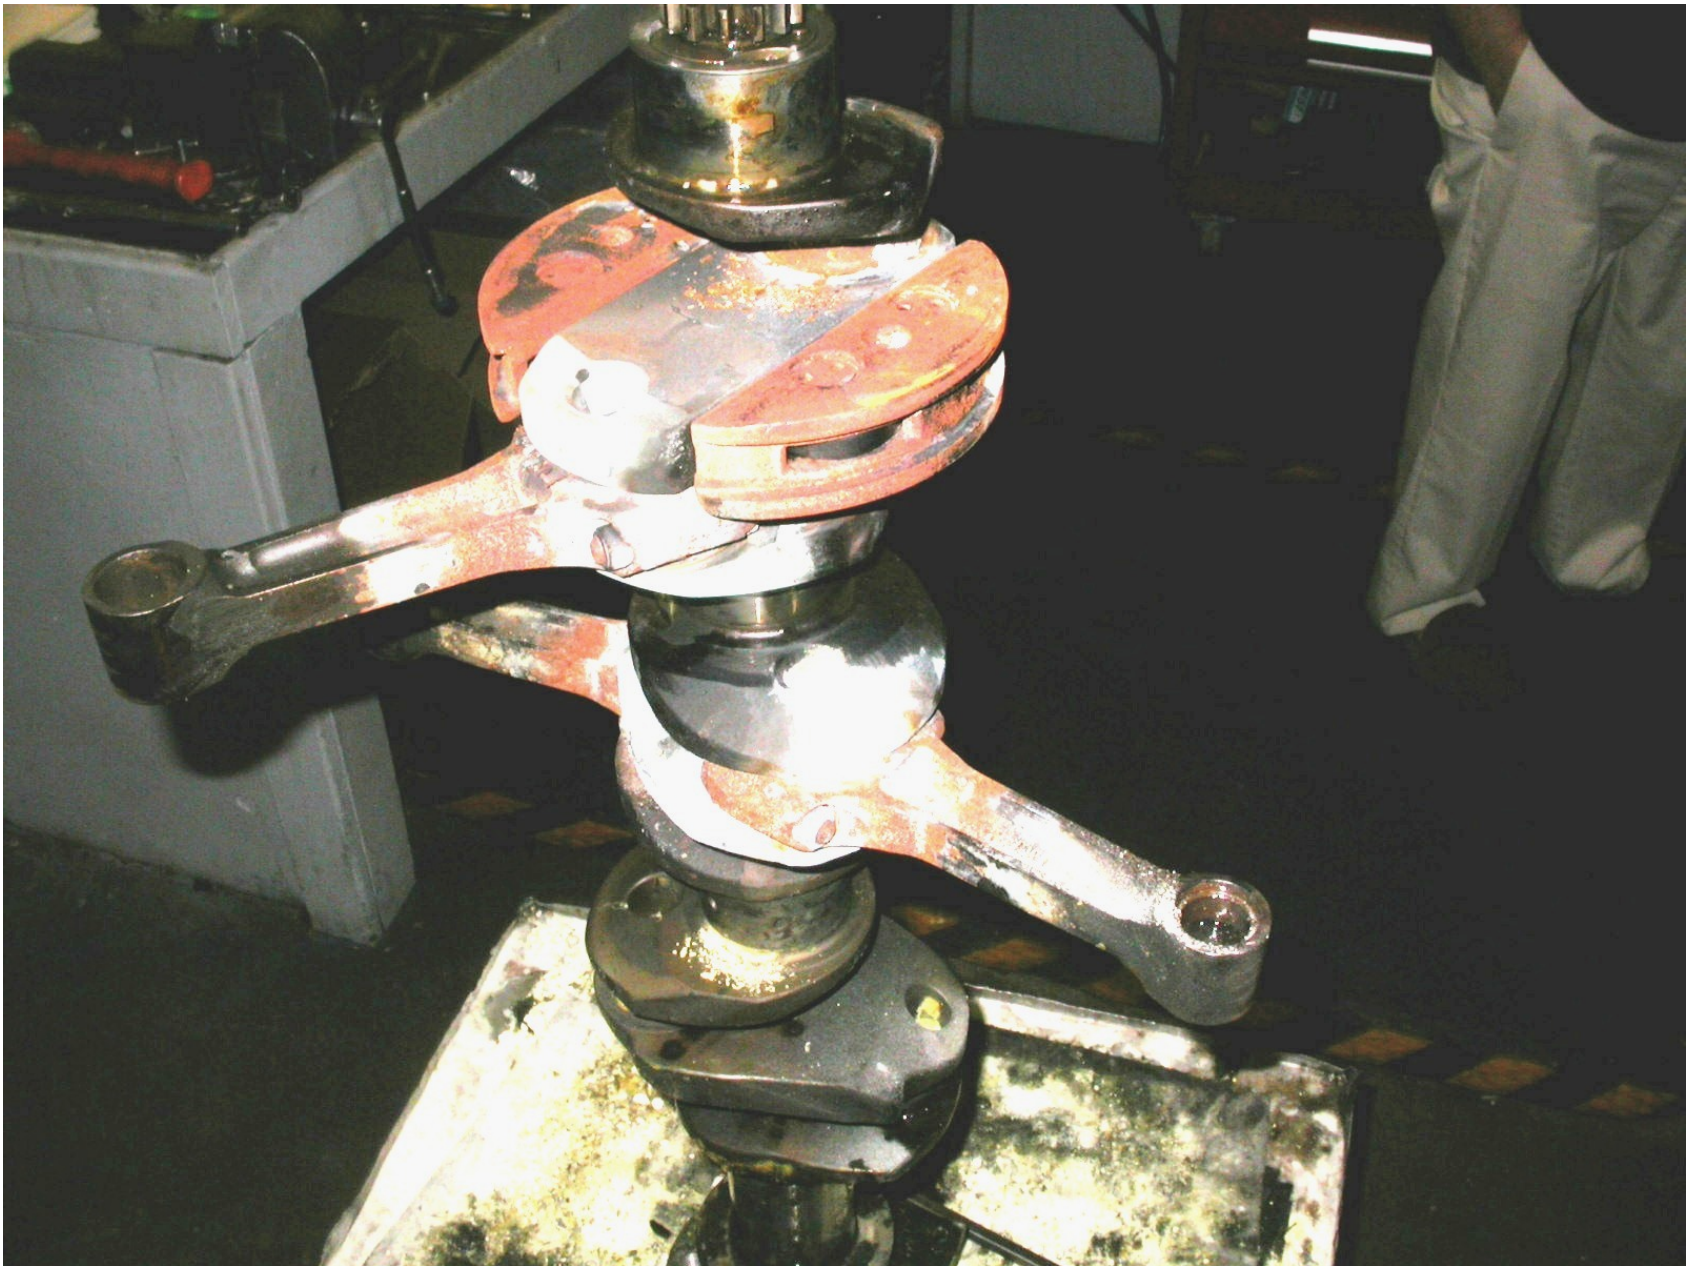
**Photo 9 - View of crankshaft with 3 piston rods still attached**

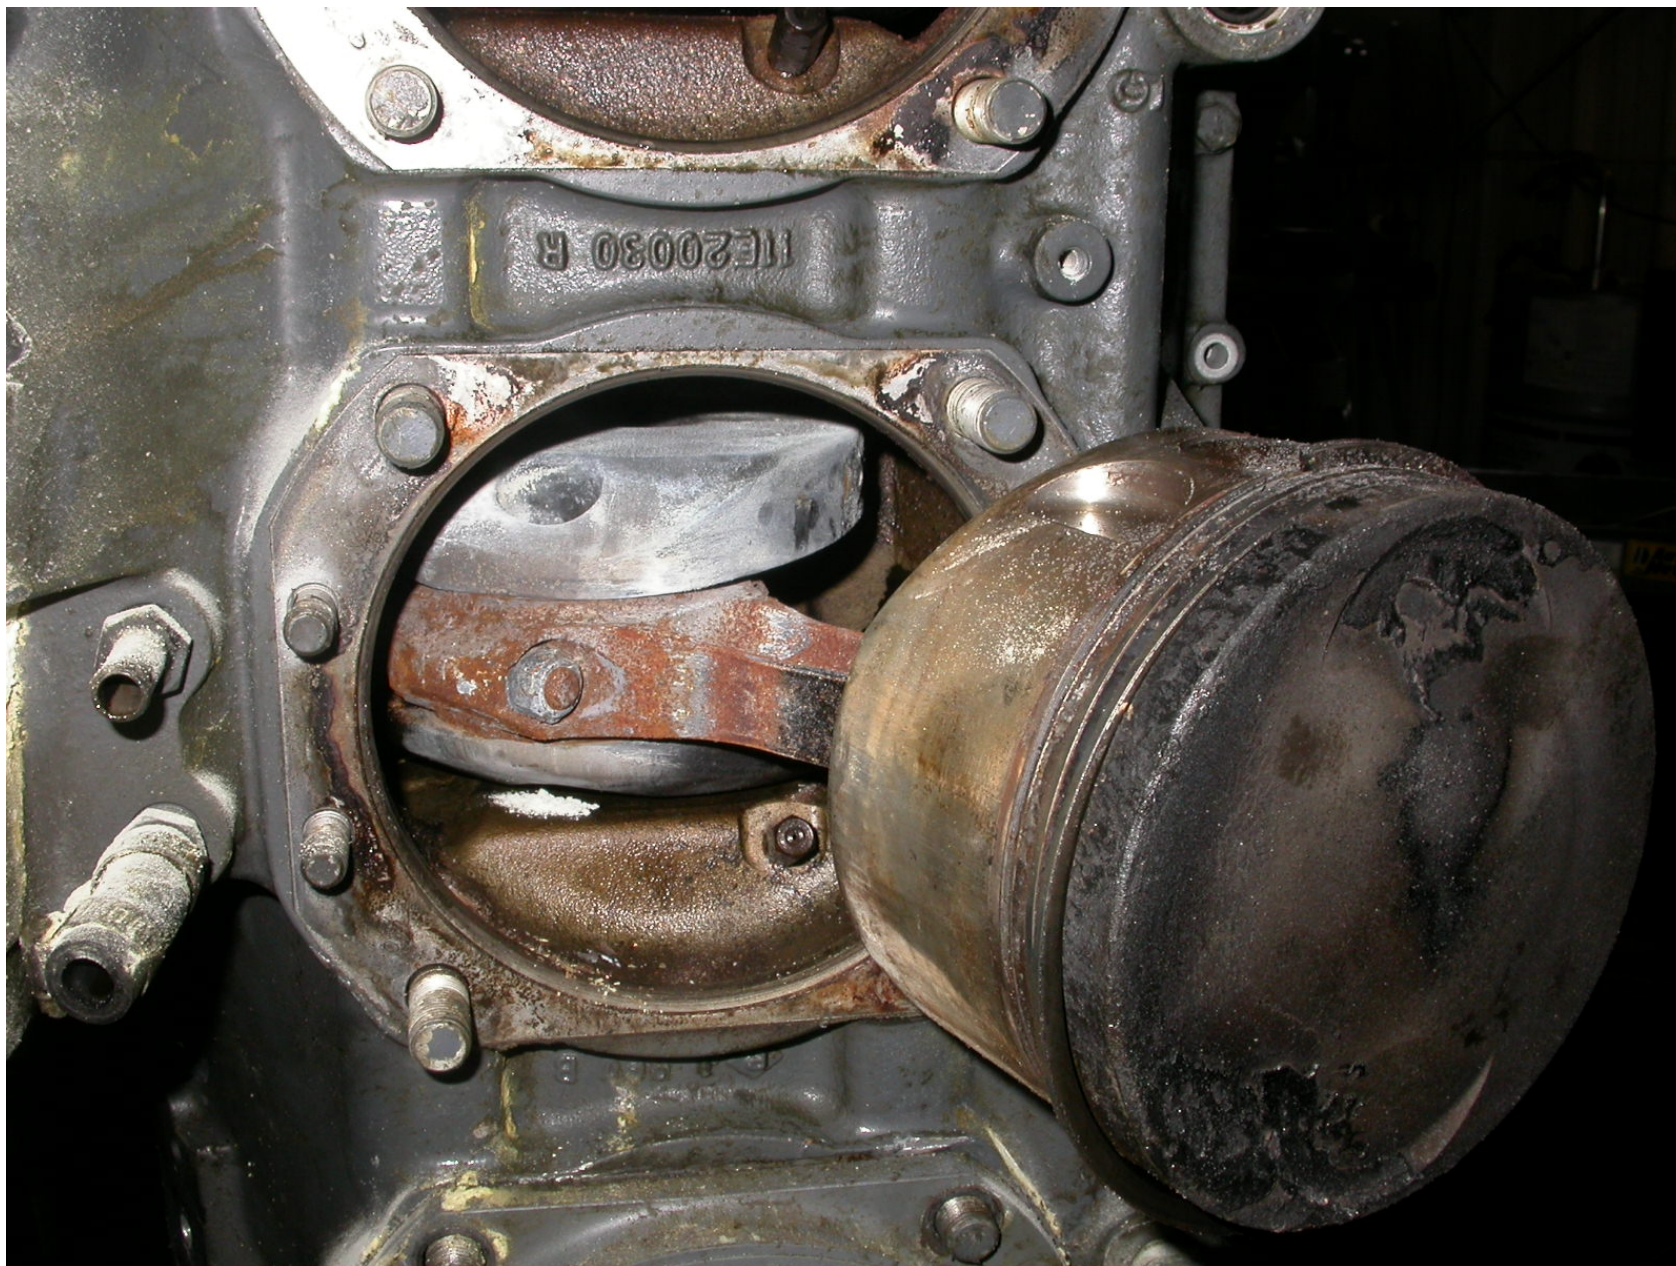
**Photo 11 – View of No. 3 piston attached to the crankshaft**

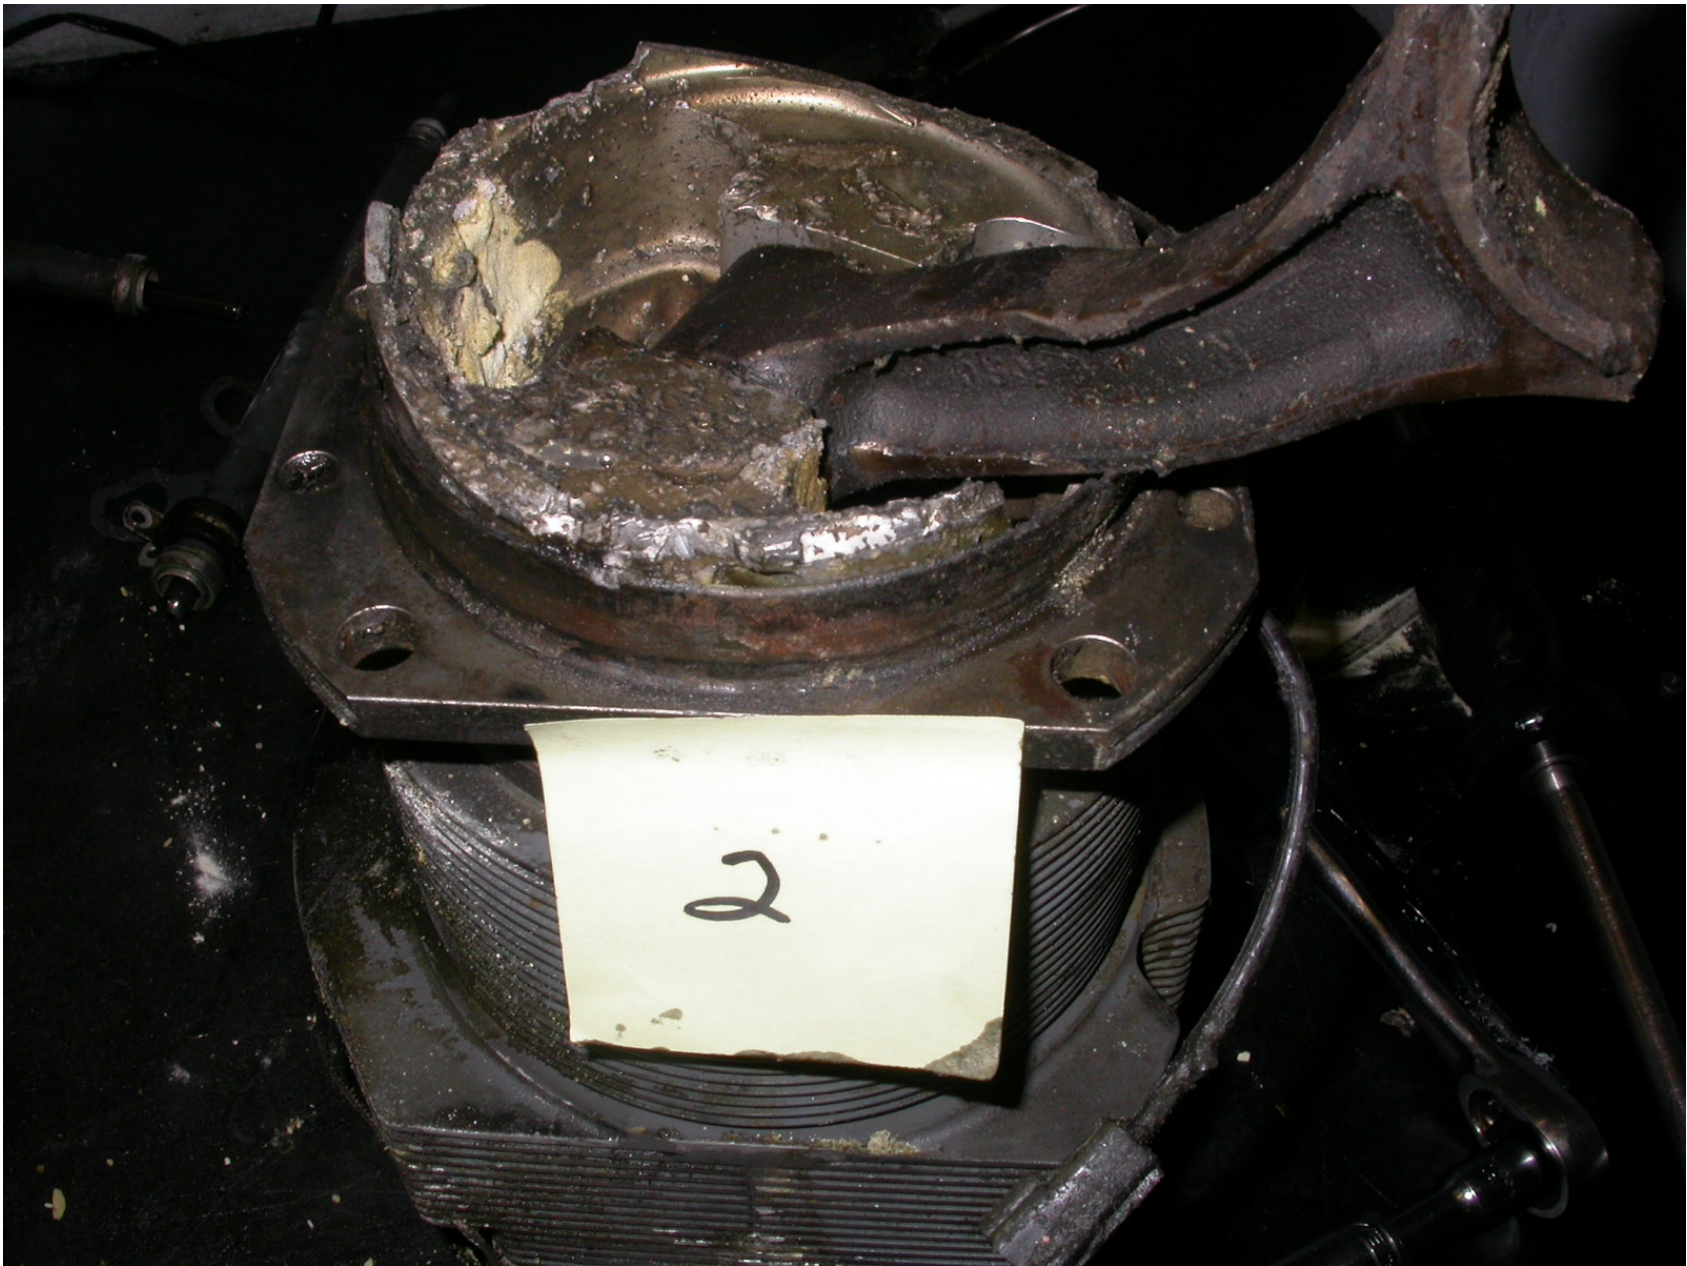
**Photo 12 – View of damaged No. 2 cylinder and piston connecting rod**

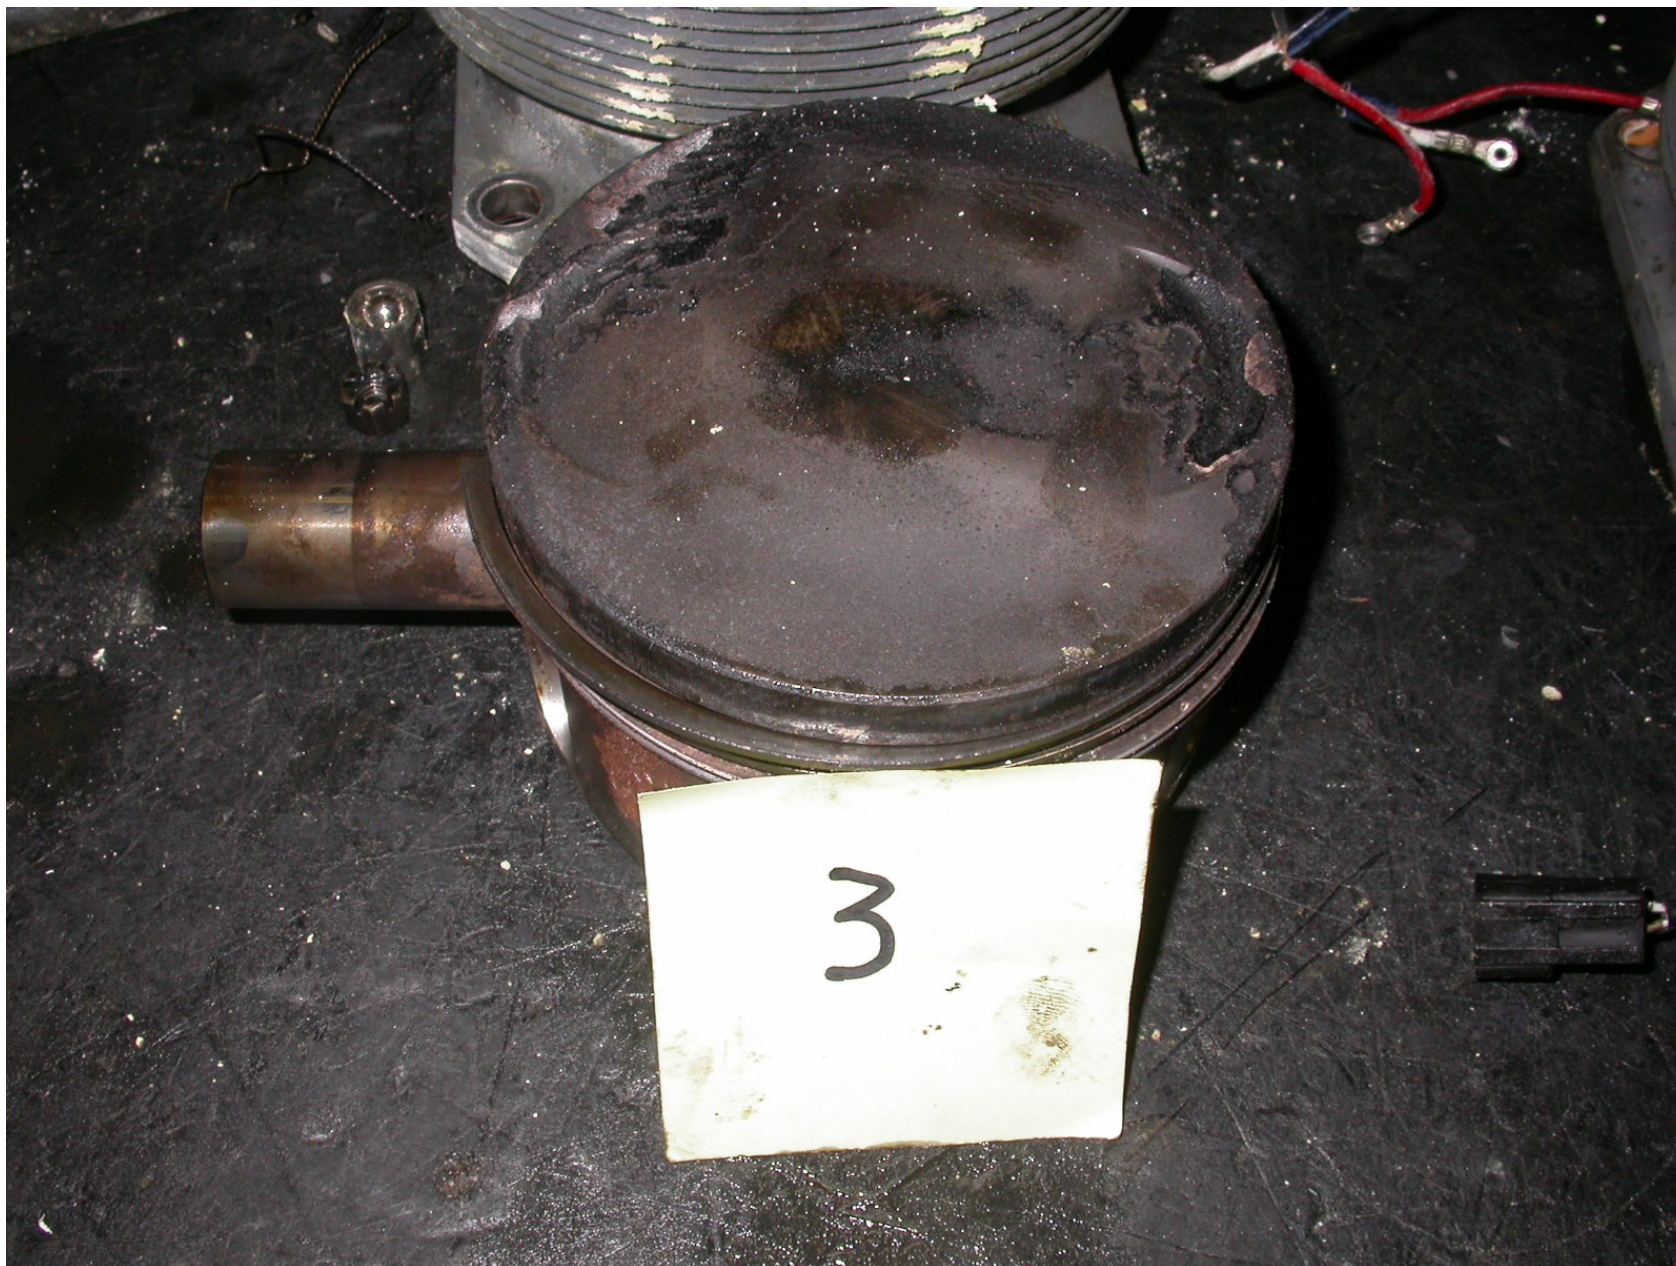
**Photo 15 – View of No. 3 piston and piston pin**

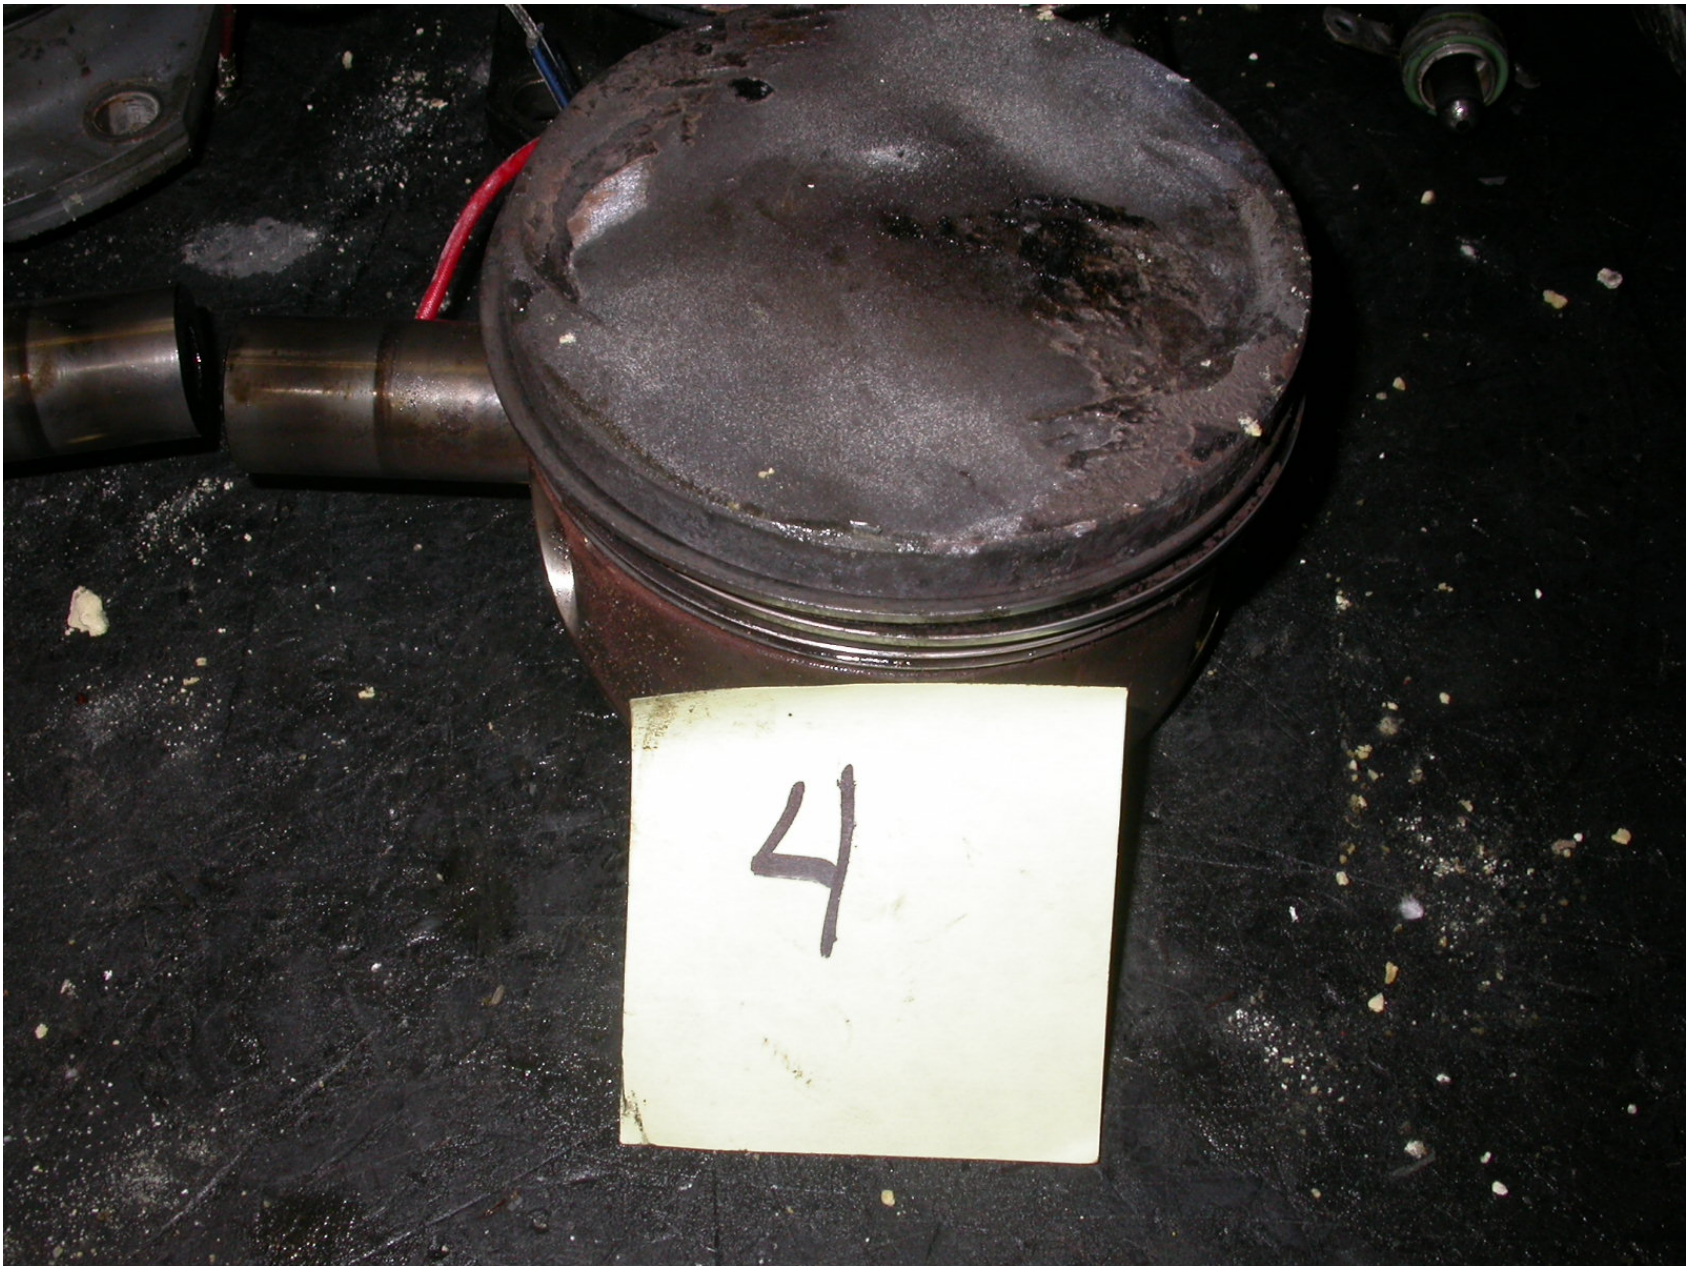
**Photo 16 - View of No. 4 piston and piston pin**

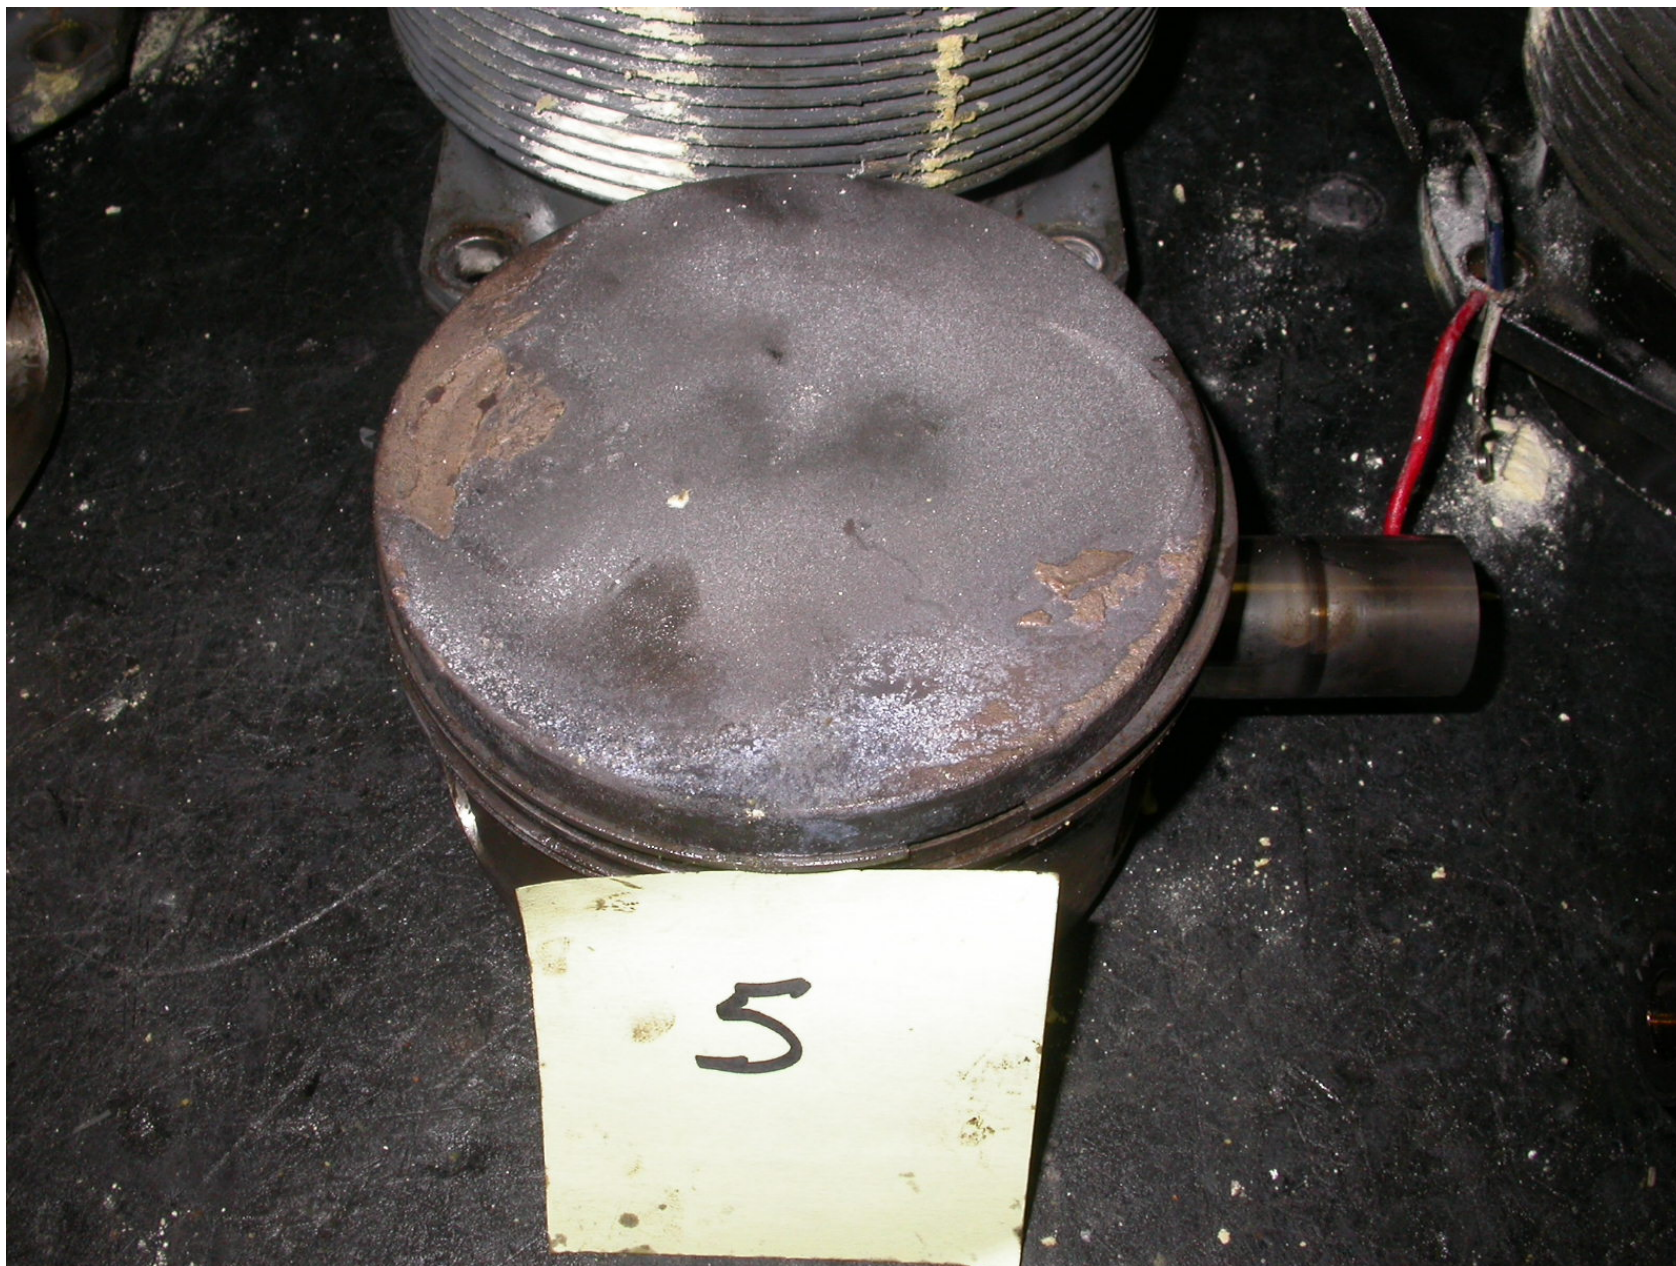
Photo 17 - View of No. 5 piston and piston pin

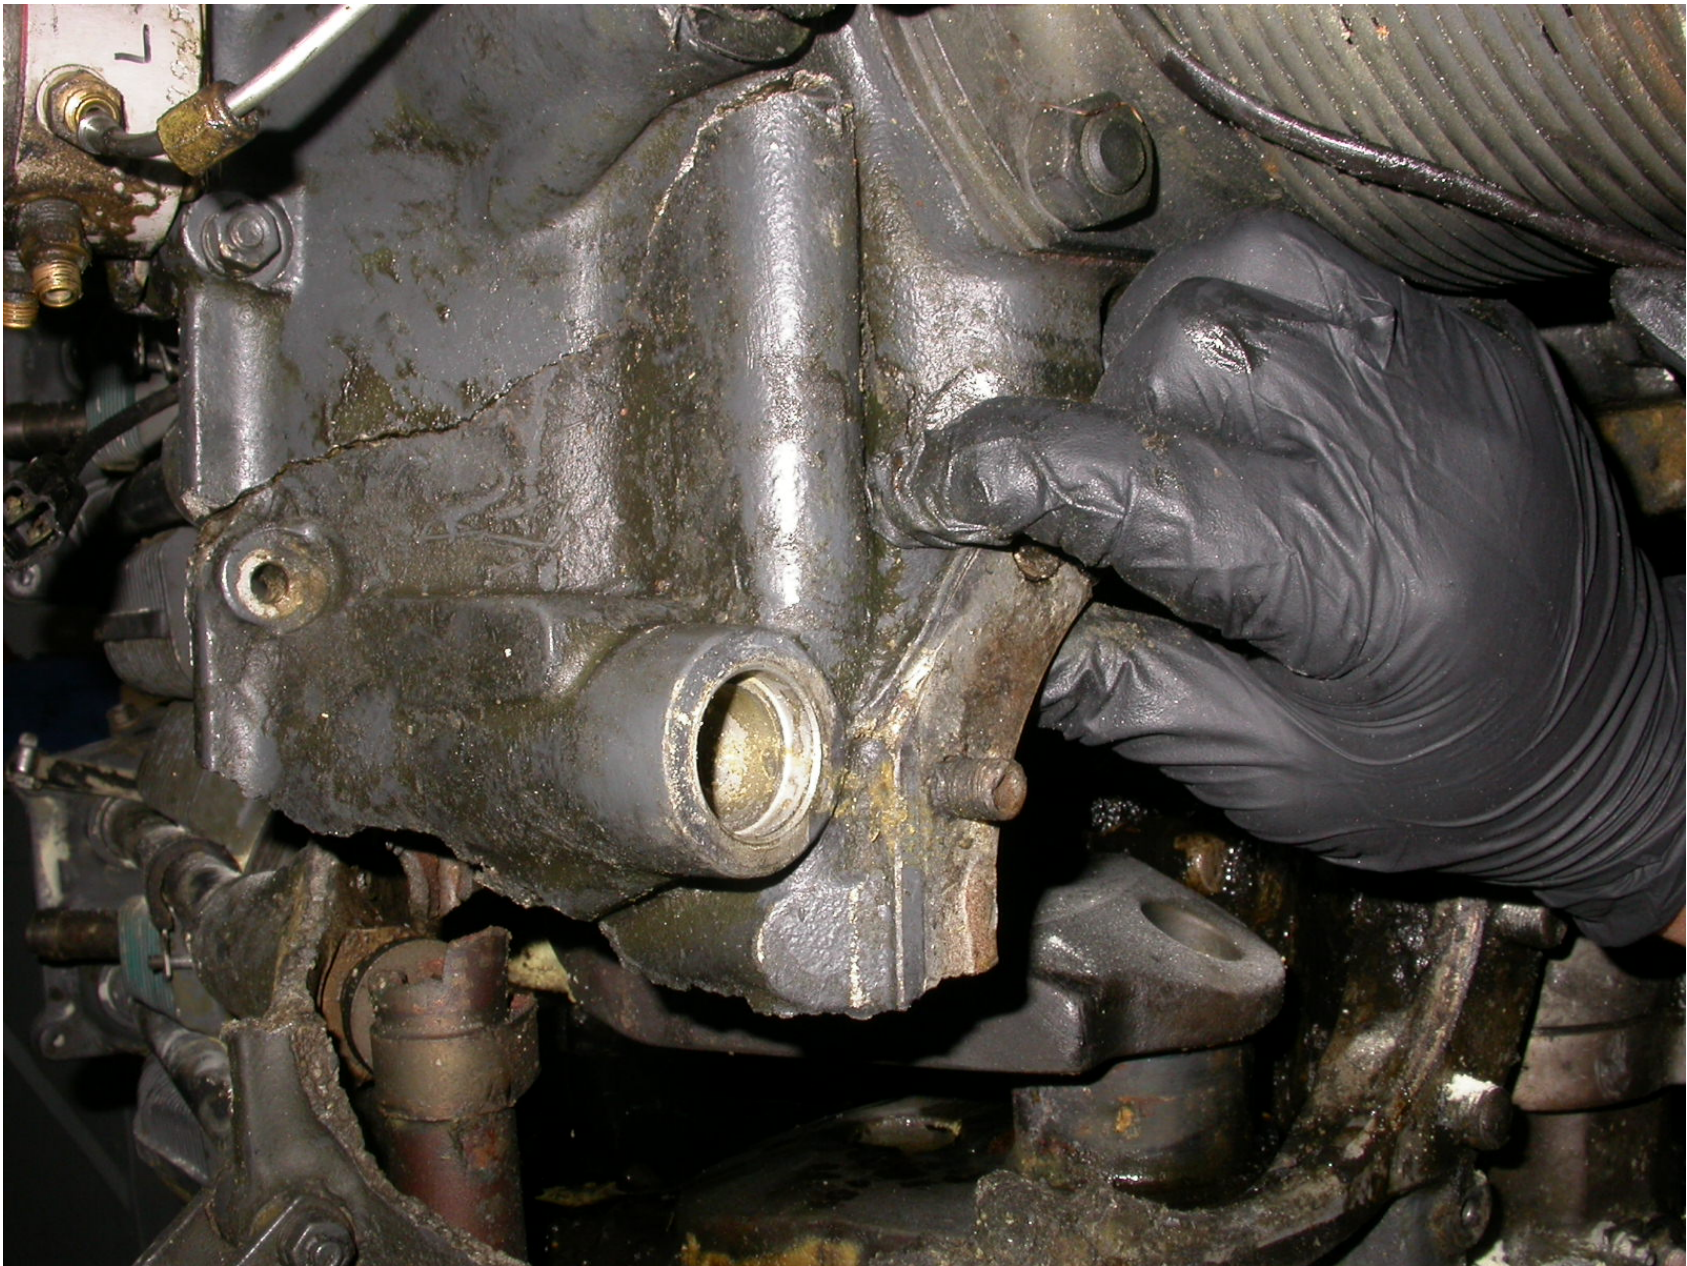
**Photo 18 – A view of a broken piece of the engine crankcase**

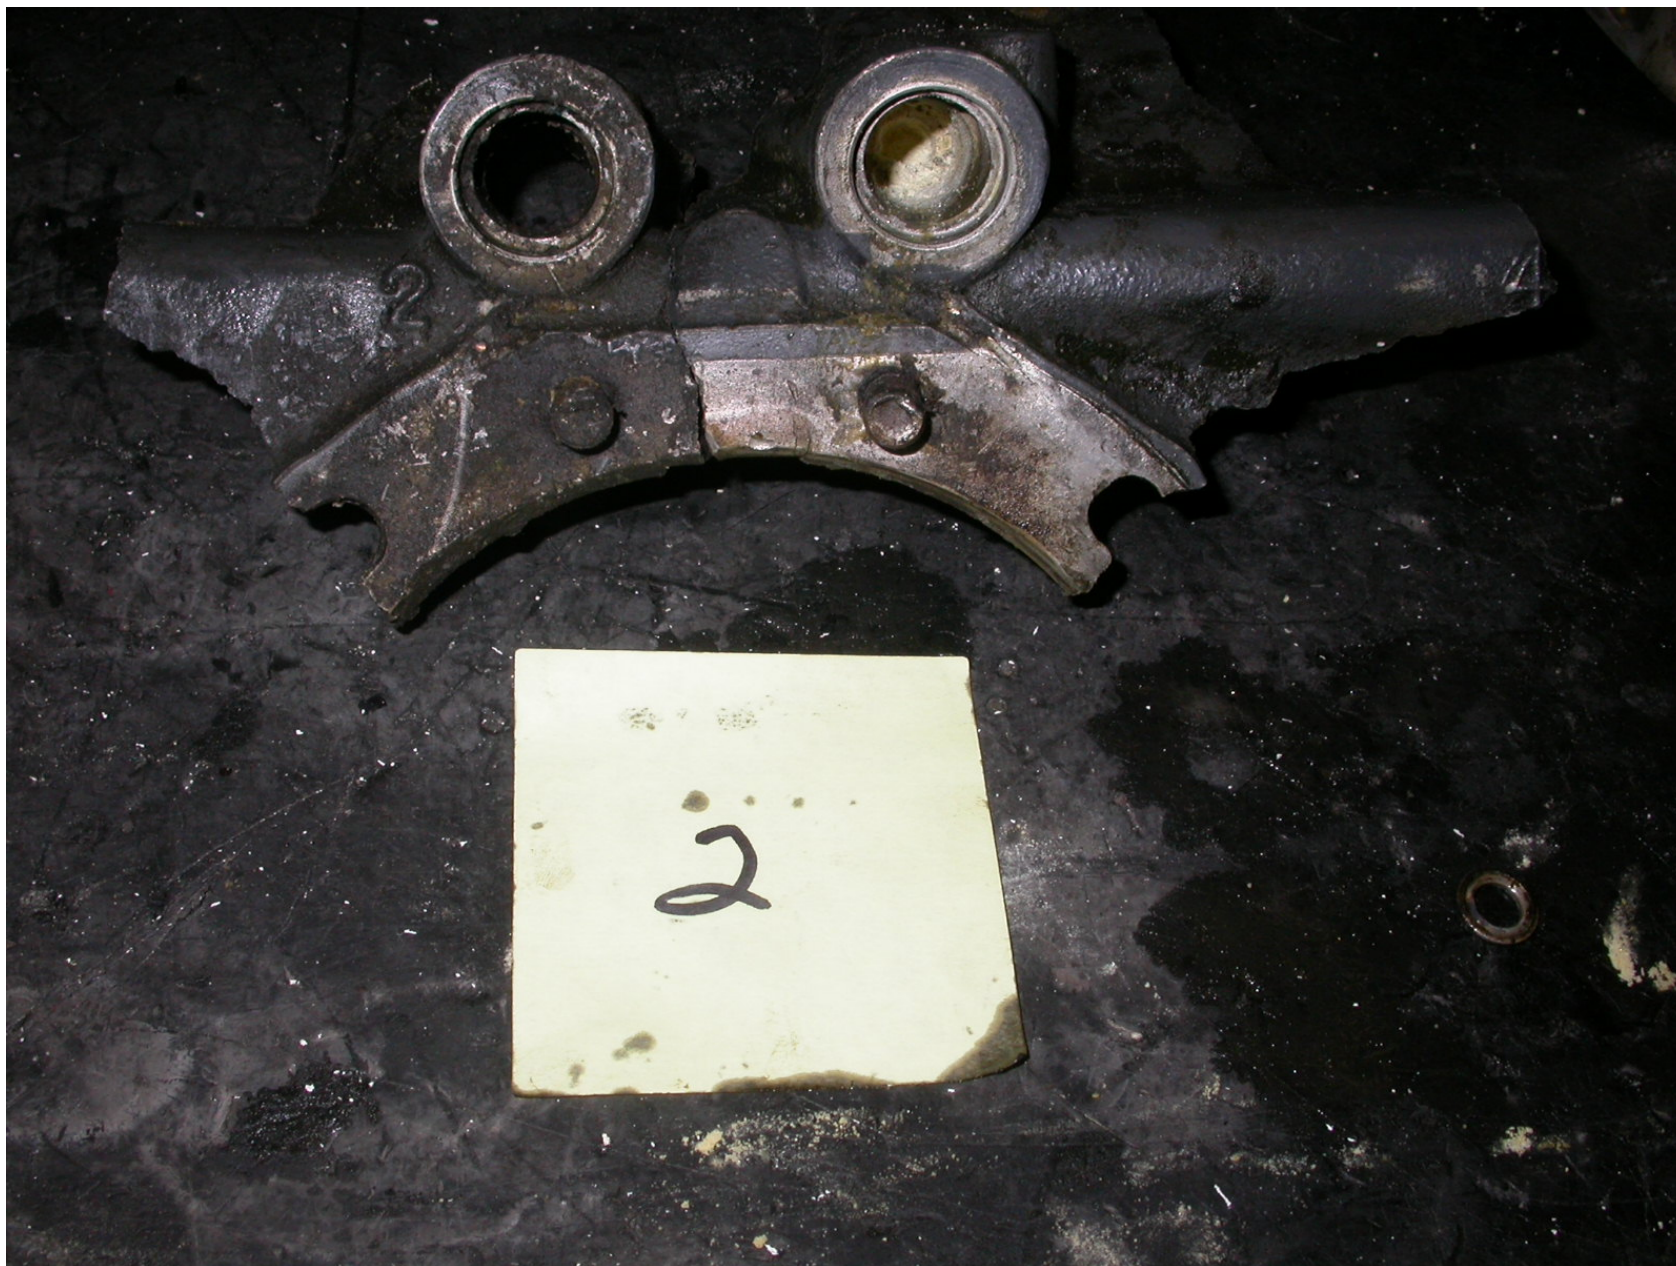
**Photo 19 – View of the No. 2 cylinder mating surface and 2 cylinder studs**
