**Photo 1 – View of engine mounted on an engine stand for teardown examination**

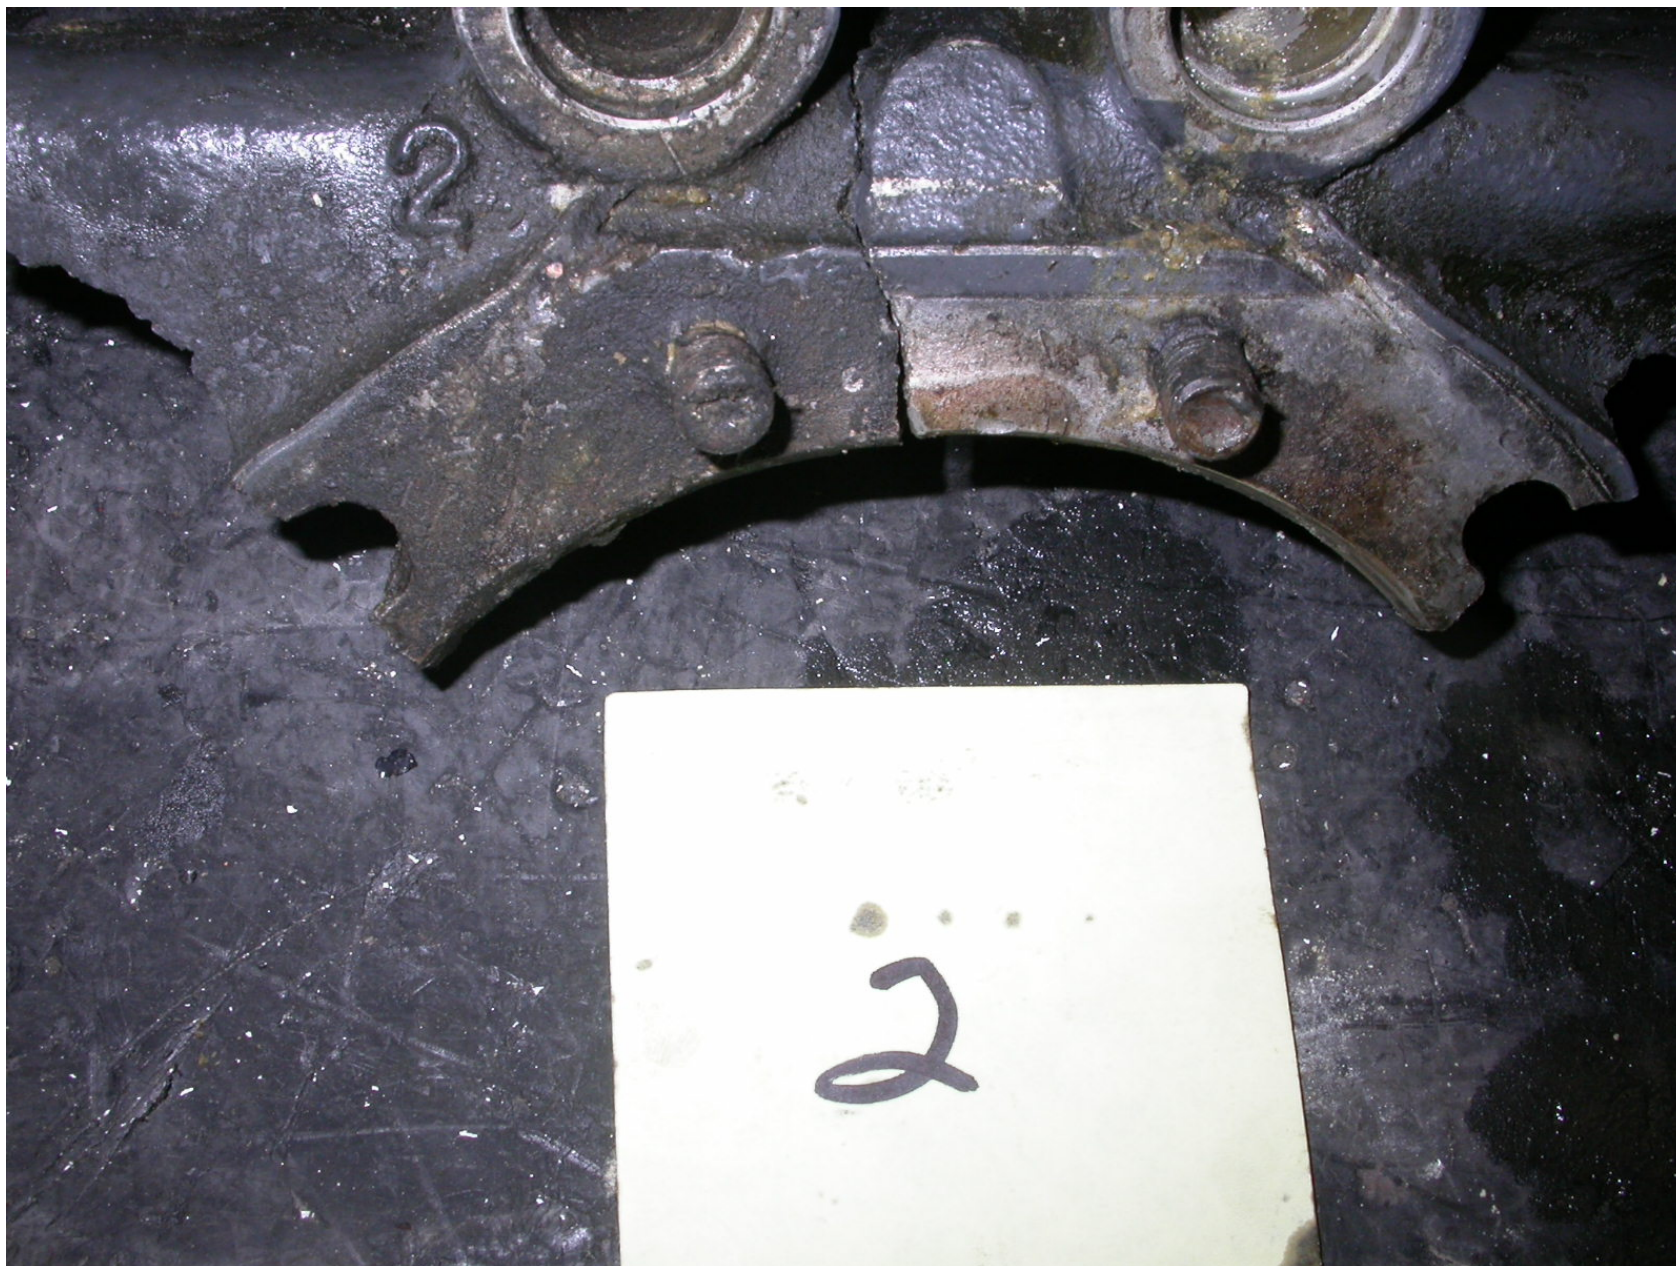
**Photo 20 - View of the No. 2 cylinder mating surface and 2 cylinder studs**

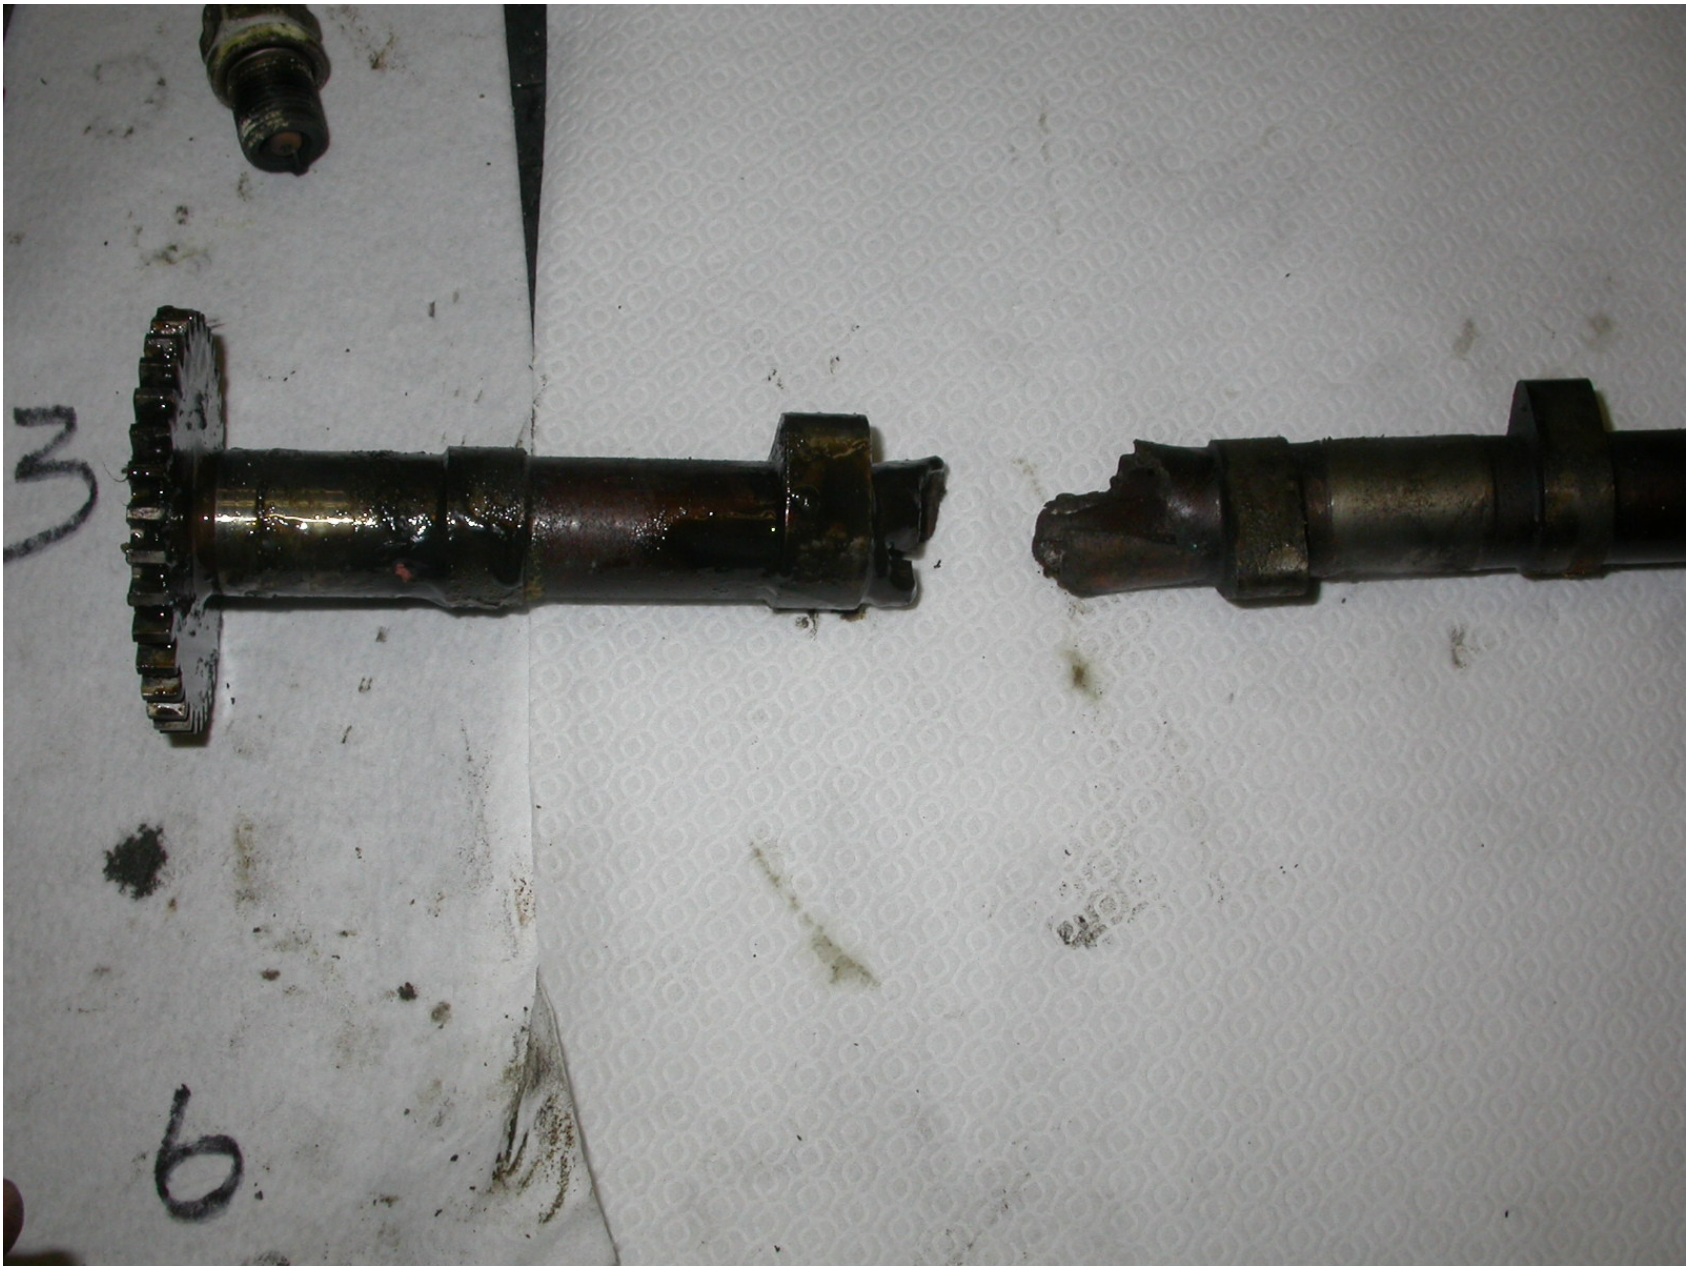
**Photo 22 - View of broken camshaft**

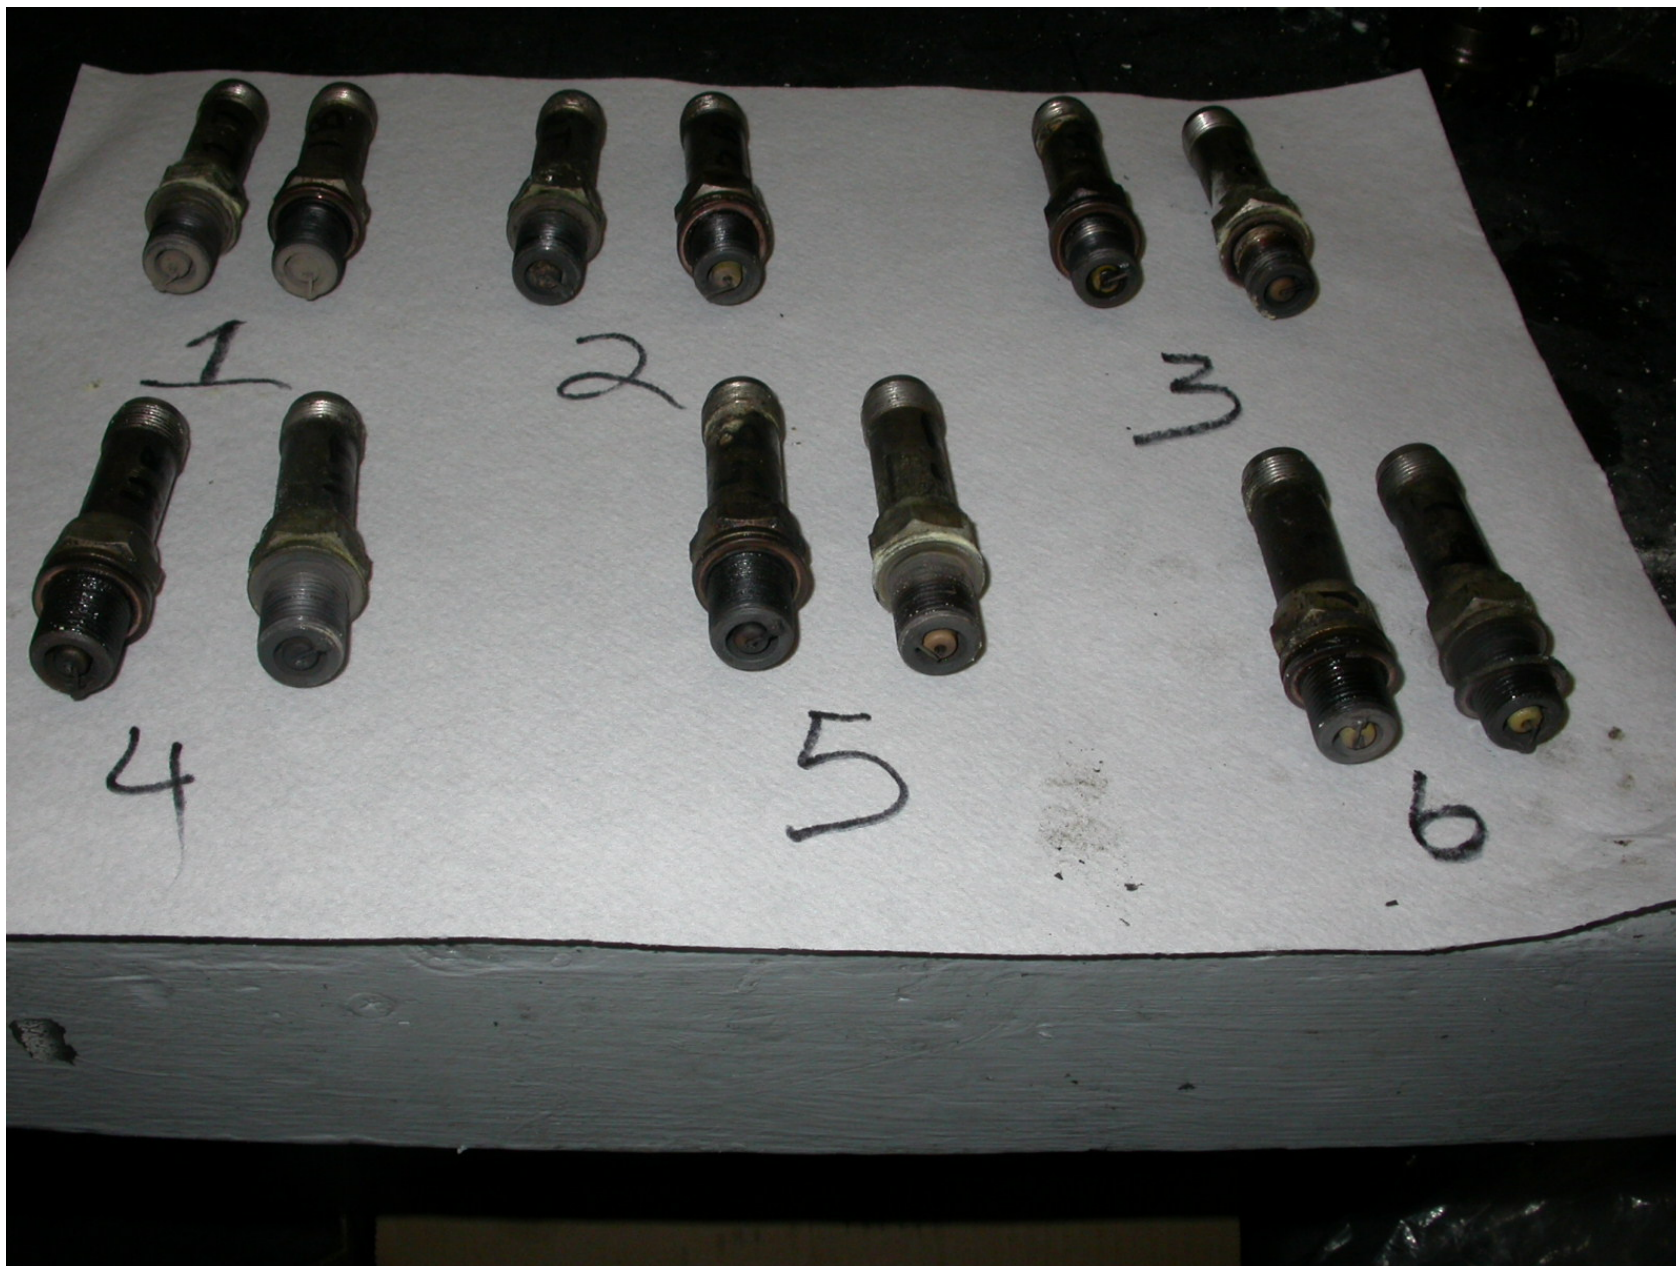
Photo 23 – View of the spark plugs removed from engine

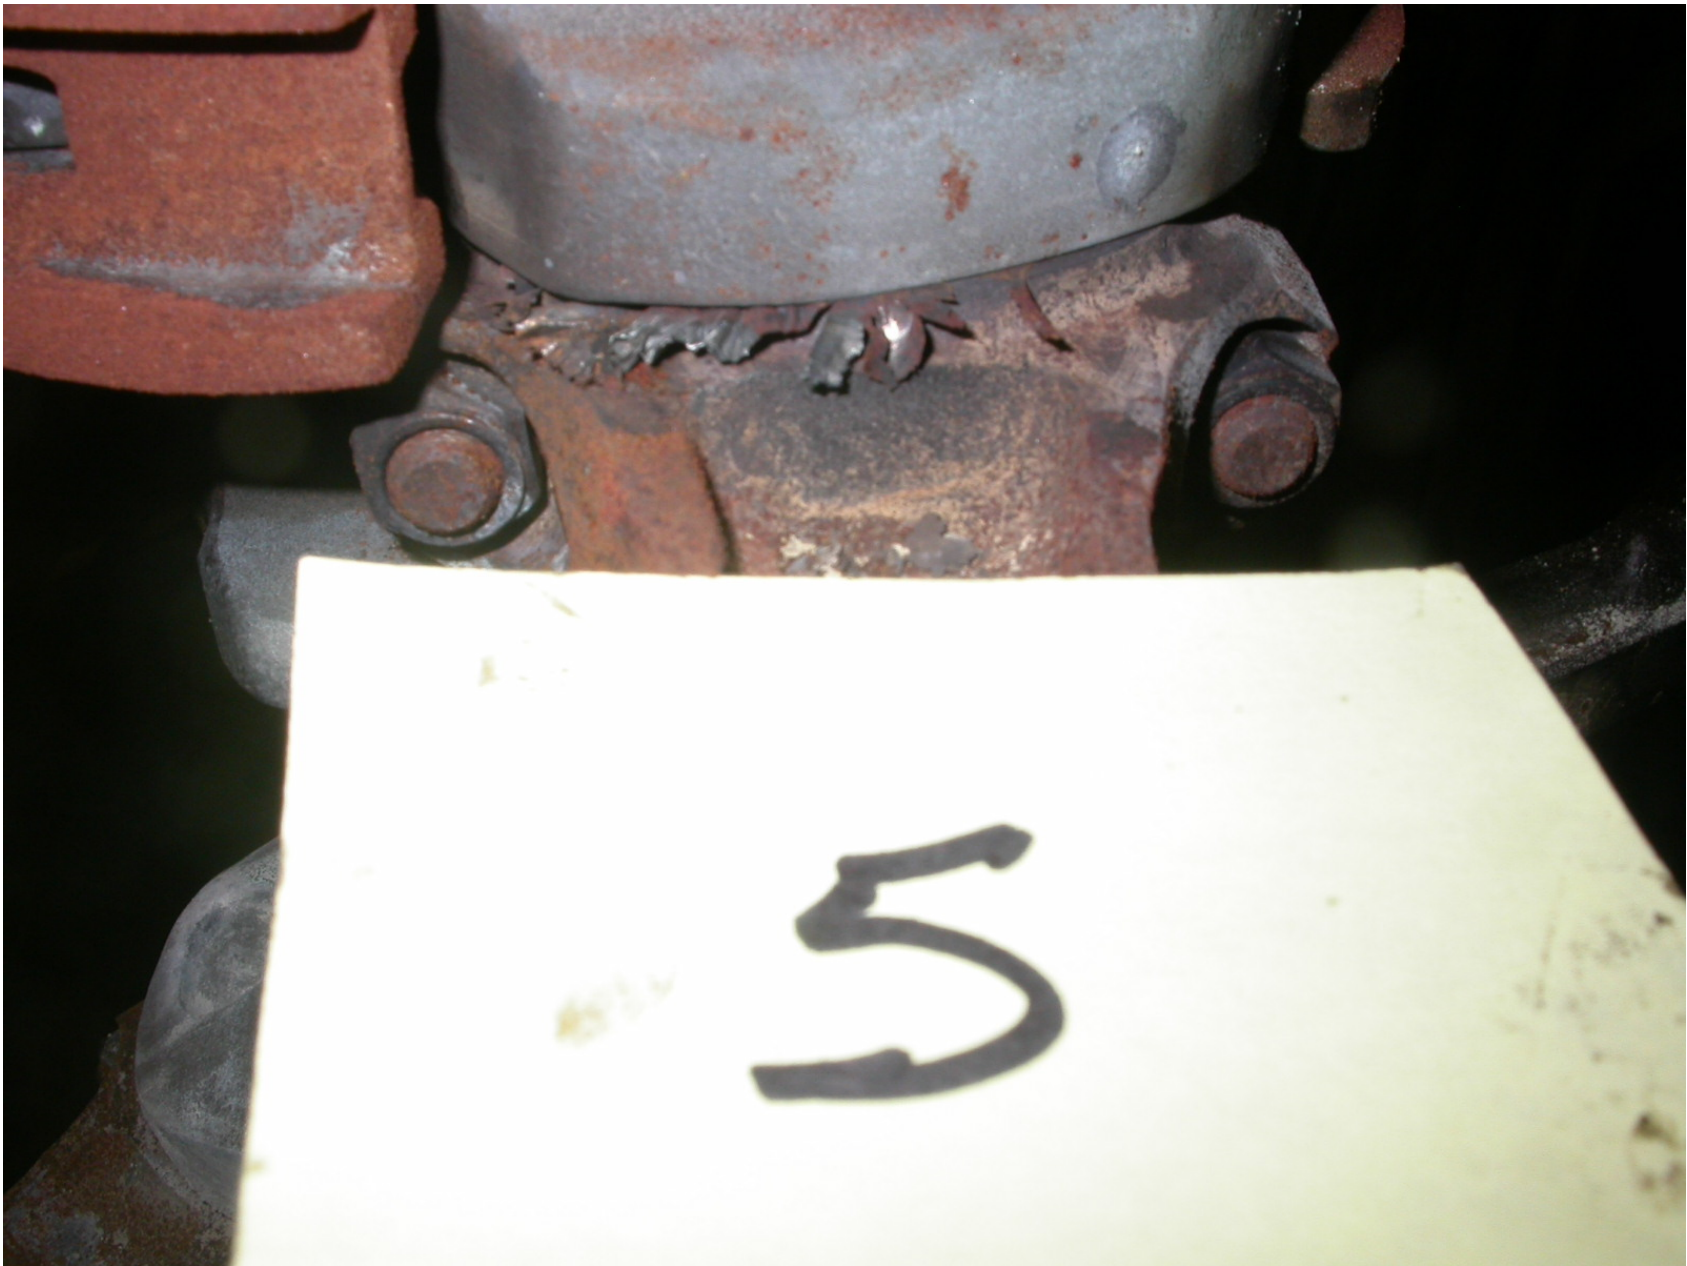
**Photo 28 – View of No. 5 connecting rod with metal bearing extrusion**

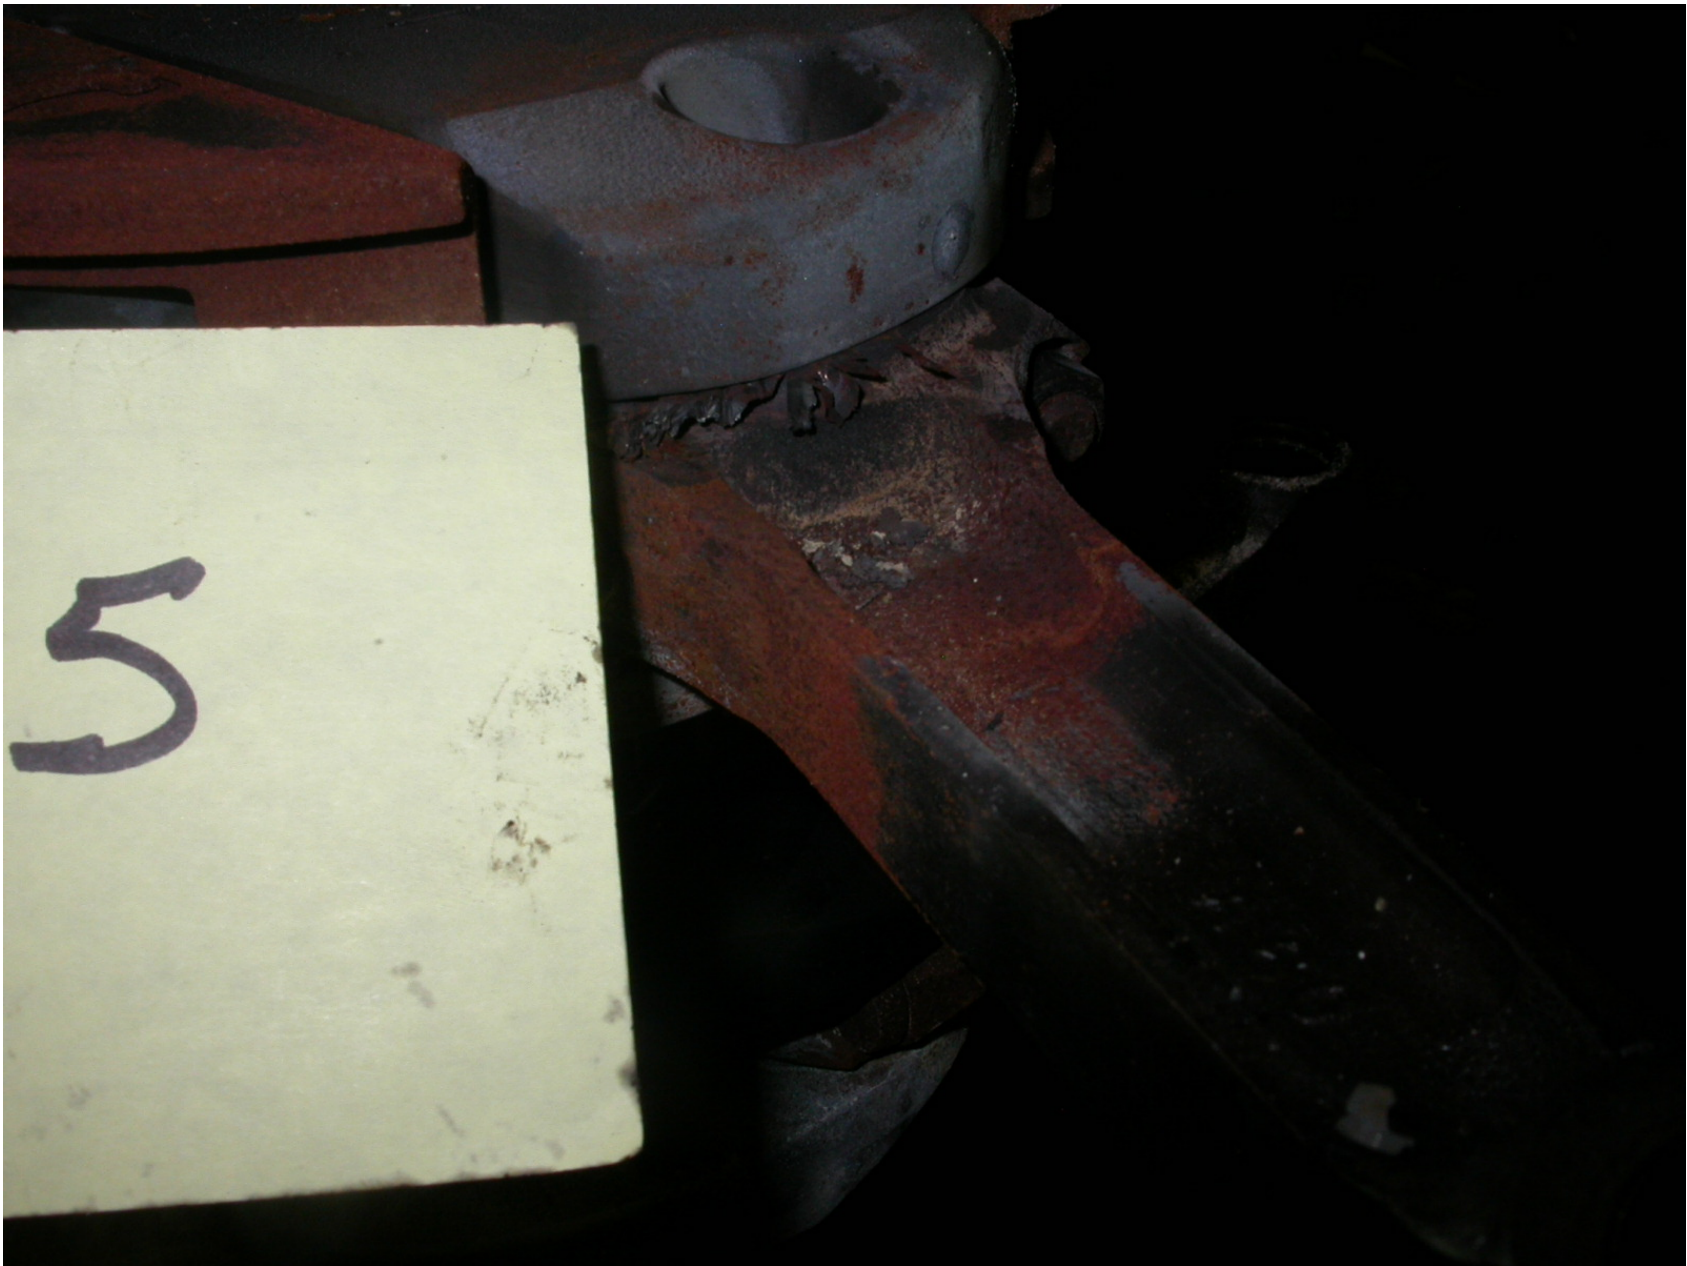
Photo 29 - View of No. 5 connecting rod with metal bearing extrusion

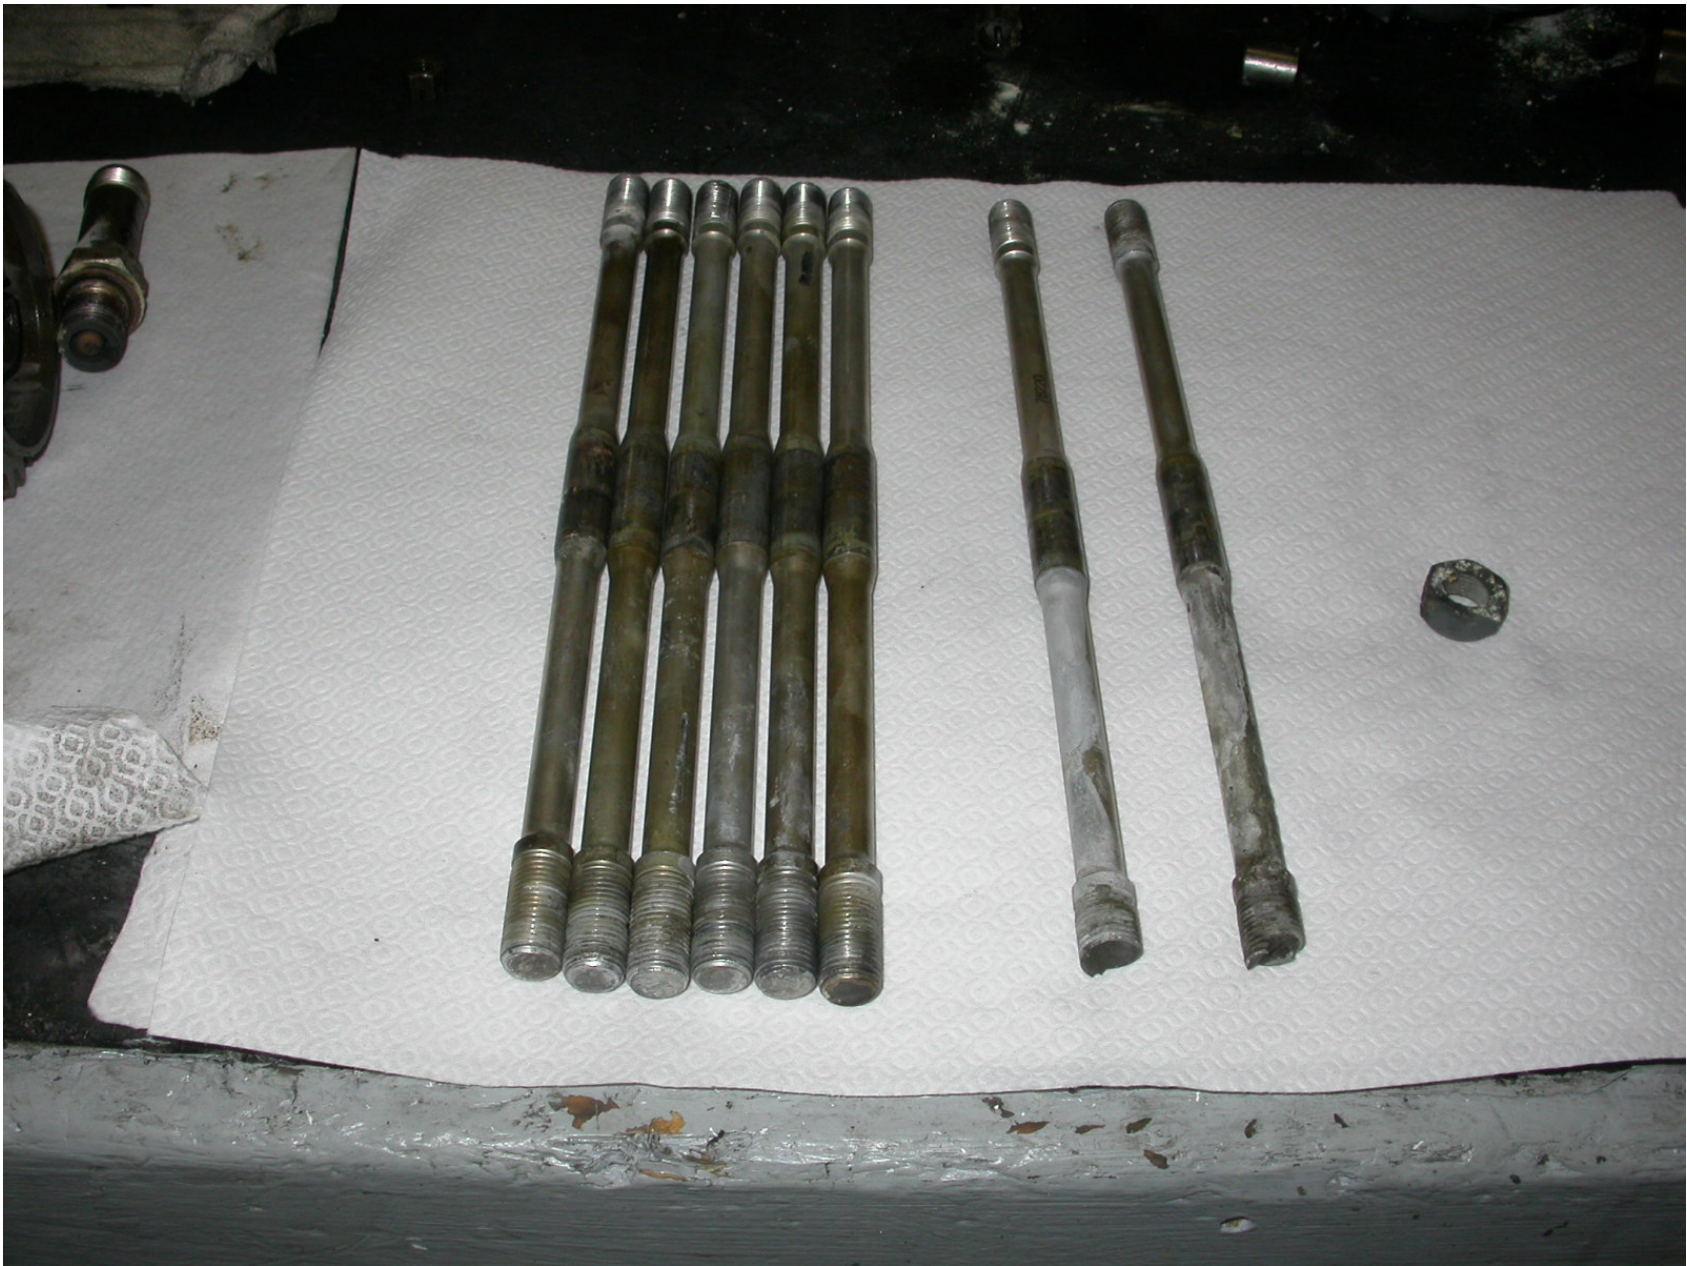
**Photo 30 – View of through bolts**

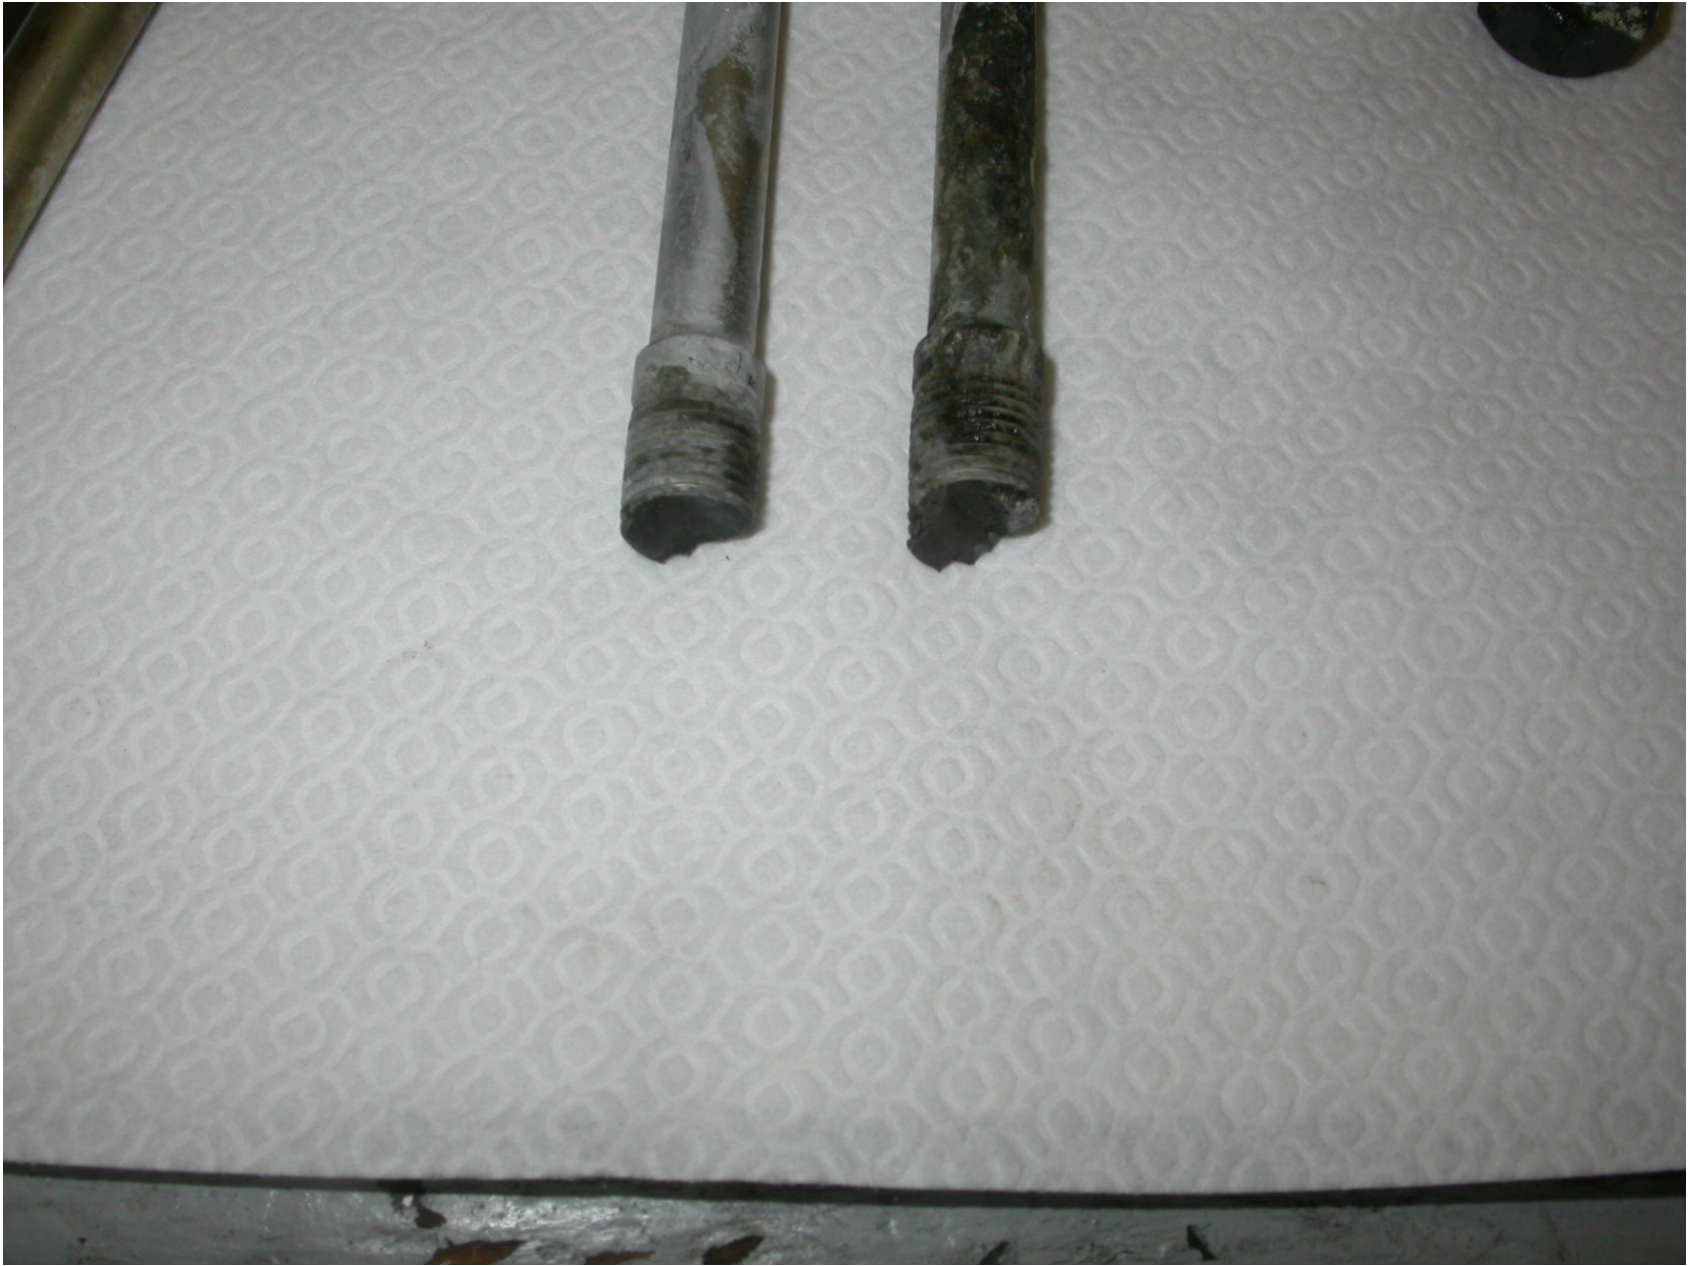
**Photo 31 – View of 2 fractured through bolts**

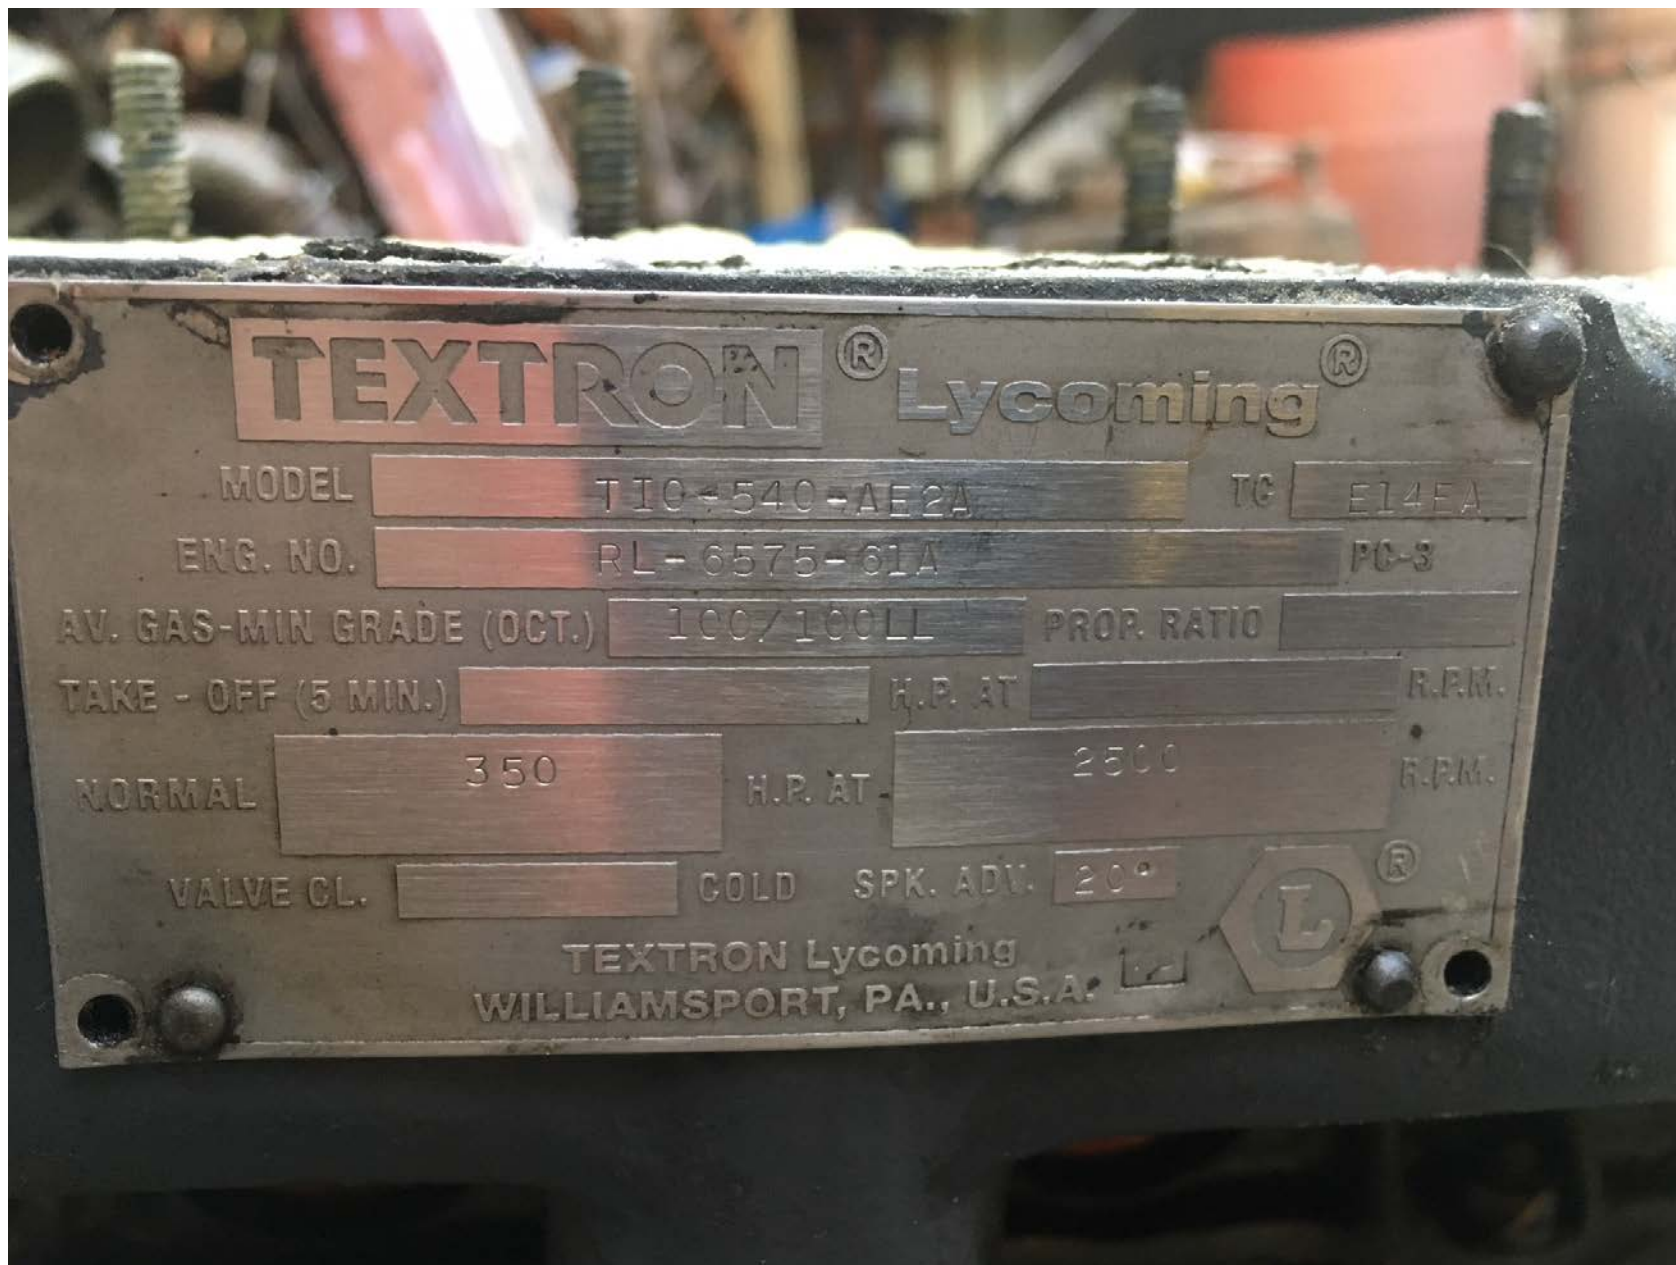
Photo 32 – View of engine data plate

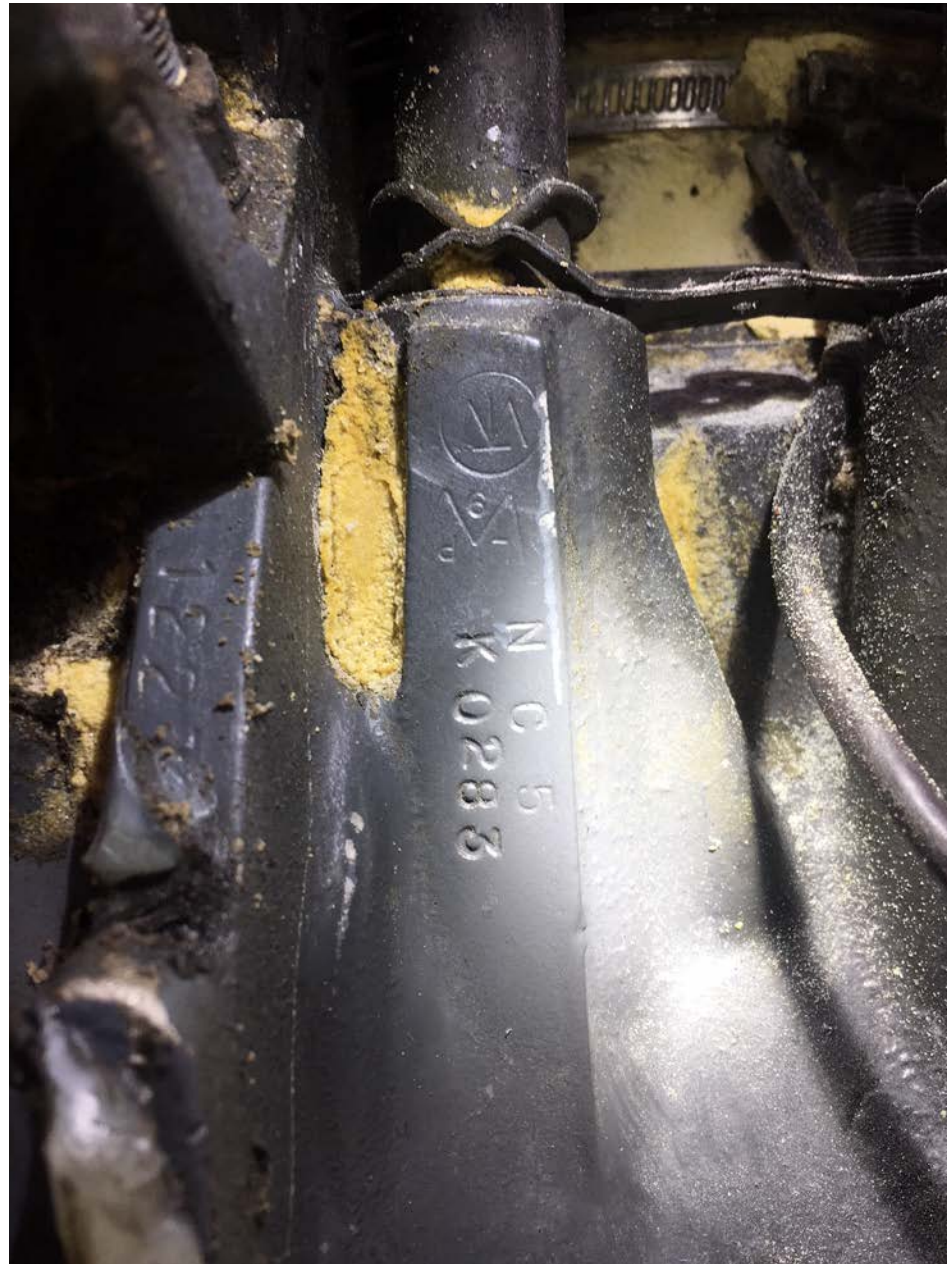
**Photo 33 – Engine case half identification numbers**

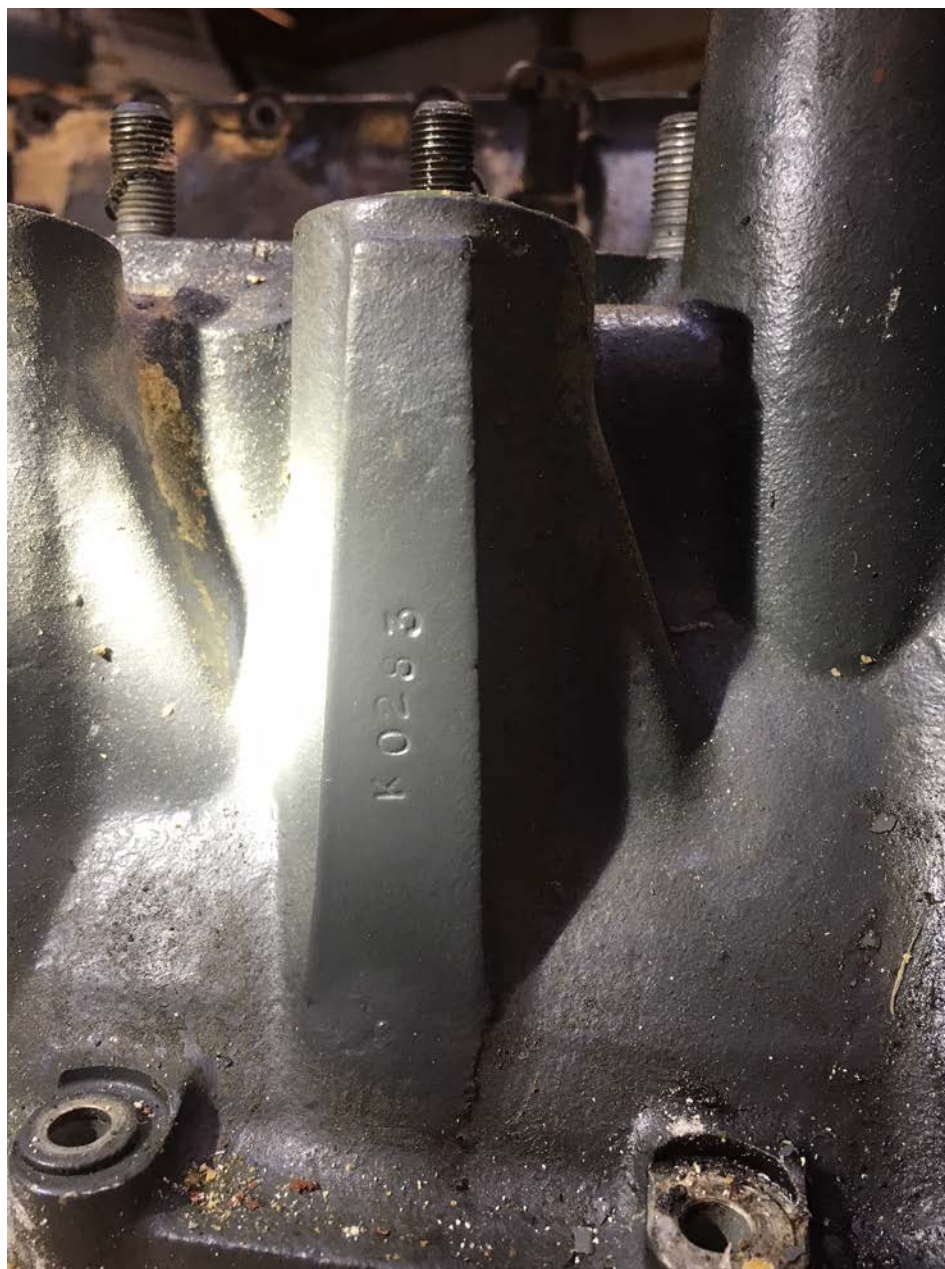
**Photo 34 - Engine case half identification numbers**

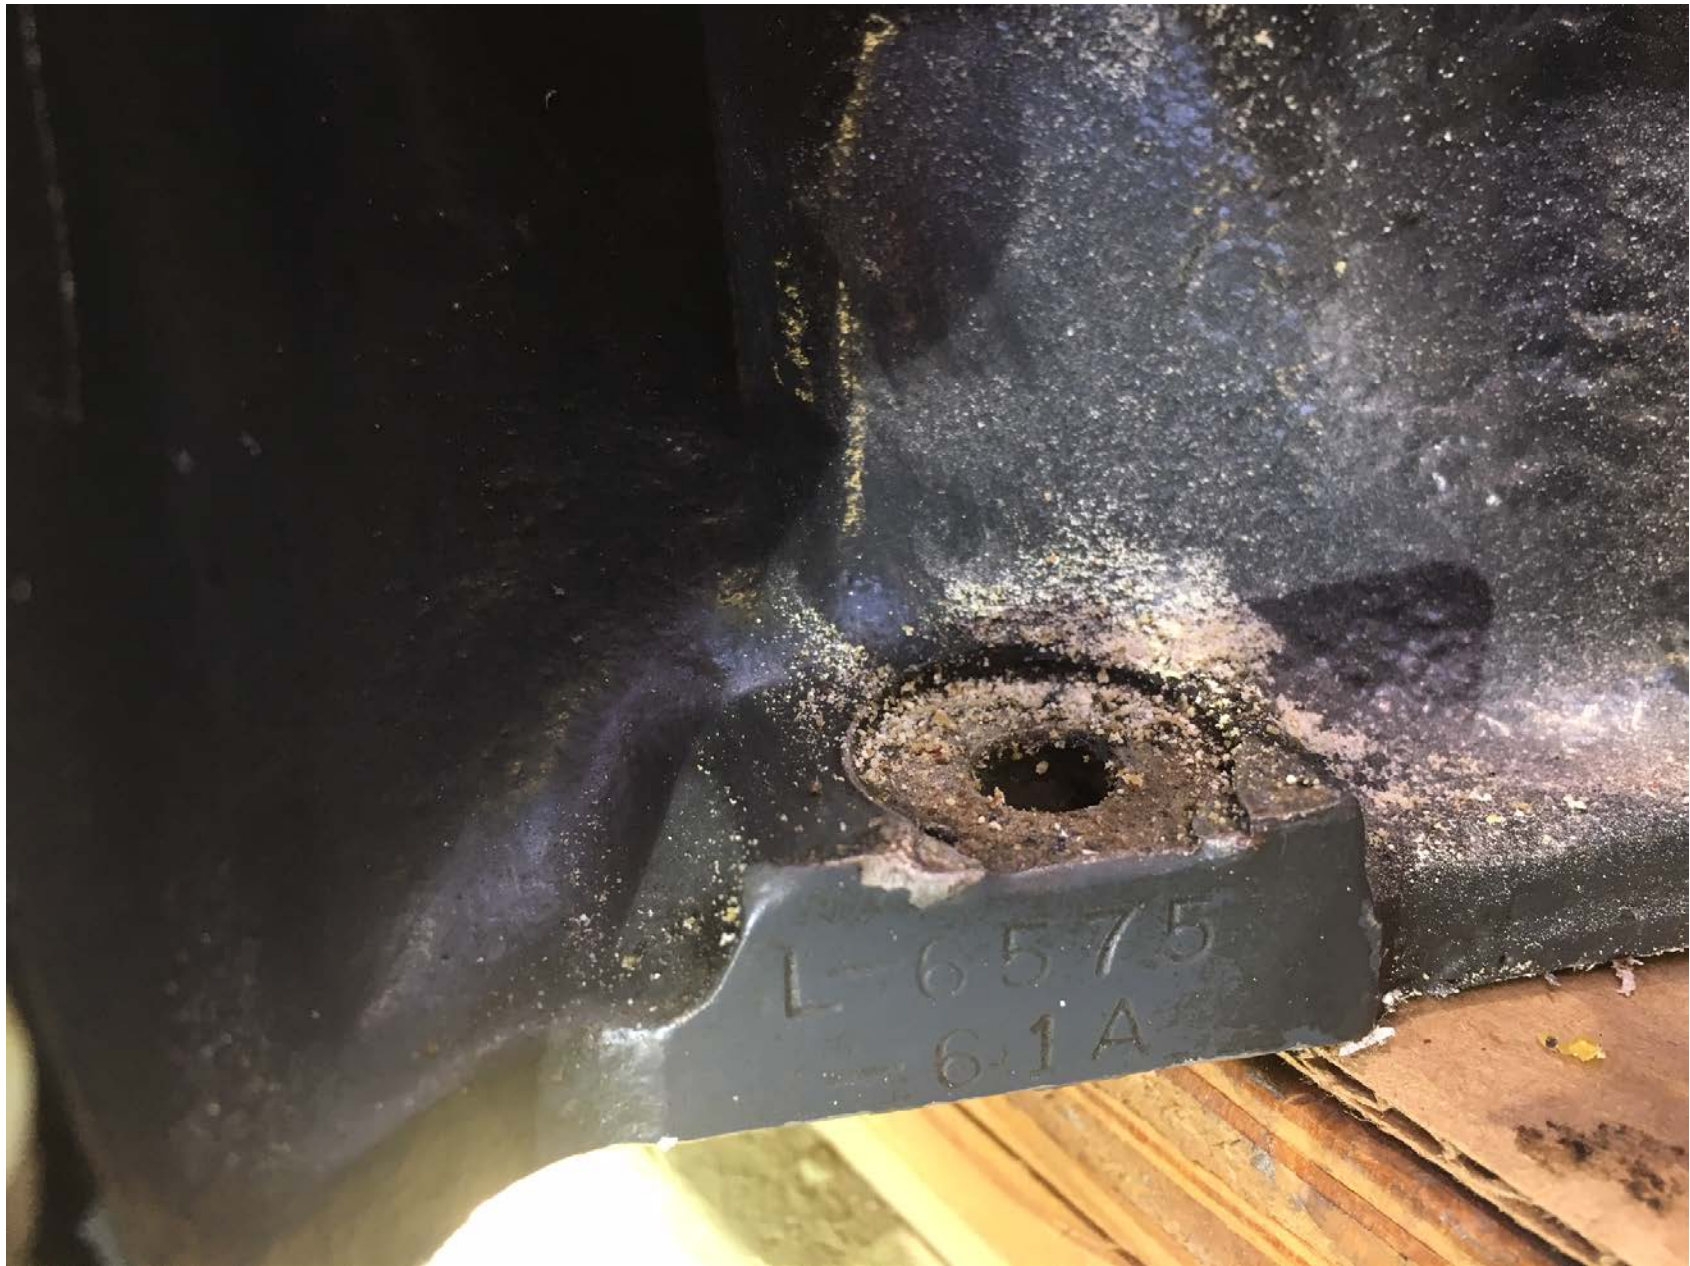
**Photo 35 - Engine case half identification numbers**

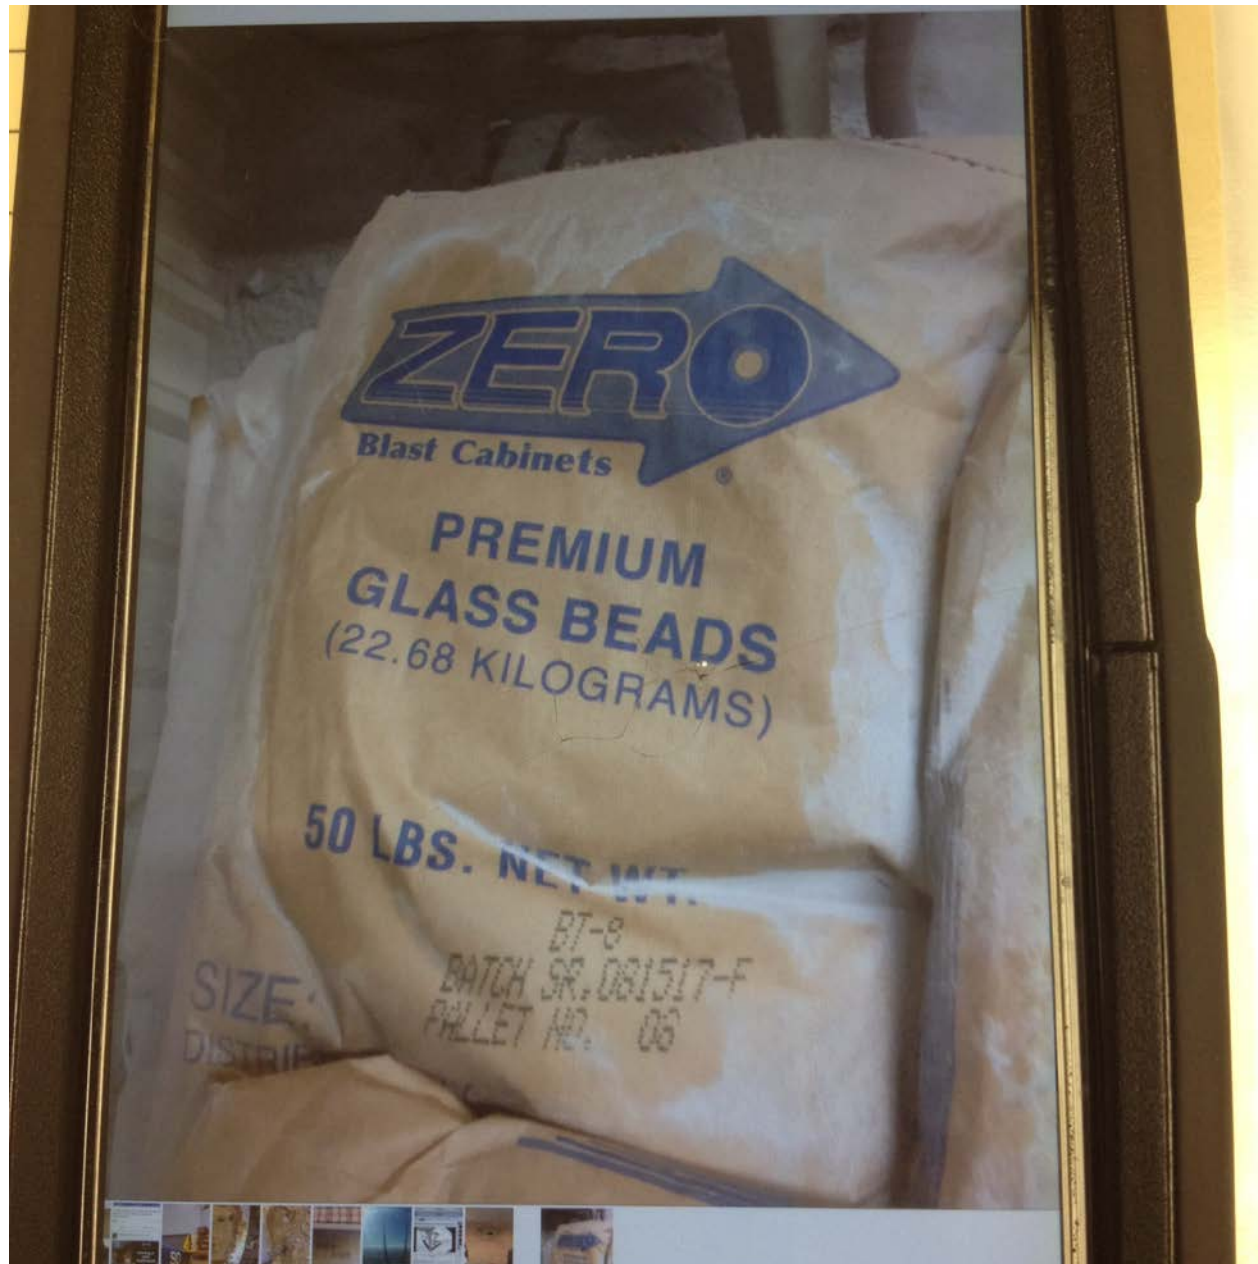
Photo 36 – Photo of a bag of ZERO premium glass beads
