**NATIONAL TRANSPORTATION SAFETY BOARD**

**CEN18FA009**

**Figure 1 - N8338S Flight Track**

**Figure 2 - N8338S Flight Track**

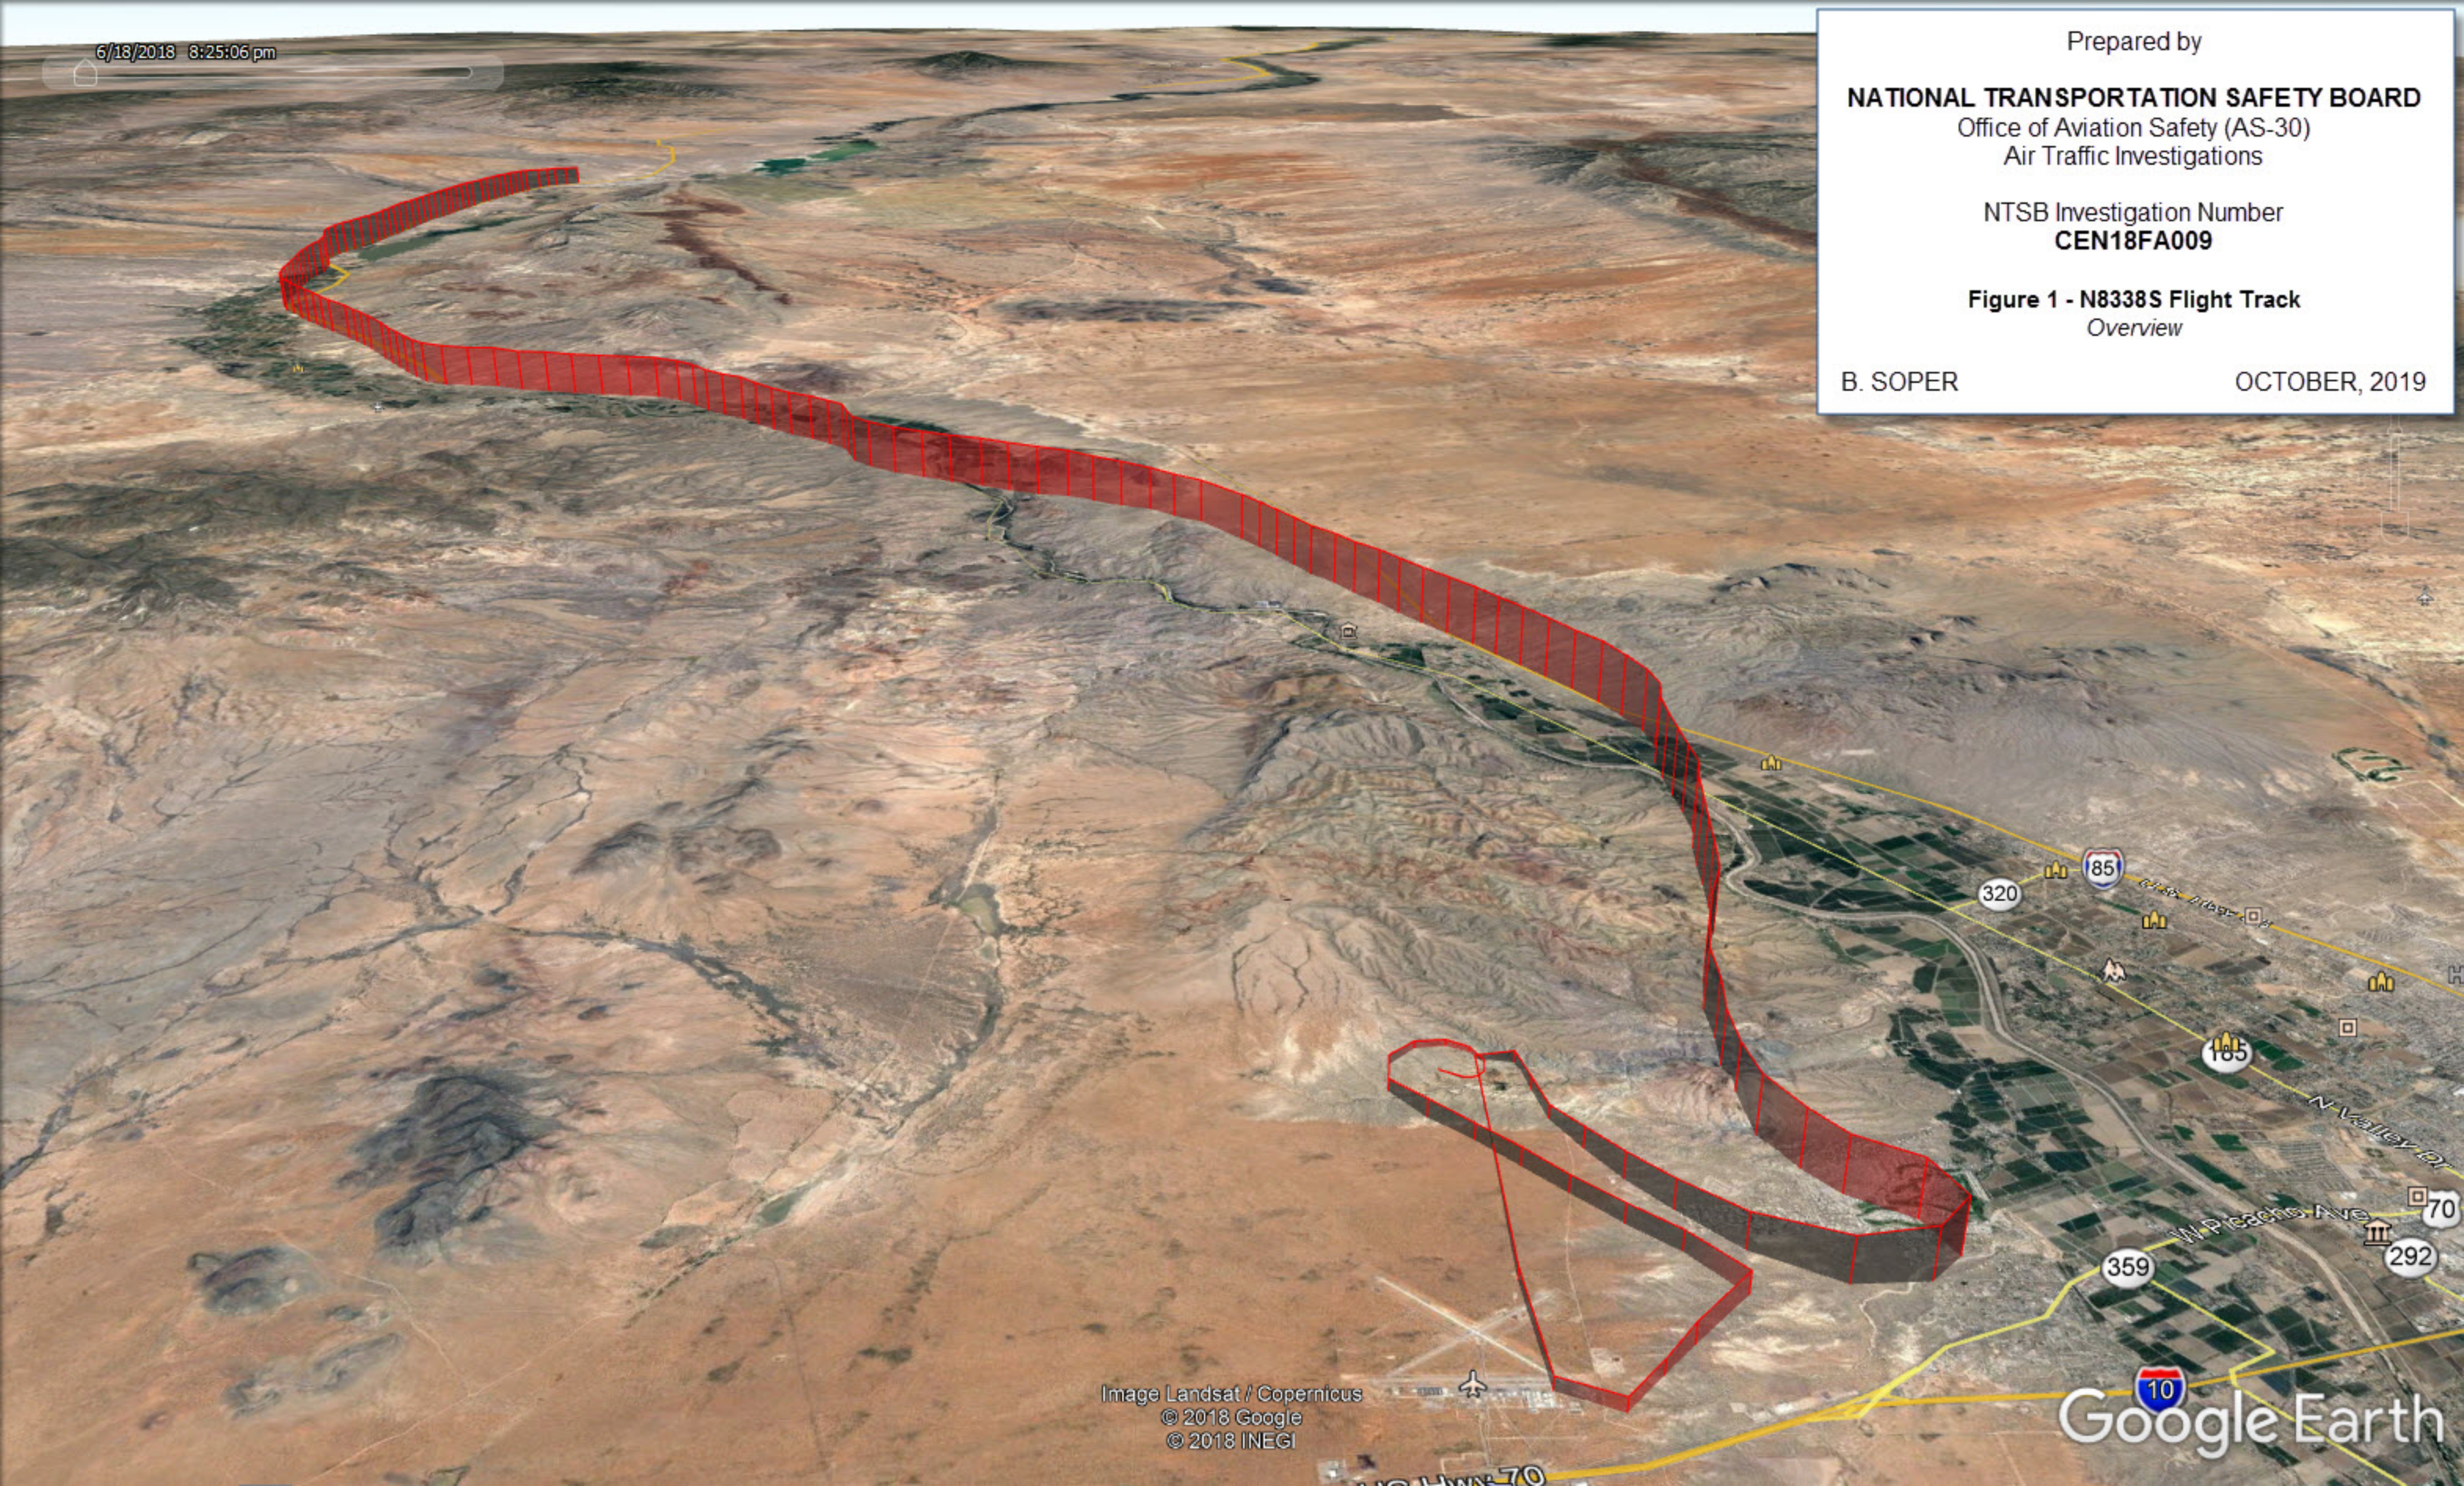
Overview
