**NATIONAL TRANSPORTATION SAFETY BOARD**

**Engine Monitor Device (EDM)**

**Specialist's Factual Report**  
**By Sean Payne**

Location: Pineville, Louisiana  
Date: November 10, 2017  
Aircraft: Temco GC-1B  
Registration: N2363B  
Operator: Private  
NTSB Number: CEN18FA030

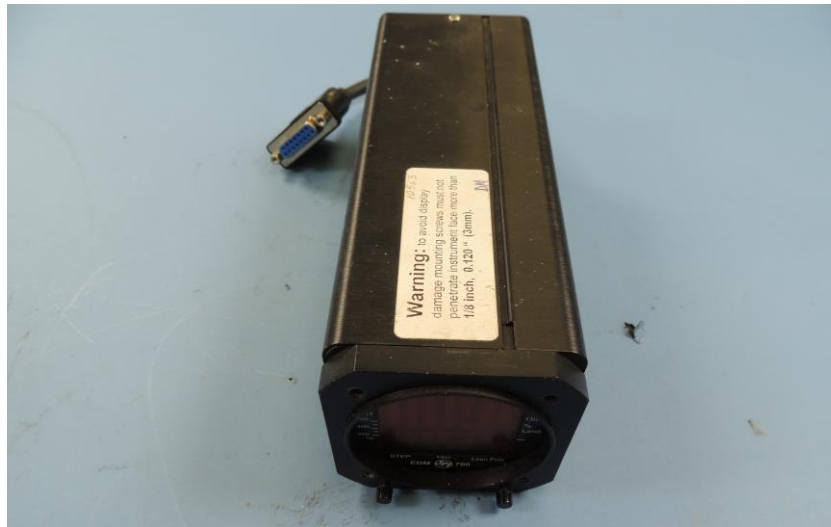
**Figure 1.** Photo of damaged unit

Upon arrival at the Vehicle Recorder Laboratory, an examination revealed the unit had not sustained any damage, however, information could not be extracted using the manufacturer's software. The unit was disassembled and the memory chips were removed and read out. The unit is shown in figure 1.
