CEN18FA037  
Cessna 172G, N4676L  
Pittsford, Vermont  
November 22, 2017

Plotted GPS Data

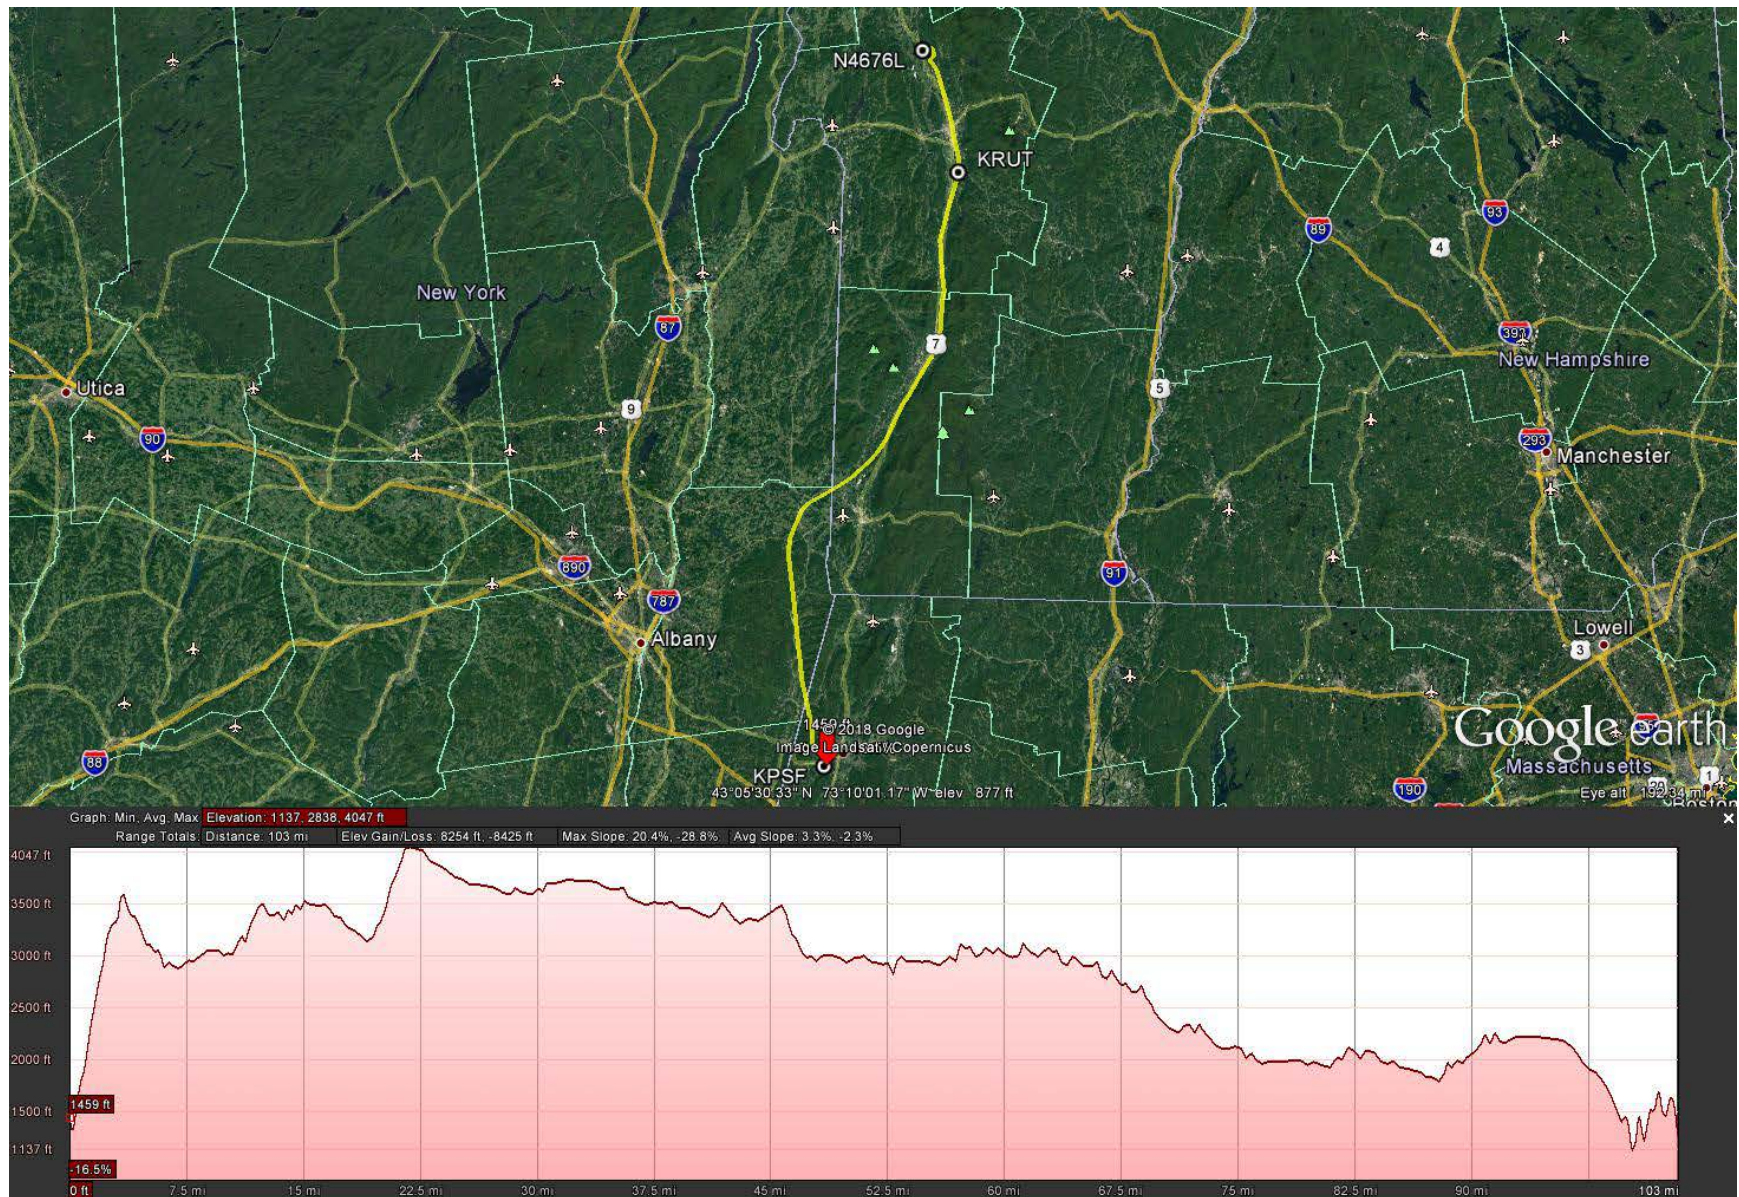
Figure 1 - Plotted GPS data of accident flight showing elevation profile.

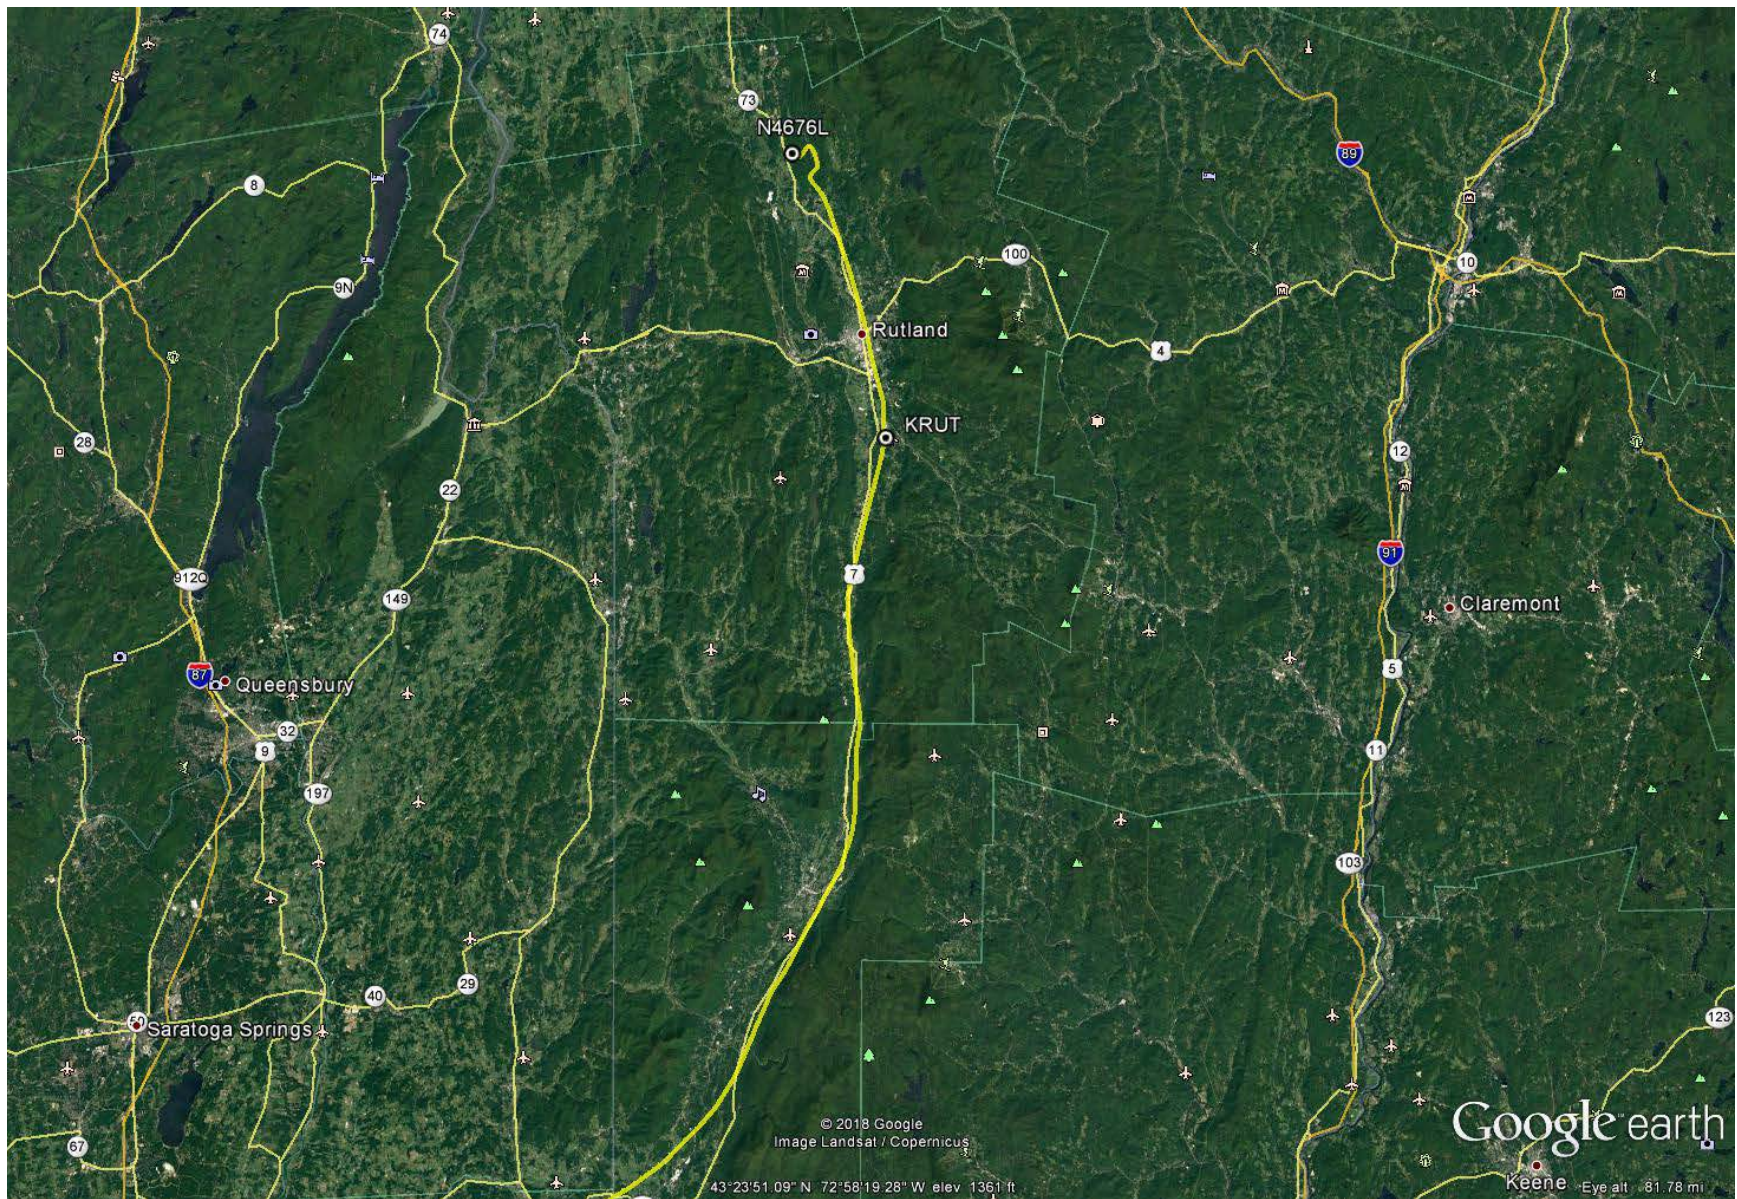
Figure 2 - GPS plot showing the airplane flight path following US Highway 7.

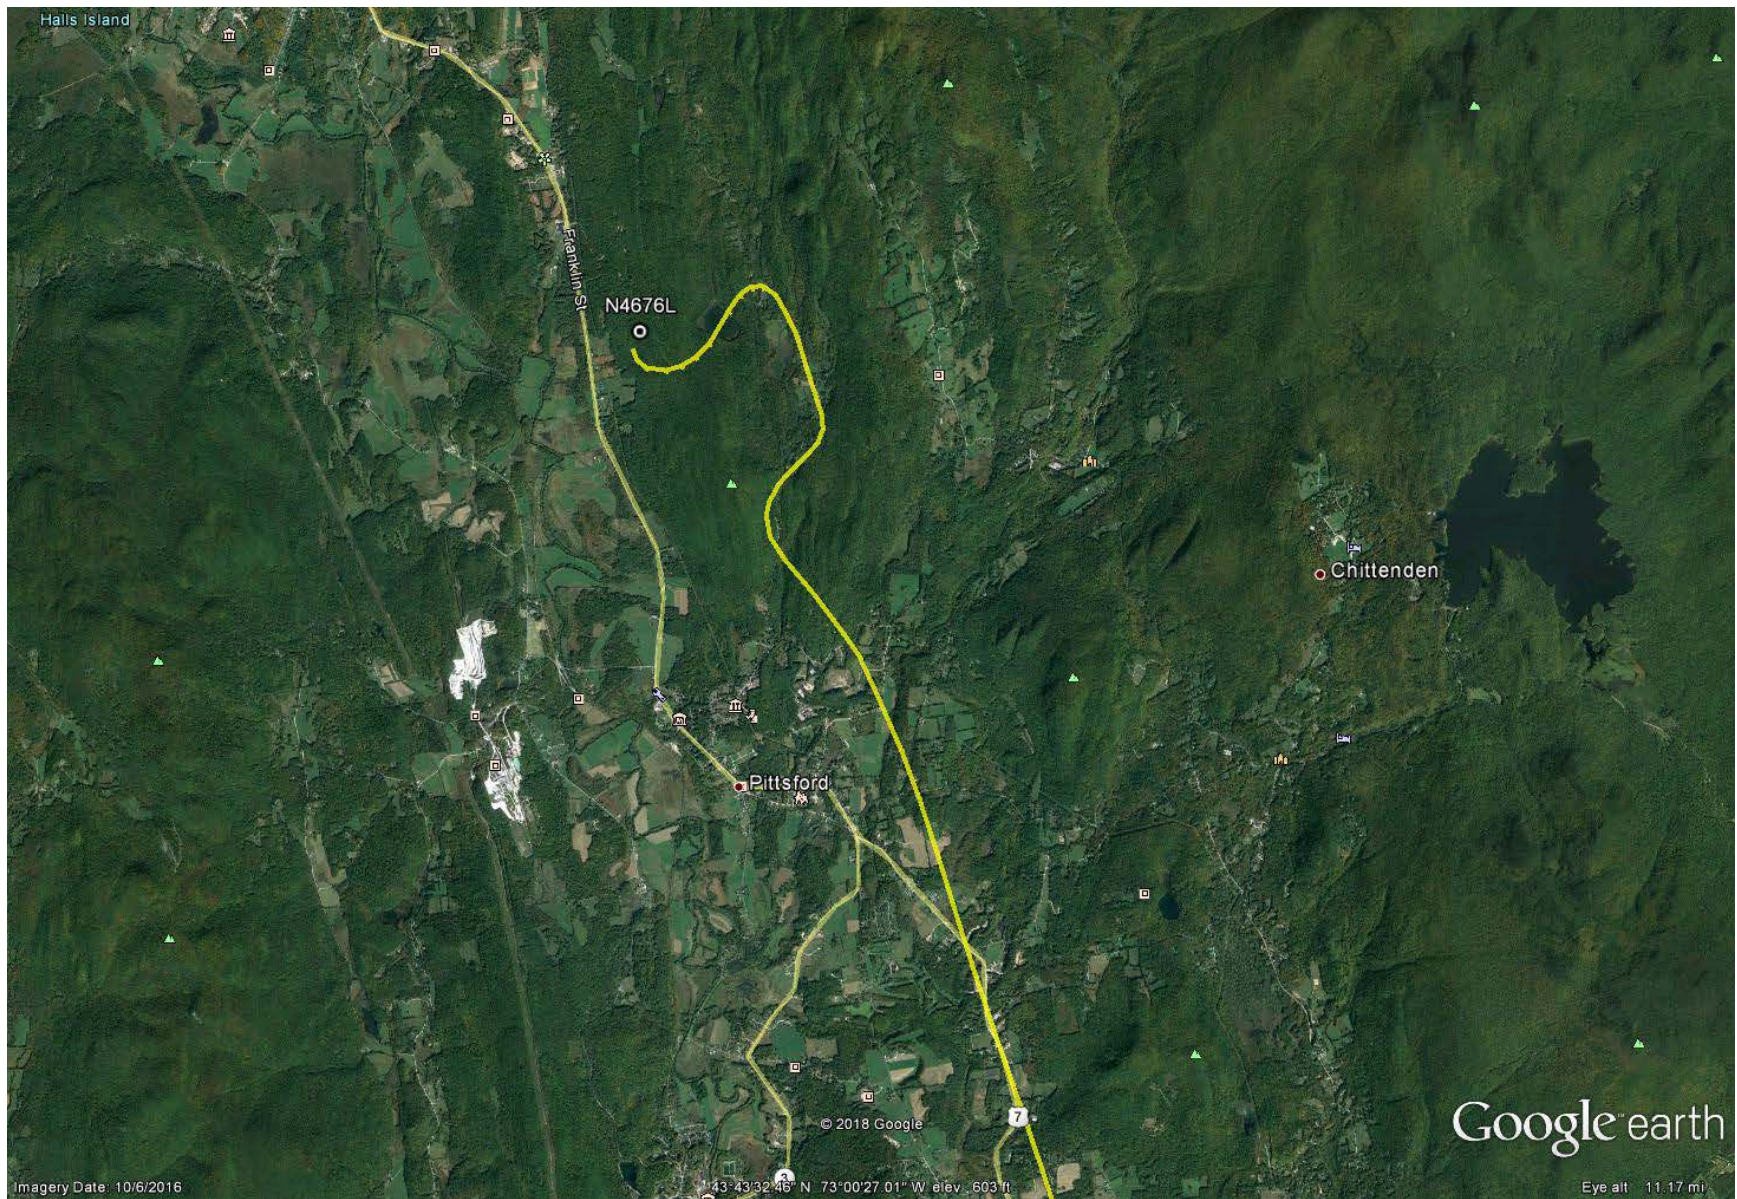
Figure 3 - GPS Plot showing the flight path diverging from the road where the road turns left.

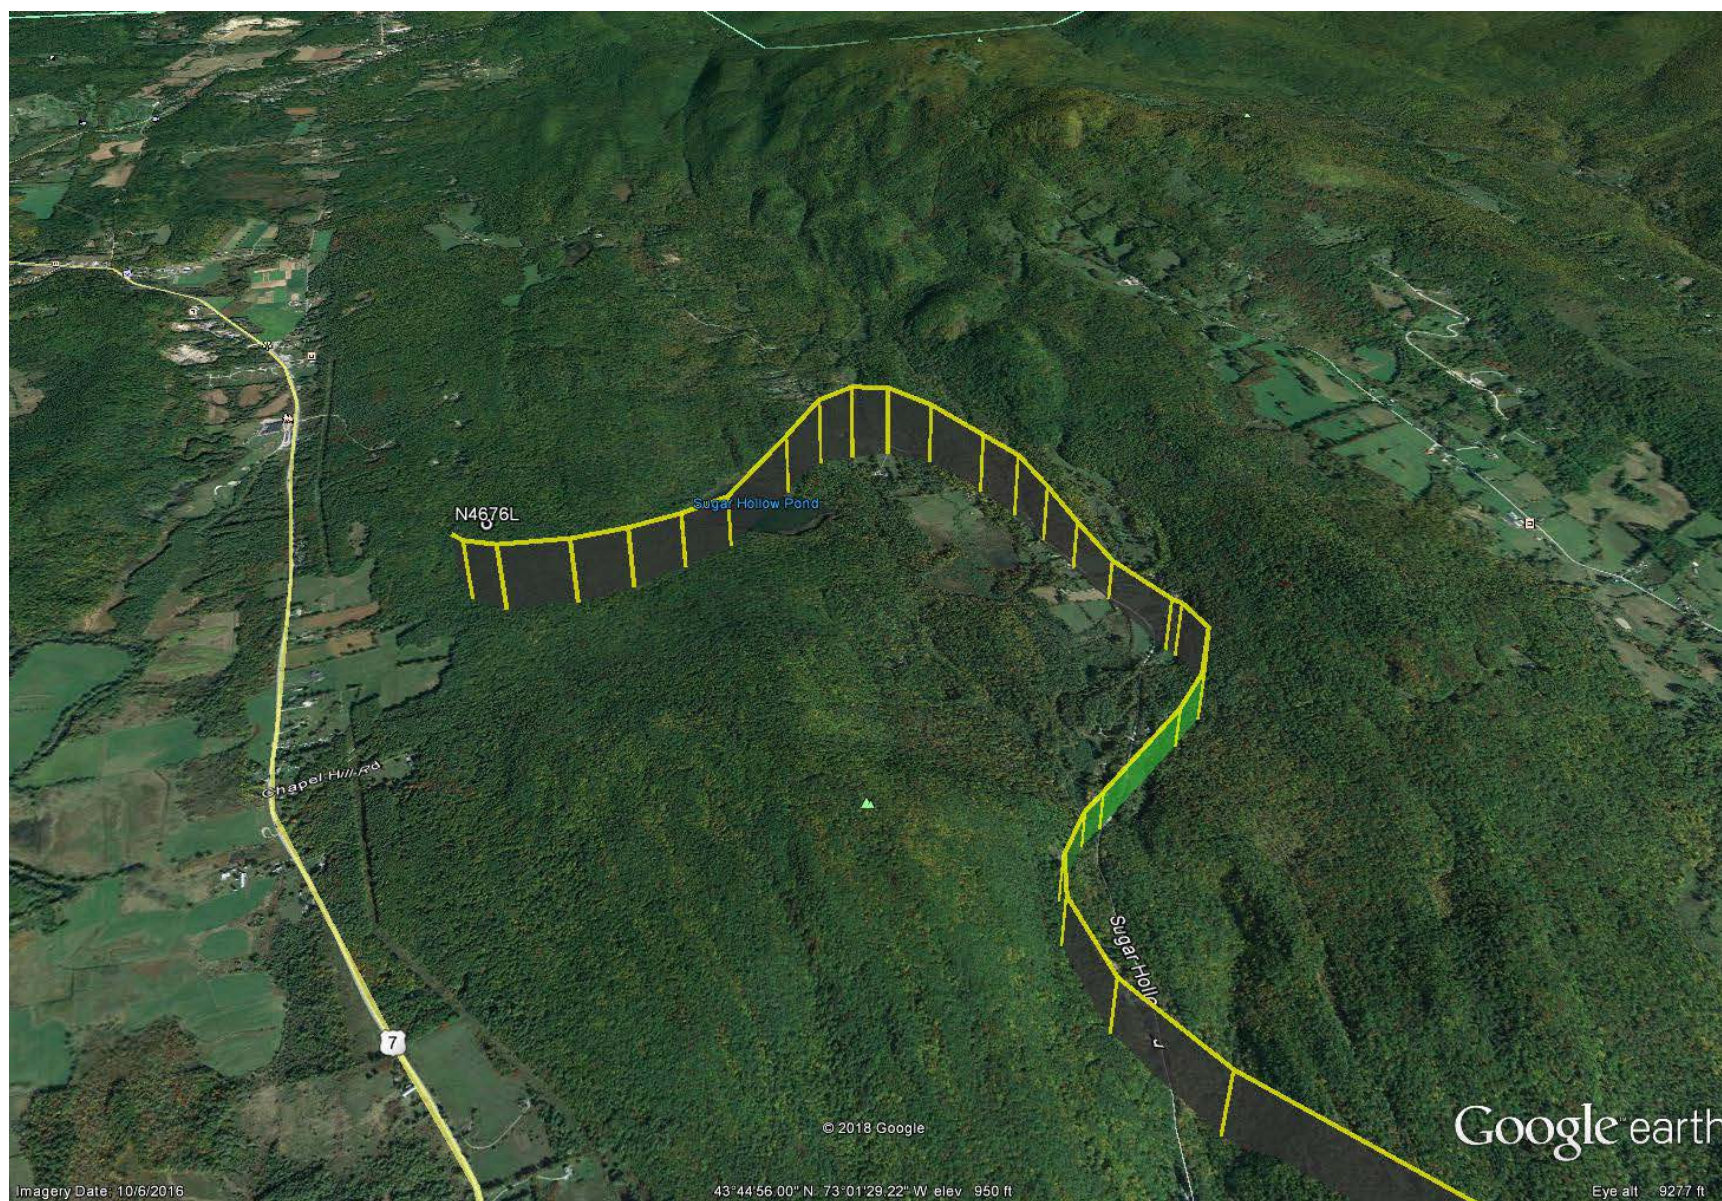
Figure 4 - GPS Plot of airplane within a valley before making a left turn and crossing one of the ridges forming the valley.

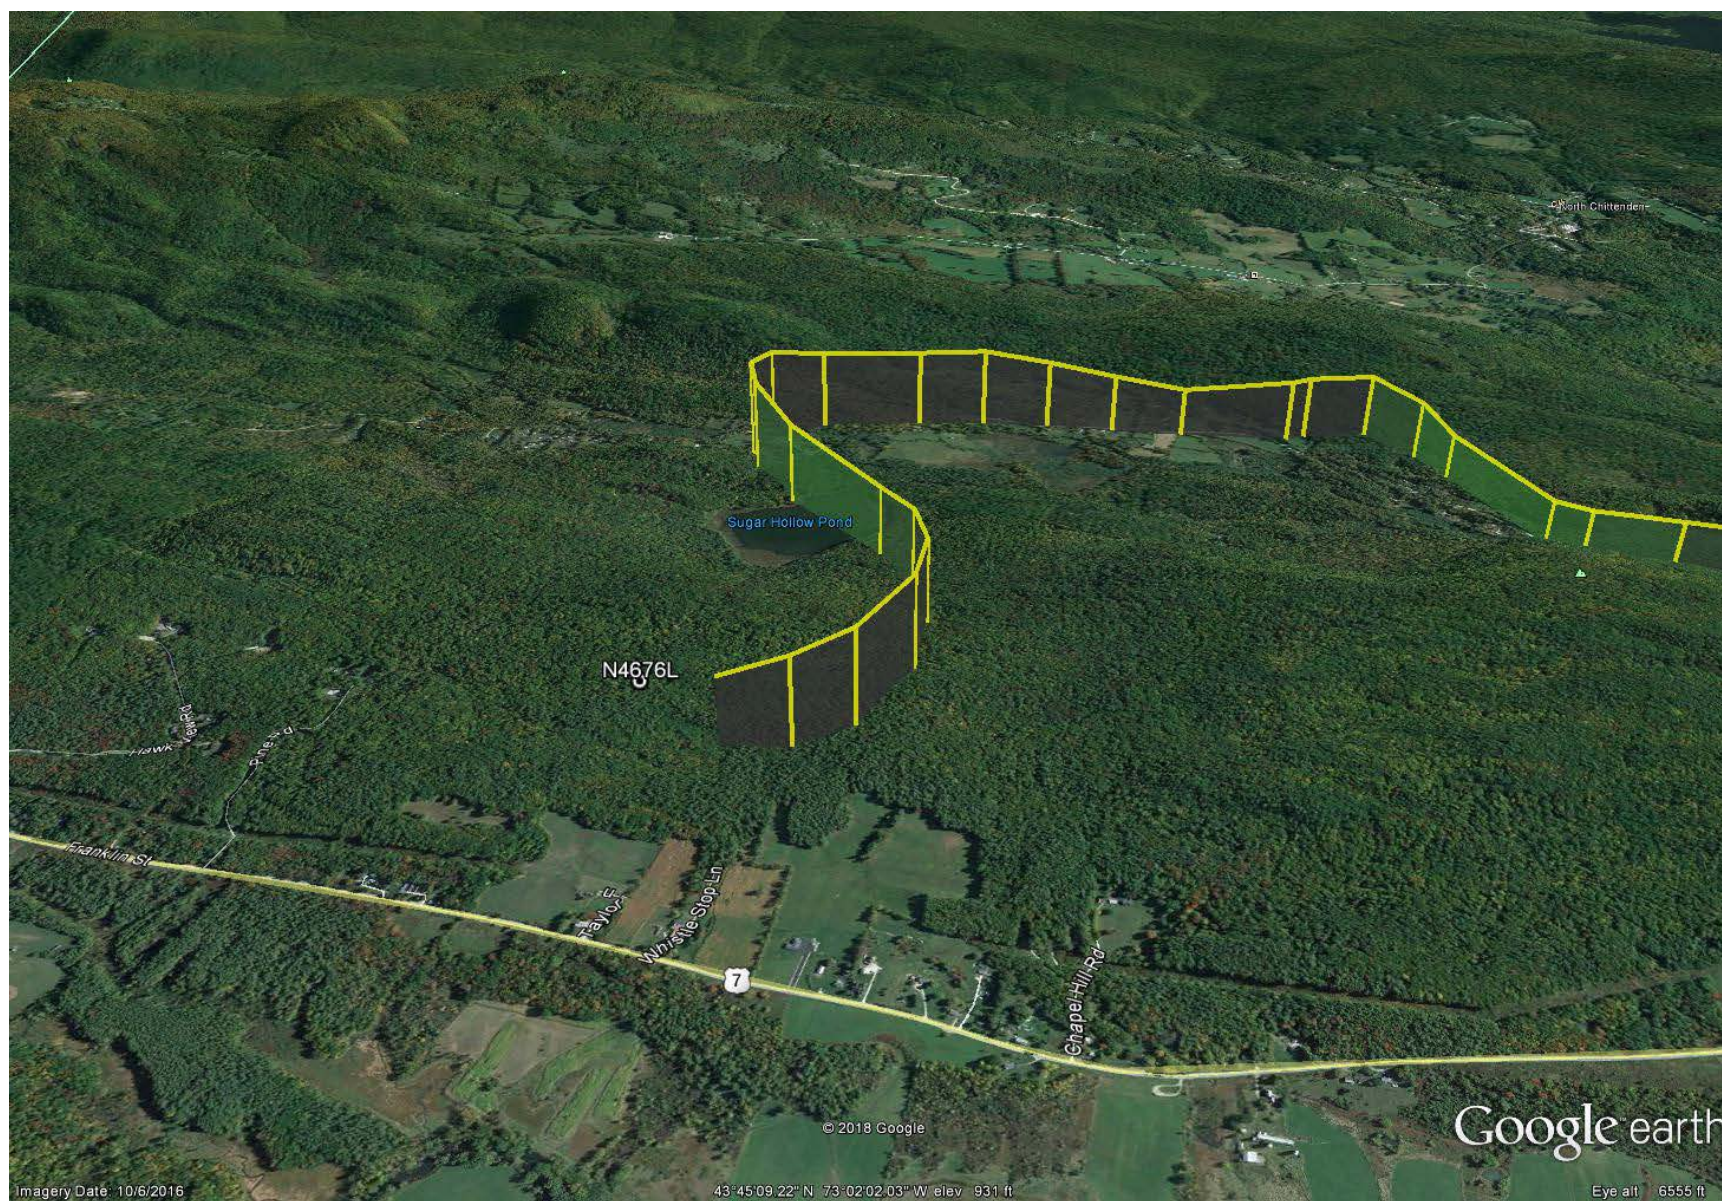
Figure 5 - Final portion of GPS data showing the descending right hand turn before the end of the recorded data.
