**NATIONAL TRANSPORTATION SAFETY BOARD**

NTSB Investigation Number  
**CEN18FATBD**

**Figure 1 - N679EA Flight Track Information**

**Figure 3 - N679EA // Flight Track - Final Portion**

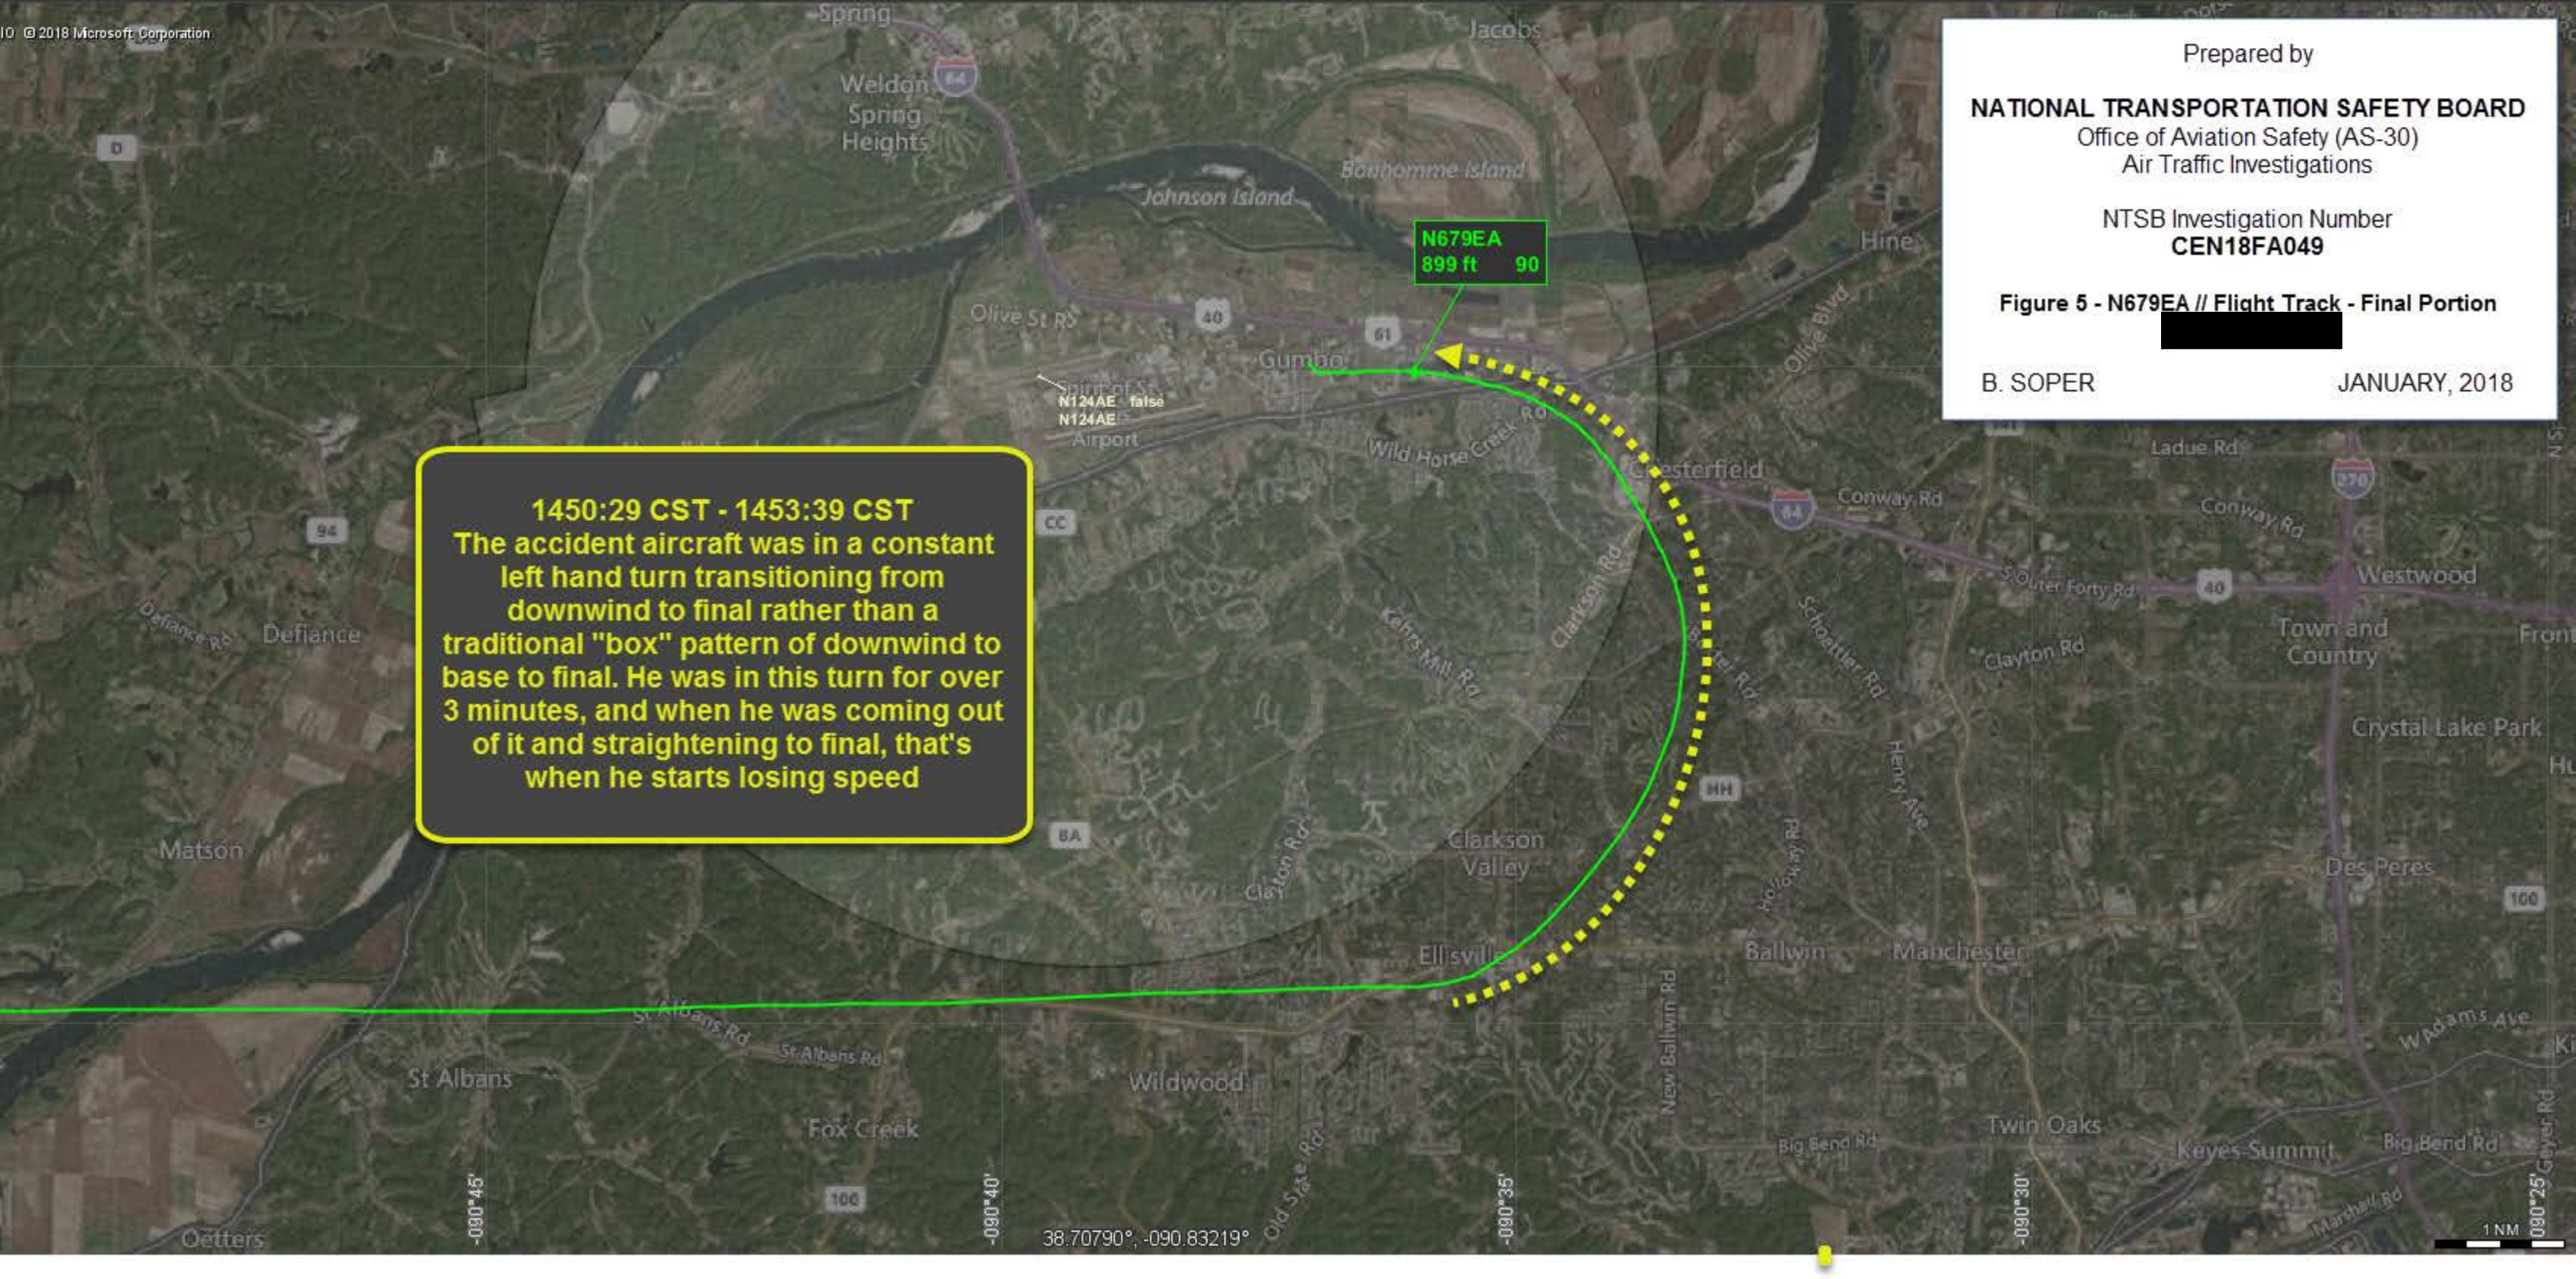
**Figure 5 - N679EA // Flight Track - Final Portion**

**1450:29 CST - 1453:39 CST**  
**The accident aircraft was in a constant left hand turn transitioning from downwind to final rather than a traditional "box" pattern of downwind to base to final. He was in this turn for over 3 minutes, and when he was coming out of it and straightening to final, that's when he starts losing speed**
