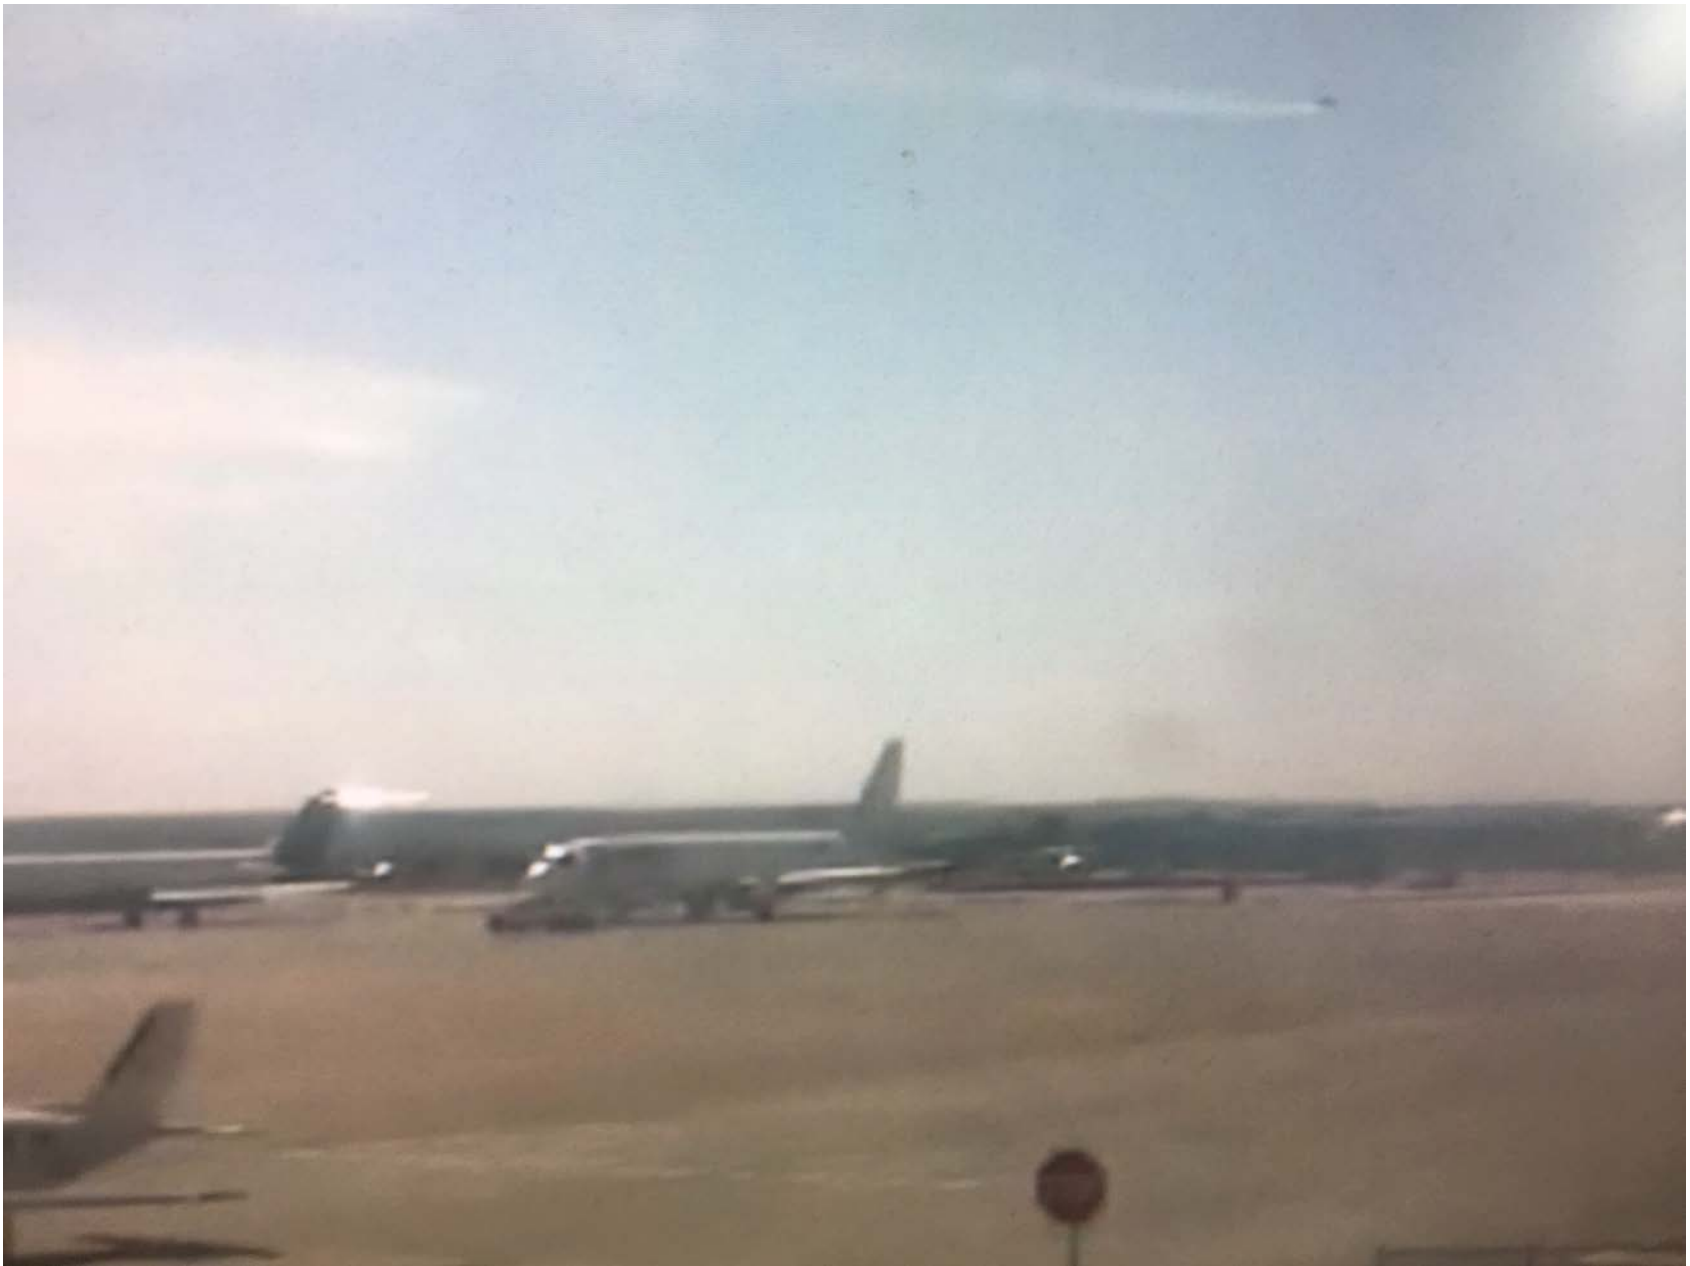
**Photo 1 – Accident airplane airborne, a white trail (smoke) Photo taken from security video: courtesy of LPD**

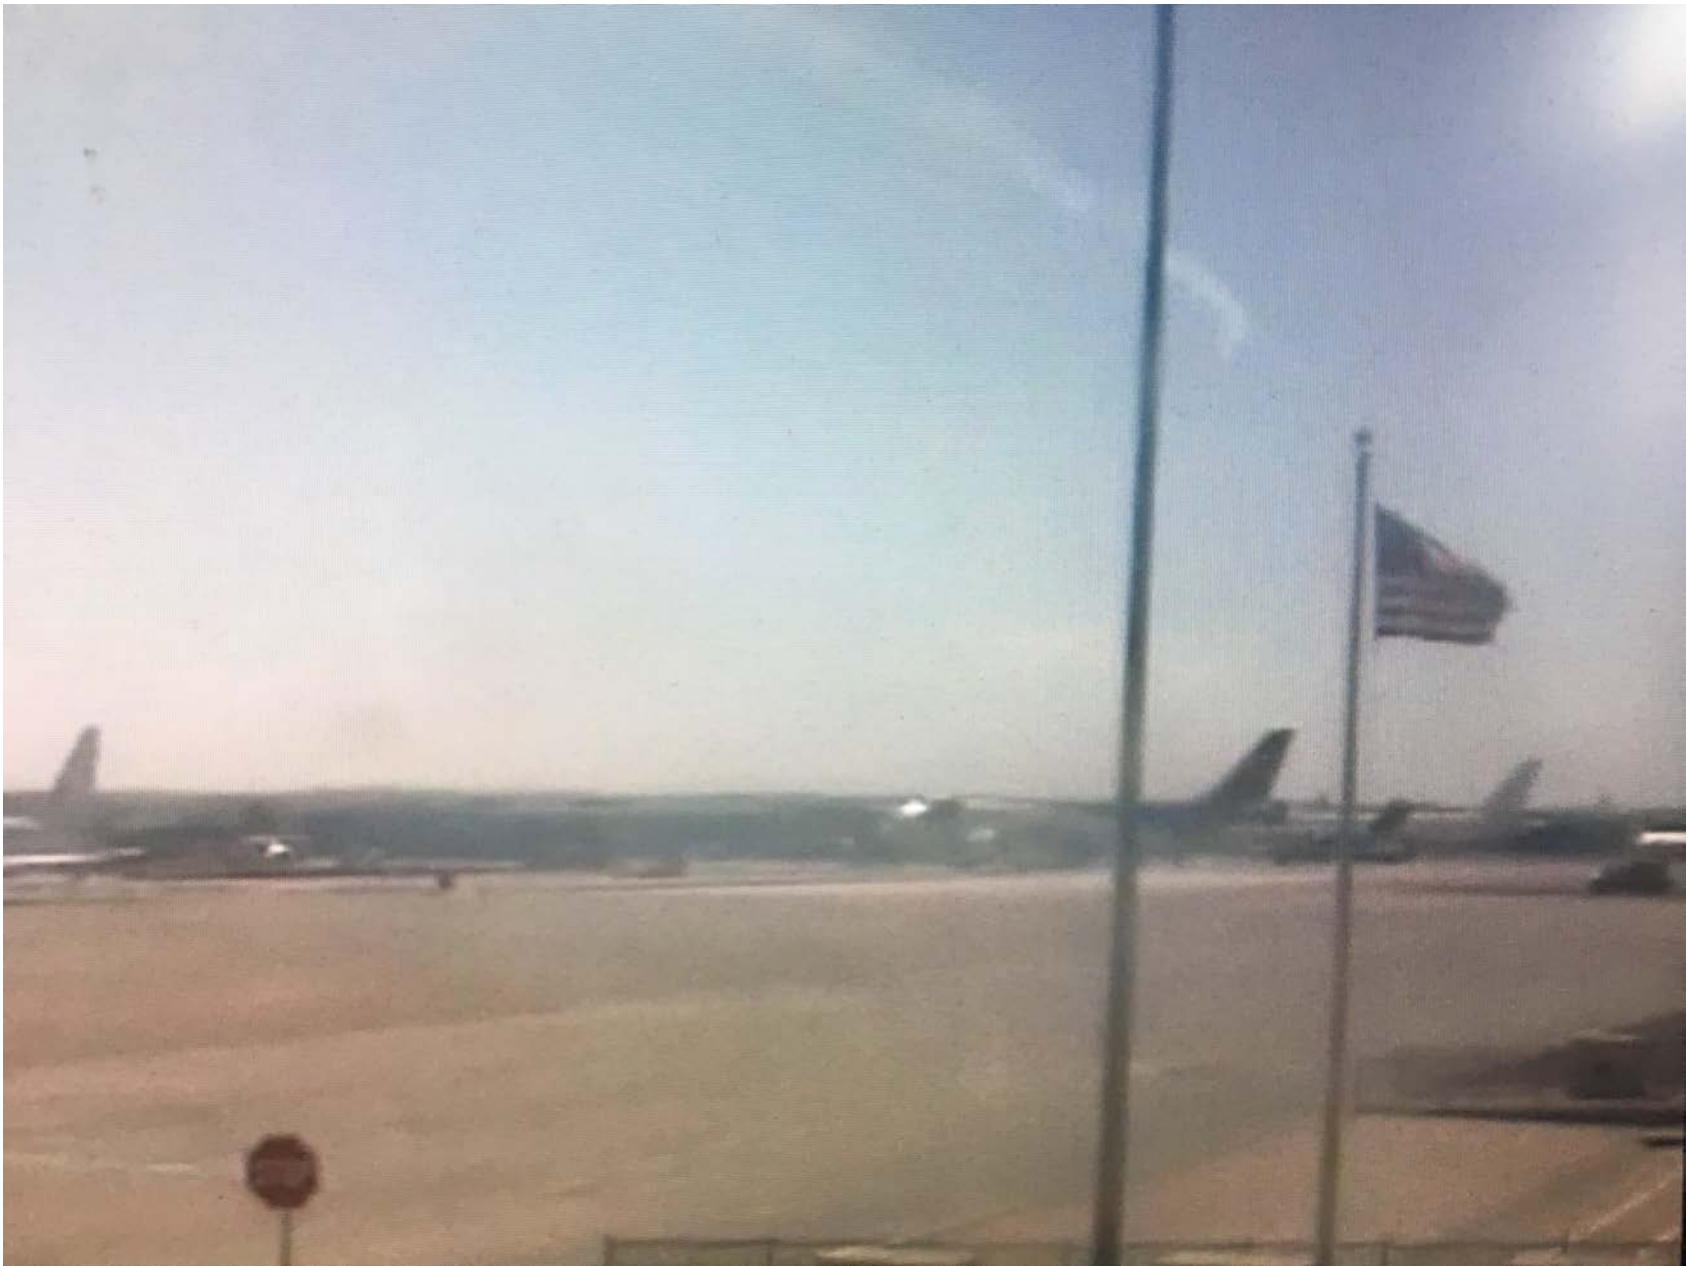
**Photo 2 - The white trail appeared to stop as the airplane turns. Photo from security video: courtesy of LPD**

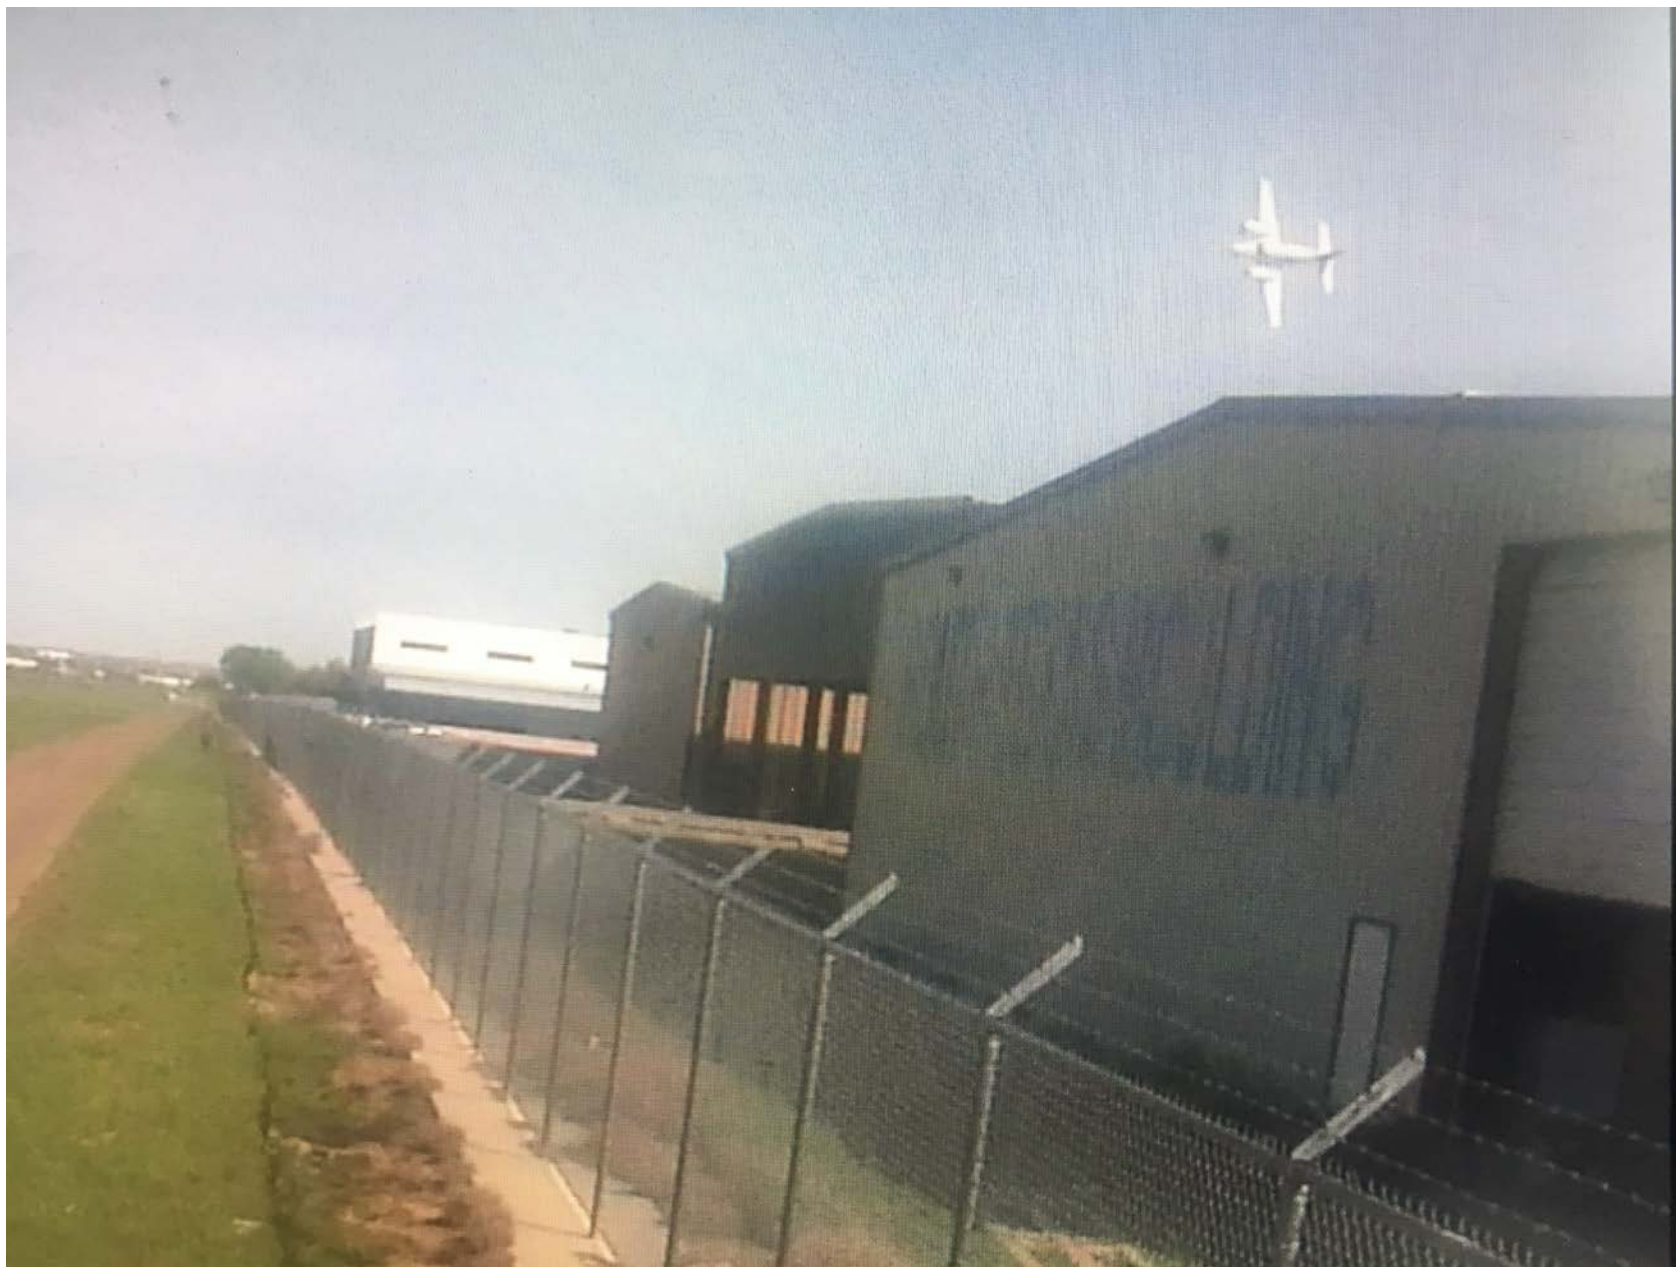
**Photo 3 – The airplane in a left steep bank. Photo taken from security video: courtesy of LPD**

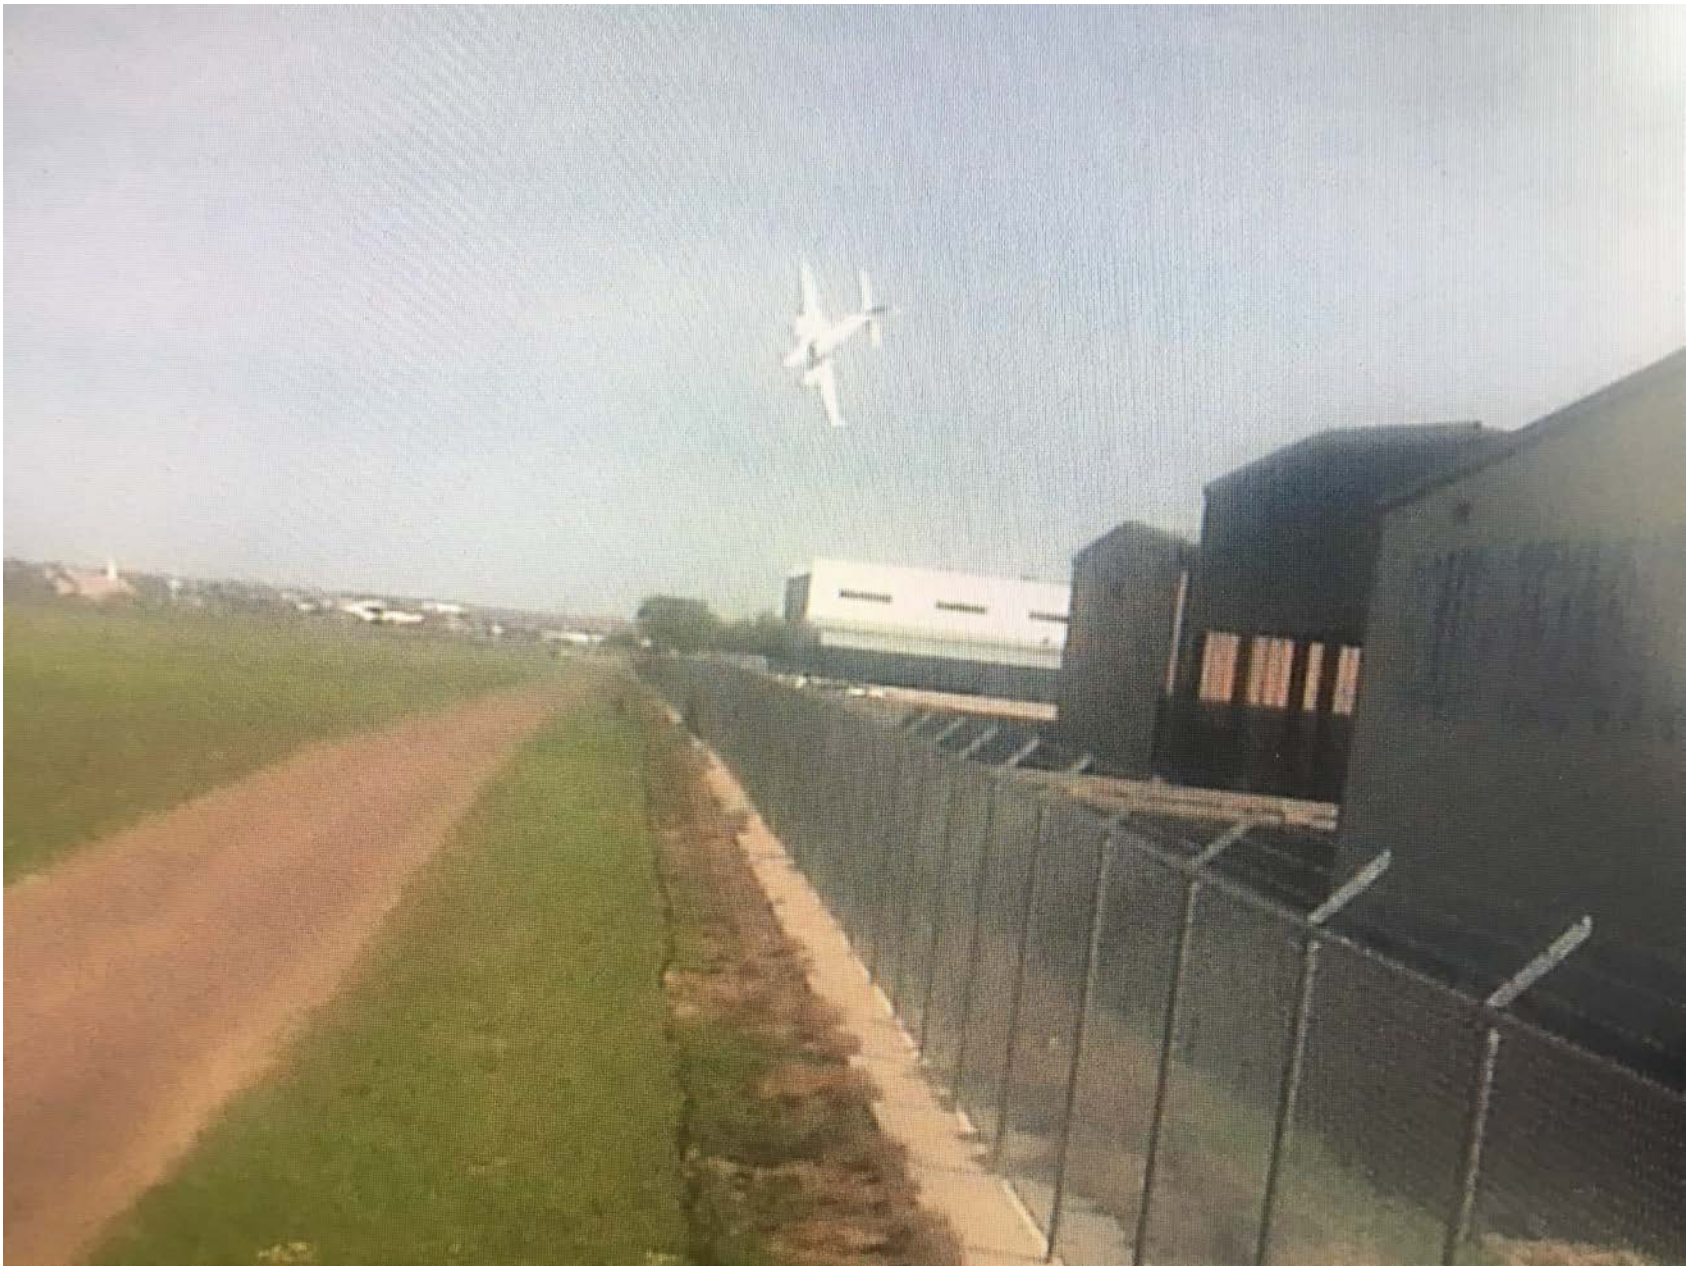
**Photo 4 - The airplane in a steep bank, just above the ground. Photo taken from security video: courtesy of LPD**

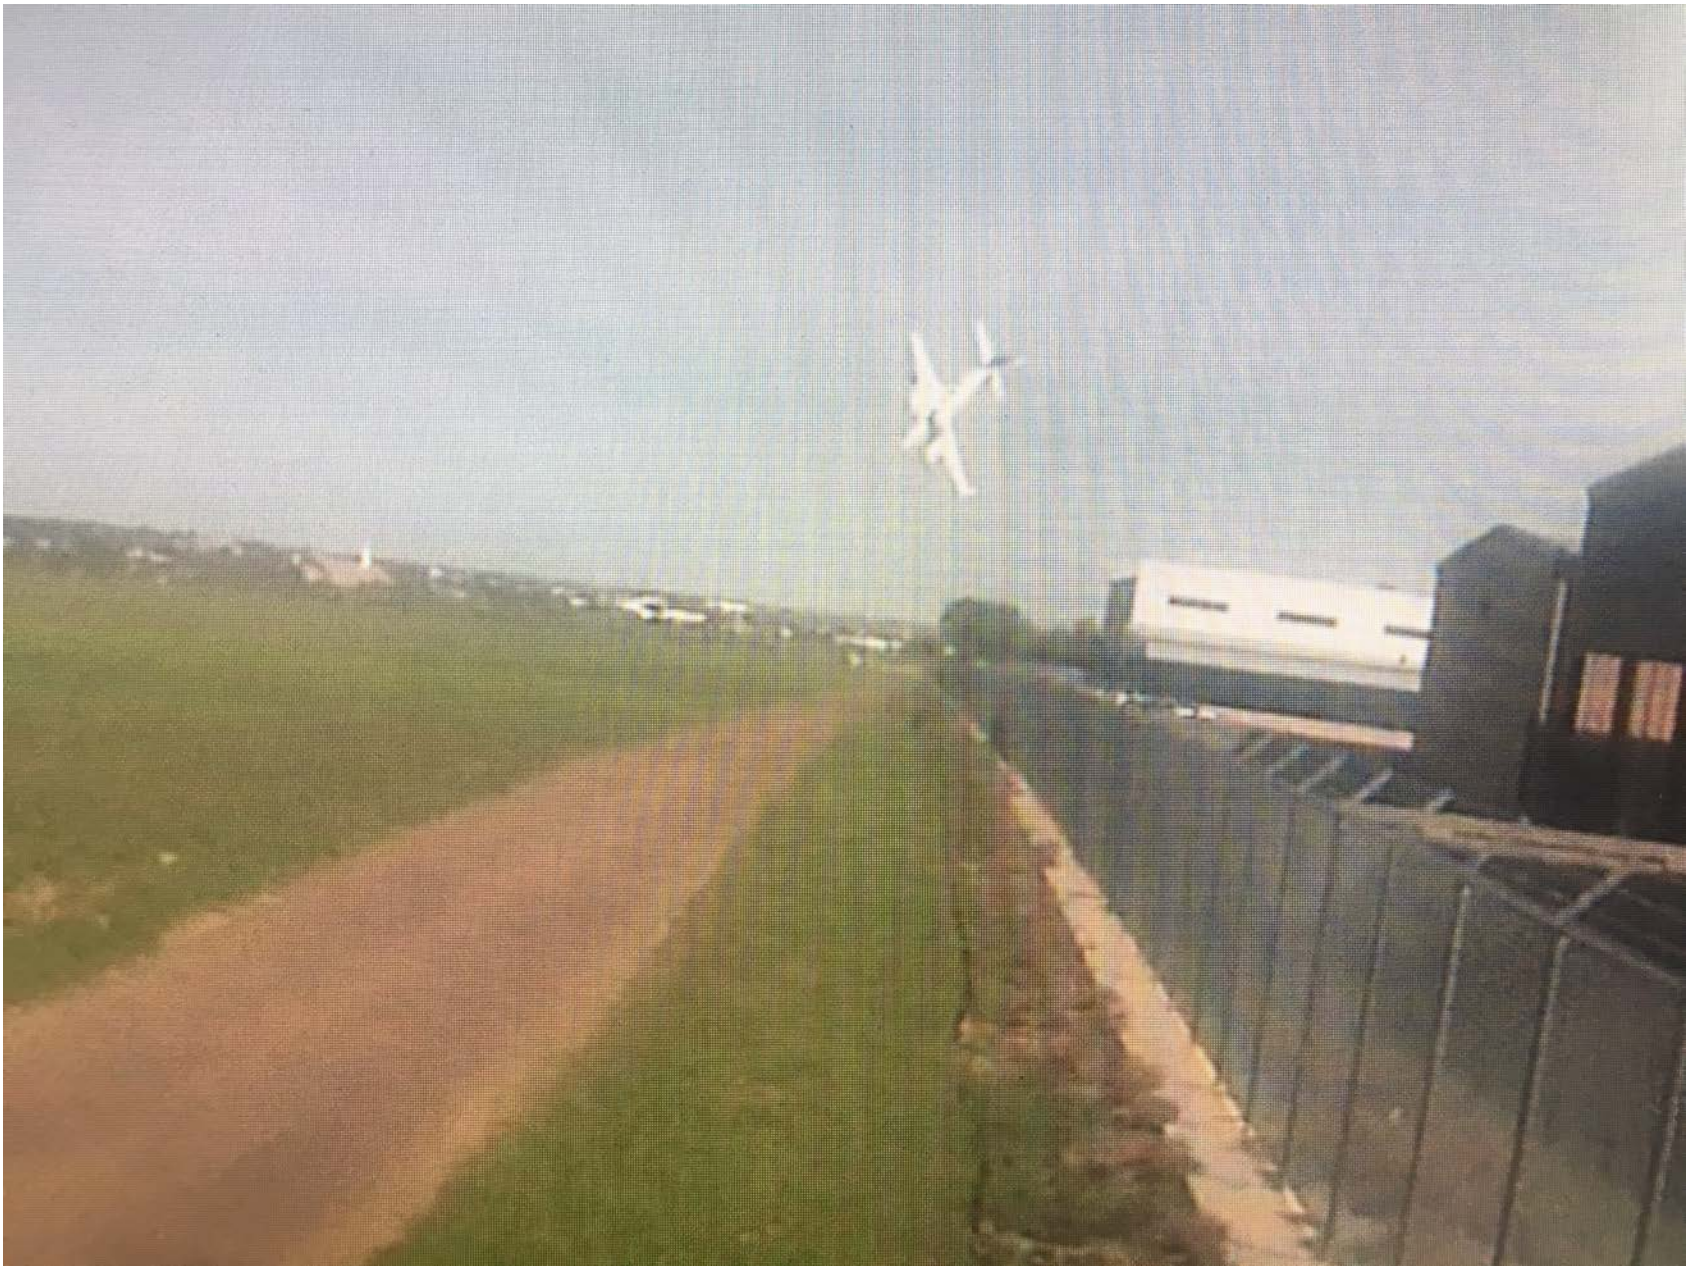
**Photo 5 – Accident airplane just before impact with terrain. Photo from security video: courtesy of LPD**

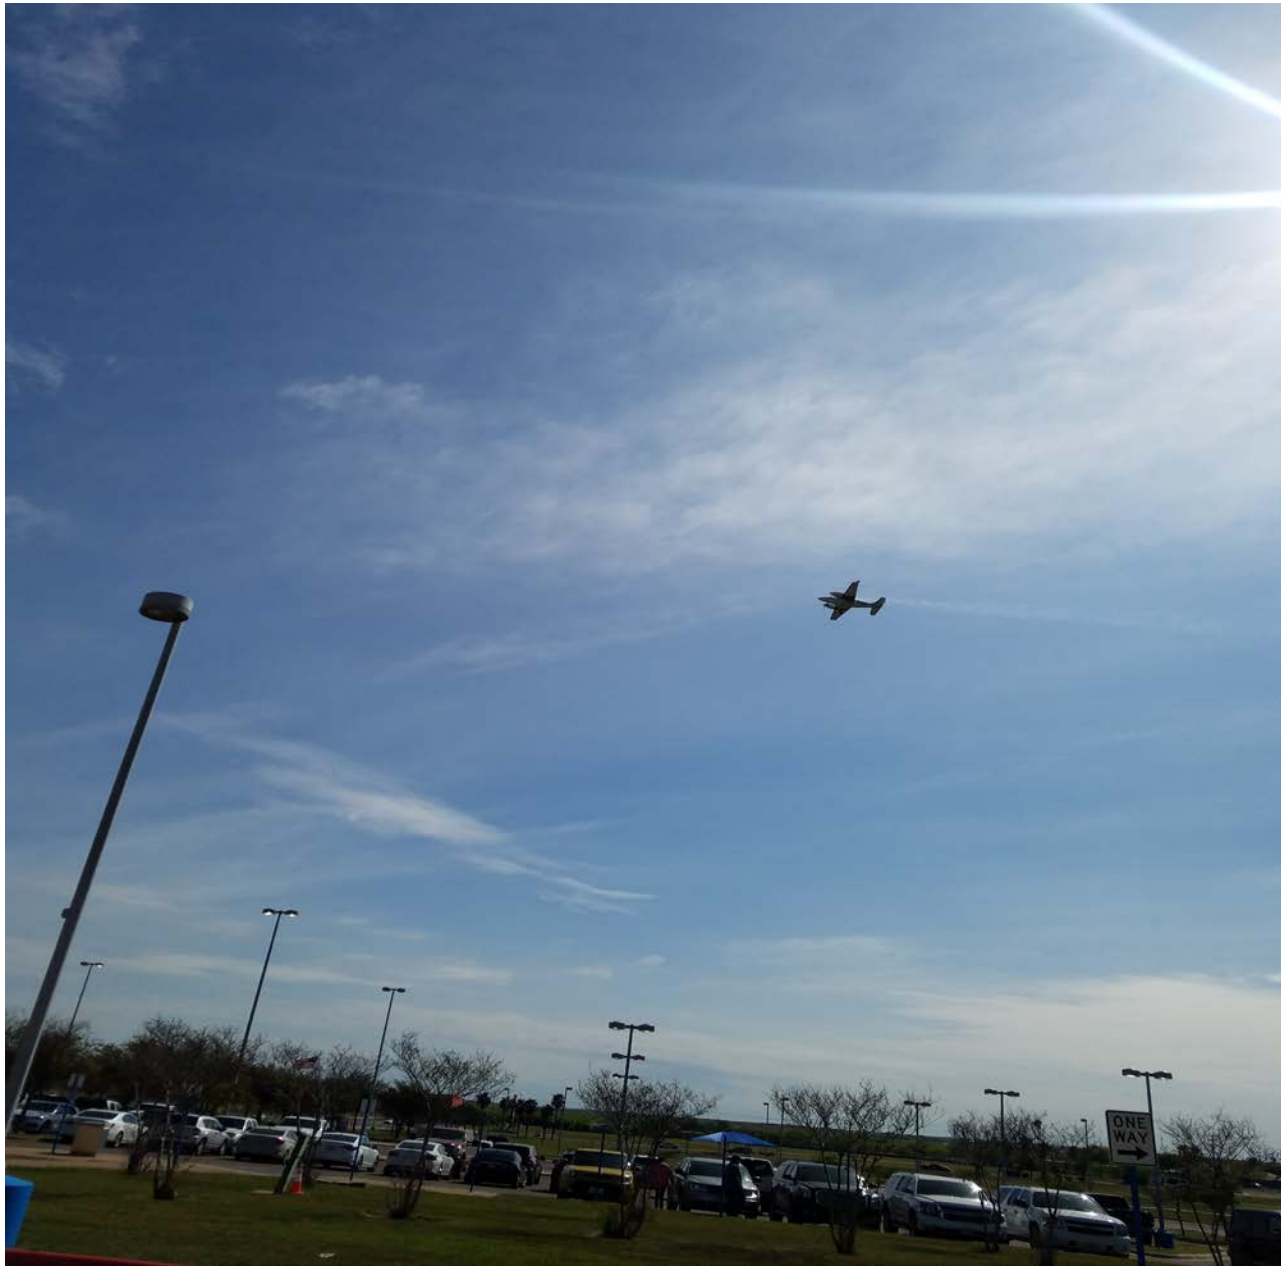
**Photo 6 - White trail of smoke behind accident airplane.      Witness photo, courtesy of FAA**

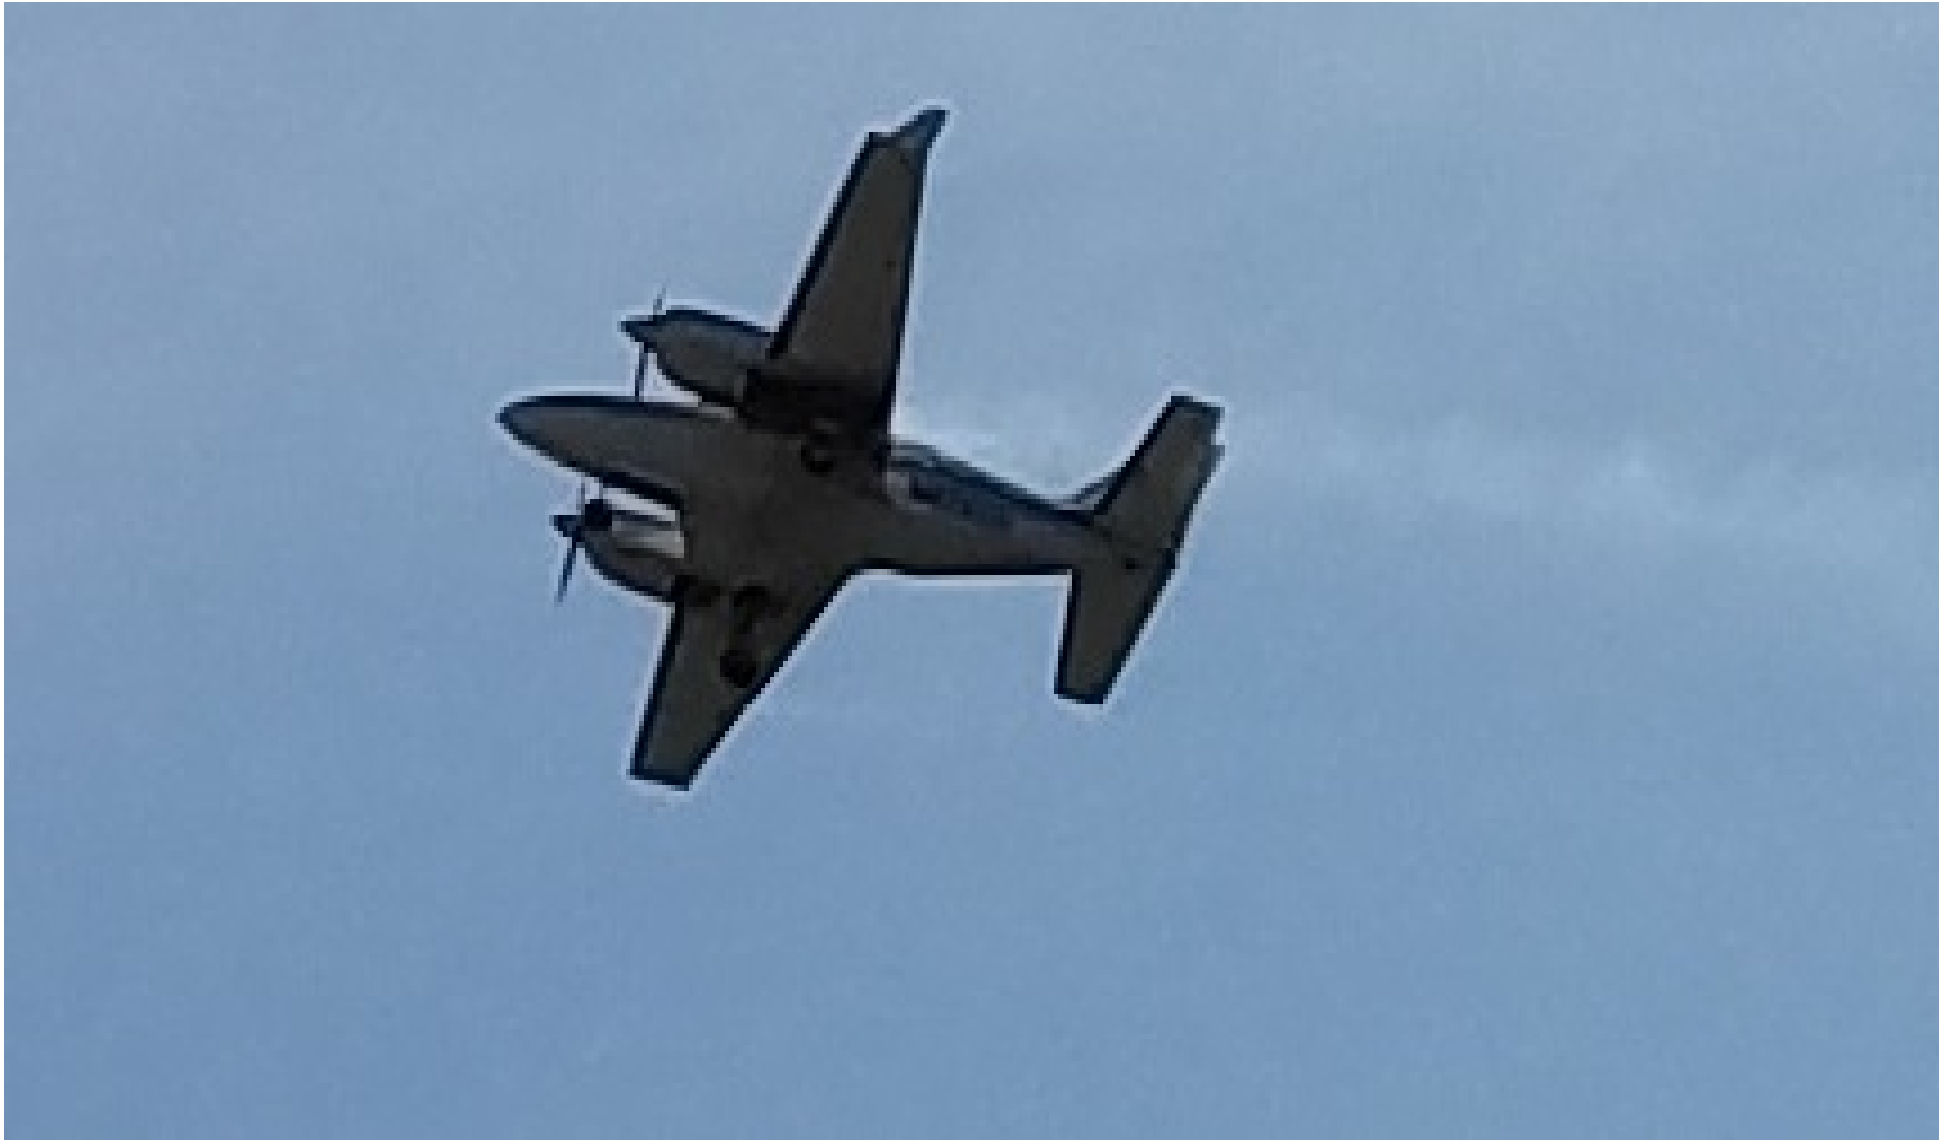
**Photo 7 – Close-up view of the airplane; area under the left engine is dark. The landing gear is down.  
Witness photo, courtesy of FAA**
