**NATIONAL TRANSPORTATION SAFETY BOARD**  
Vehicle Recorder Division  
Washington, D.C. 20594

## **Electronic Devices**

### **Specialist's Factual Report By Deven Chen**

Location: Moriarty, New Mexico  
Date: July 10, 2018  
Aircraft: Schempp-Hirth Flugzenbau GMBH Ventus 3F motorized glider  
Registration: N753R  
Operator: Private  
NTSB Number: CEN18FA262

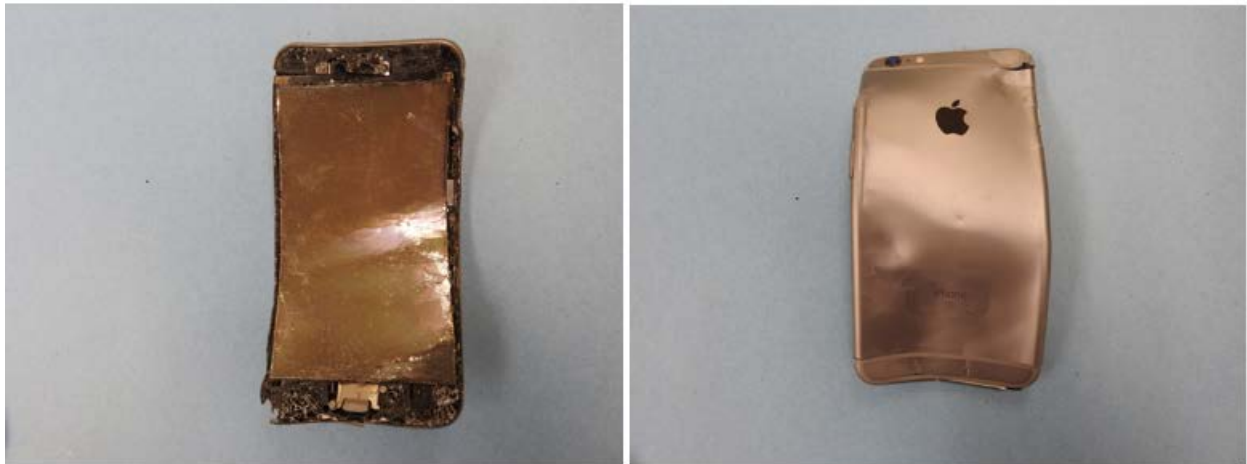
**Figure 1. Front and back of Apple iPhone 6s Plus as received**

Upon arrival at the Vehicle Recorder Division, an exterior examination revealed the device had severe damage, as shown in Figure 1. The internal circuit board was removed, and the board was severely bent in the accident, as shown in Figure 2. The circuit board could not be powered on with a surrogate due to its damage. The extent of the damage precluded normal recovery procedures and additional attempts were unsuccessful in yielding data.

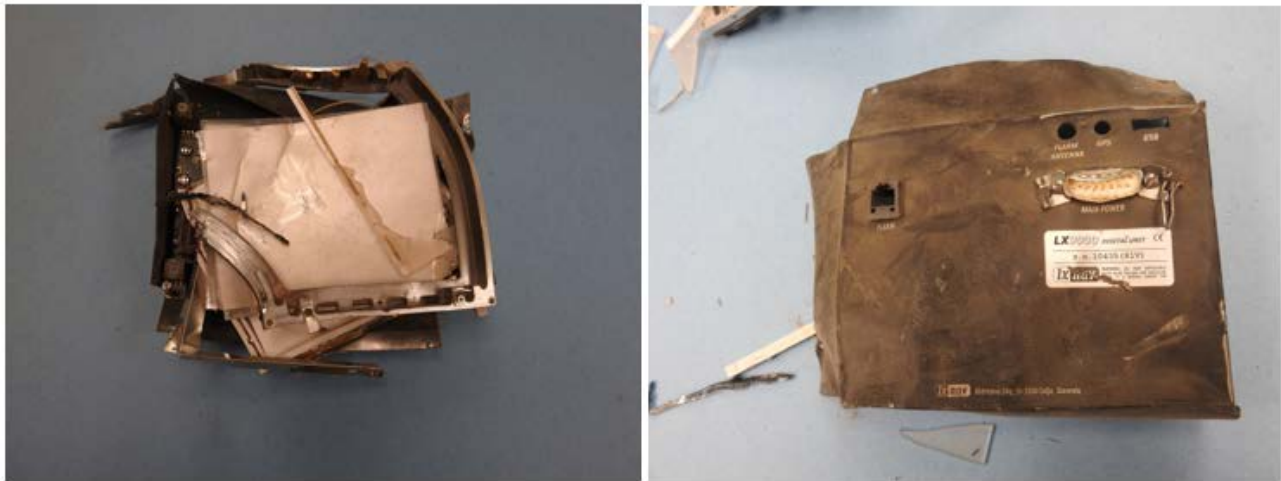
Figure 3. Front and back of LX 9000 Display as received

Upon arrival at the Vehicle Recorder Division, an exterior examination revealed severe damage to the unit, as shown in Figure 3. No internal SD memory card was received and no non-volatile memory<sup>1</sup> chip was found on the circuit board. The extent of the damage precluded normal recovery procedures and additional attempts were unsuccessful in yielding data.

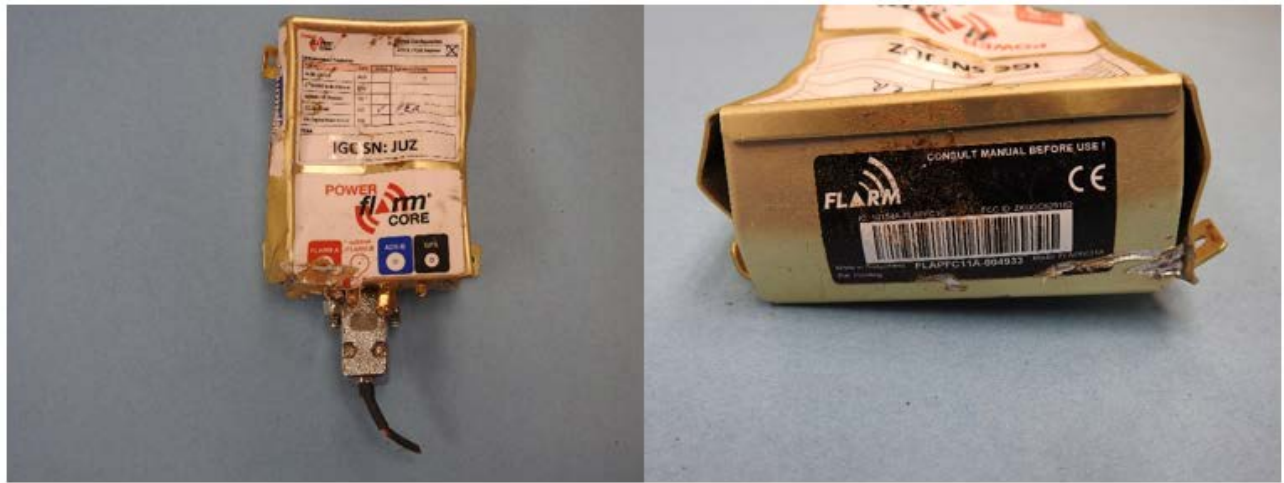
Figure 4. Front and Side of PowerFLARM Core as received

Upon arrival at the Vehicle Recorder Division, an exterior examination revealed damage to the unit, as shown in Figure 4. The non-volatile memory chip as shown in Figure 5, was removed and imaged using laboratory hardware and software. The data was decoded with technical assistance from the government of France's *Bureau d'Enquêtes et d'Analyses pour la sécurité de l'aviation civile* (Bureau of Enquiry and Analysis for Civil Aviation Safety, or BEA).
