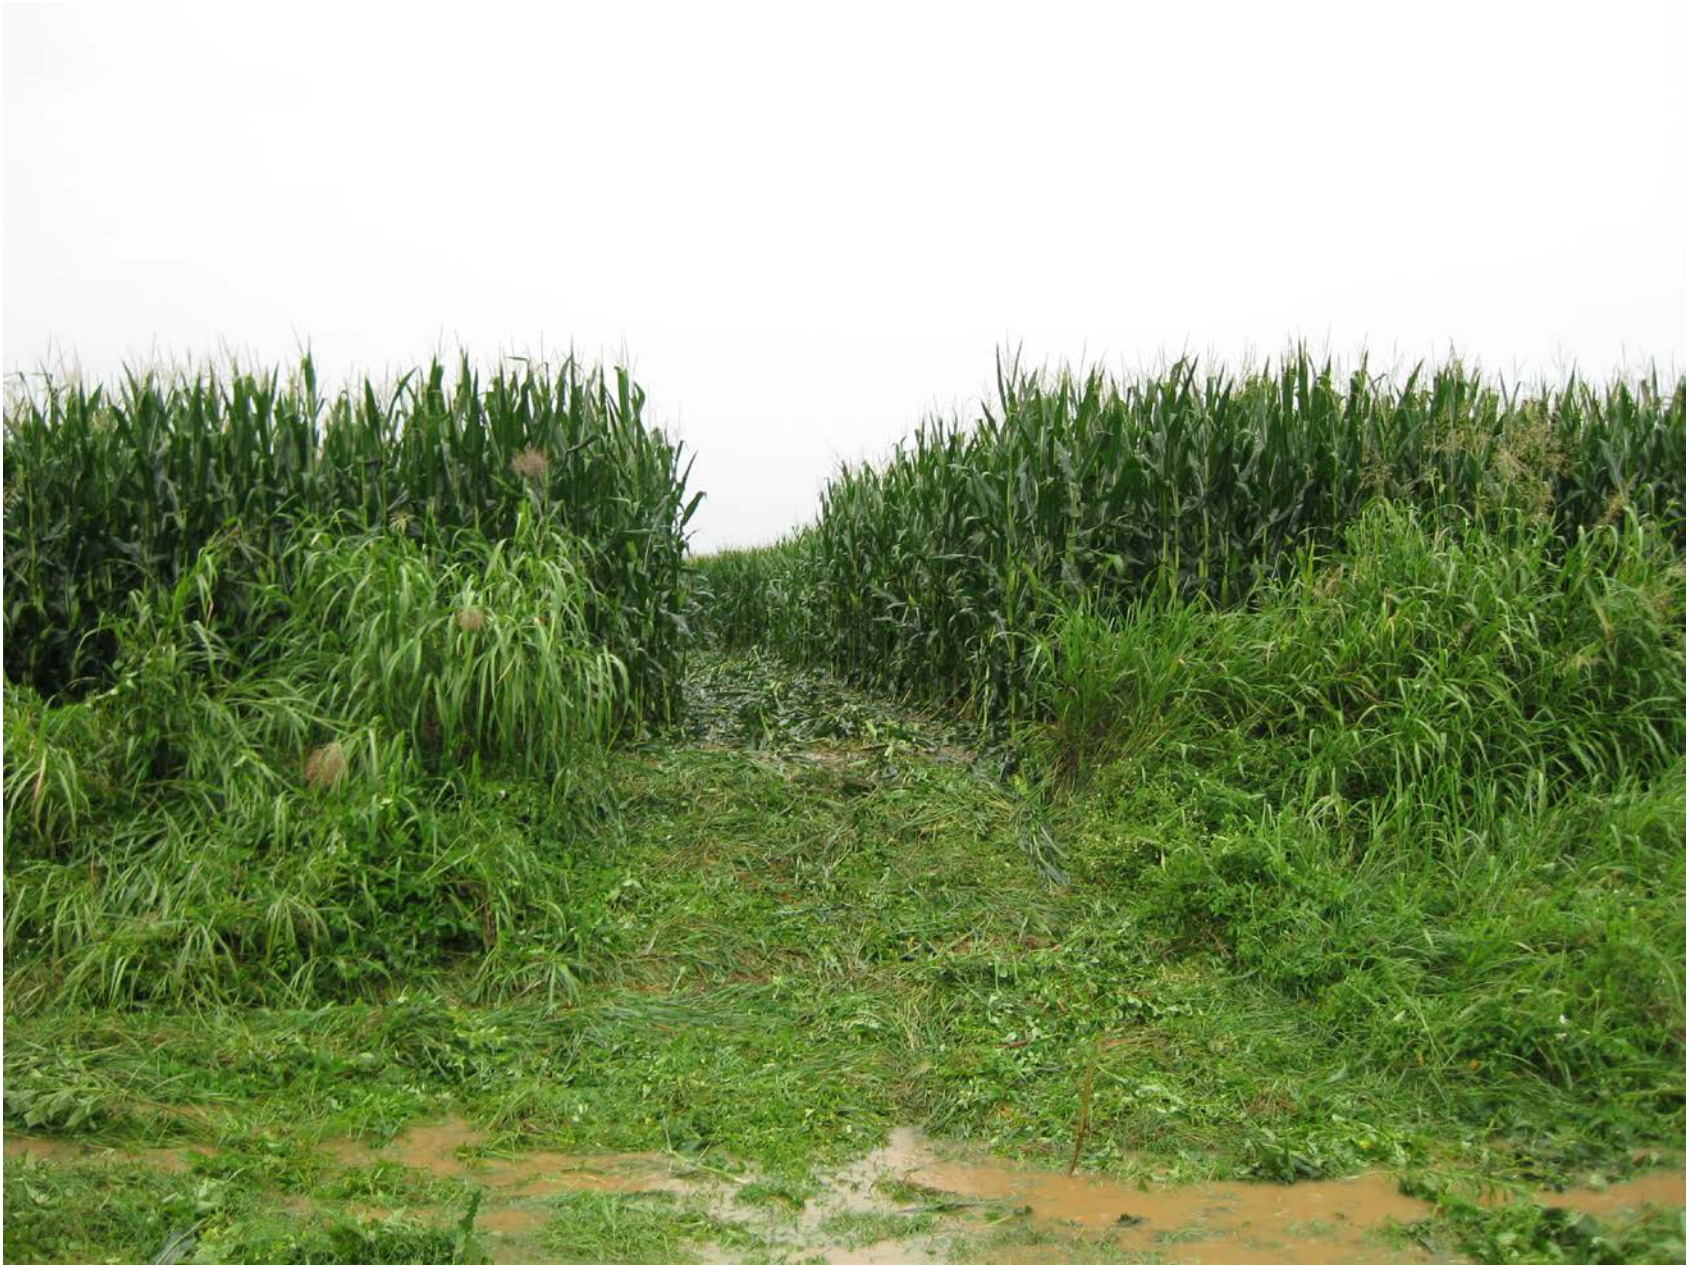
**Photo 1 – Entrance to the accident site in a located cornfield 40 feet south of Indiana Highway 156. Corn stalks were about 7 to 8 feet tall.**

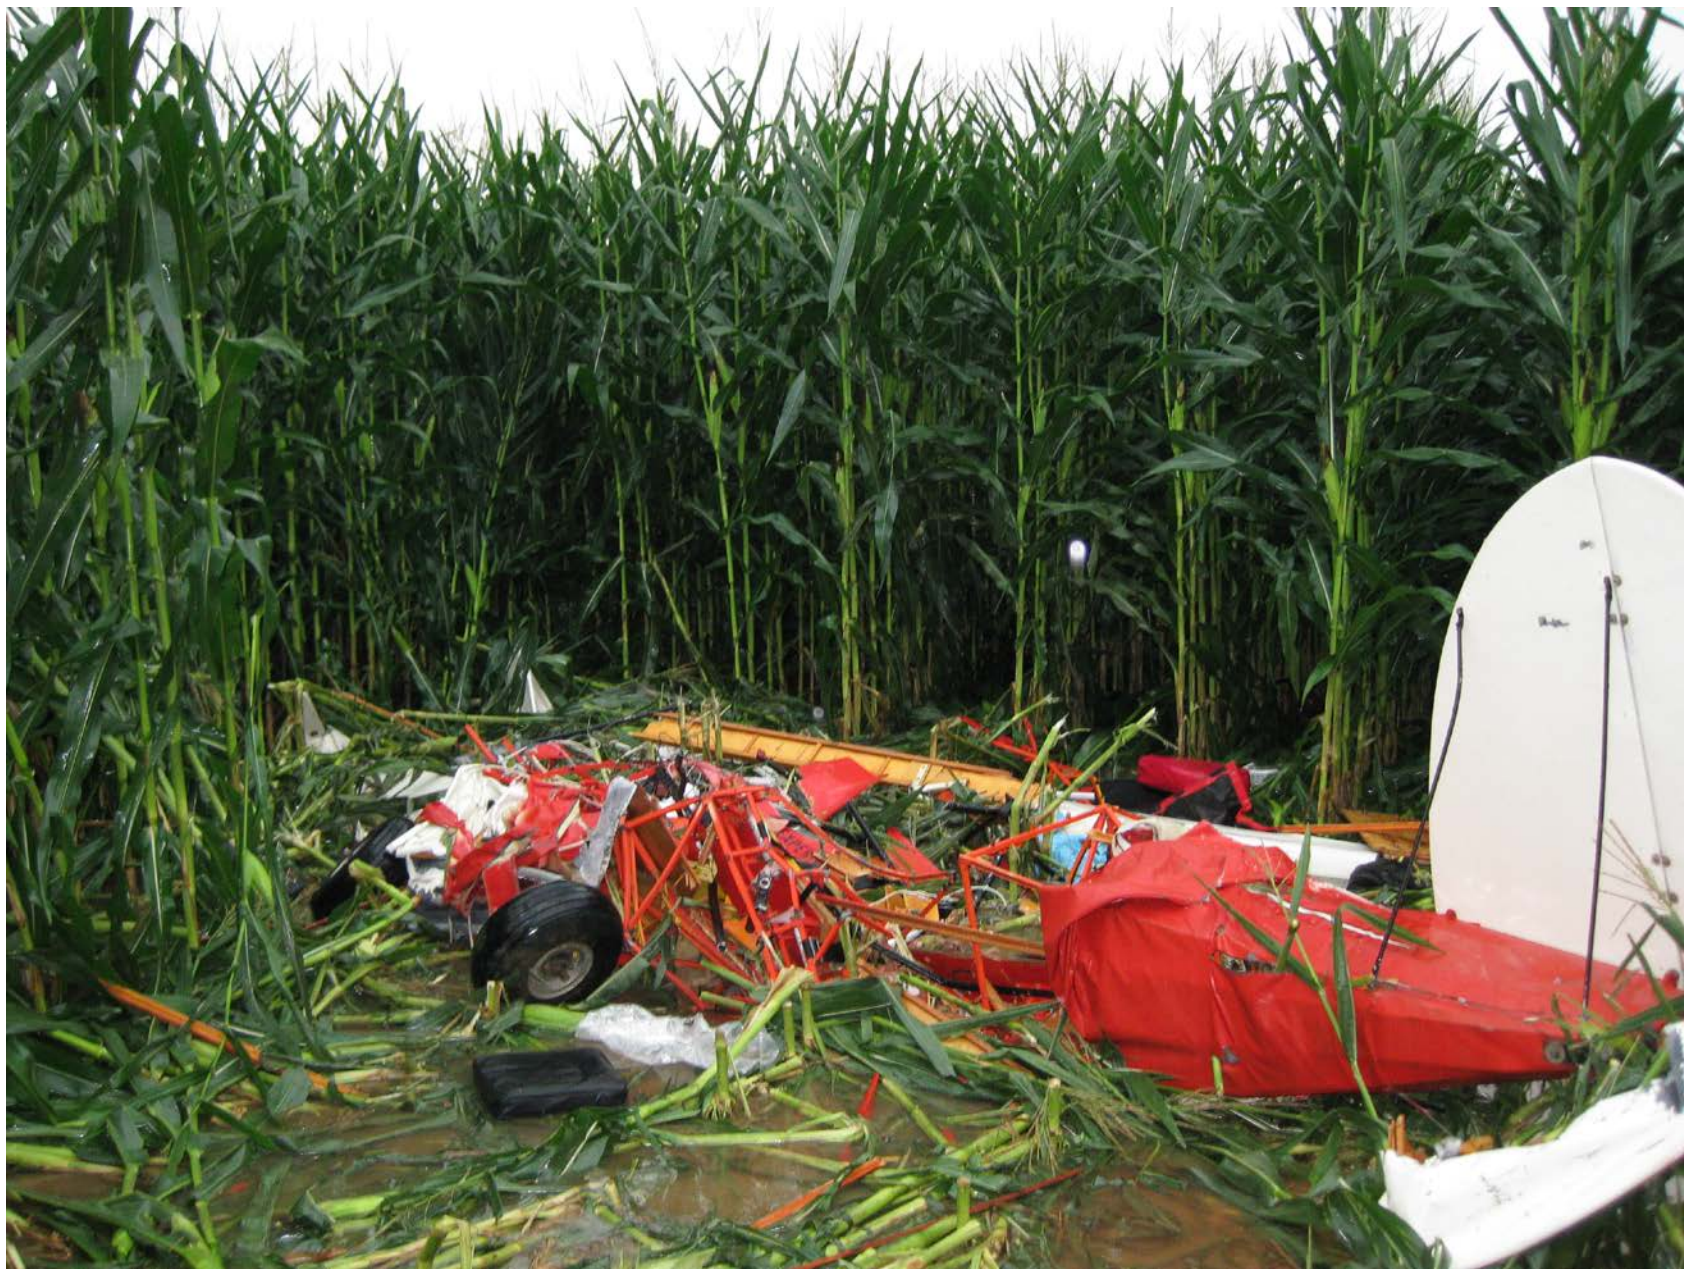
**Photo 2 – N228LC on its right side as found at the accident site.**

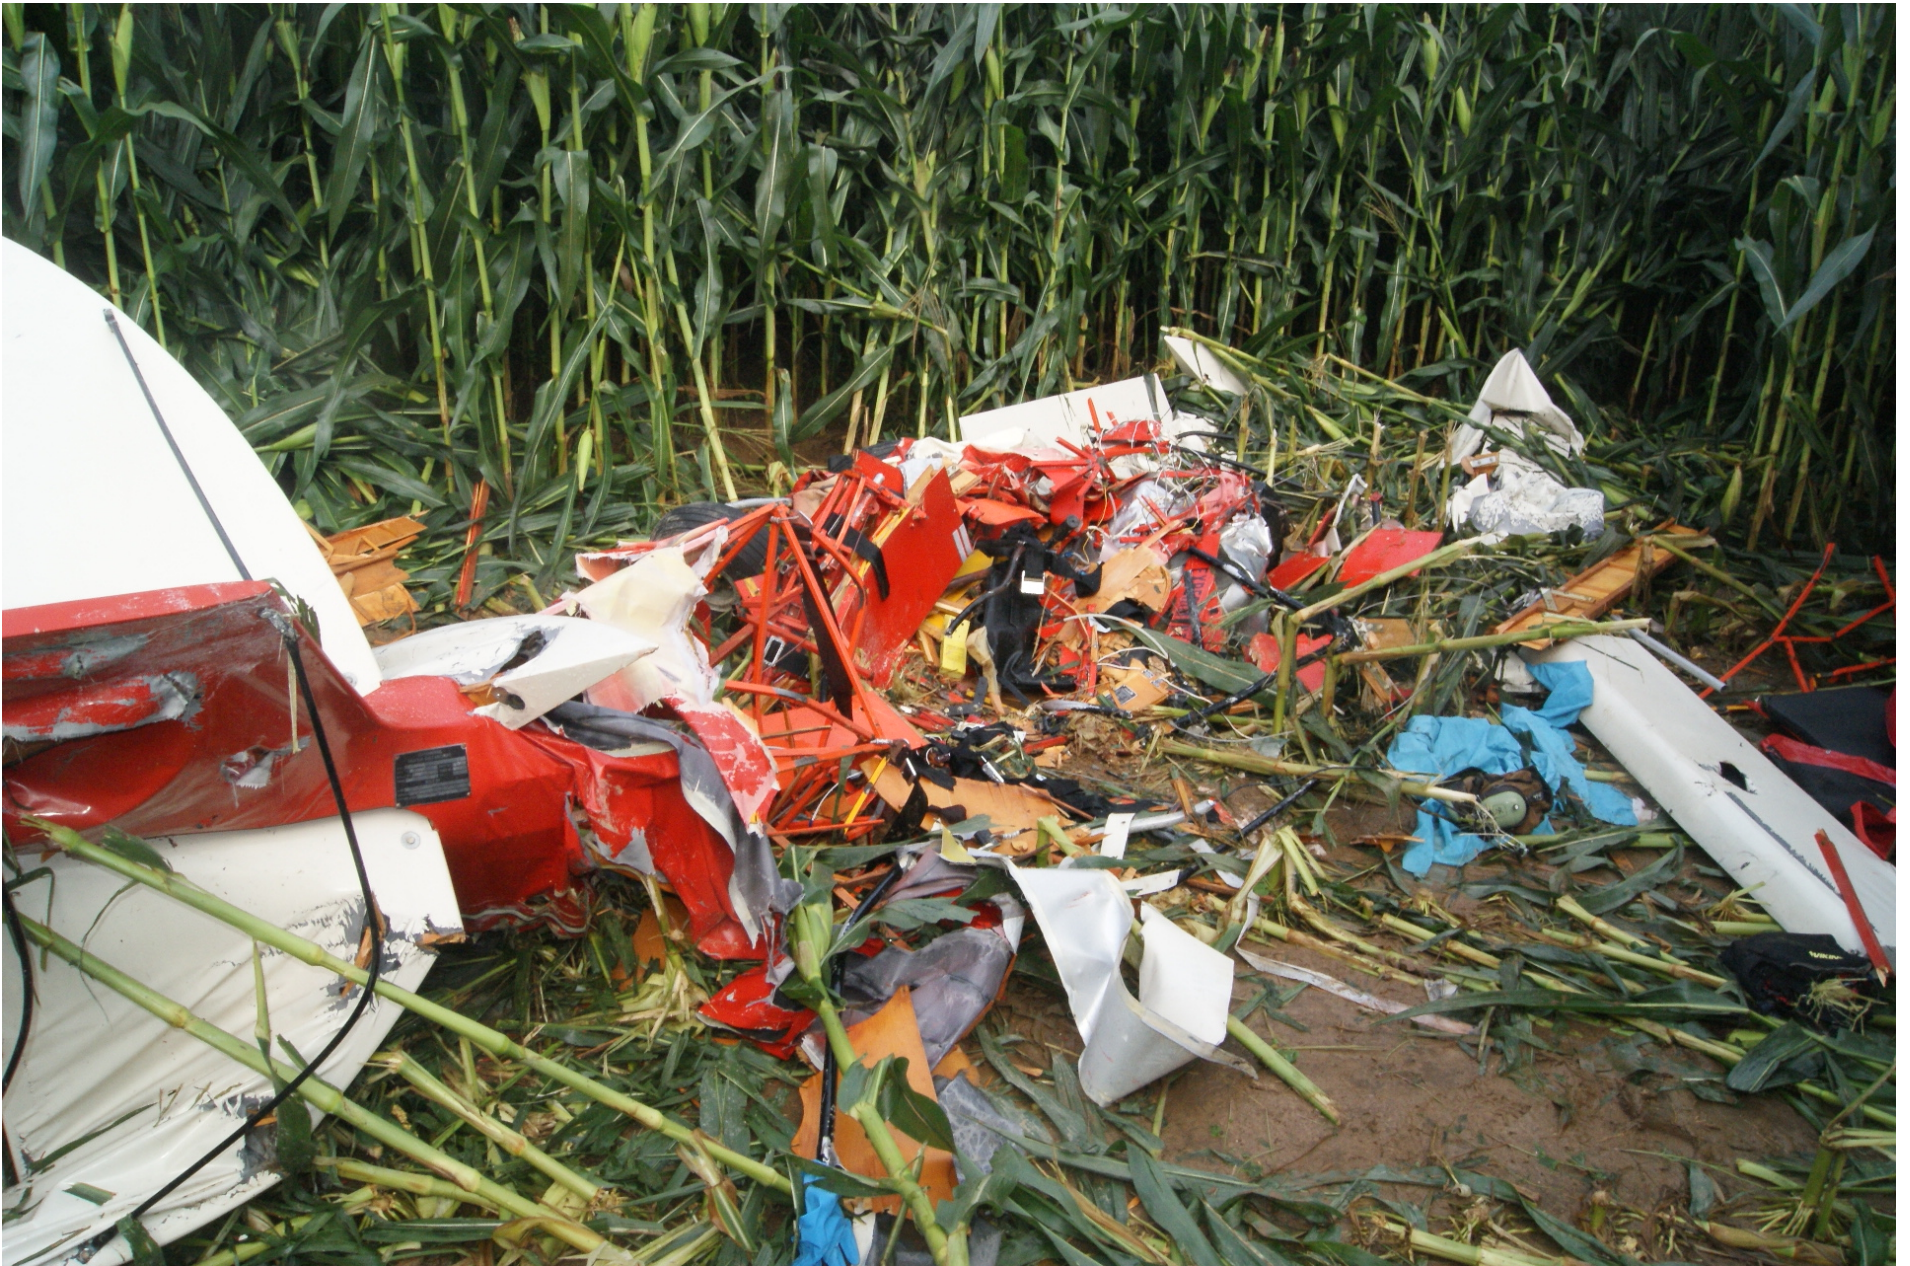
**Photo 3 – Another view of the Fisher Celebrity wreckage as seen from the right side.**

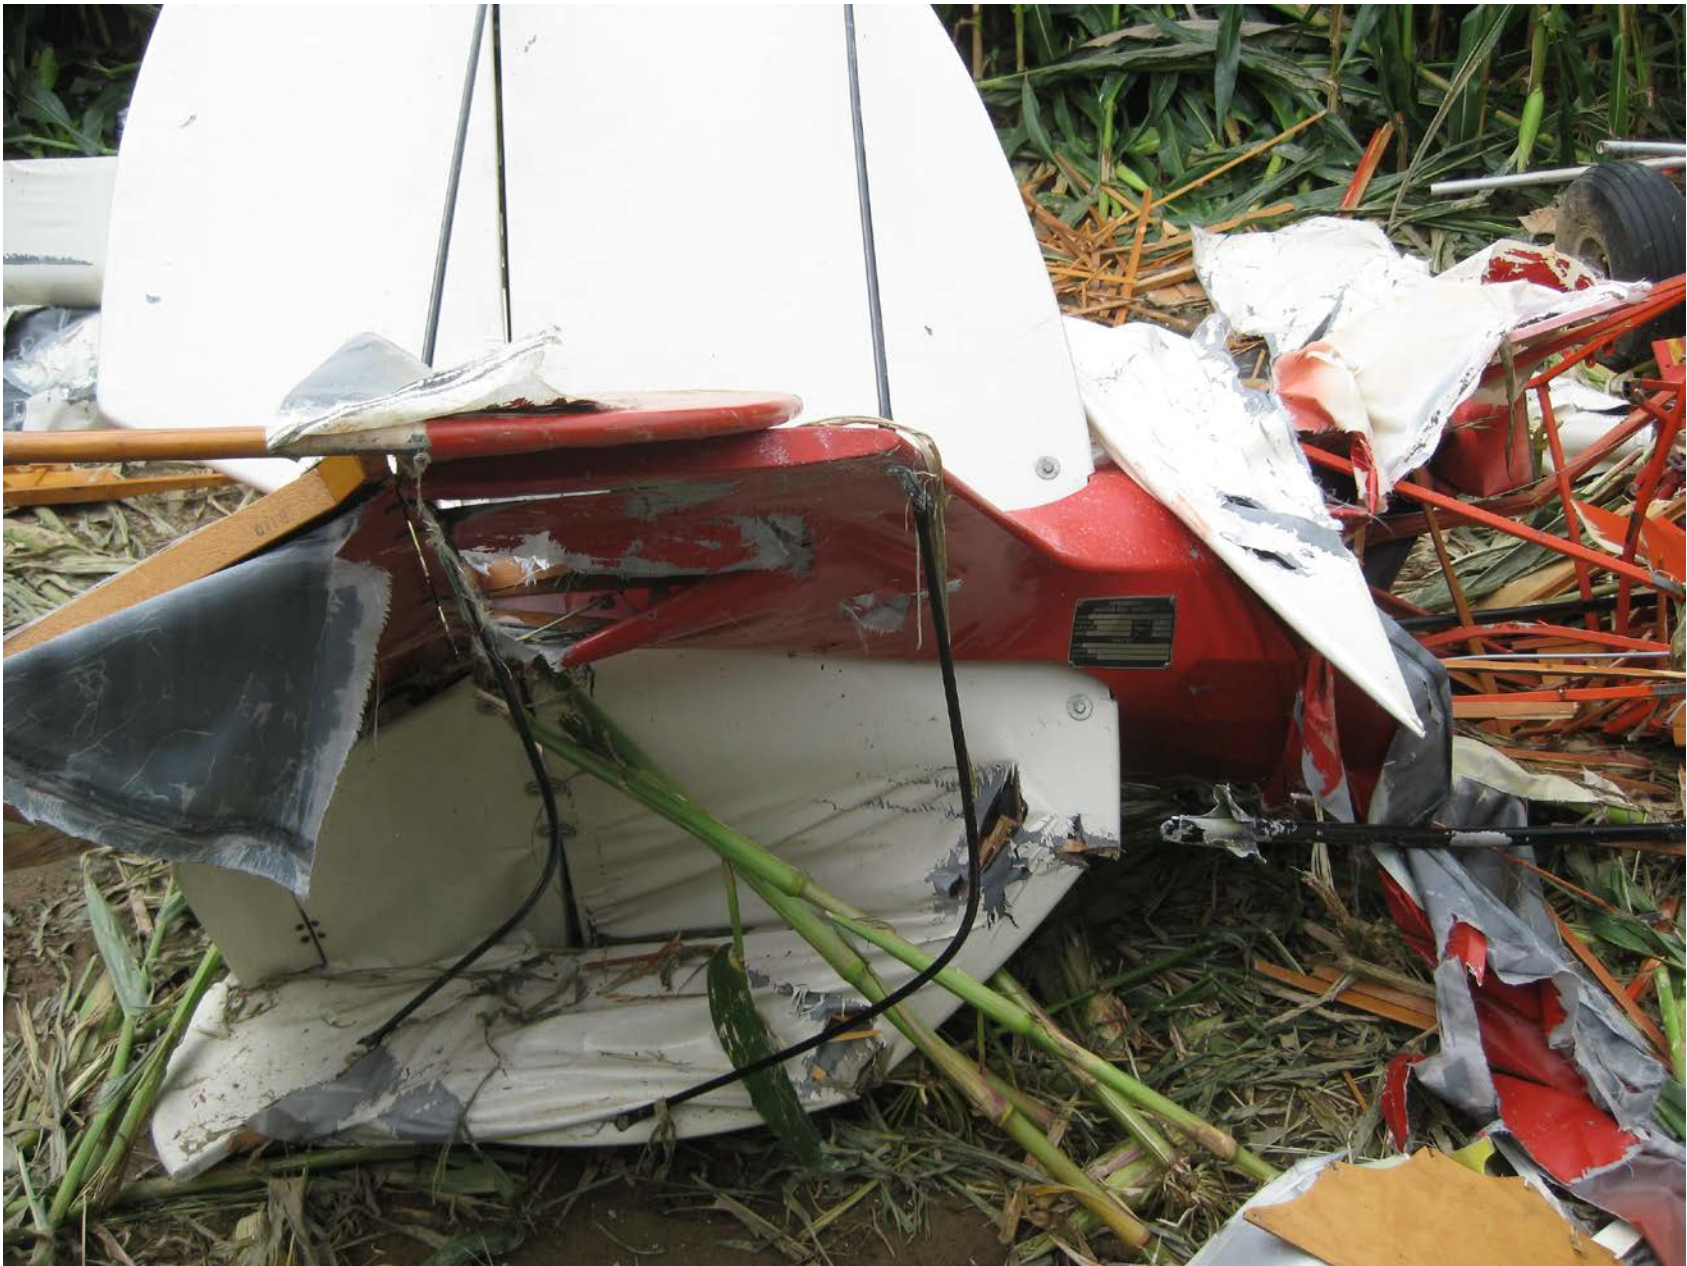
**Photo 4 – The empennage. The right horizontal stabilizer was crushed. The left horizontal stabilizer was undamaged.**

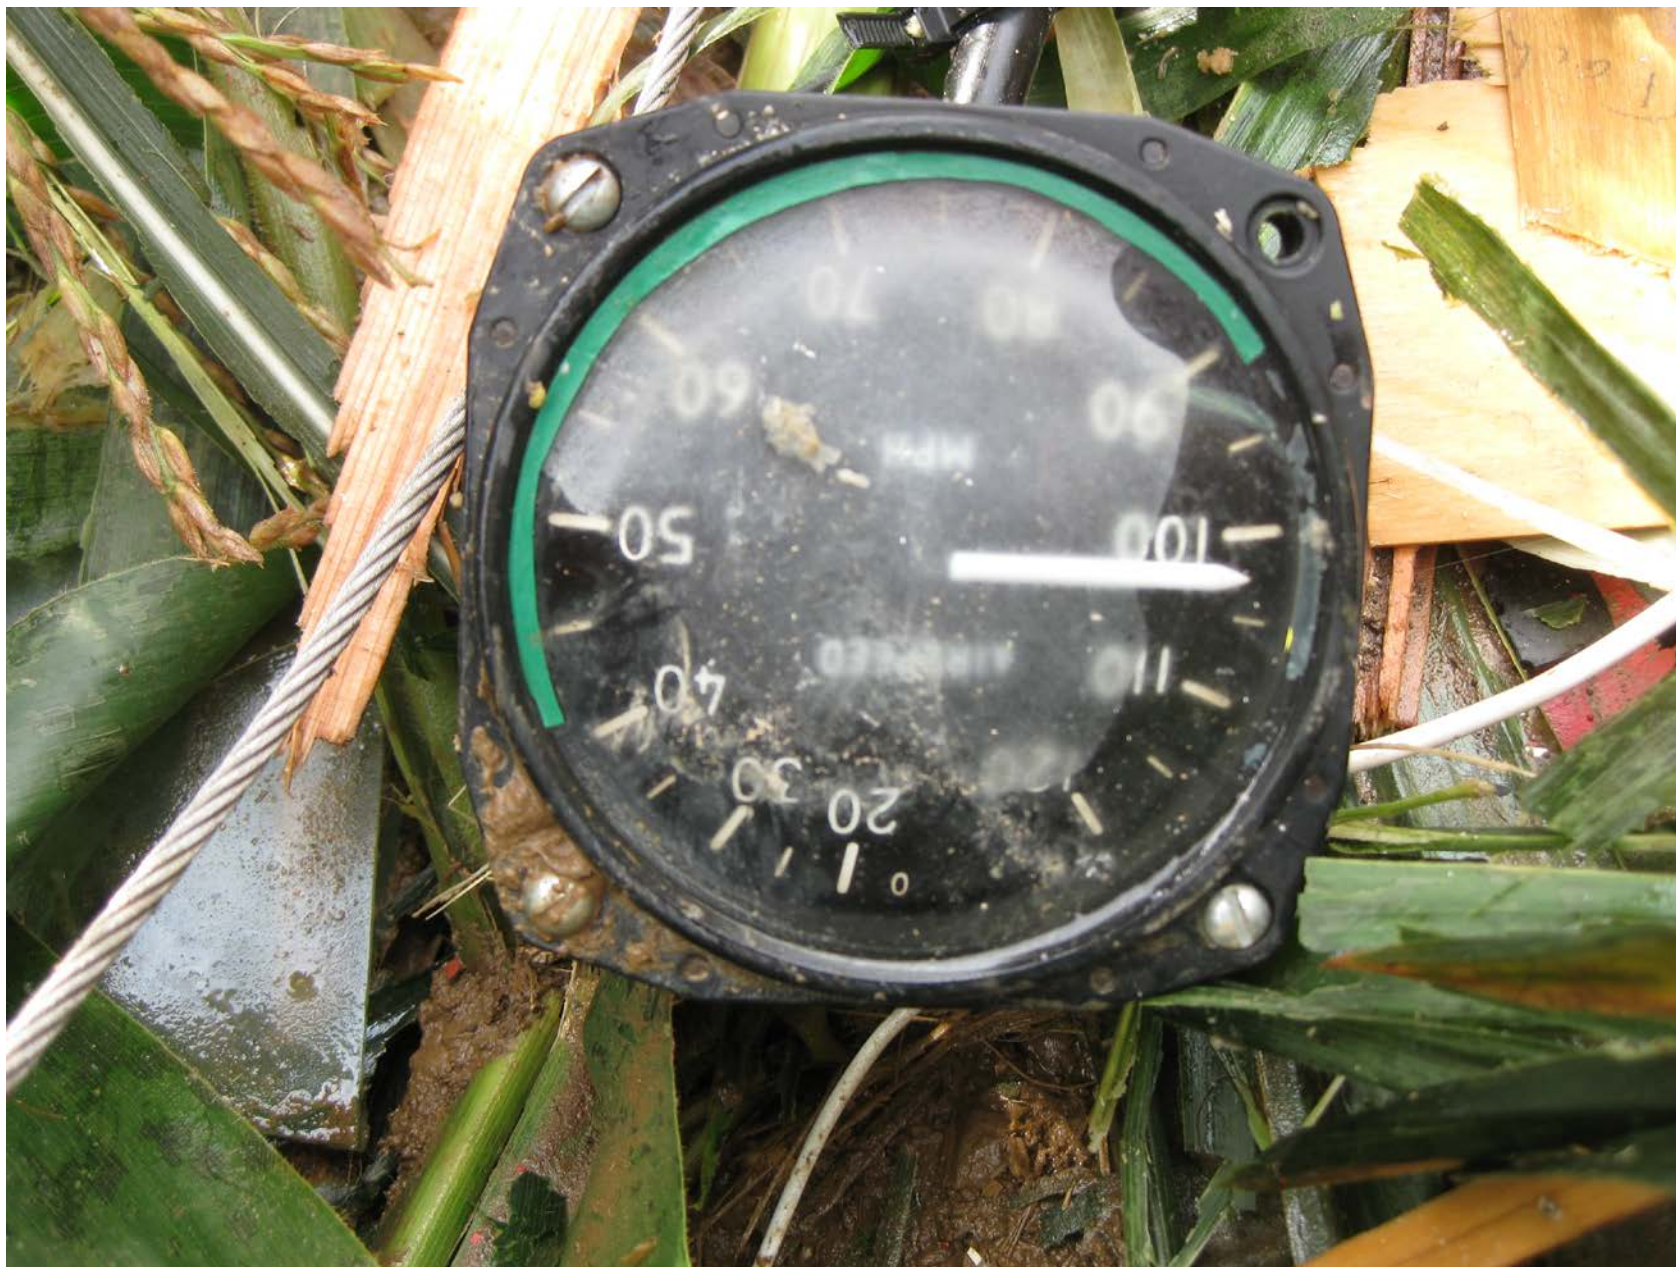
**Photo 5 – The airspeed indicator, as found at the accident site, indicated 103 mph.**

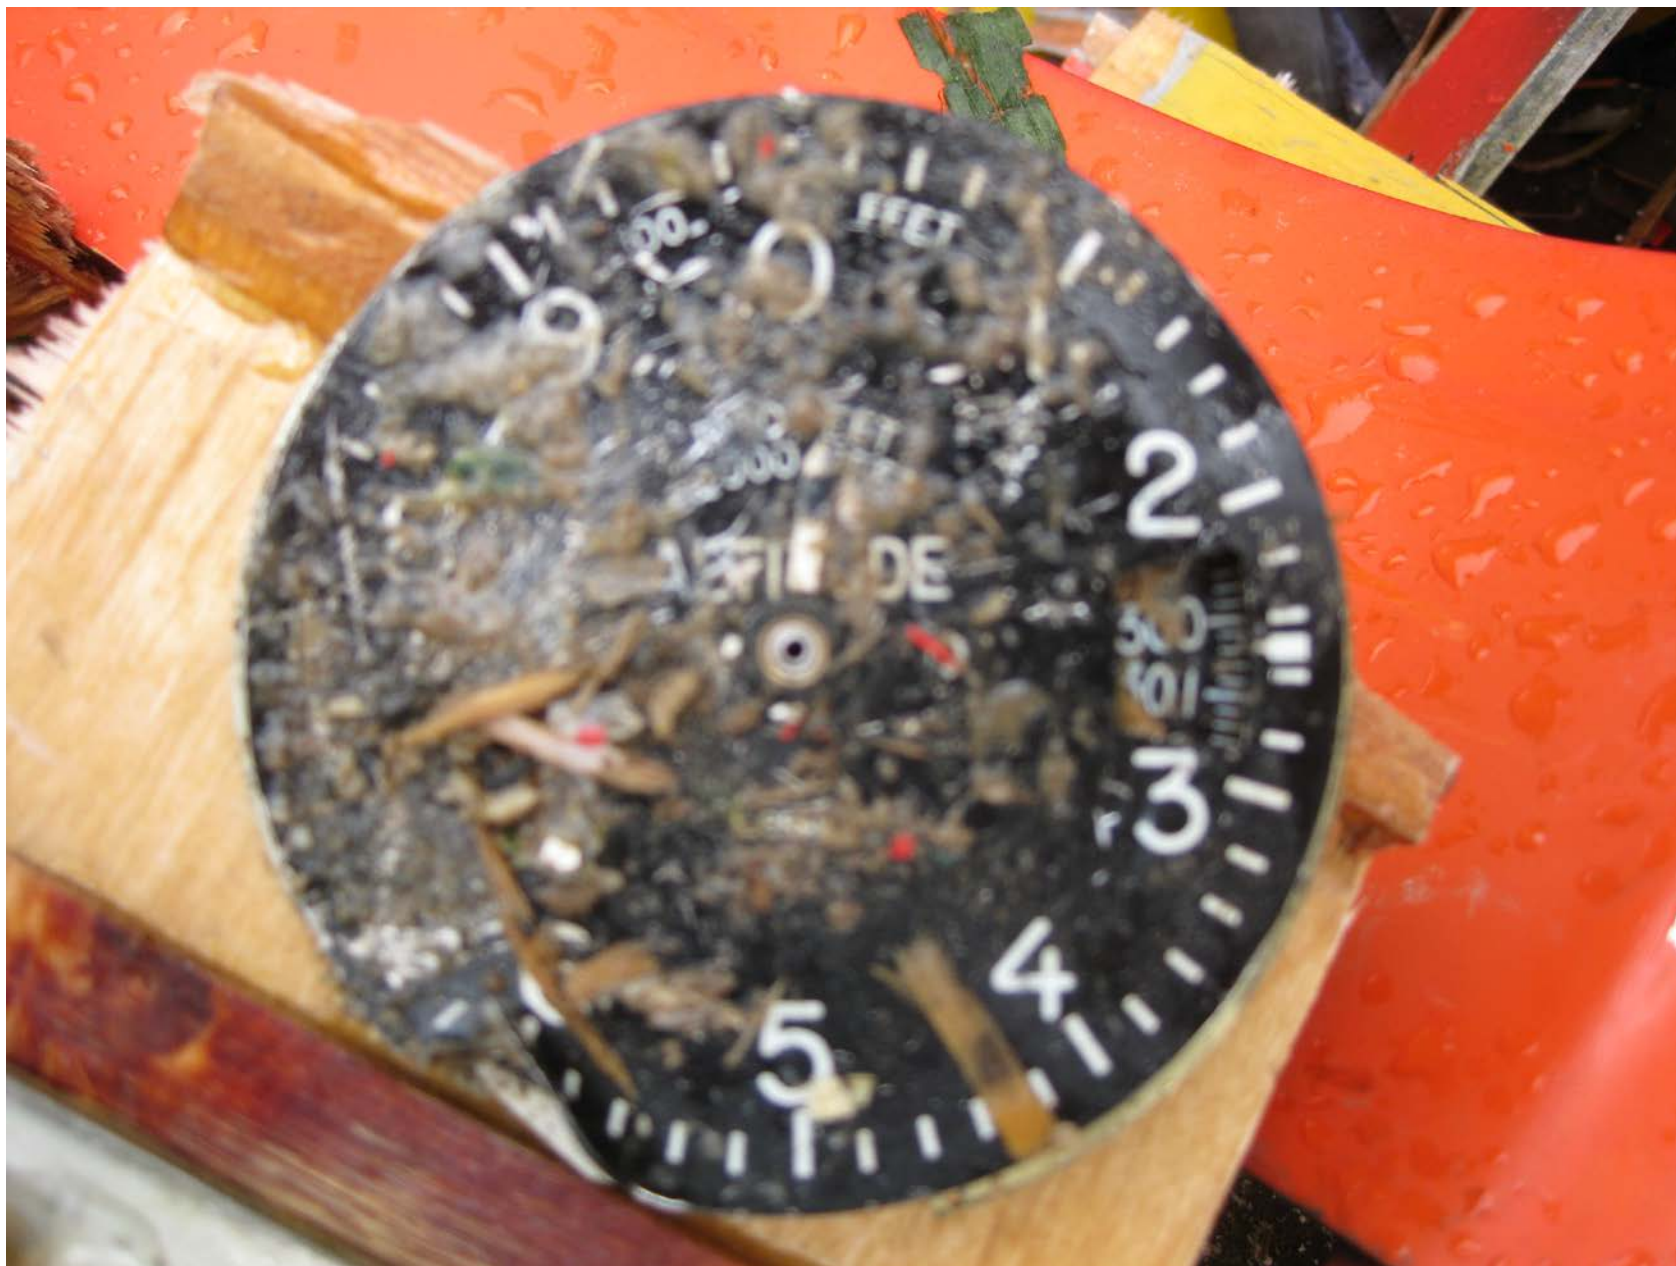
**Photo 6 – The altimeter’s faceplate, as found at the accident site. The barometric pressure was set at 30.04 inches of mercury in the Kollsman window.**

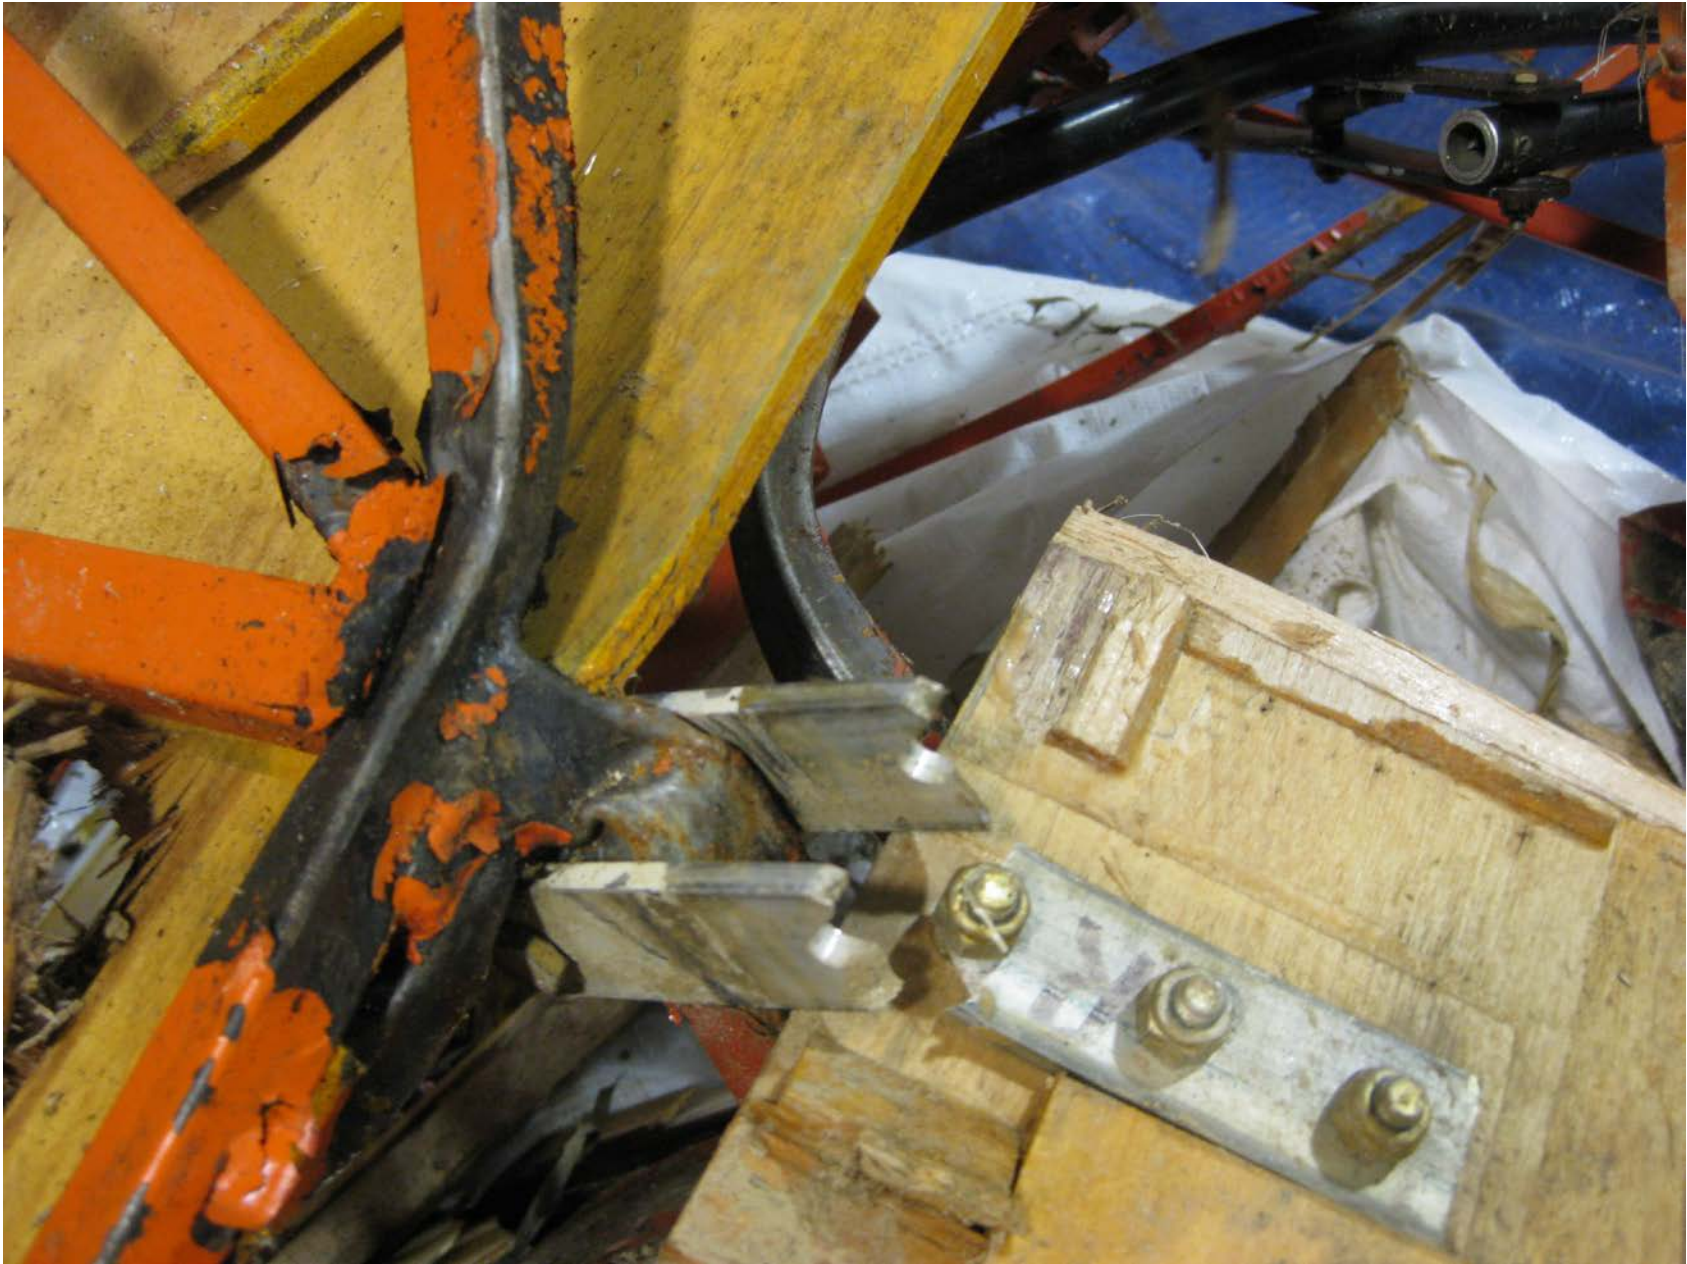
**Photo 7 – Lower right wing main spar bracket and attachment fitting bore signatures consistent with overload.**

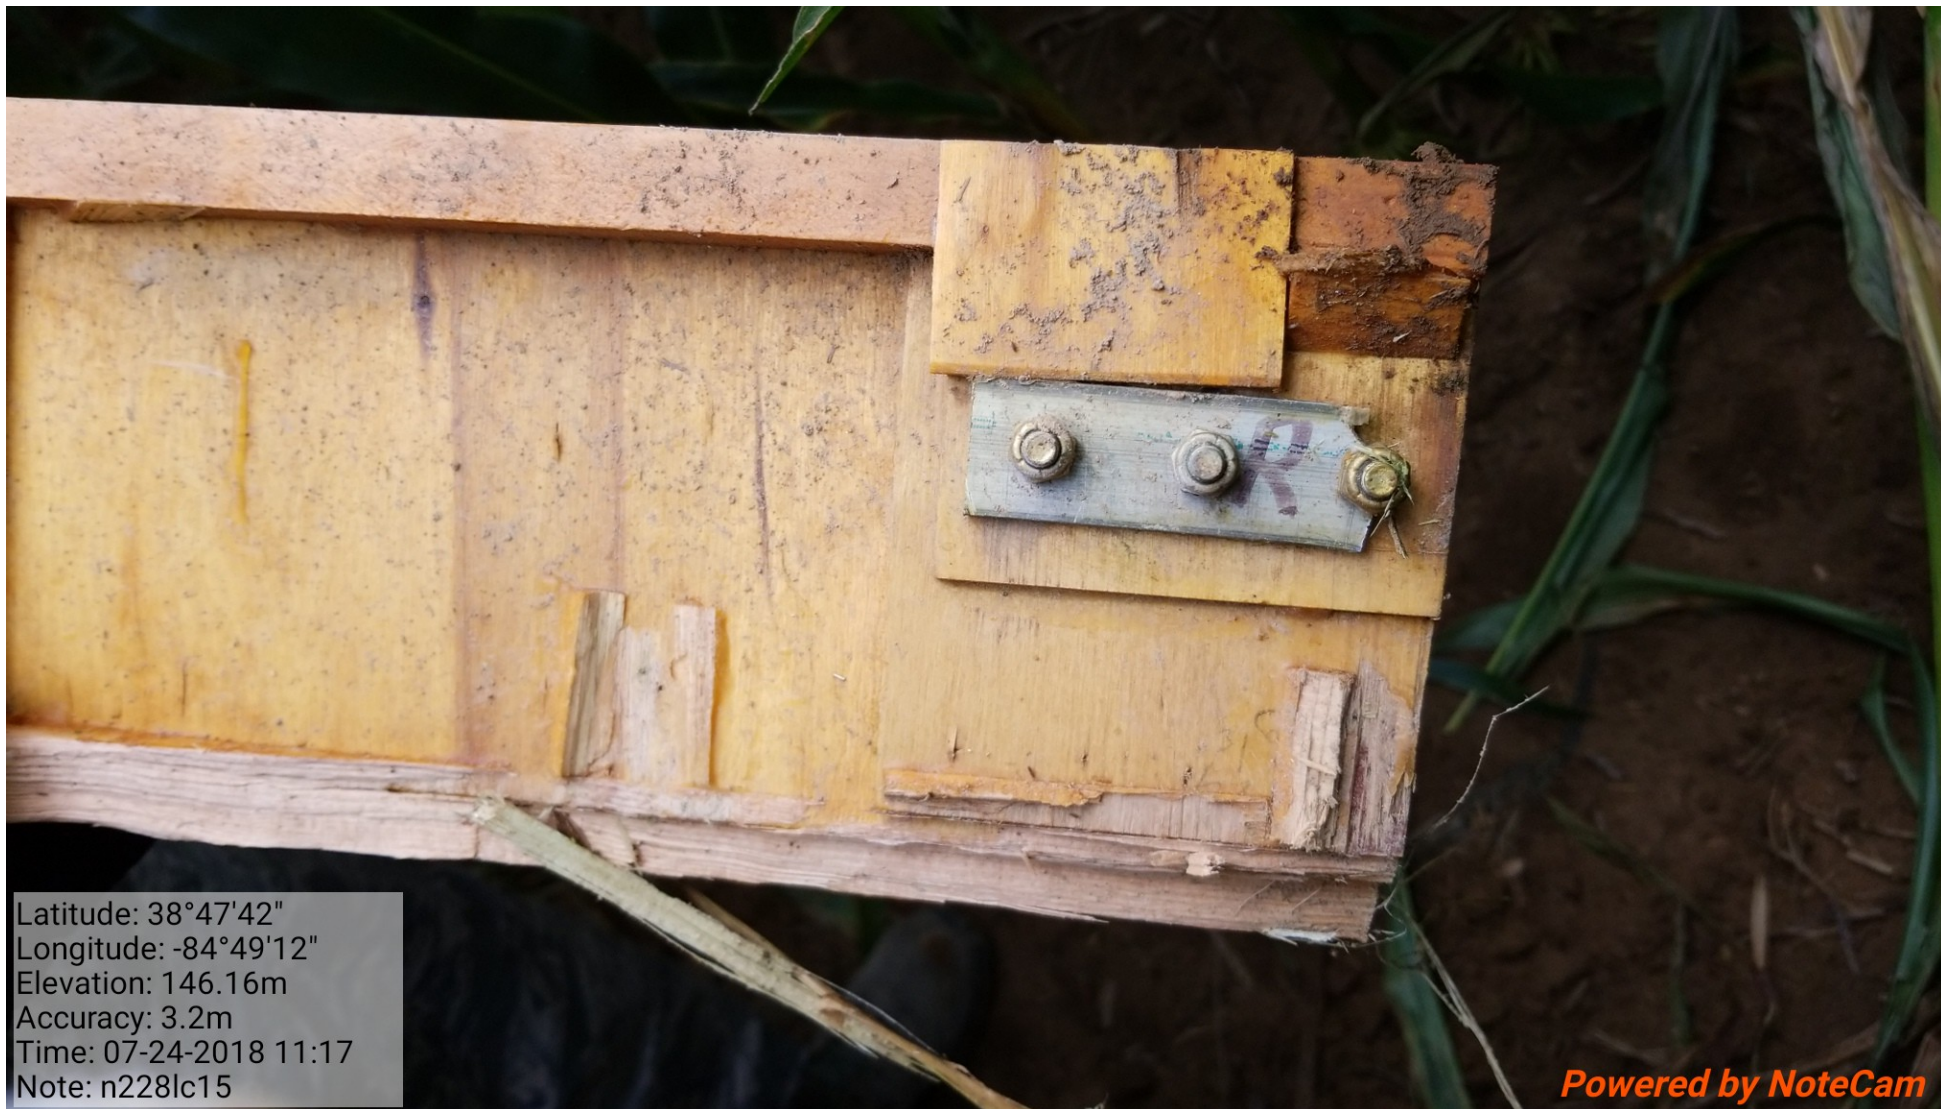
**Photo 8 – The other end of the lower right wing main spar bracket attached to a portion of the spar.**

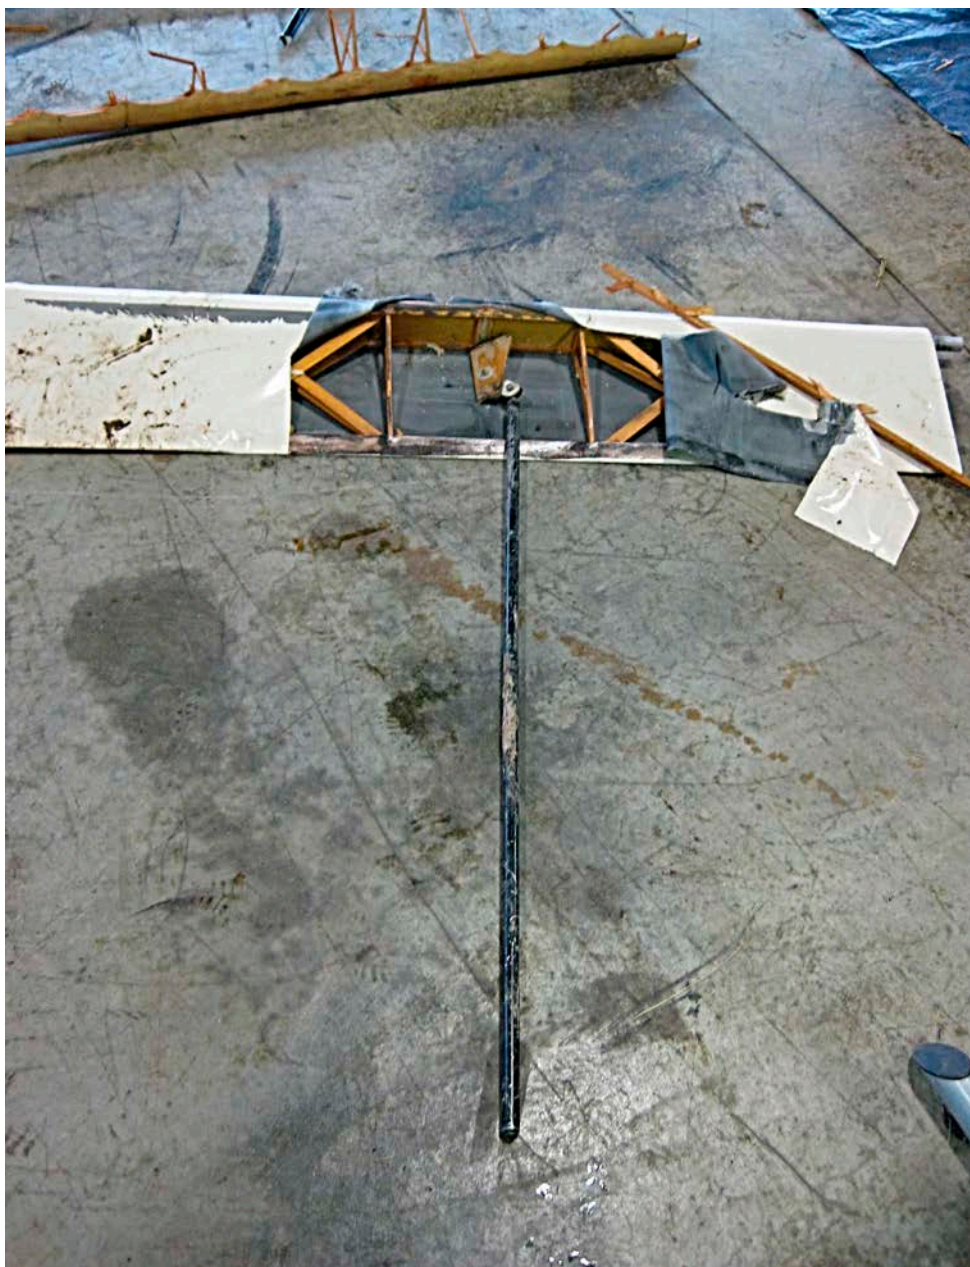
**Photo 12 – Right aileron and torque tube.**

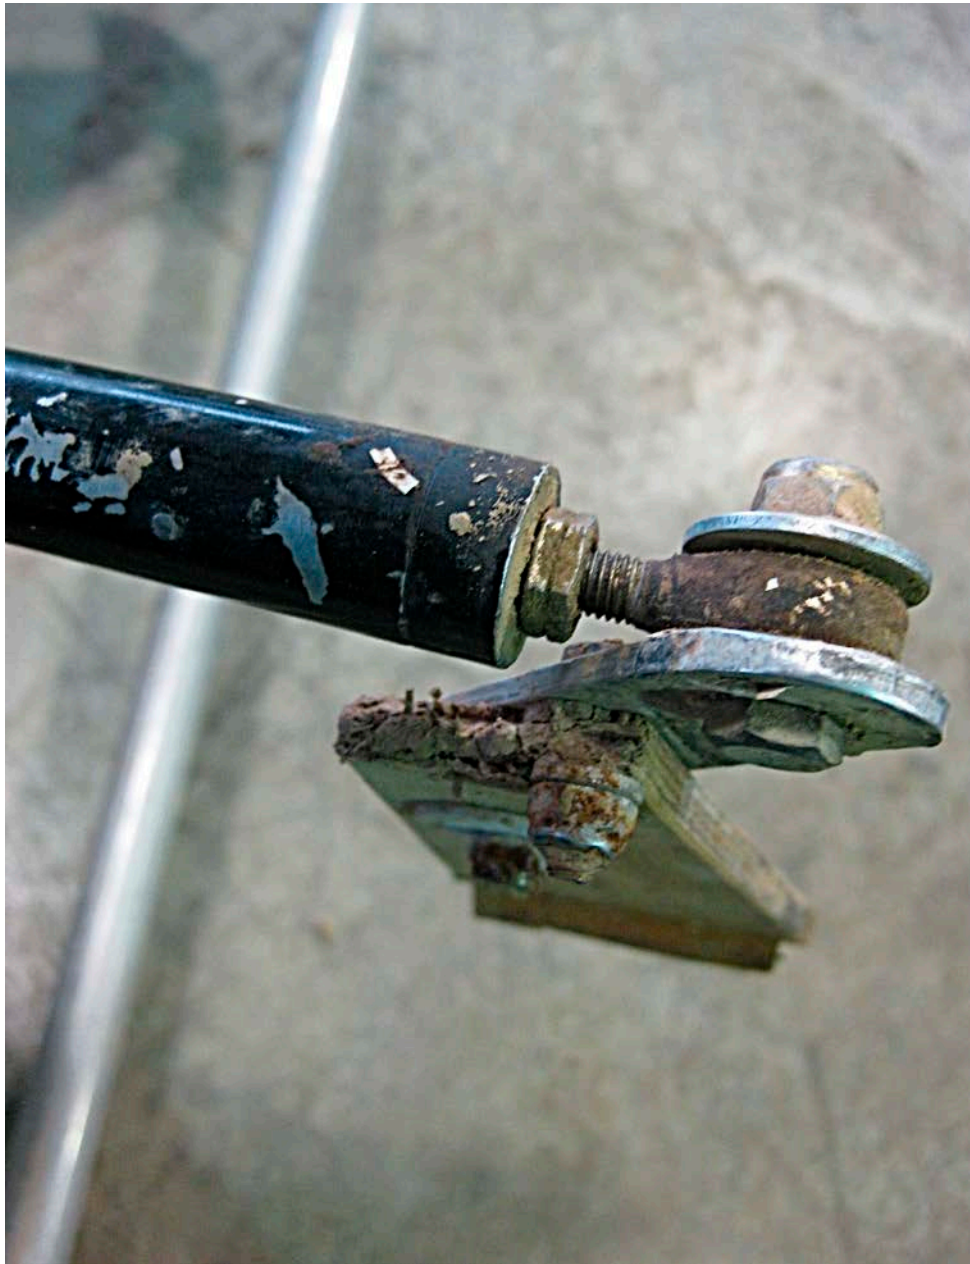
**Photo 13 – Right aileron torque tube and attachment fitting where it attaches to the aileron.**
