# **NATIONAL TRANSPORTATION SAFETY BOARD**

## **Global Positioning System**

### **Specialist's Factual Report by Alice Park**

Location: Fort Walton Beach, Florida  
Date: August 30, 2018  
Aircraft: Beech 60  
Registration: N1876L  
Operator: Henry Leasing Company, LLC  
NTSB Number: CEN18FA358

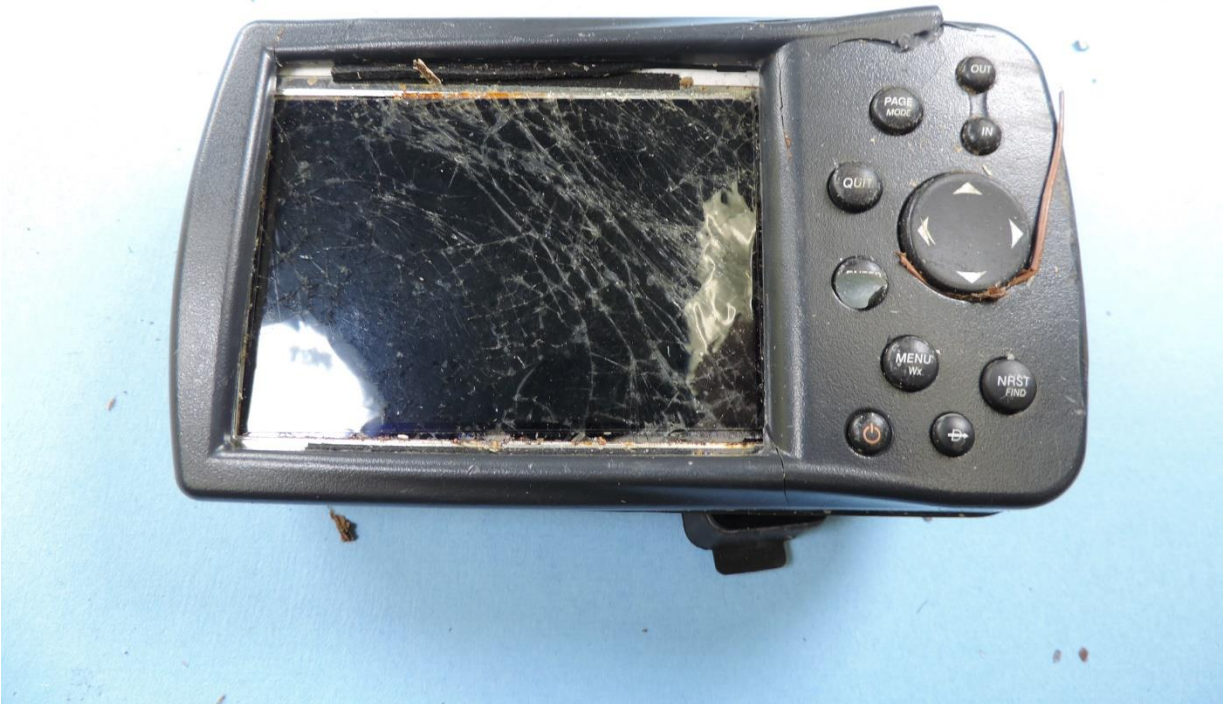
Upon arrival at the Vehicle Recorder Laboratory, an exterior examination revealed that the unit had sustained impact damage during the accident and would not power on (Figures 1 and 2). It was disassembled for further examination.

**Figure 1. External view of the Garmin GPSMAP 496 - front (s/n 19724050).**

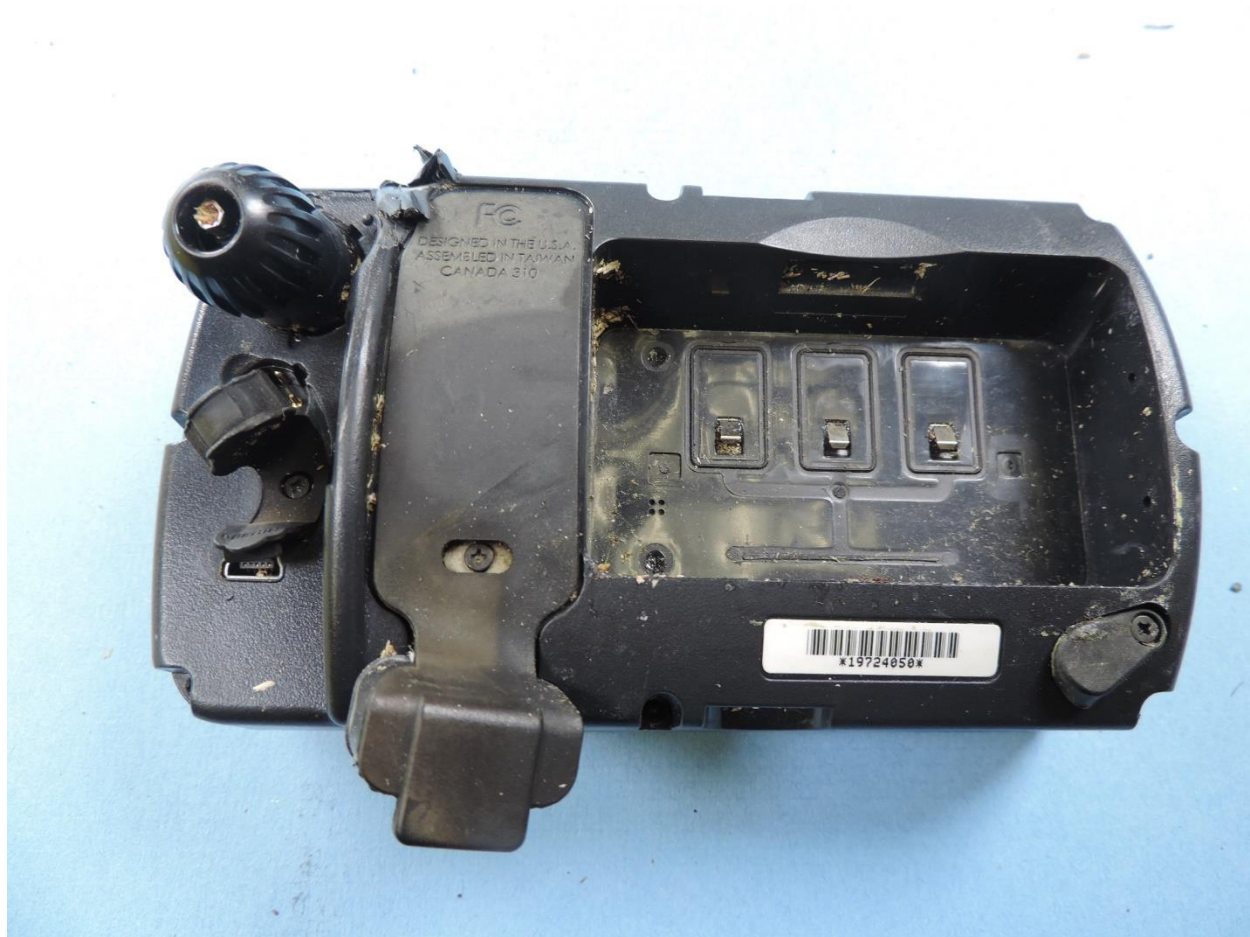
**Figure 2. External view of the Garmin GPSMAP 496 - back (s/n 19724050).**

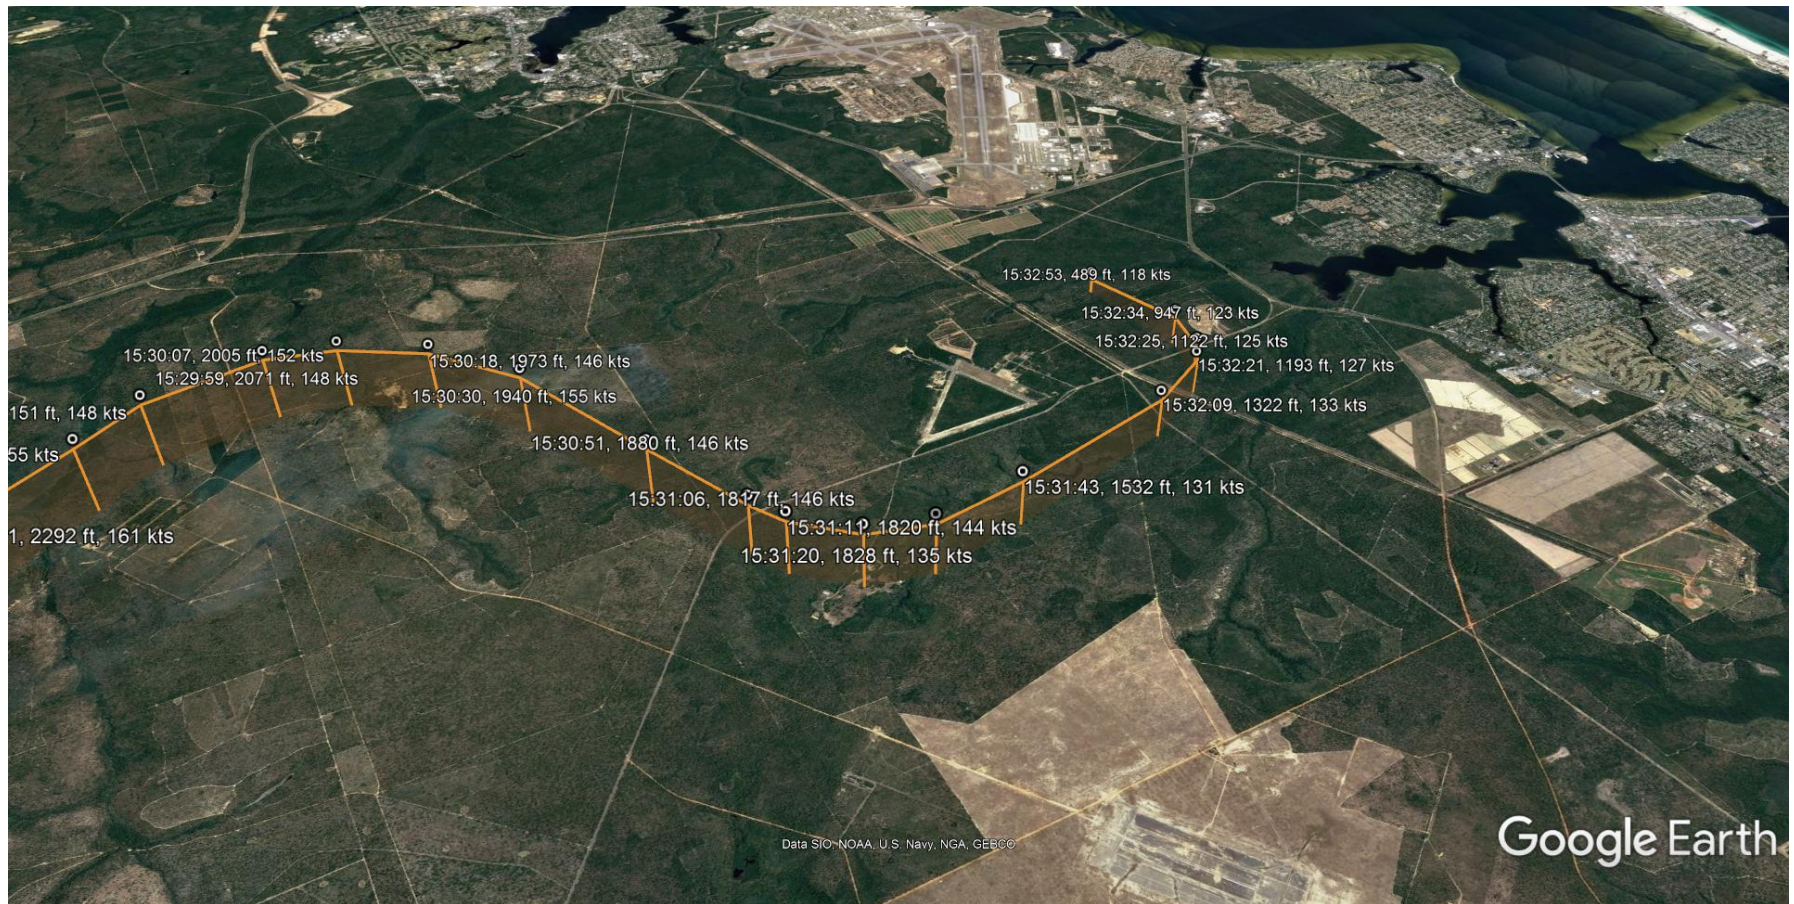
as shown in Figure 3. Figure 4 shows that at about 1530, the accident flight approached Destin Executive Airport (DTS) with a steady descending altitude and decreasing speed. The last data point at 1532:53 indicates sudden altitude drop from 947 ft to 489 ft as shown on Figure 5. As explained Table 1, the computed average ground speed between the last two recorded latitude and longitude points was 118 knots.

**Figure 5 Close view of the last segment of the accident flight data**
