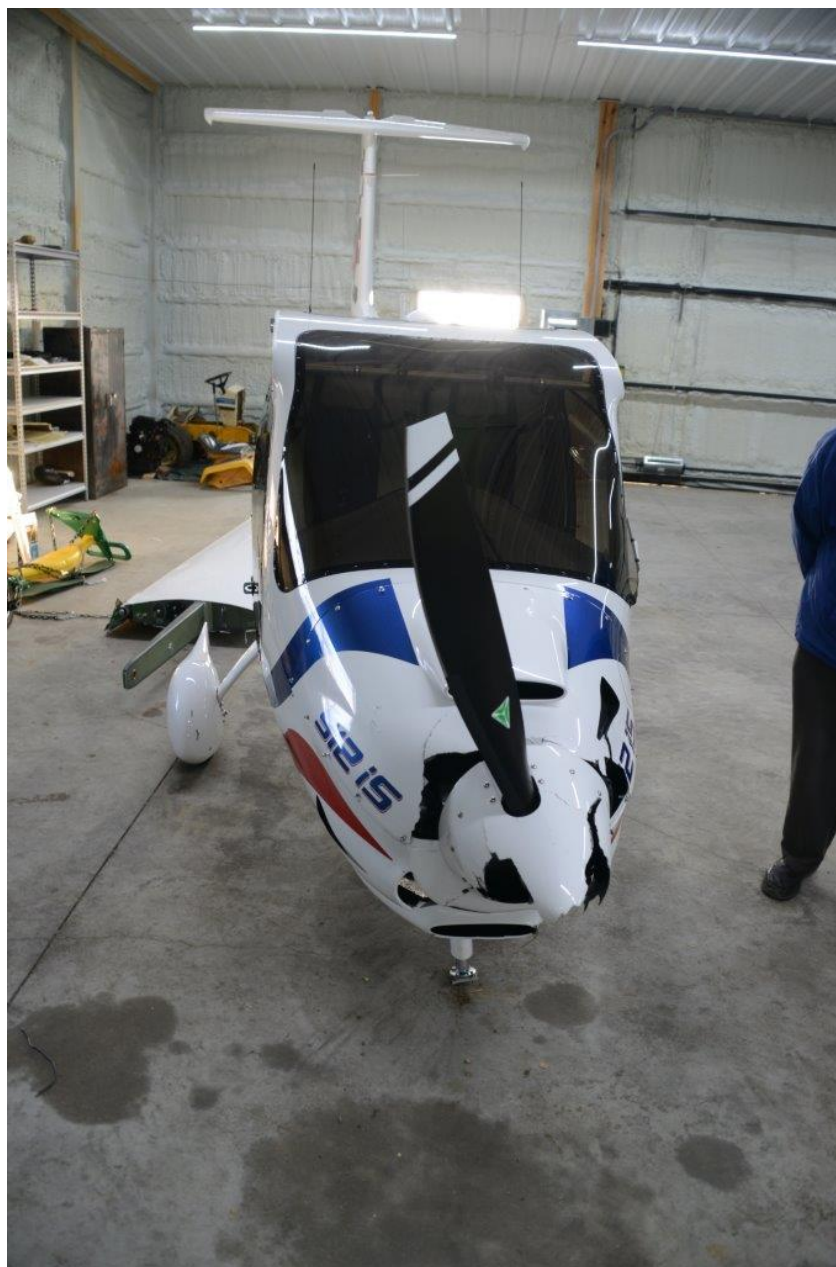
**Photo 1 – View of the front of the recovered aircraft.**

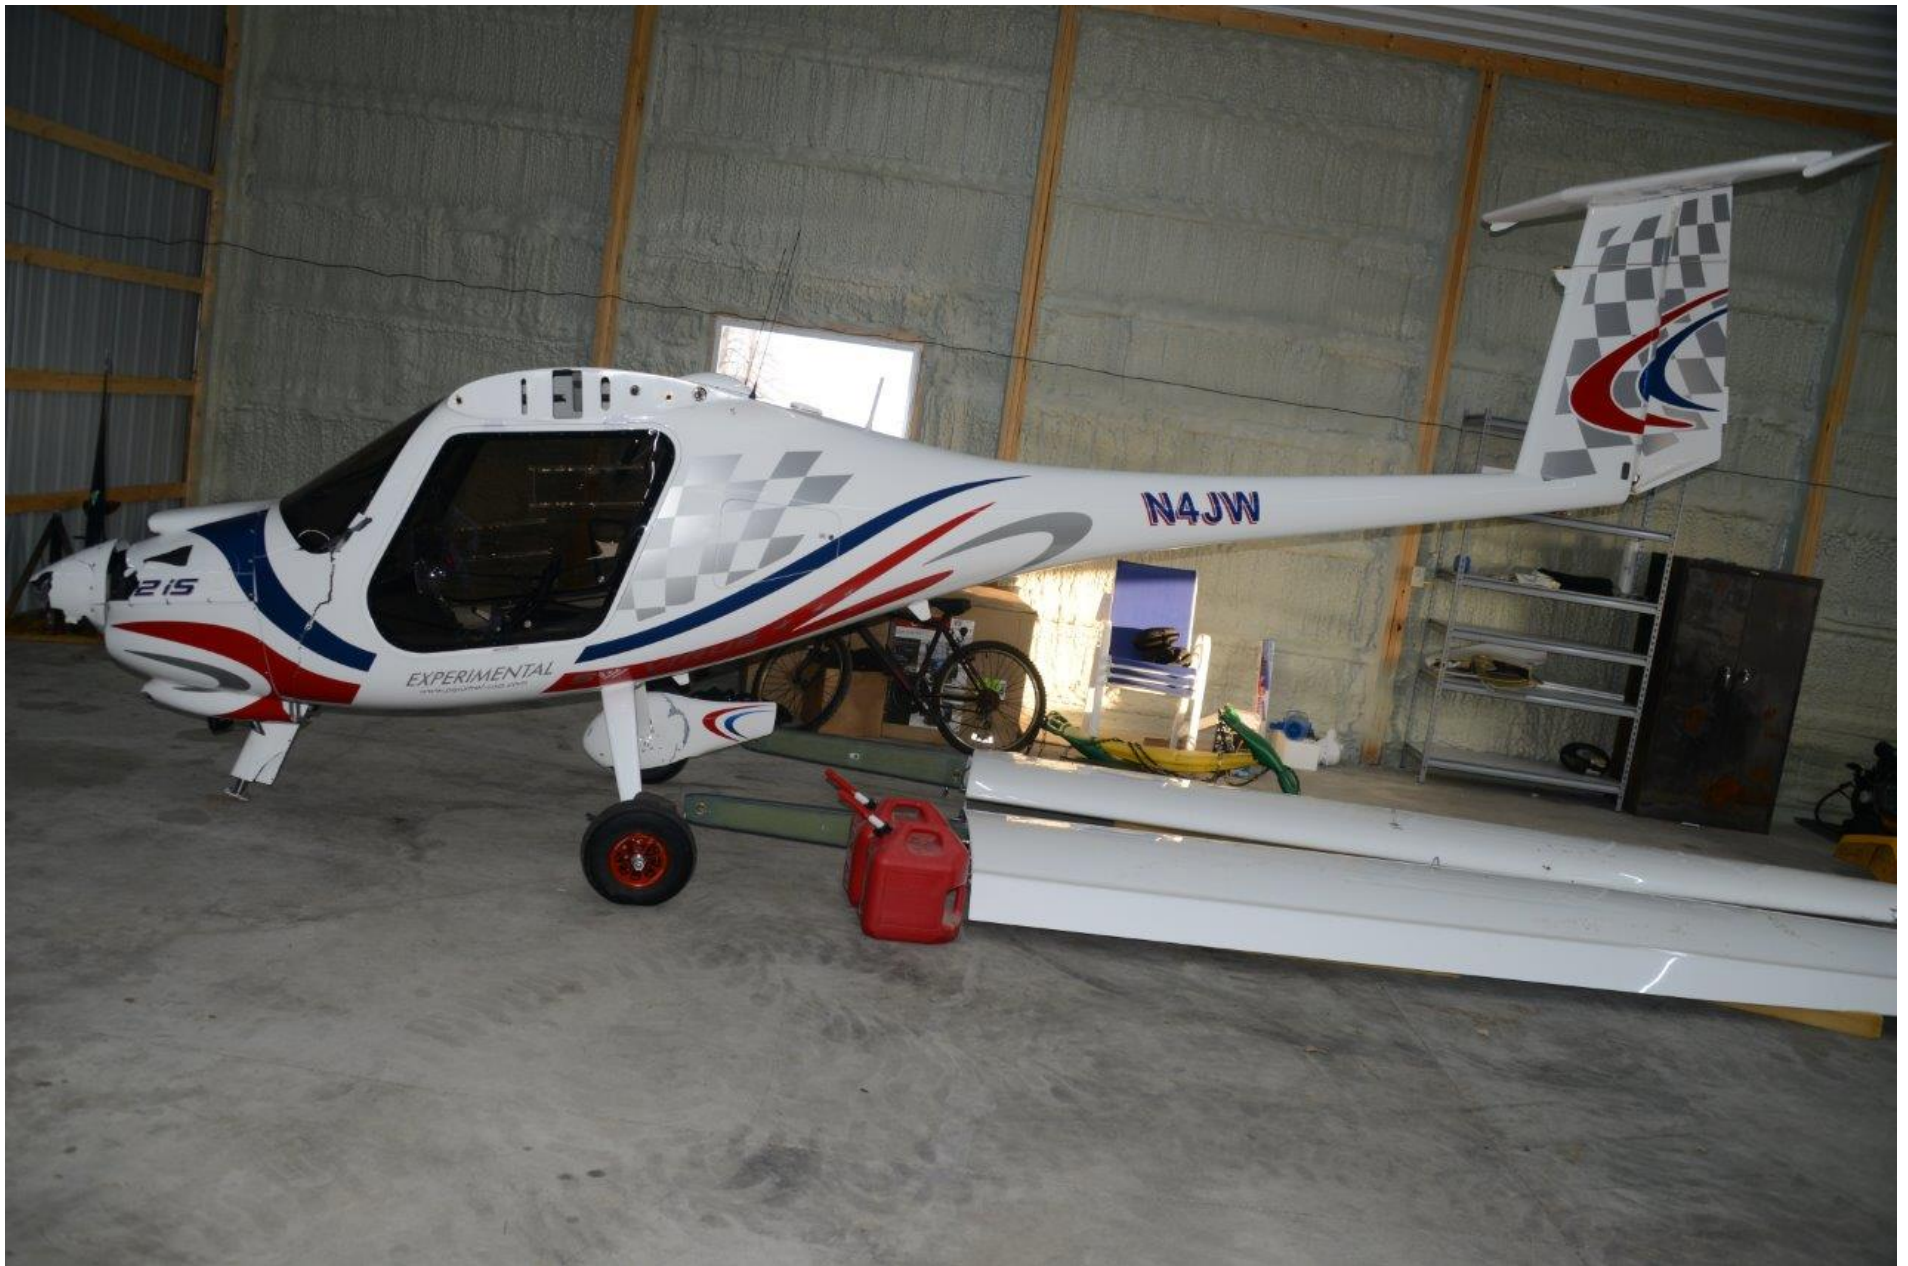
**Photo 2 - View of the left side of the recovered aircraft.**

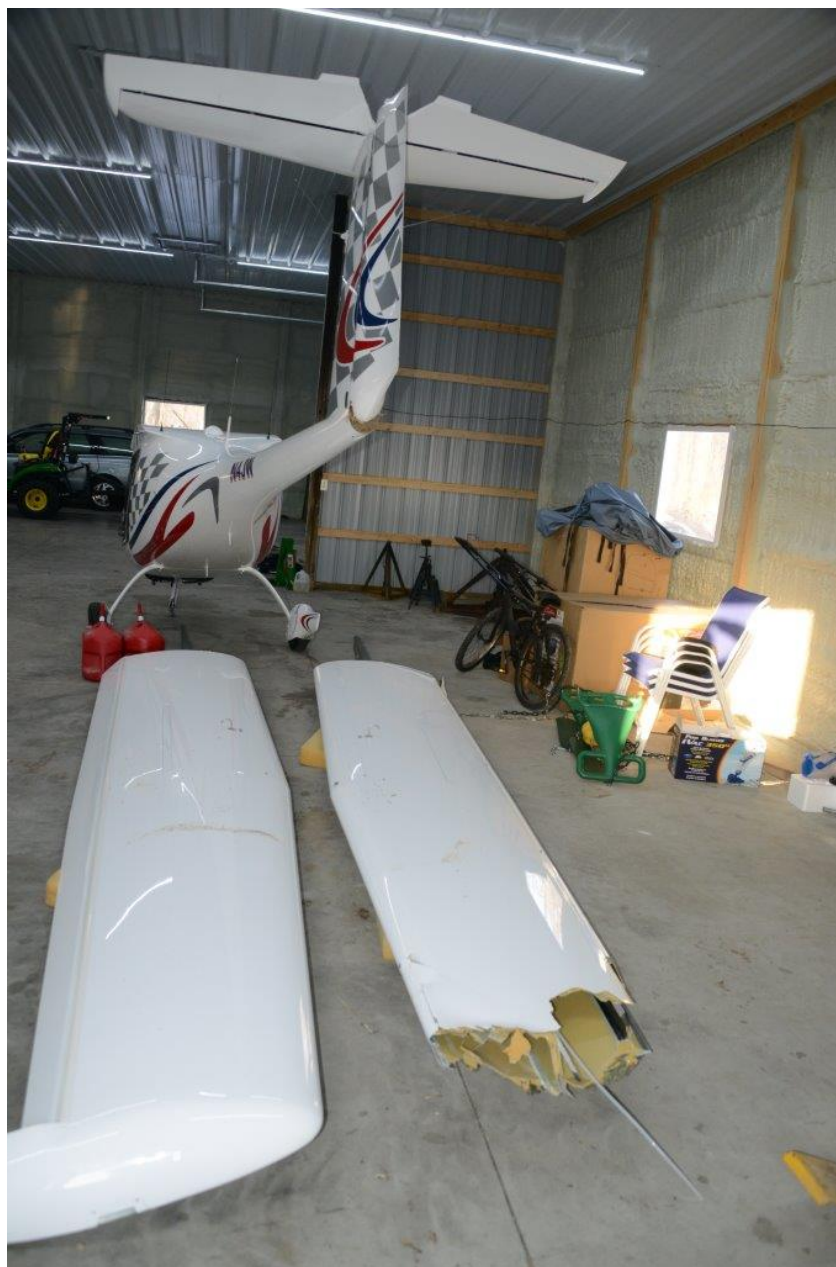
**Photo 3 - View of the rear side of the recovered aircraft and detached wings.**

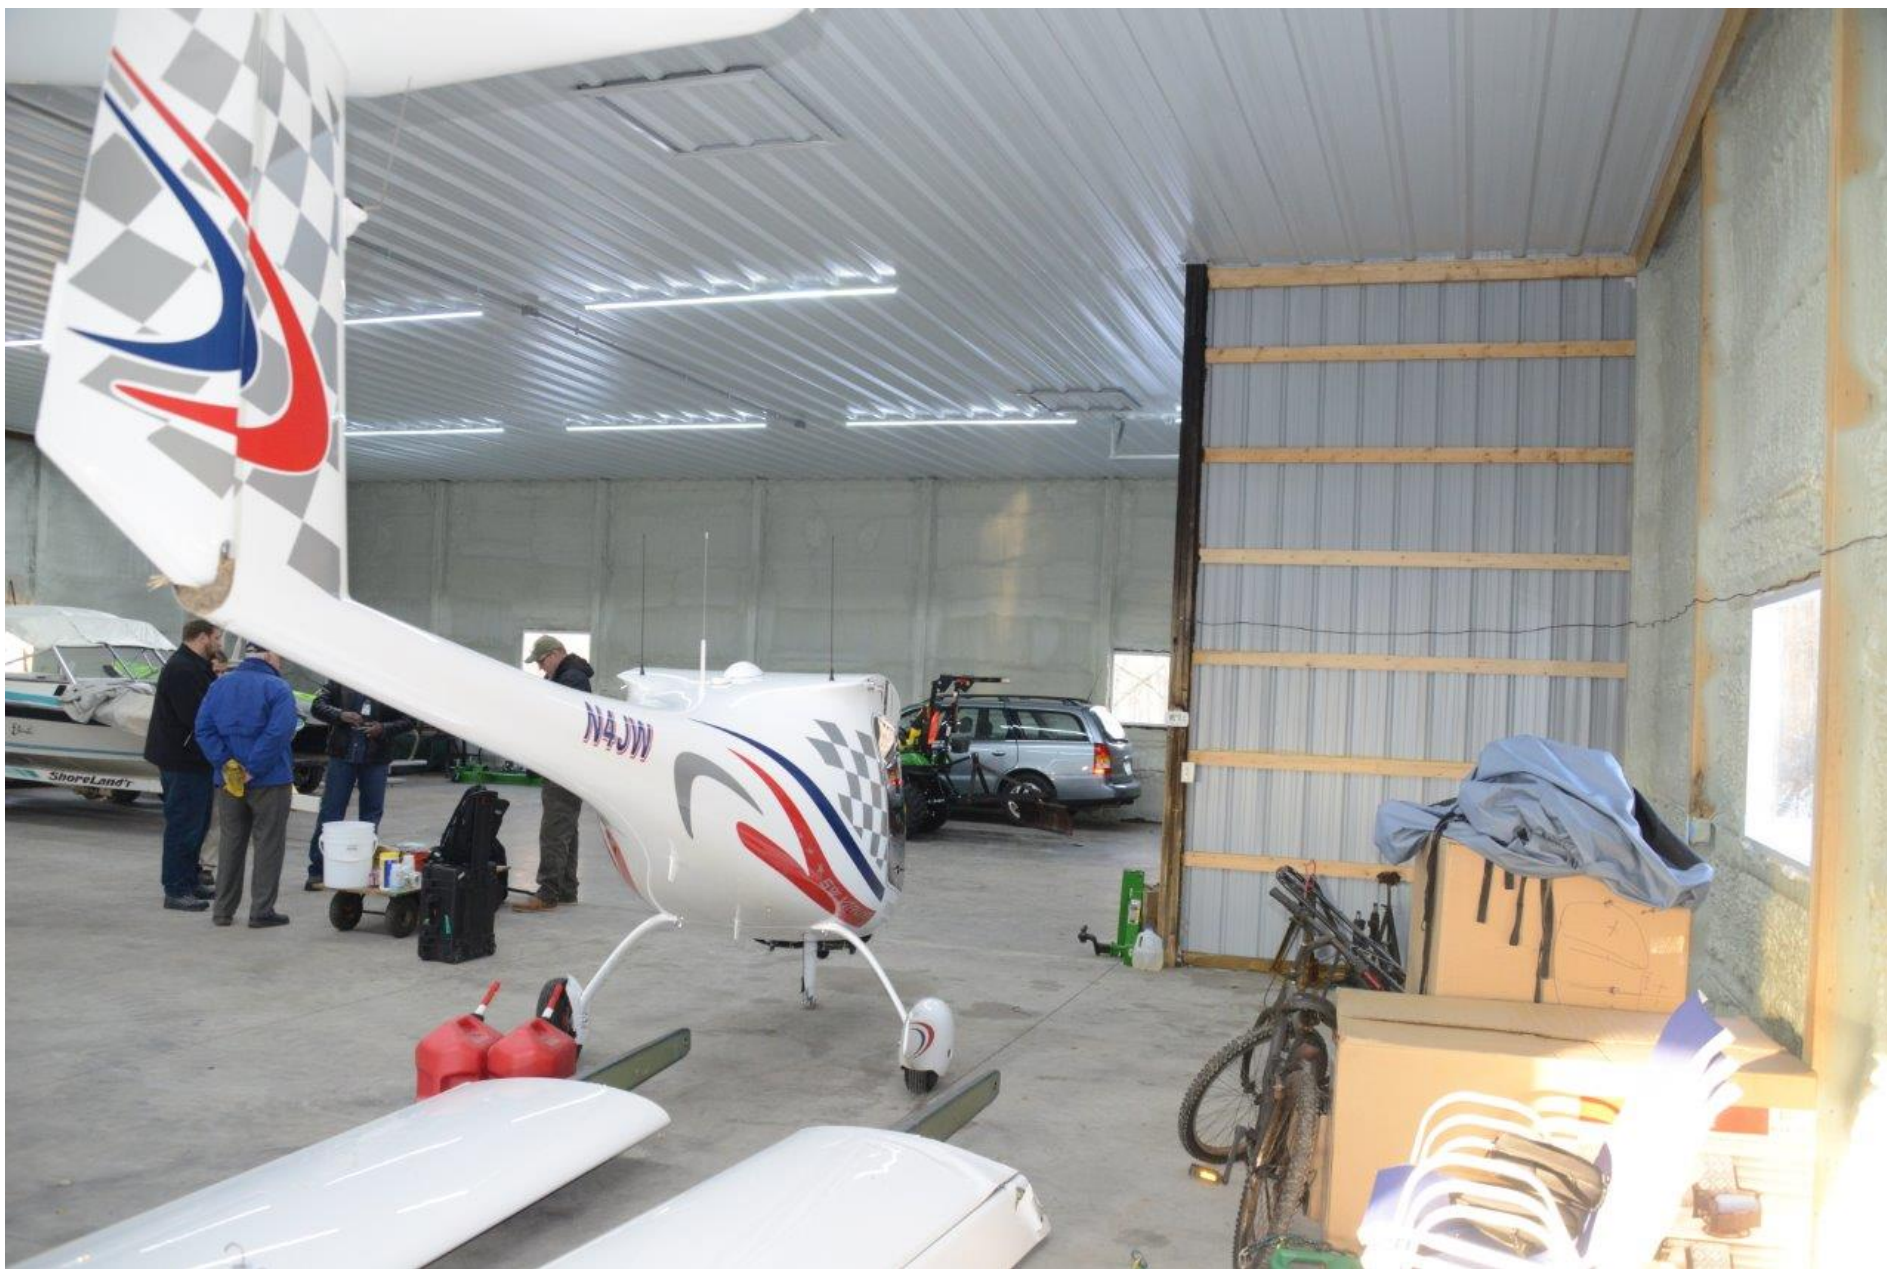
**Photo 4 - View of the right side of the recovered aircraft.**

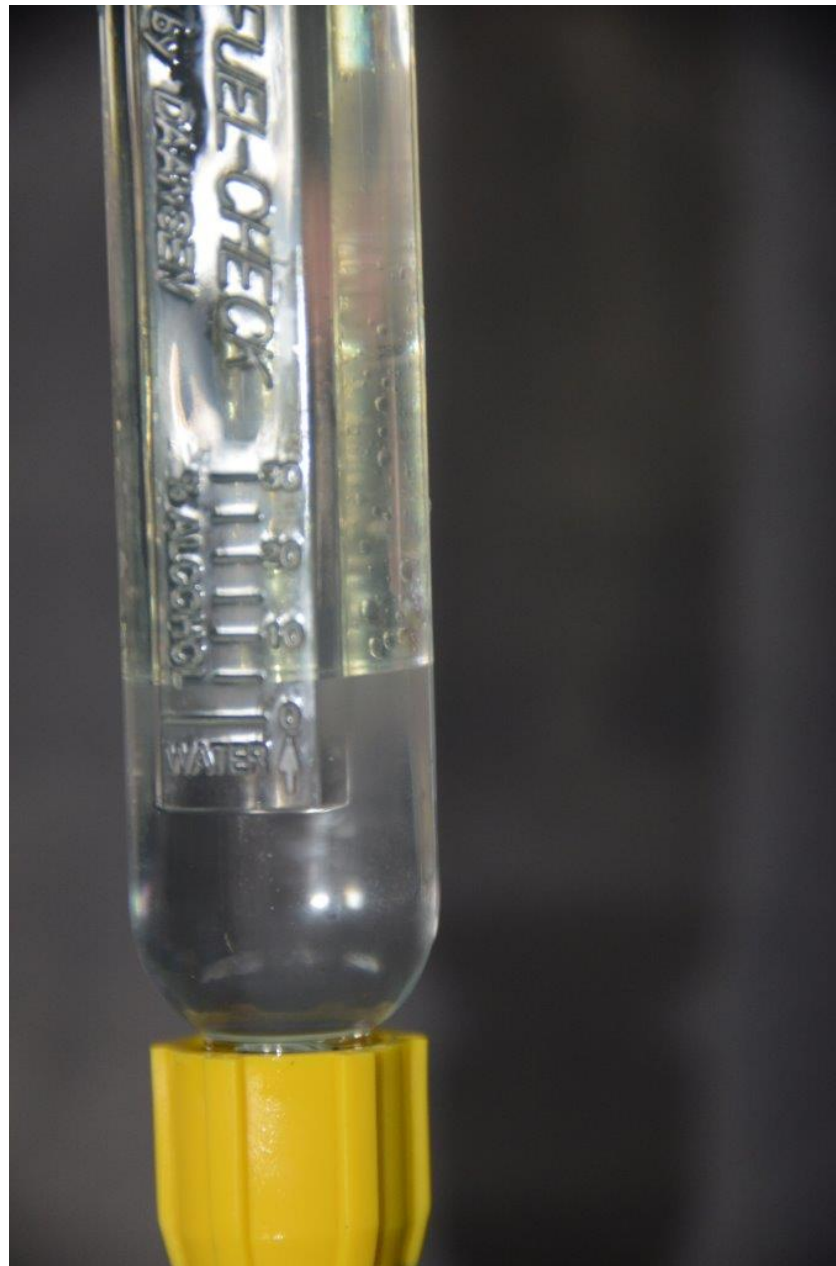
**Photo 5 - View of the alcohol tester exhibiting a reading about 5%.**

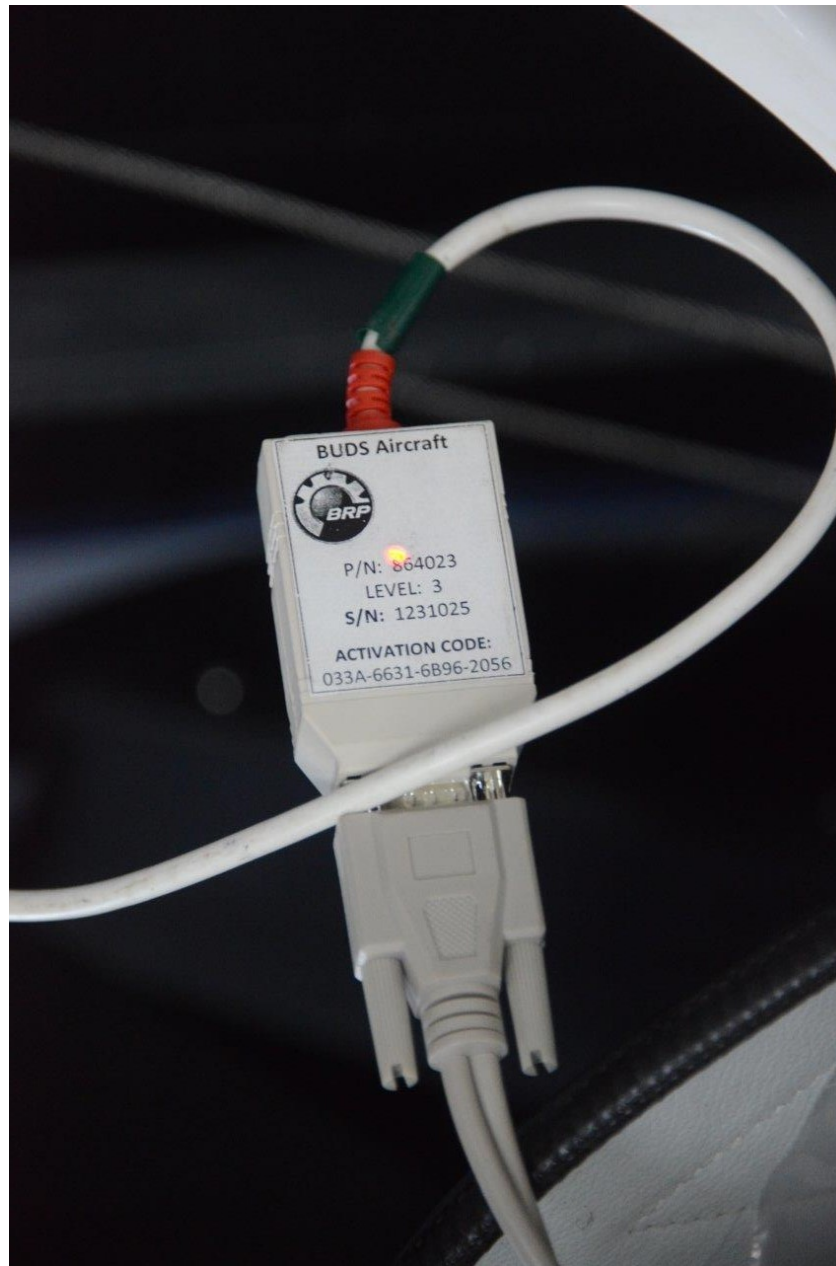
**Photo 6 - View of an electrical connector during the ECU download.**

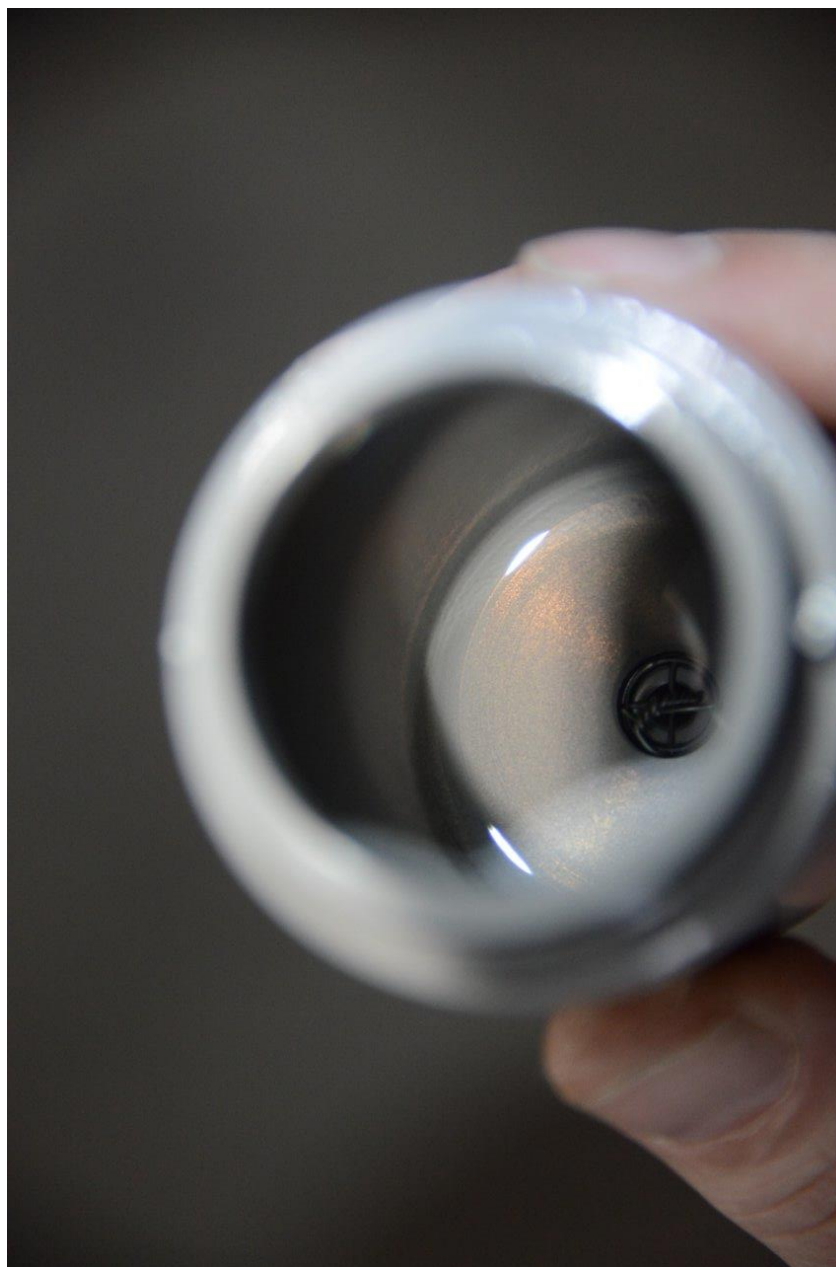
**Photo 7 - View of the fuel filter bowl with a liquid present.**

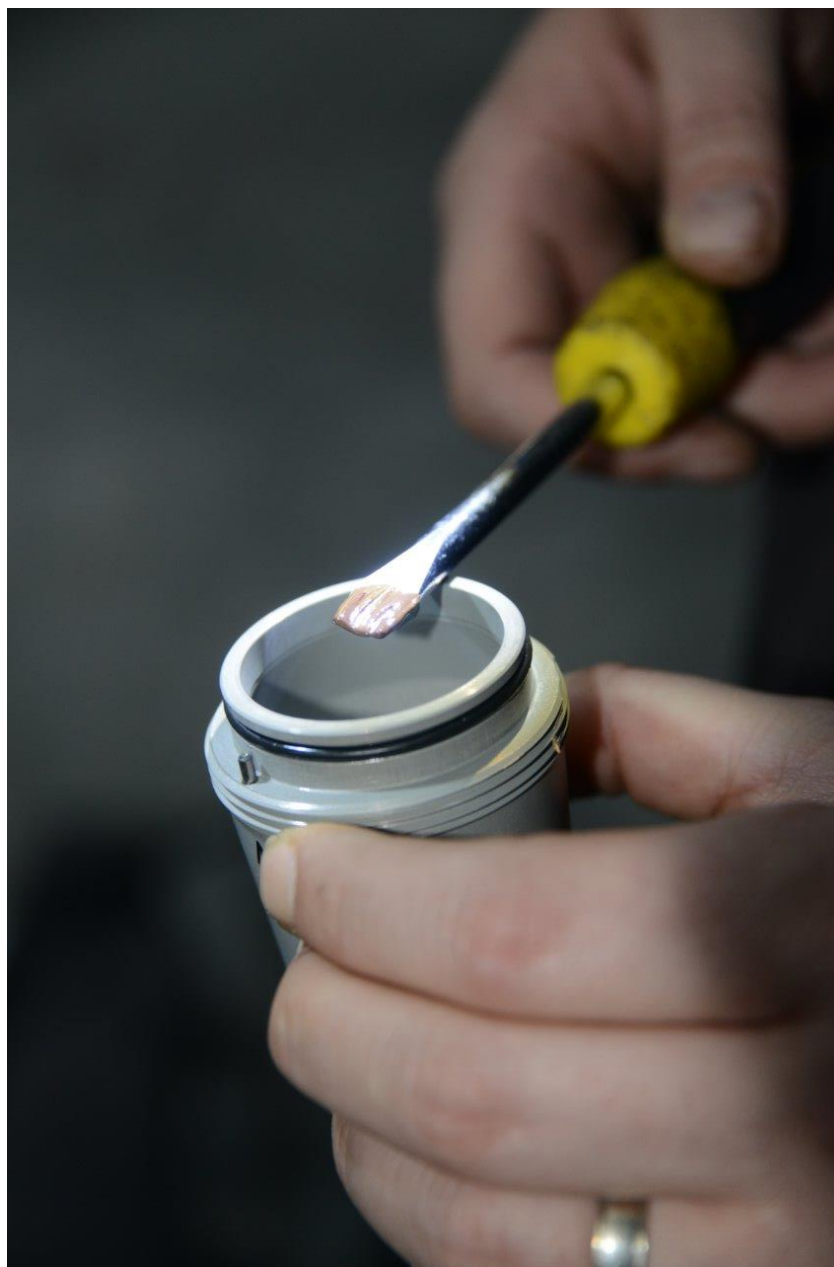
**Photo 8 - View of the fuel filter bowl during testing of the liquid present for water. Testing paste exhibited no water present.**

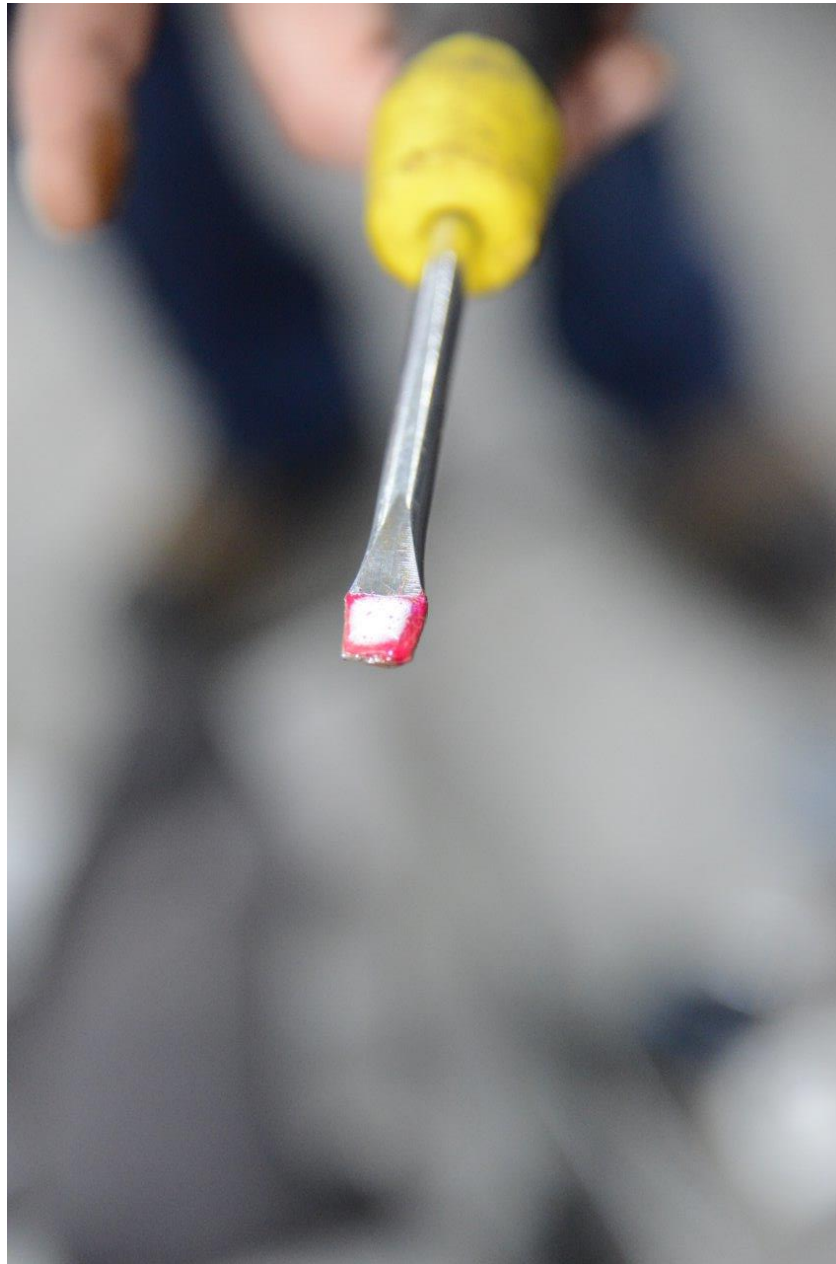
**Photo 9 - View of the testing paste with water applied subsequent to fuel filter bowl liquid testing.**

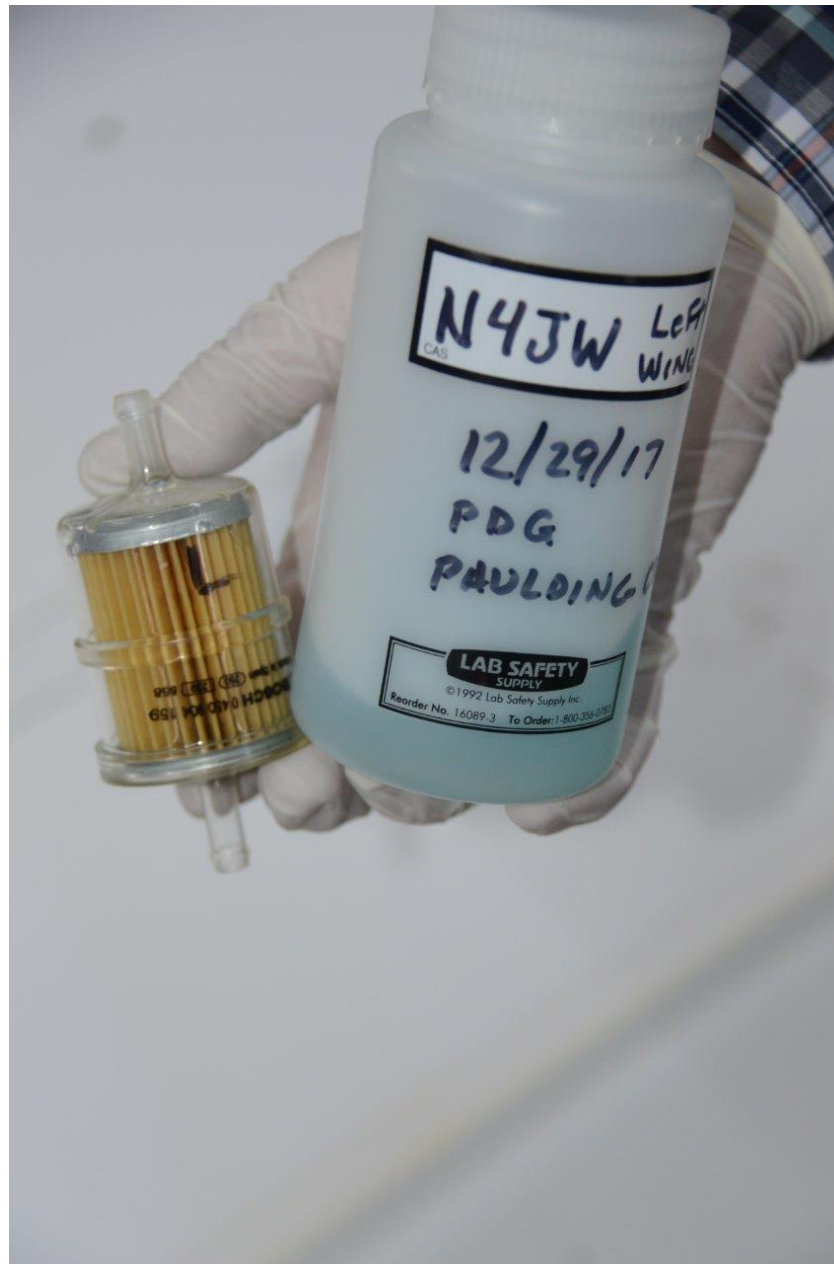
**Photo 10 - View of the inline fuel filter and fuel tank sample from the left fuel system.**

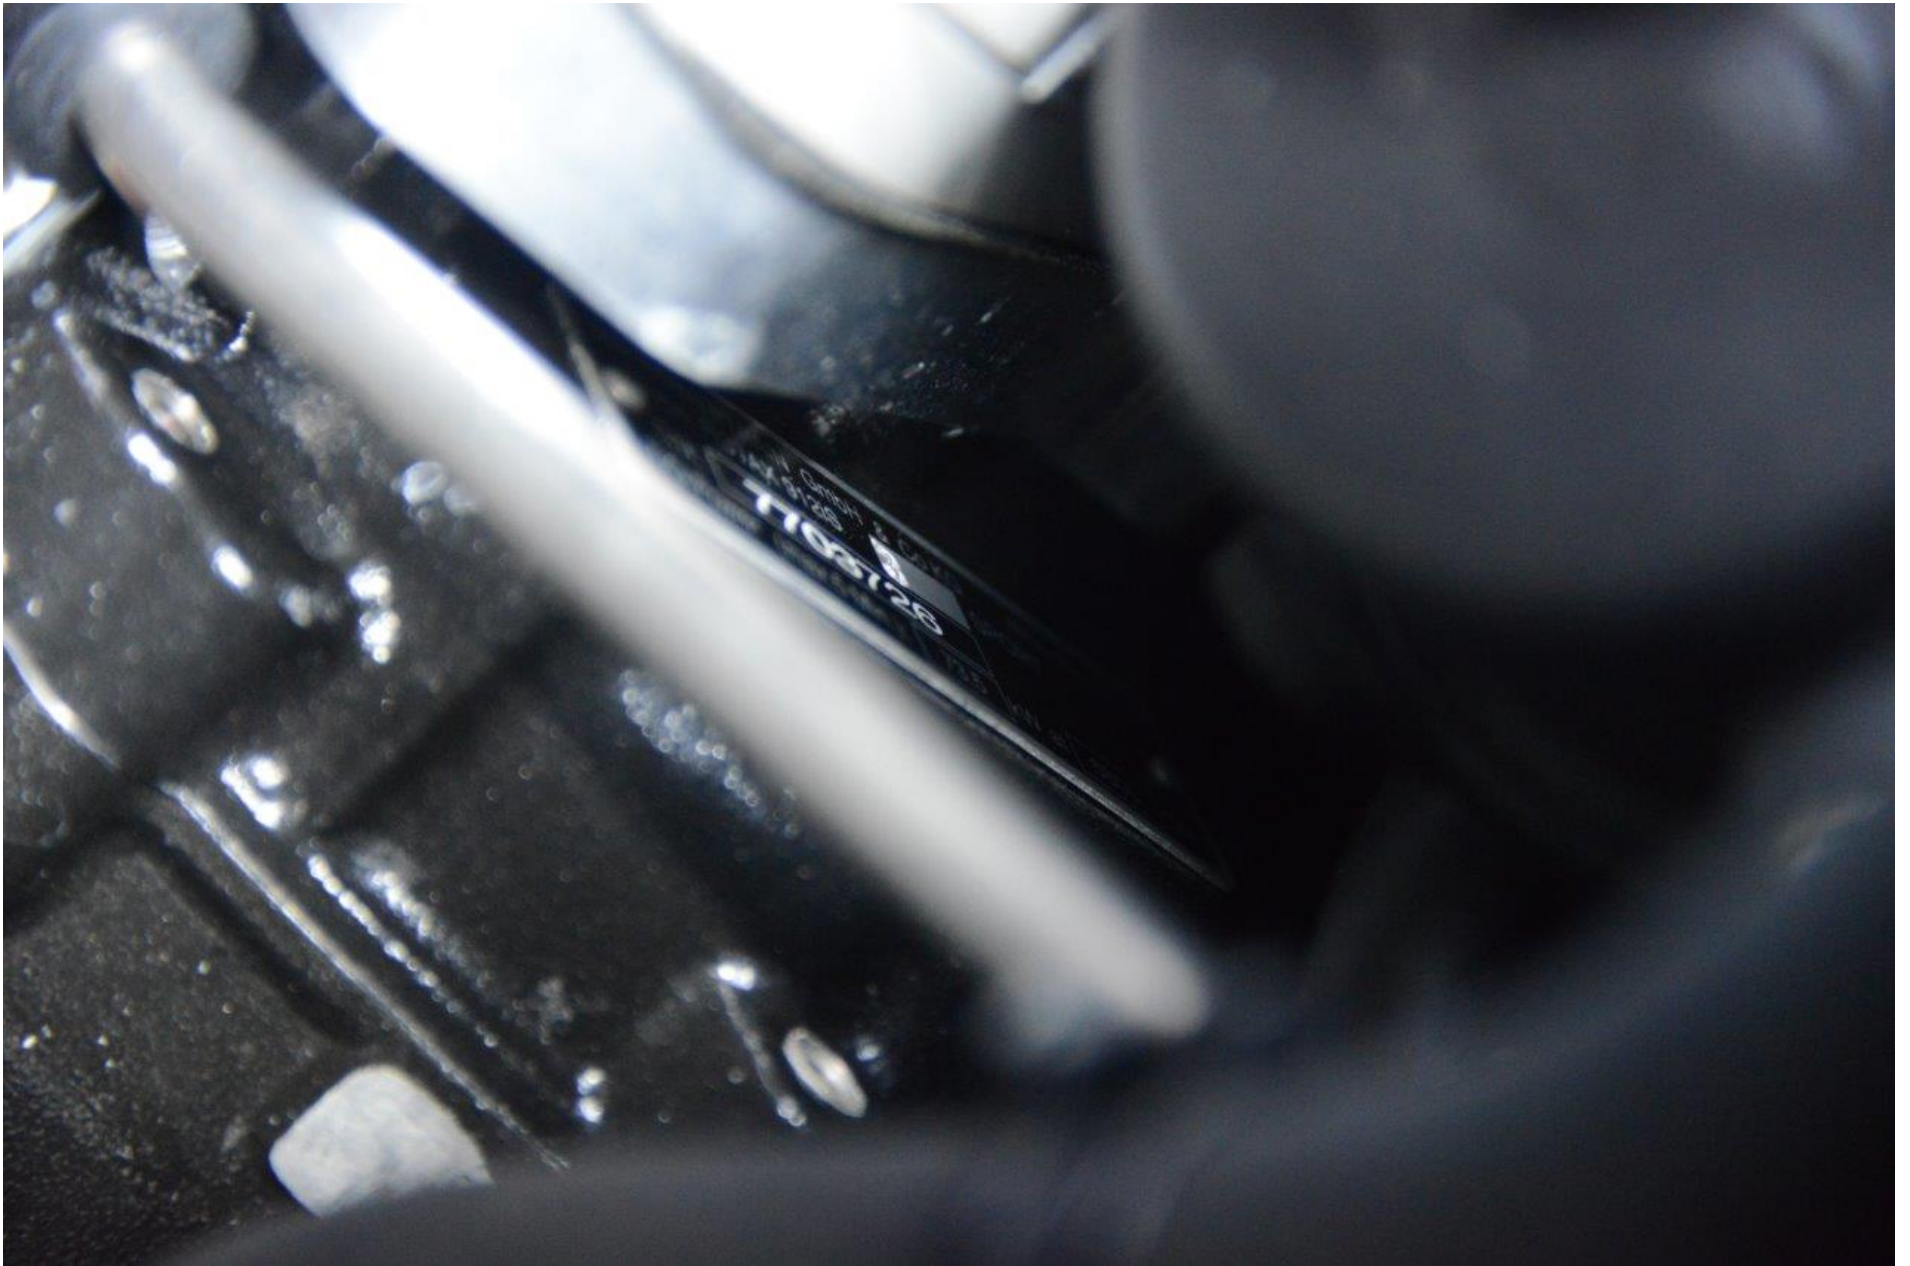
**Photo 13 - View of the engine data plate.**

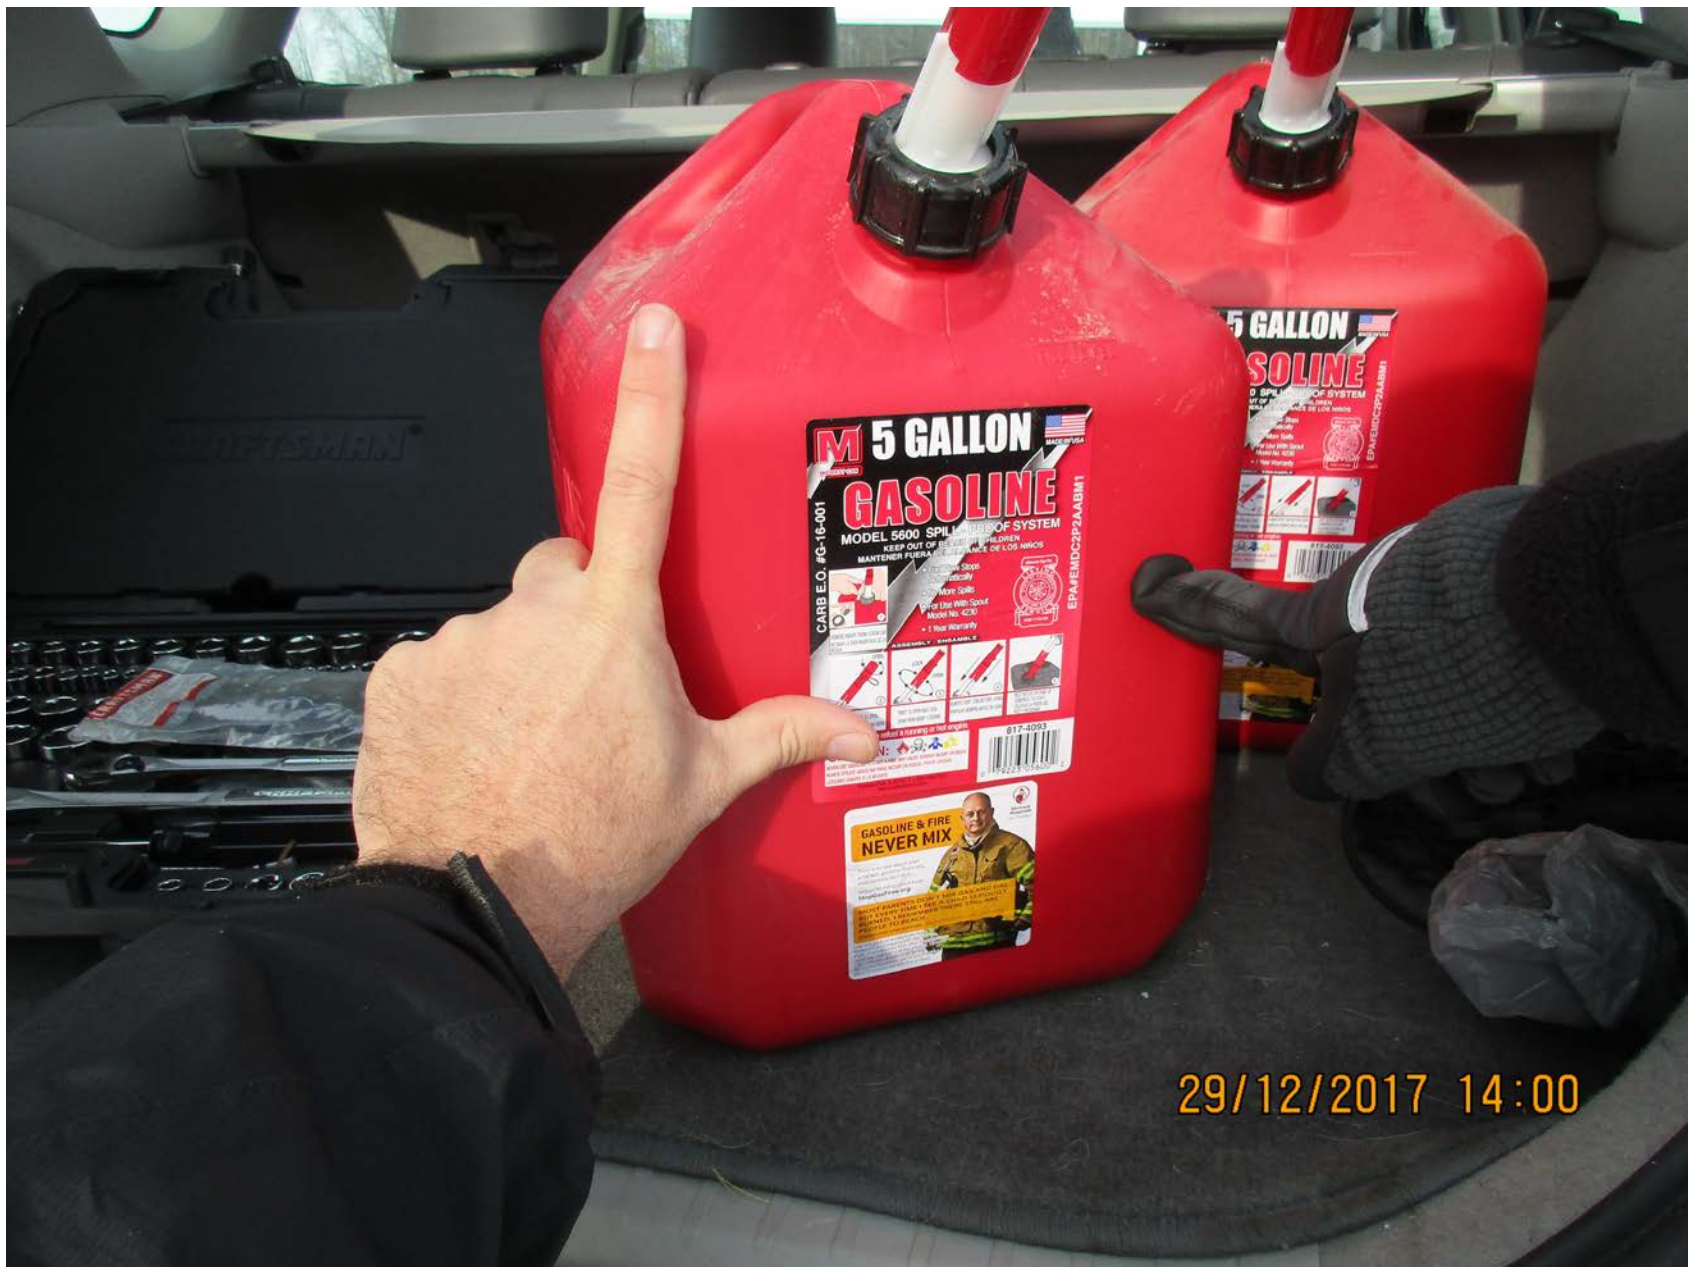
**Photo 14 - View of a 5-gallon container of recovered fuel from the left tank. The recovered fuel filled about half of the container.**

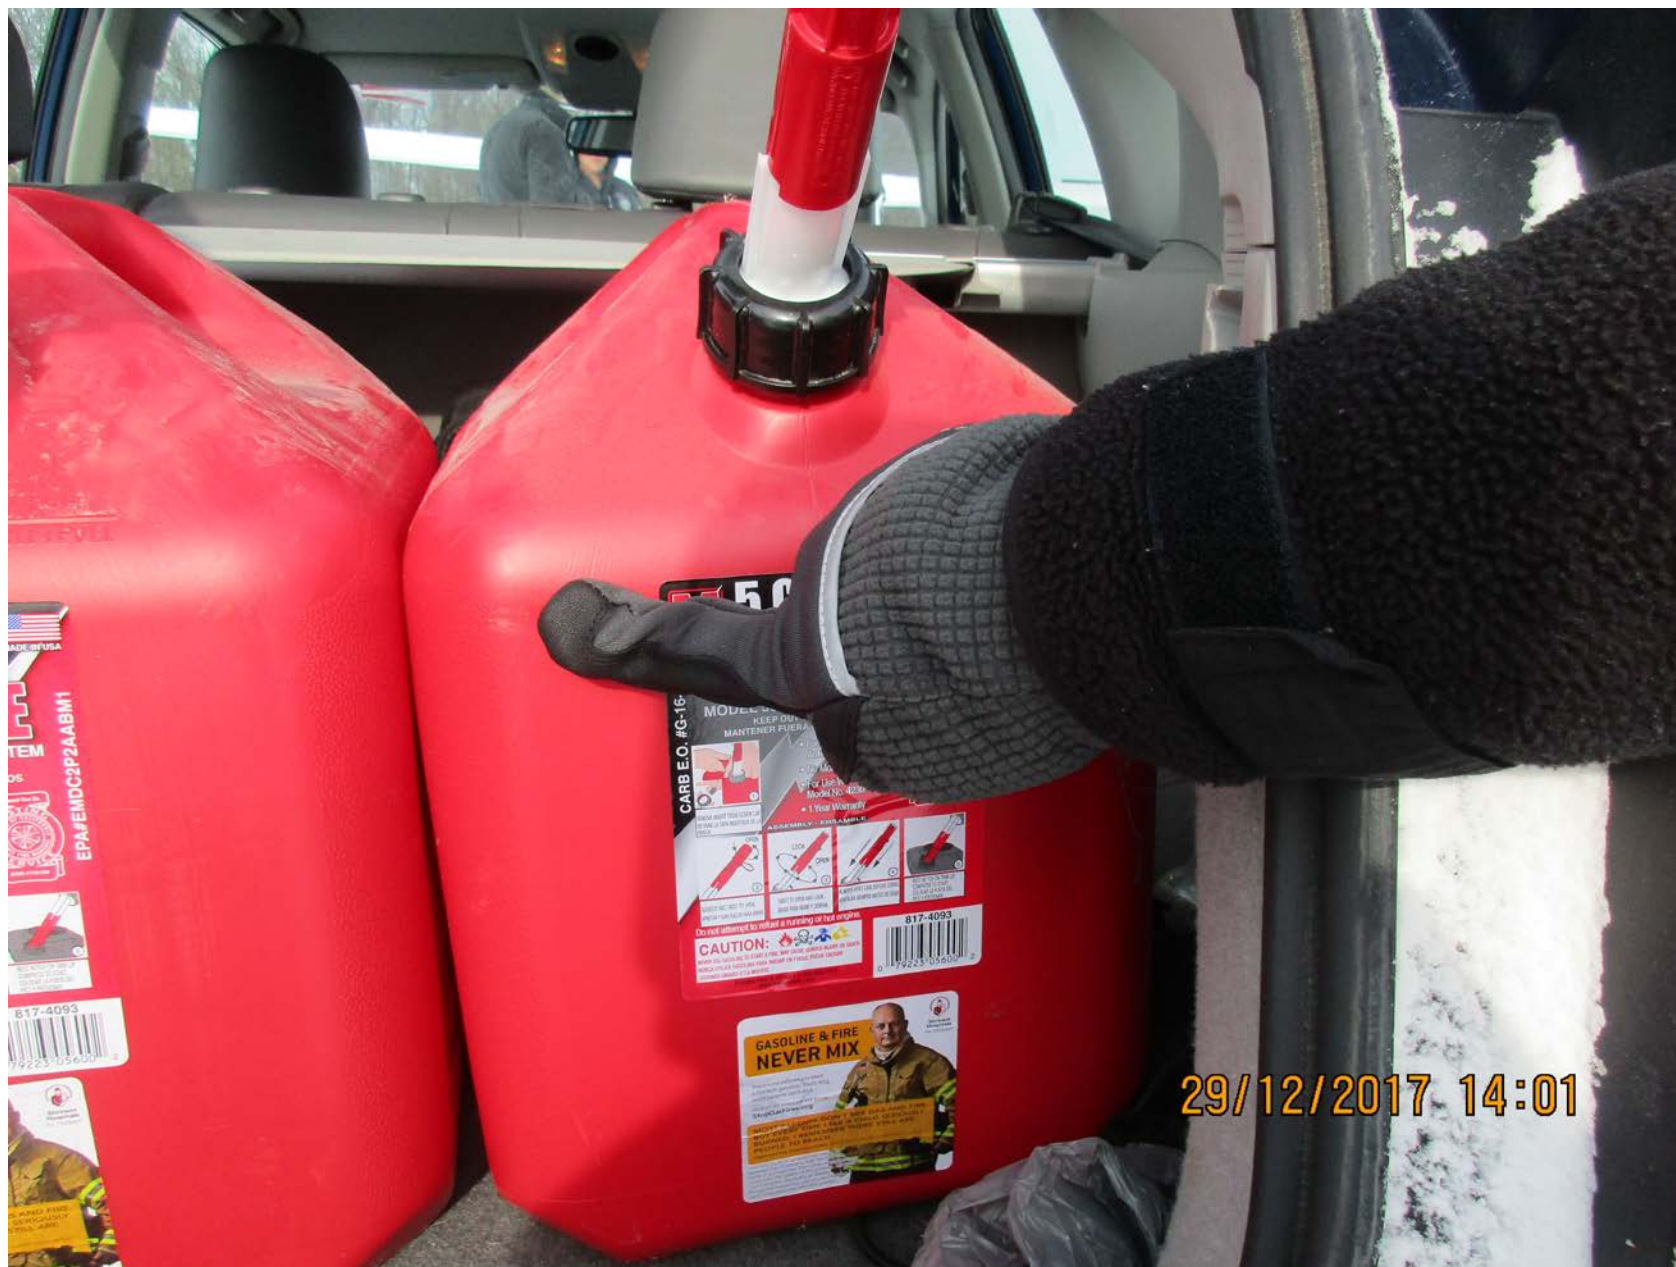
**Photo 15 - View of a 5-gallon container of recovered fuel from the right tank. The recovered fuel filled about three quarters of the container.**

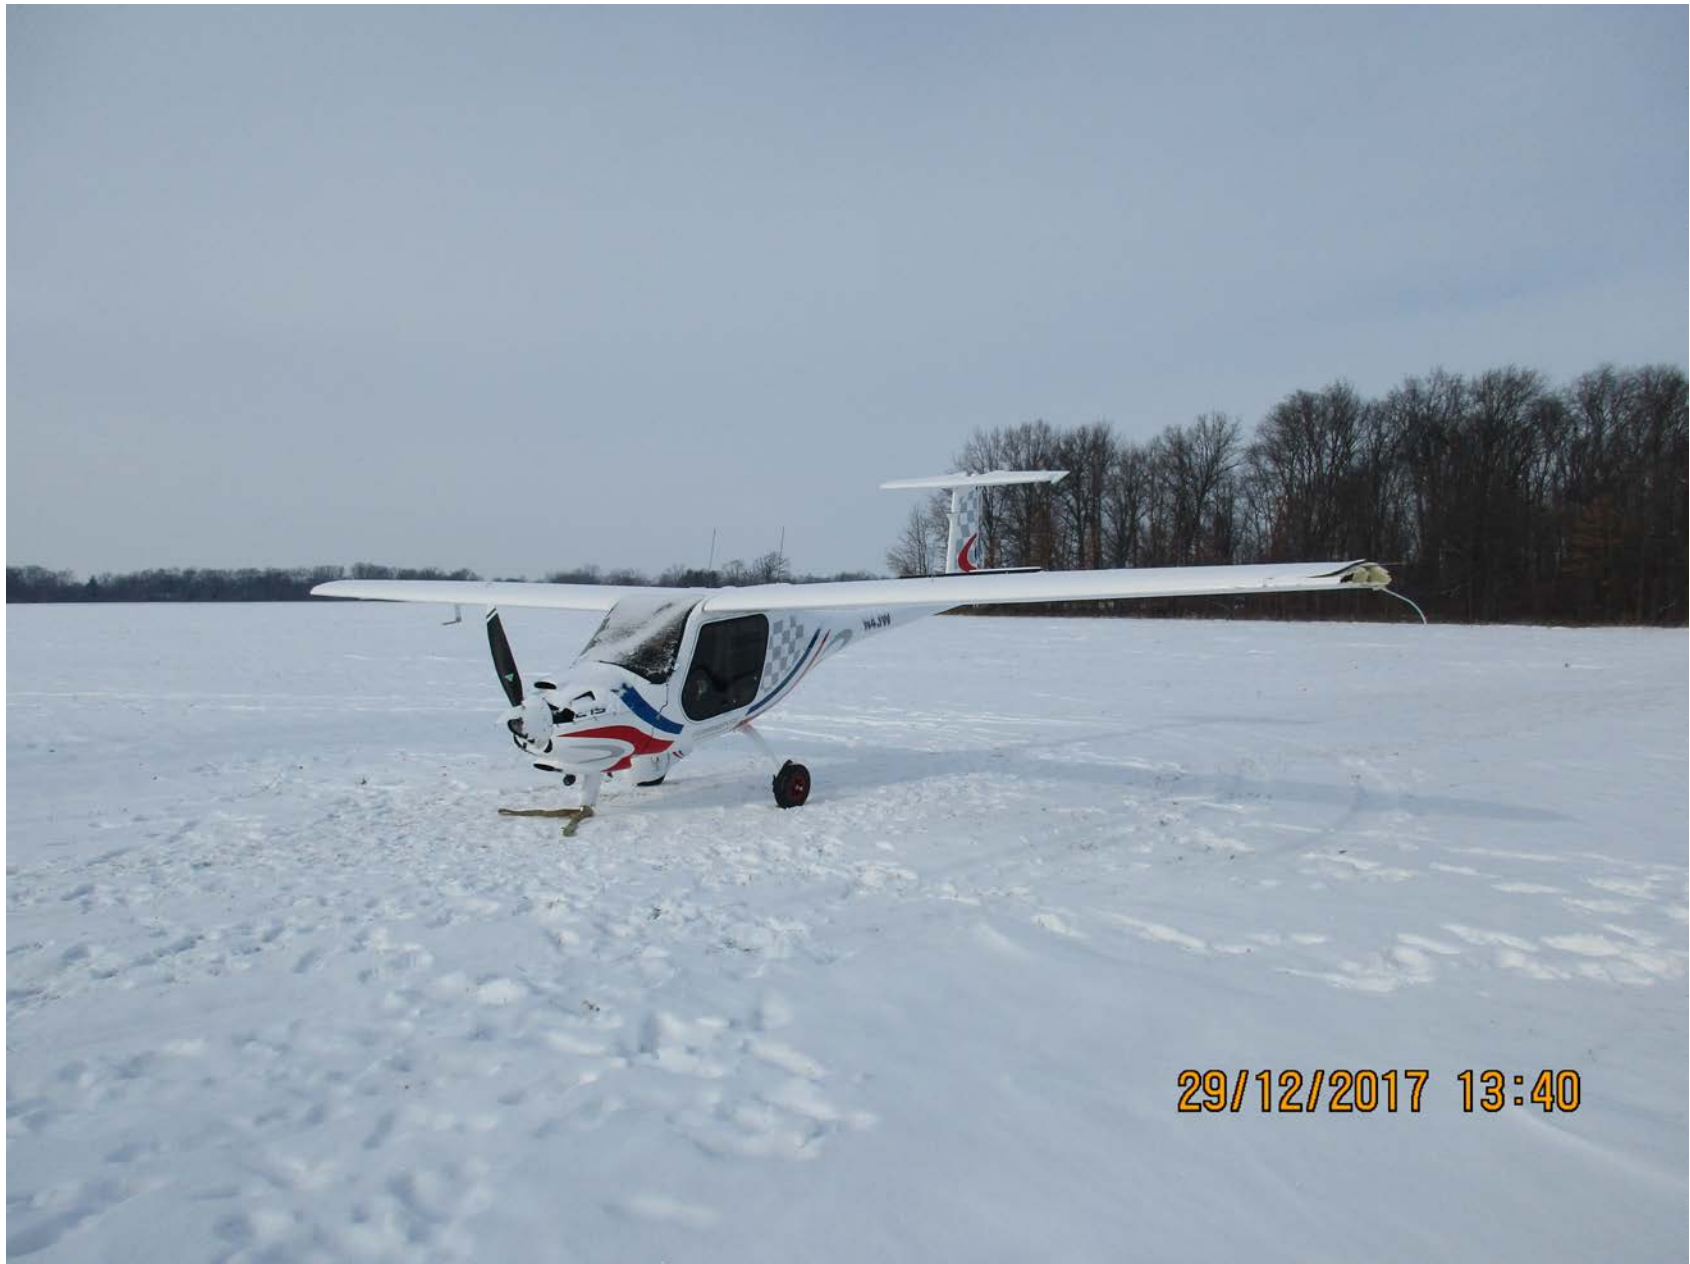
**Photo 16 - View of the aircraft in a snow-covered field.**
