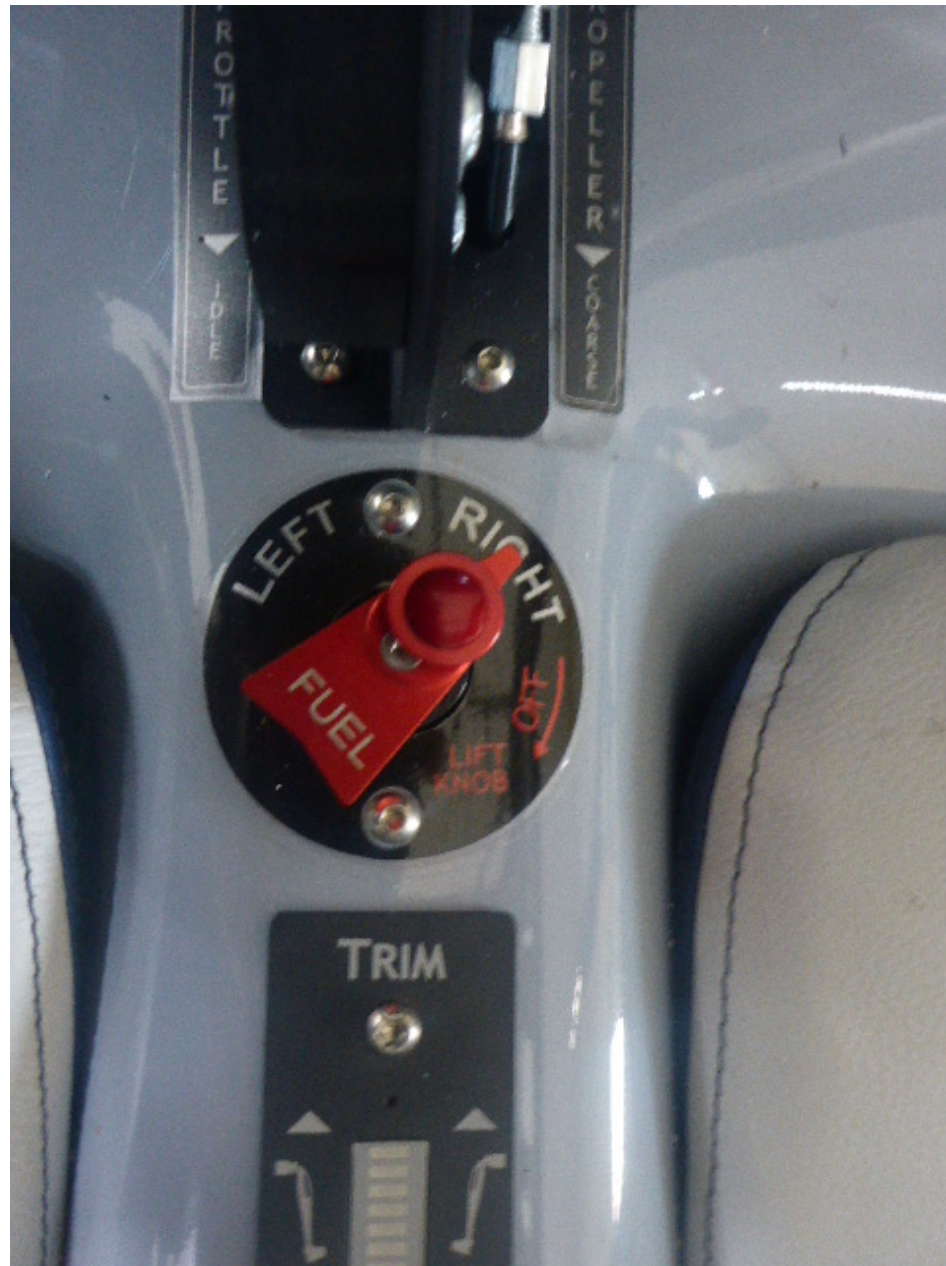
**Photo 17 - View of the fuel selector showing the right tank is selected.**

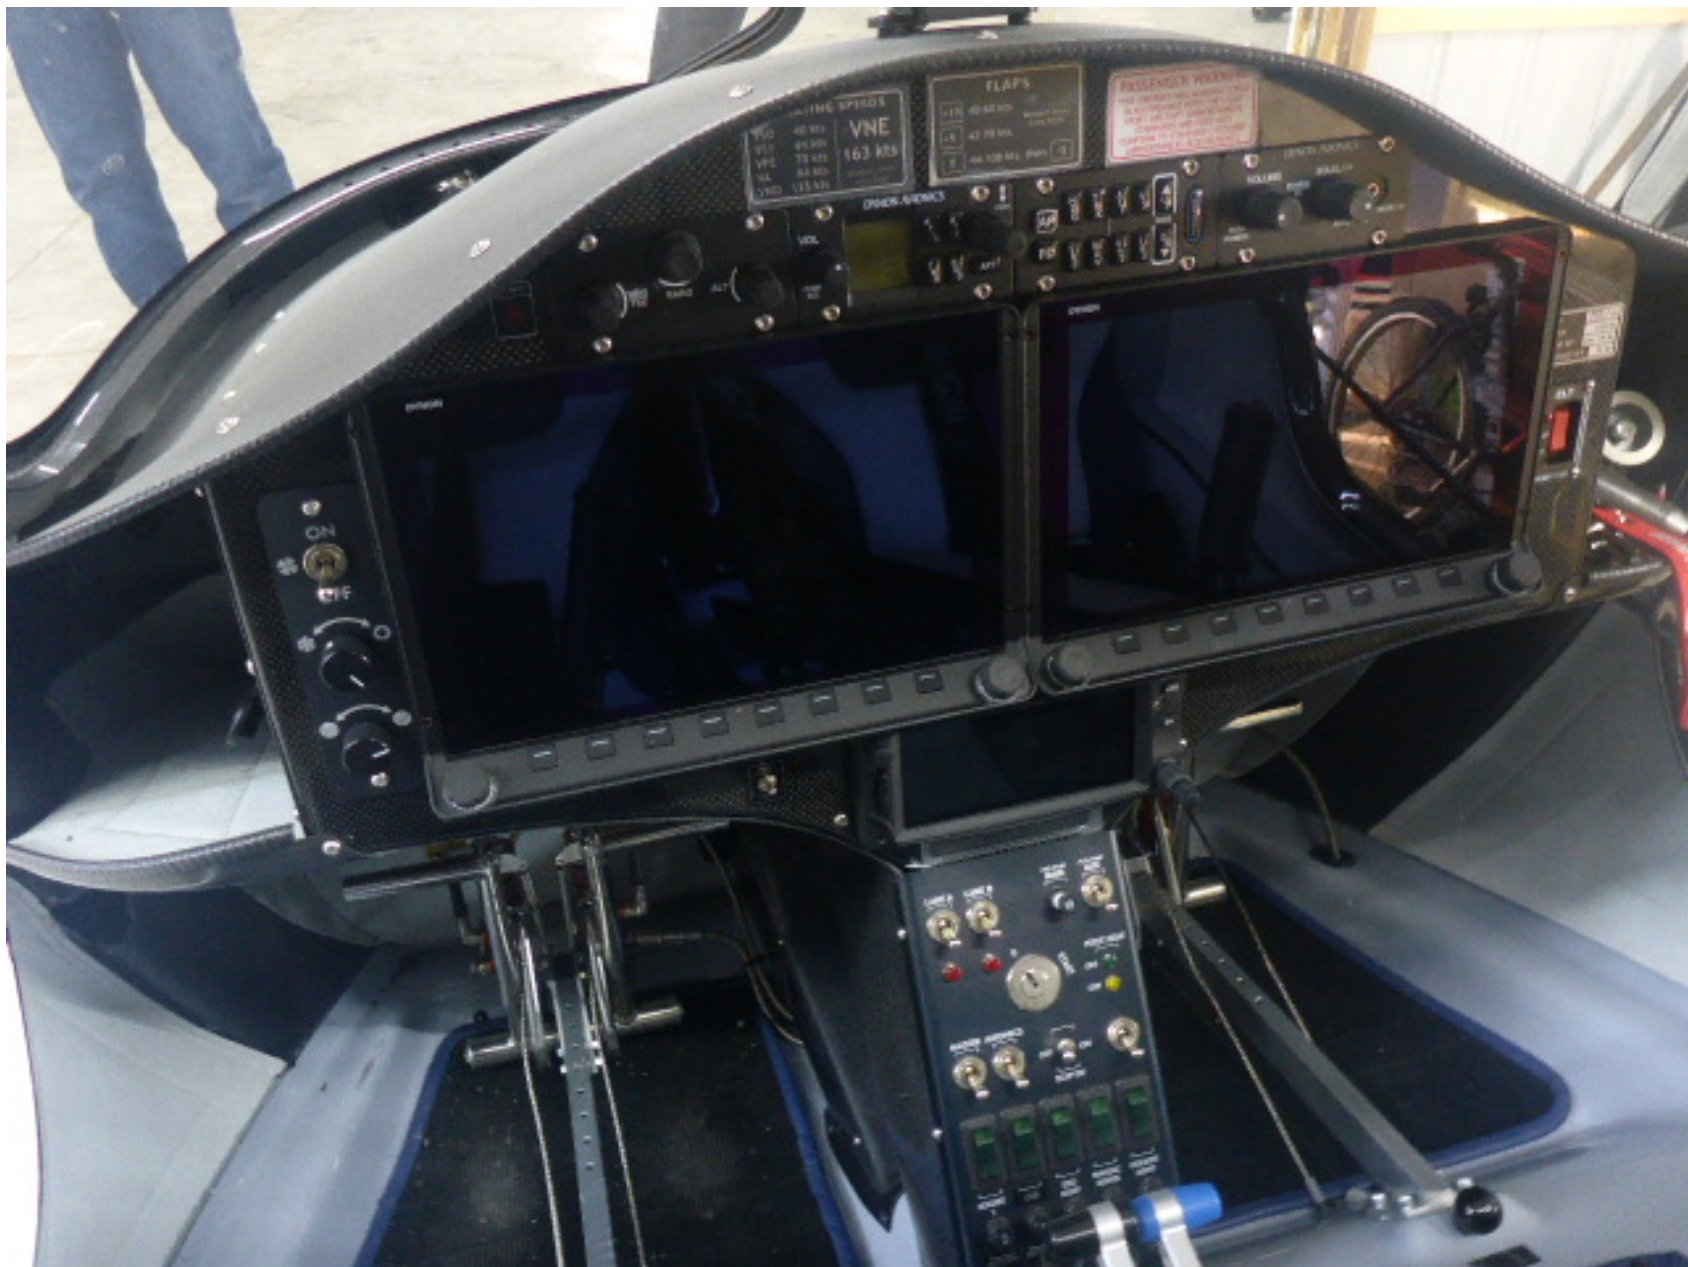
**Photo 18 - View of the Dynon units before they were removed.**

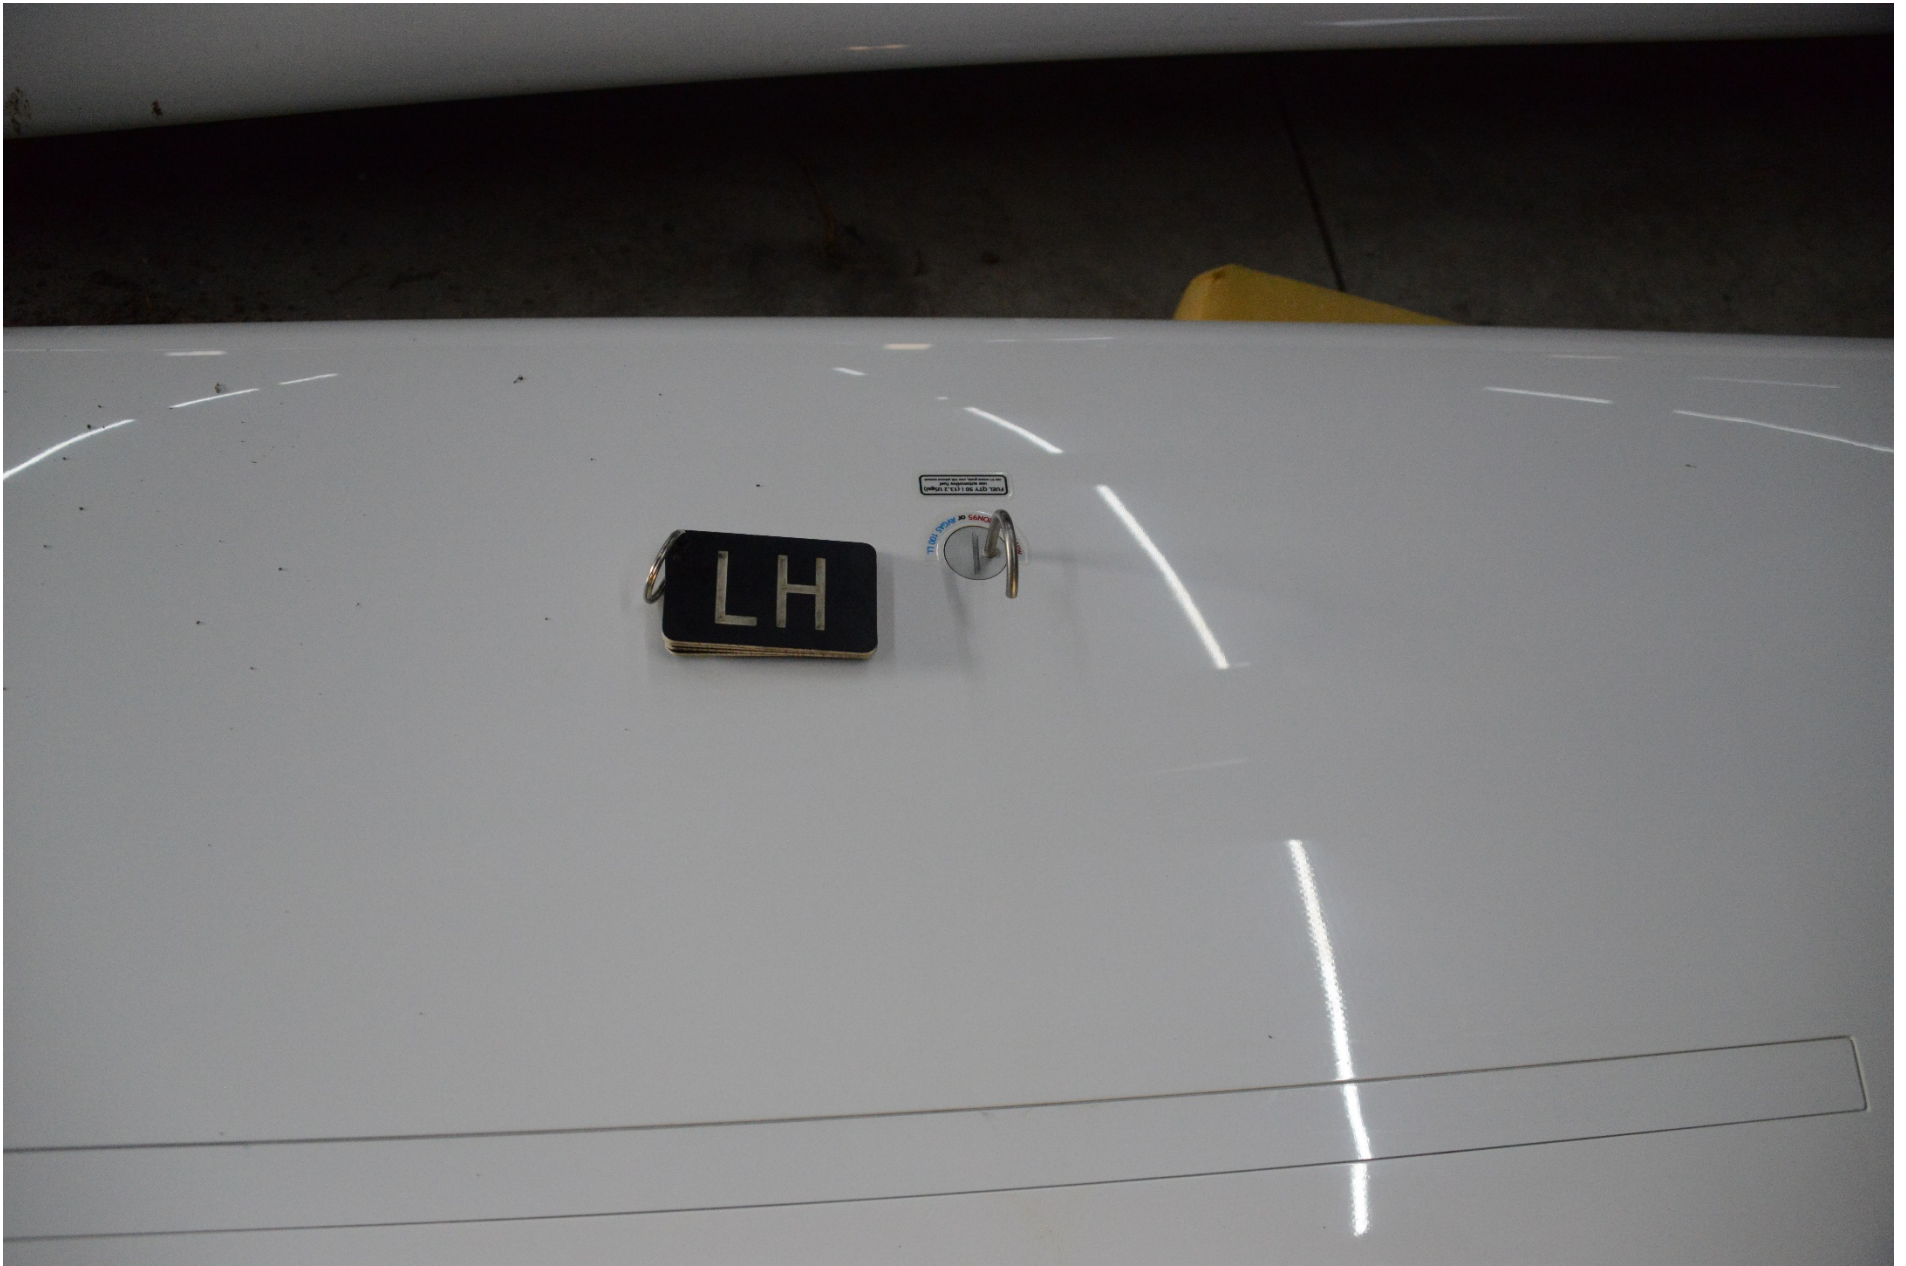
**Photo 19 - View of the left fuel tank filler neck cap and vent.**

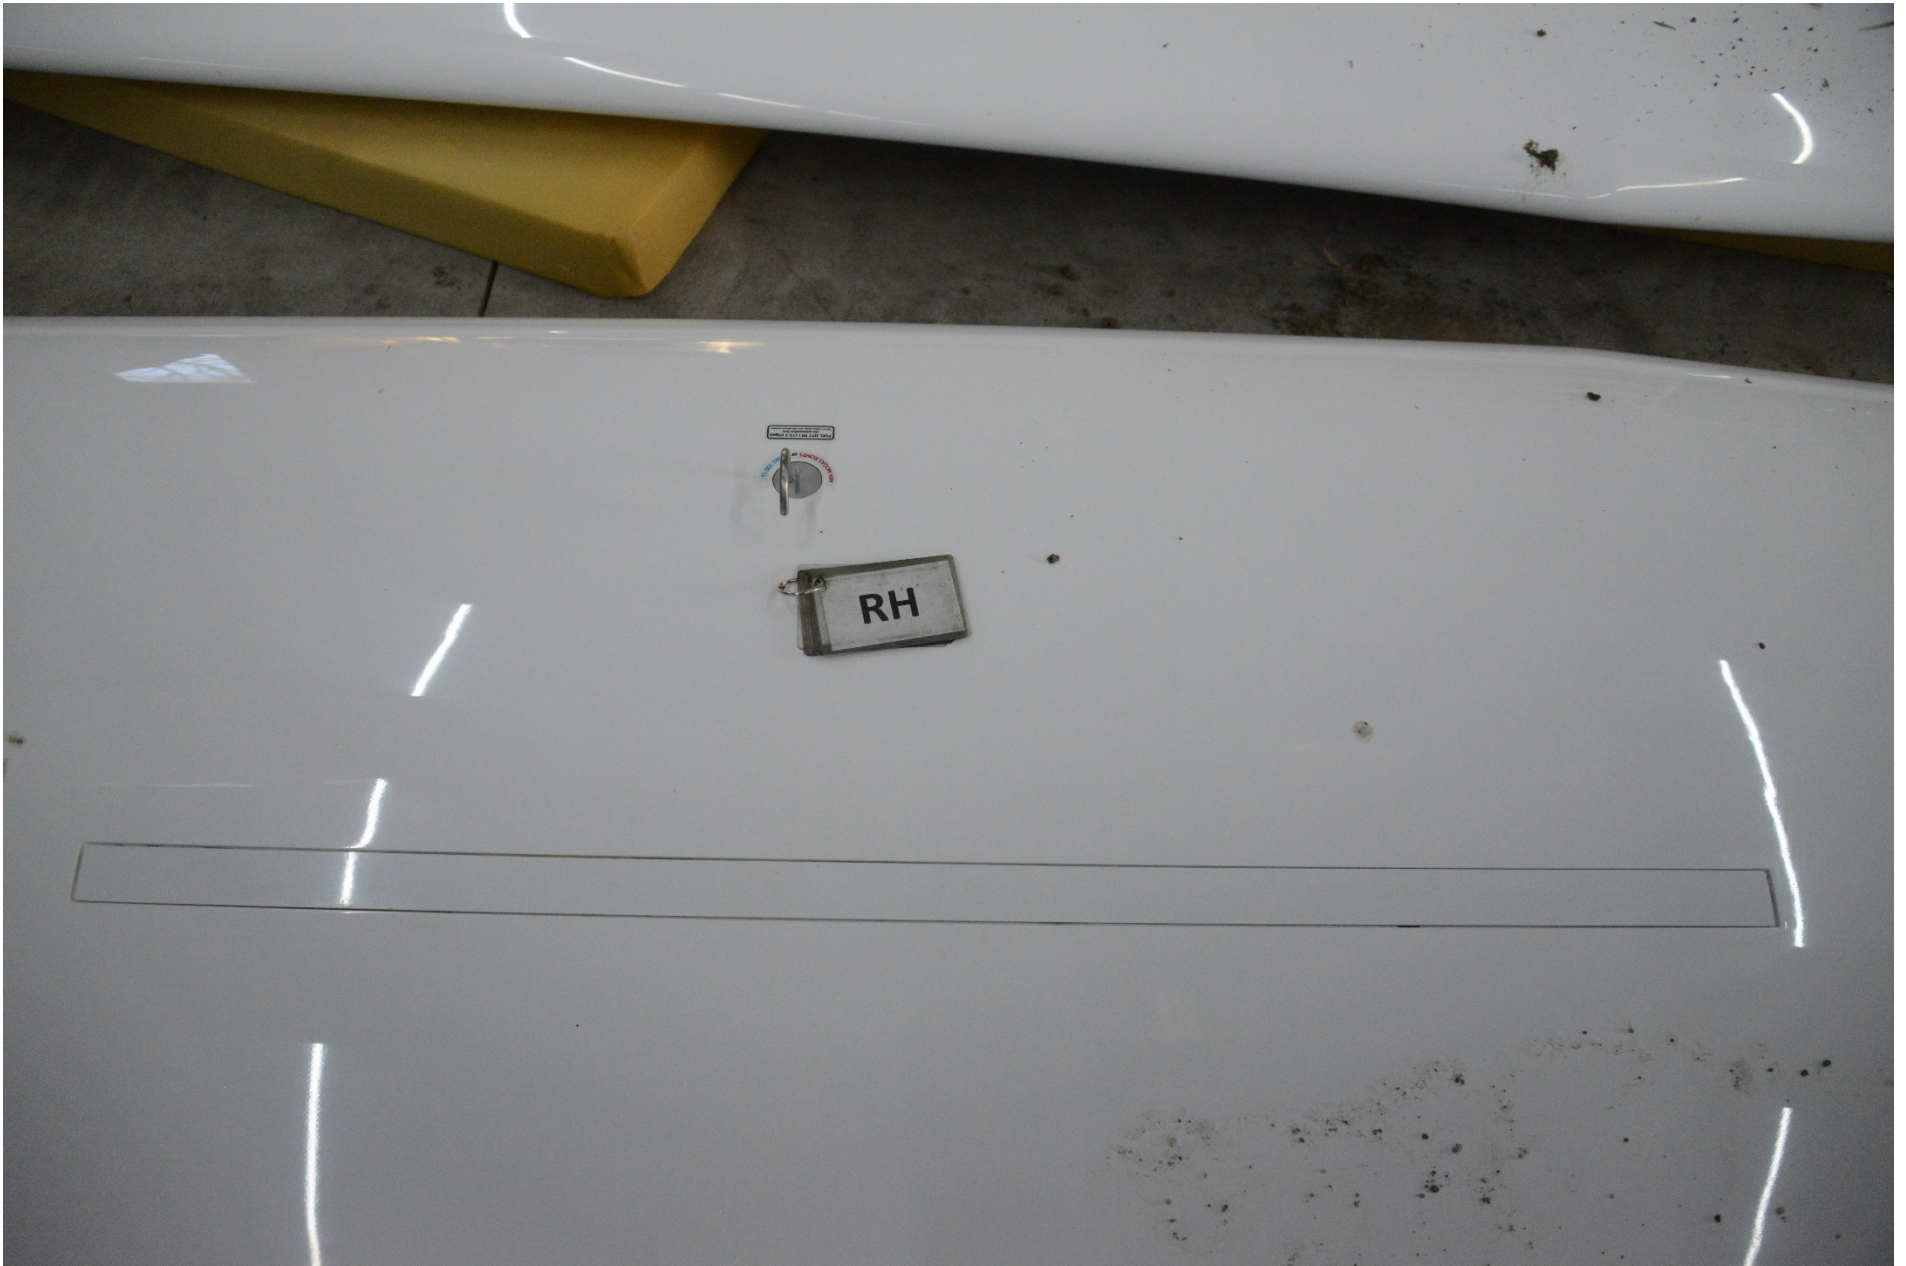
**Photo 20 - View of the right fuel tank filler neck cap and vent.**
