## **NATIONAL TRANSPORTATION SAFETY BOARD**

# **METEOROLOGY**

CEN18LA077

Location: Near Santa Fe, New Mexico  
Date: January 15, 2018  
Time: 1935 mountain standard time  
0235 Coordinated Universal Time (UTC) on January 16, 2018  
Aircraft: Velocity XL-RG, Registration: N787SB

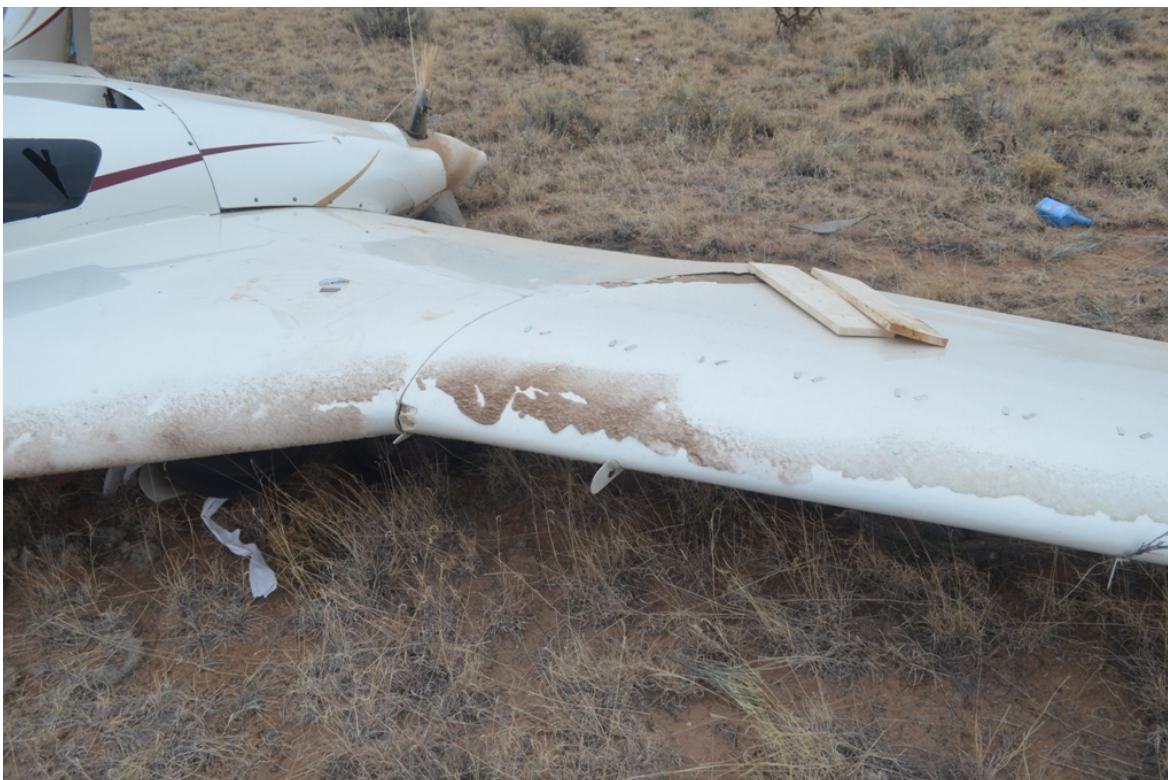
Several accident scene pictures were taken by an FAA inspector the morning after the accident and show the ice accretion on the accident airplane (figures 14, 15, 16, 20, and 21). In addition, chunks of ice that had been on the accident airplane were found on the ground located near the final accident site location (figures 17, 18, and 19).

**Figure 14 – Accident scene picture of ice accretion on the left wing**

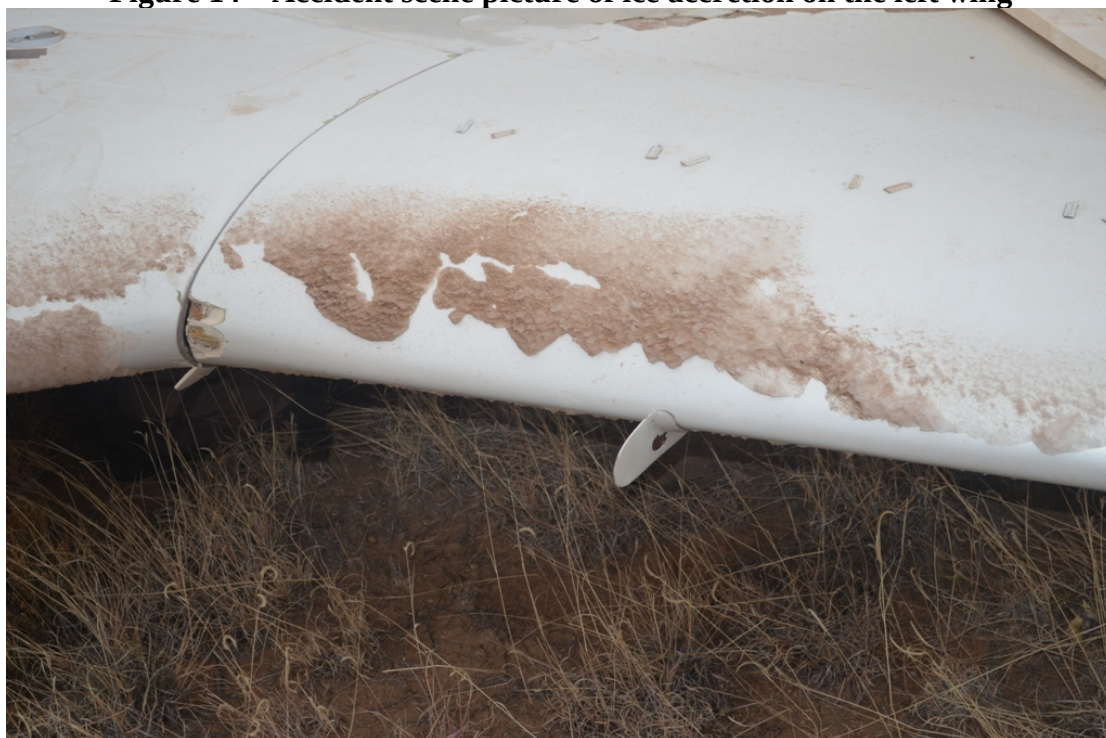
**Figure 15 – Accident scene picture of ice accretion on the left wing**

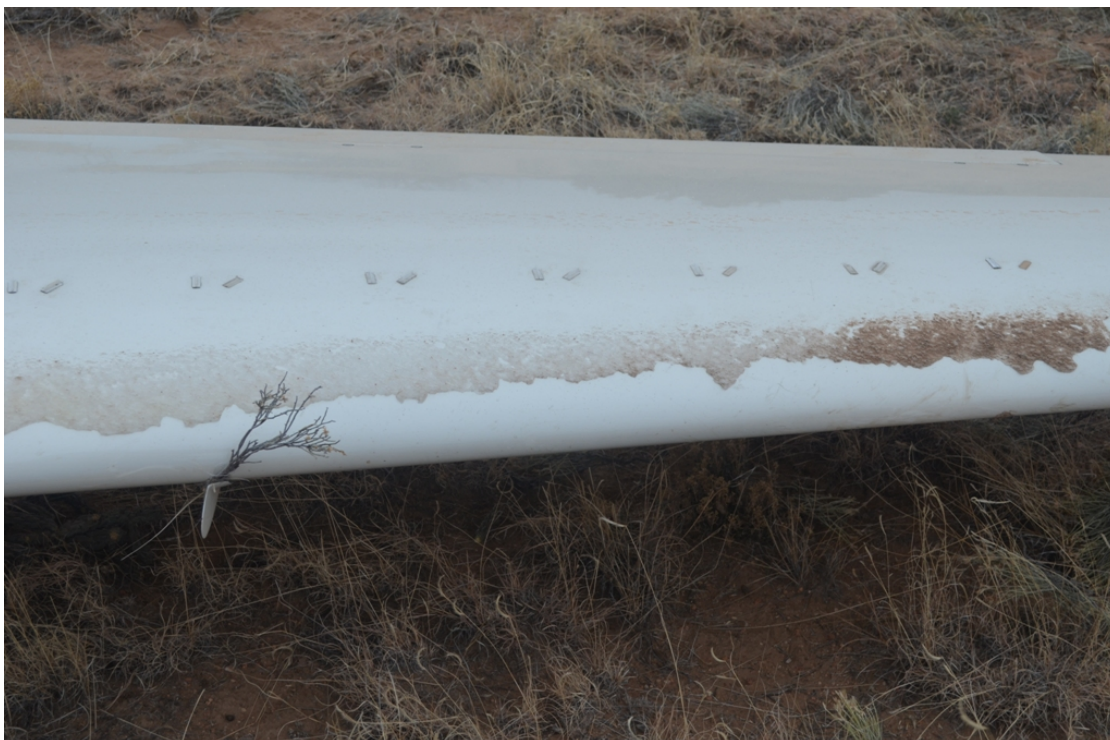
**Figure 16 – Accident scene picture of ice accretion on the left wing**

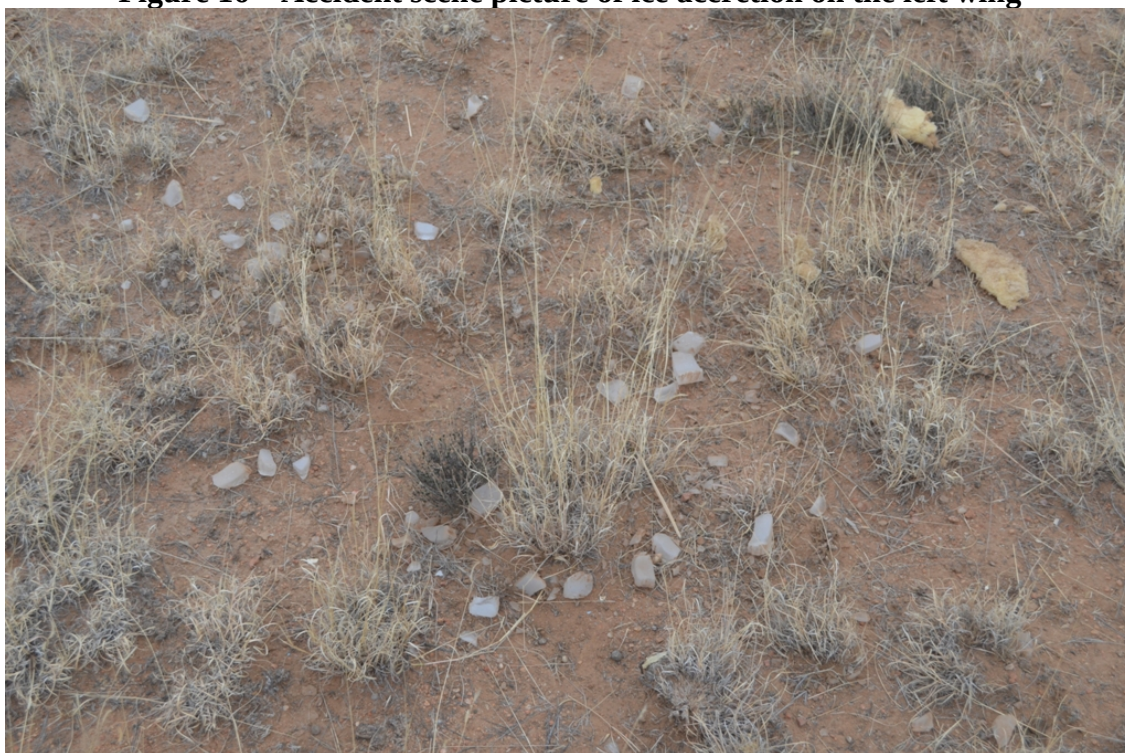
**Figure 17 – Accident scene picture of ice chunks that had fallen off the accident plane on the ground**

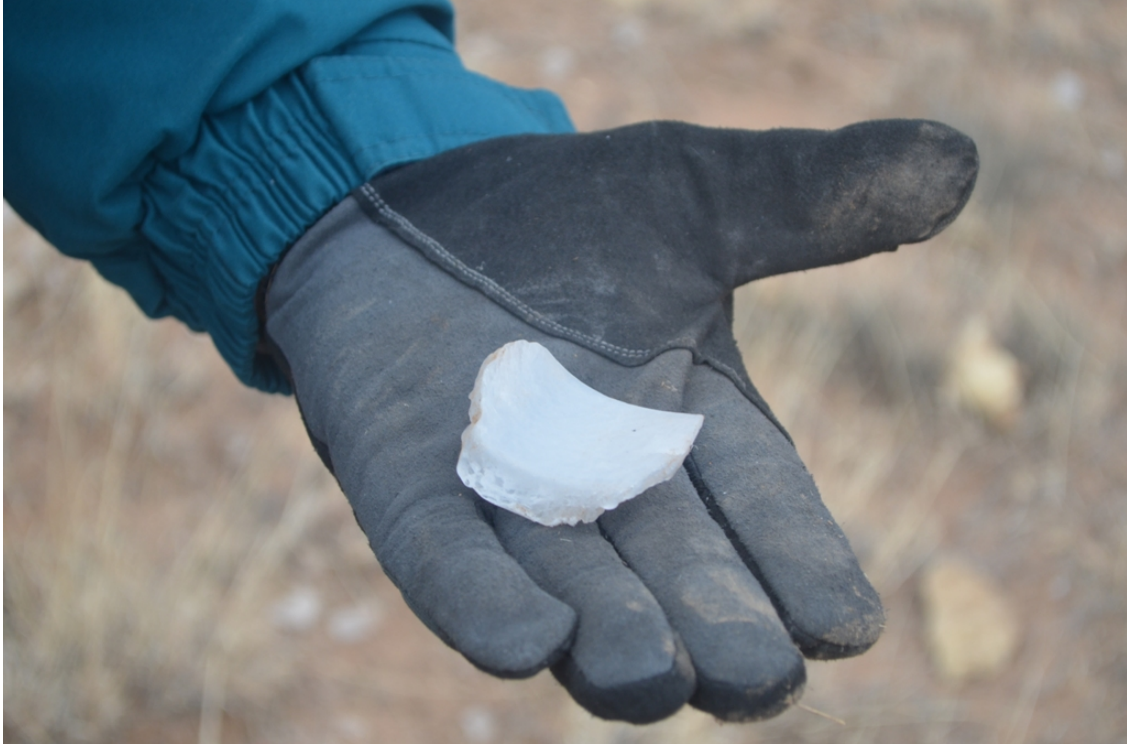
**Figure 18 – Accident scene picture of an ice chunk that had fallen off the accident plane on the ground**

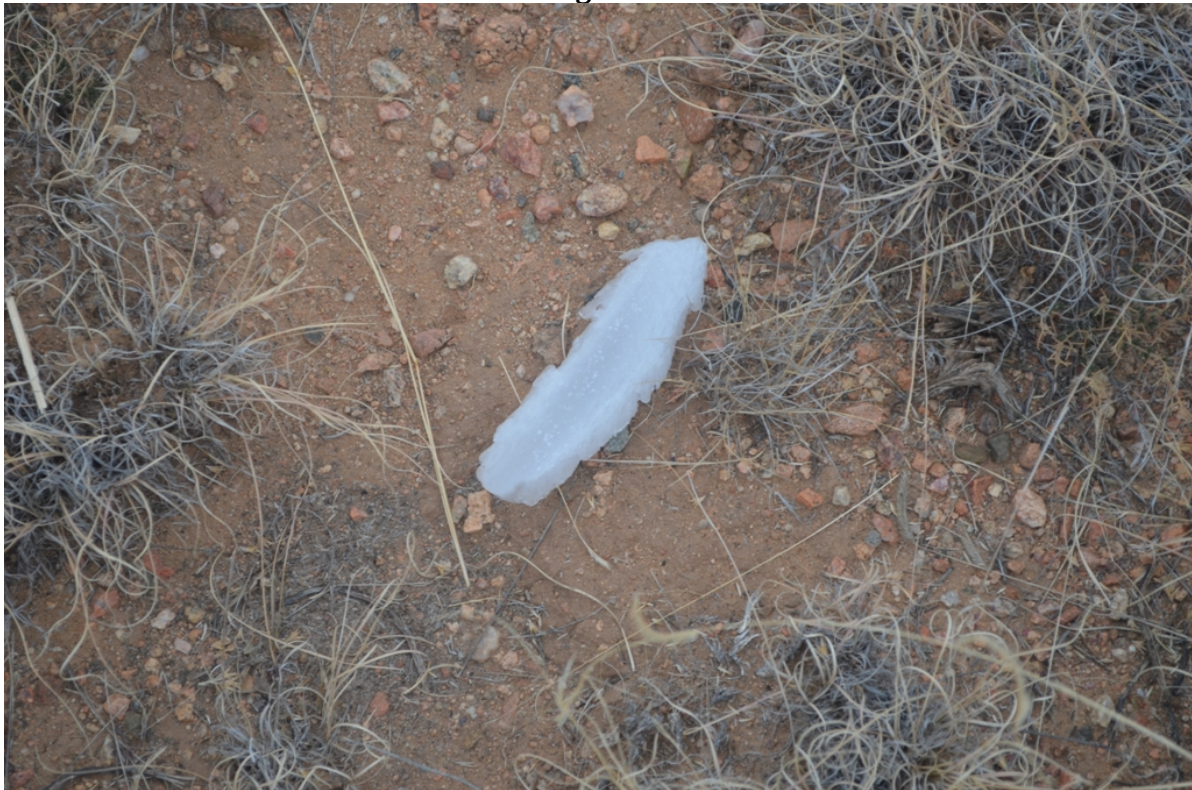
**Figure 19 – Accident scene picture of an ice chunk that had fallen off the accident plane on the ground**

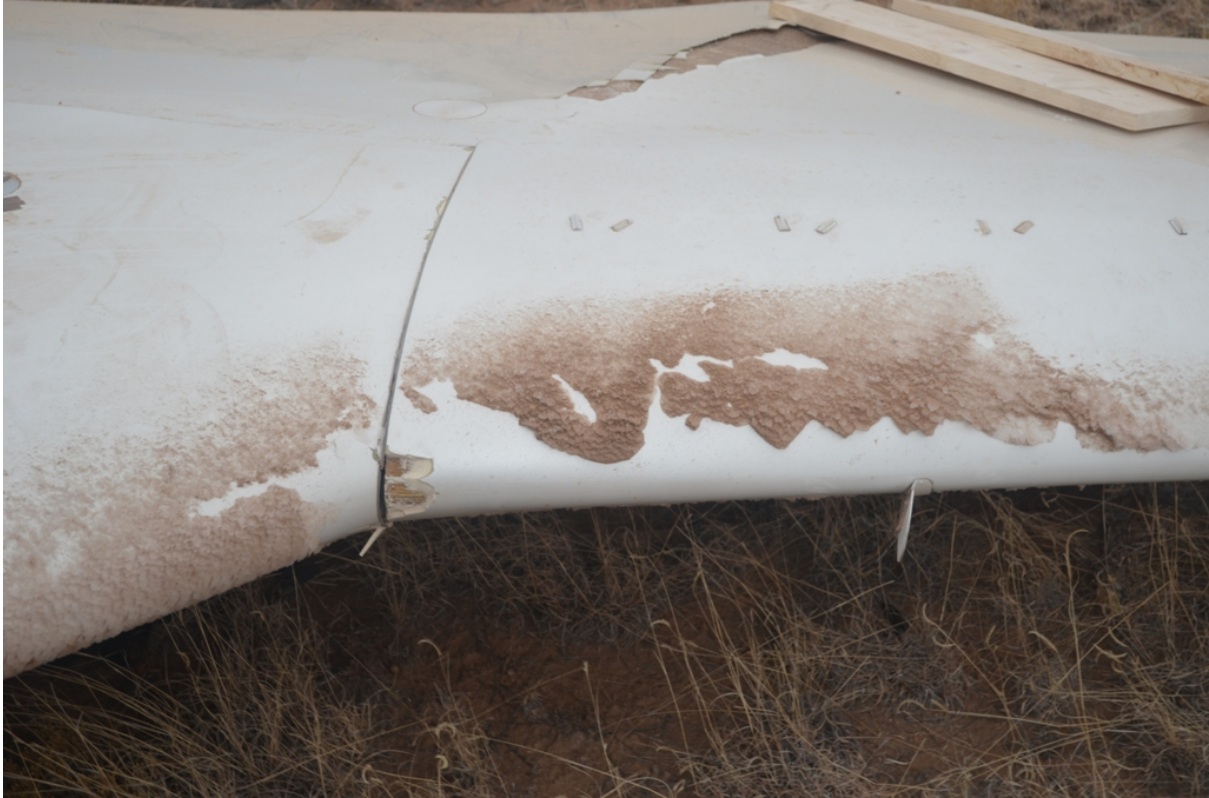
**Figure 20 – Accident scene picture of ice accretion on the left wing**

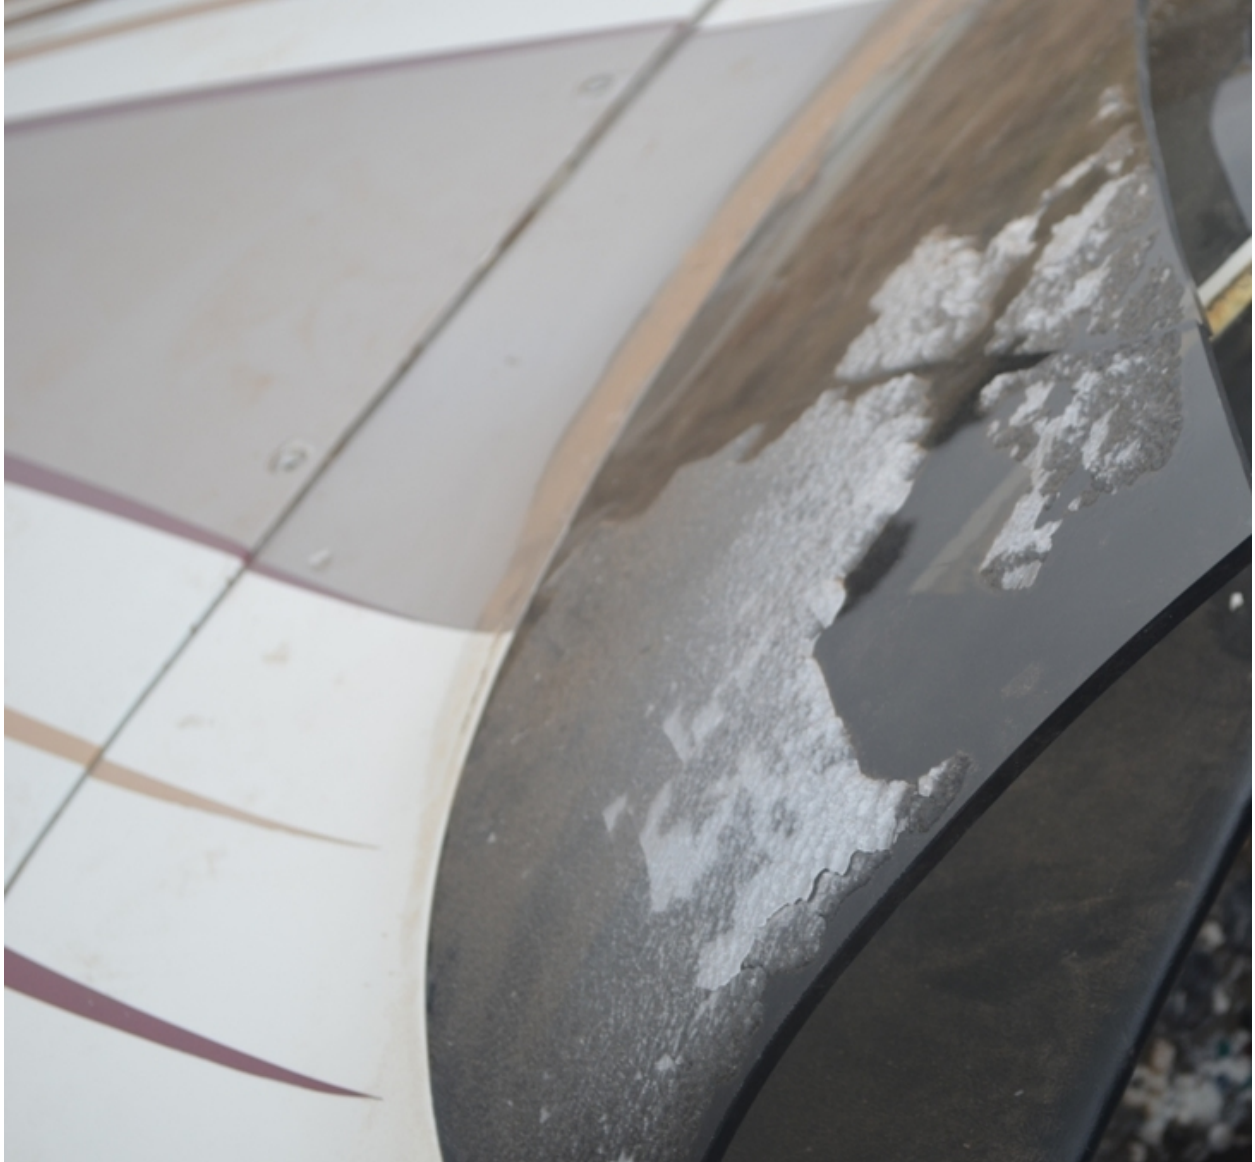
**Figure 21 – Accident scene picture of ice accretion on the front windshield**
