# Continental Motors

## ENGINE EXAMINATION REPORT

| ENGINE MODEL | IO520BB10B |
| FILE NUMBER | 17-603 |

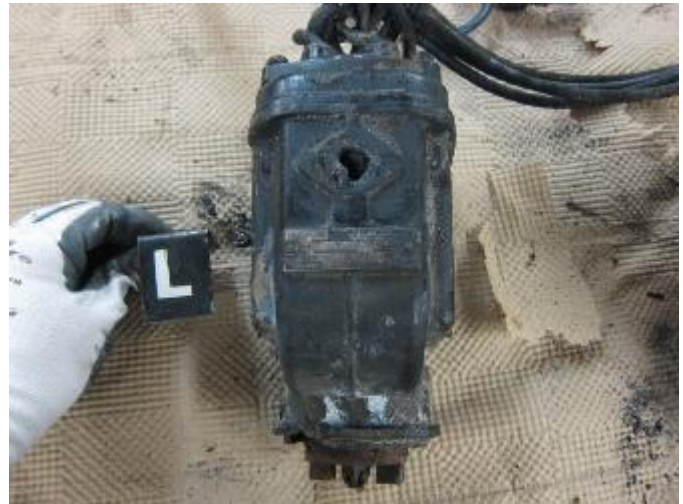
**LEFT  
MAGNETO**

The left Magneto was thermally damaged and detached from its mounting pad.

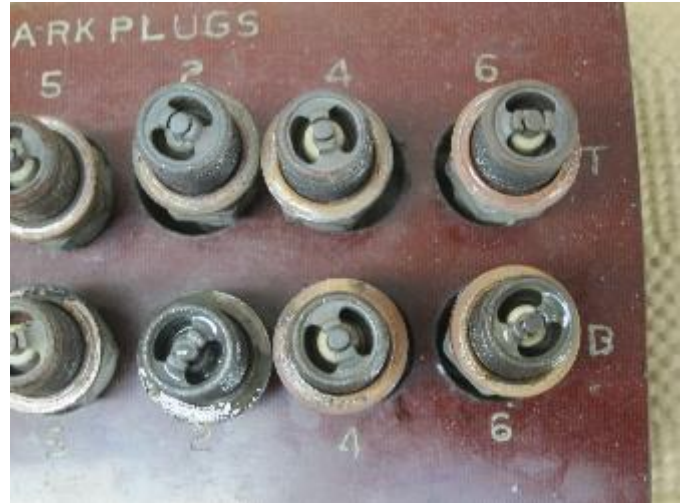
**PAGE 8 of 40****SPARK PLUGS**

The spark plugs exhibited normal operating signatures.

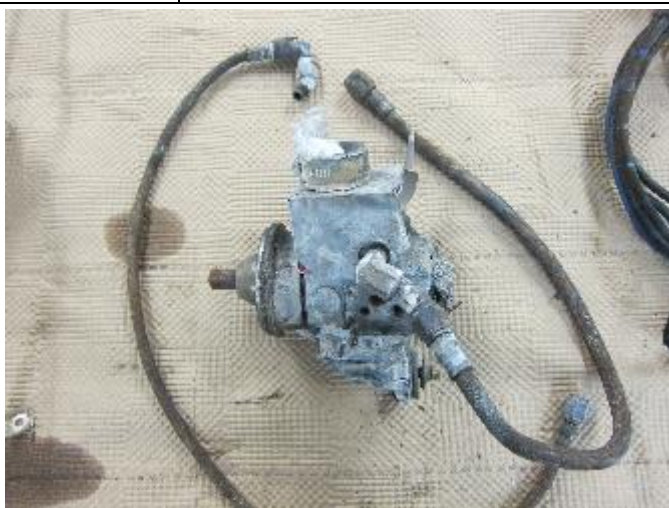
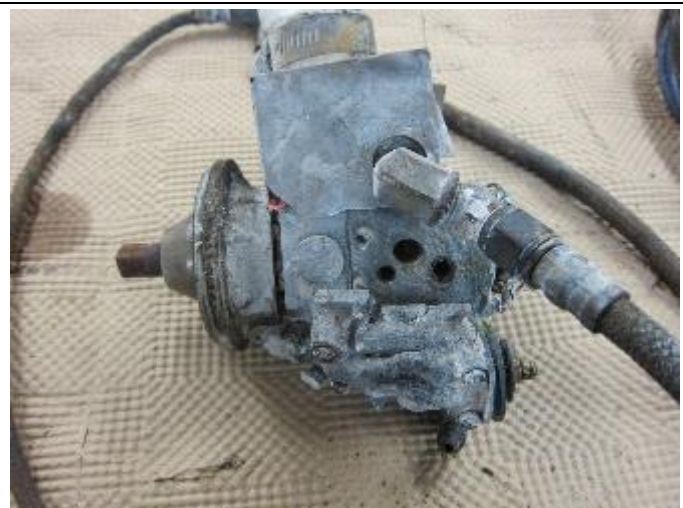
**FUEL PUMP**

The fuel pump was thermally damaged and would not rotate. The drive coupling was intact.

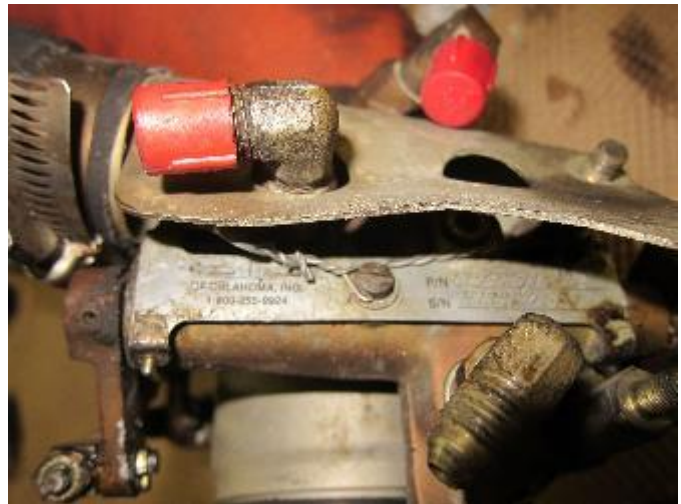
## THROTTLE BODY METERING UNIT

The throttle body had mechanical and thermal damage.

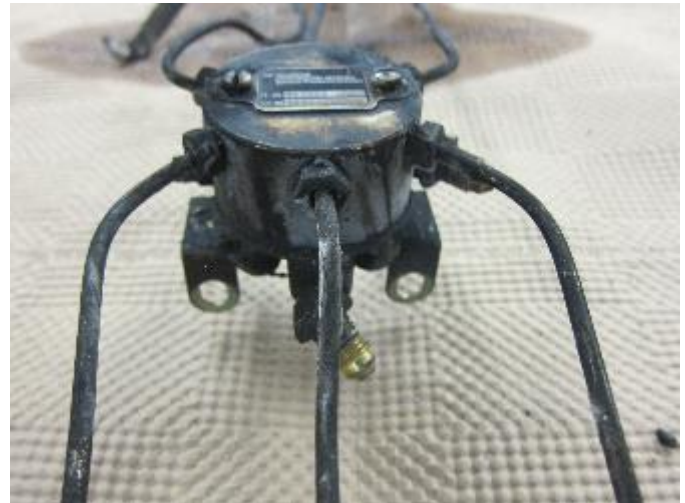
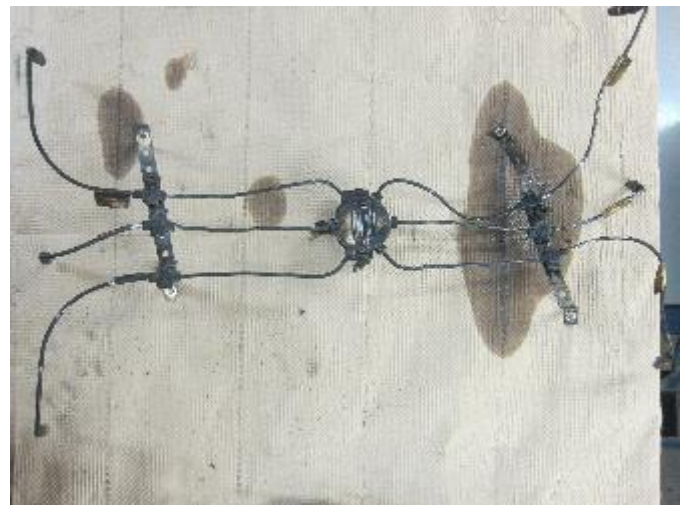
## FUEL MANIFOLD VALVE

Condition: Exhibited thermal damage to the body lines and nozzles.

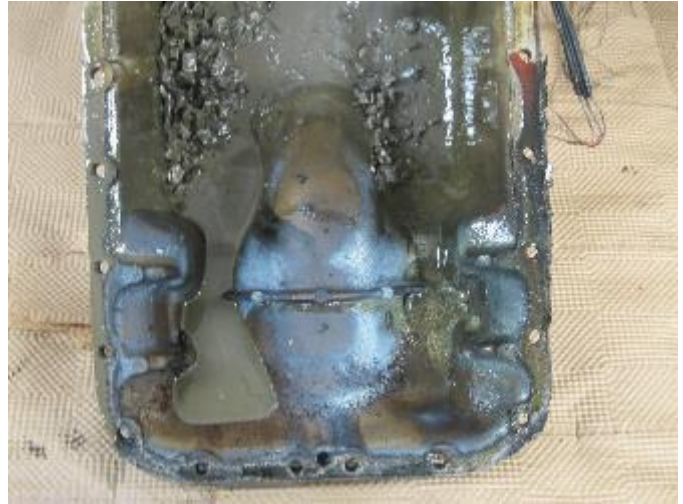
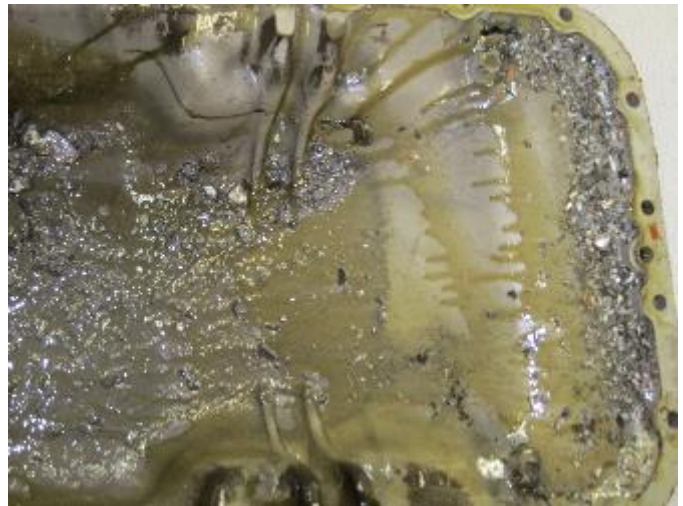
#### OIL SUMP

Exhibited thermal damage and contained fragments of the internal engine components

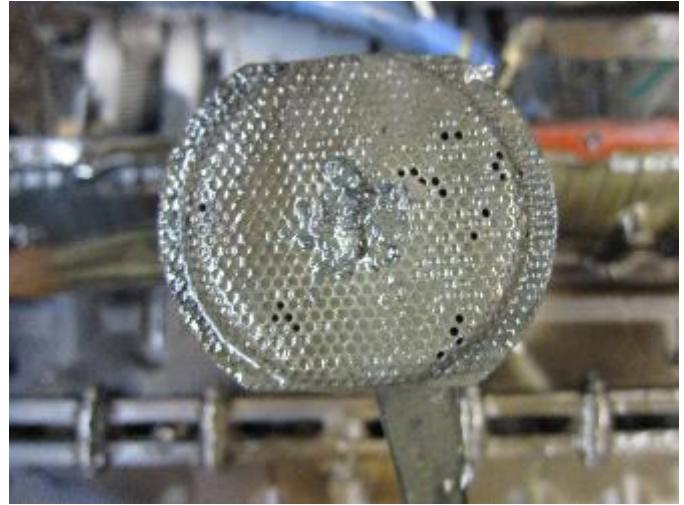
### OIL PICK-UP TUBE & SCREEN

The oil pick-up tube was undamaged and contained small fragments of the internal engine components.

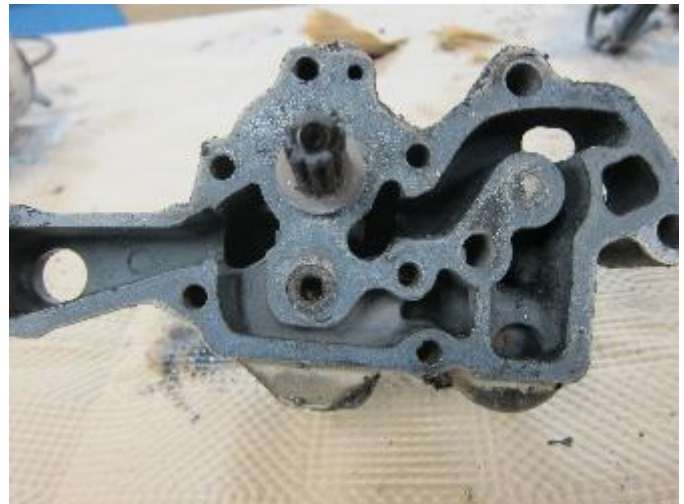
### OIL PUMP

Was intact and exhibited thermal damage. The oil pump drive was intact.

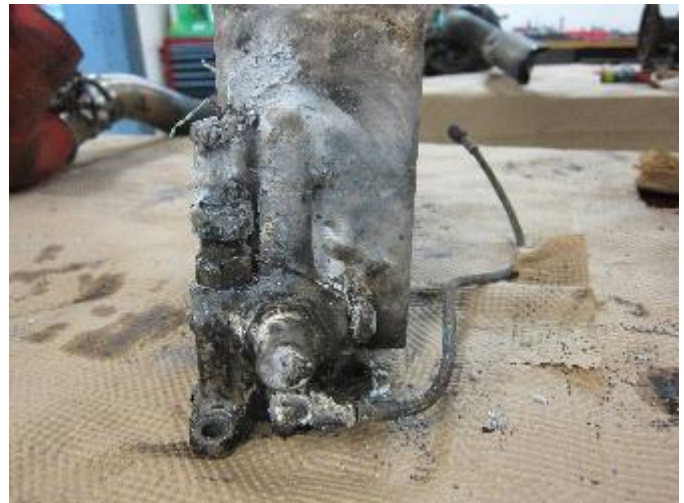
## OIL COOLER

Exhibited thermal damage.

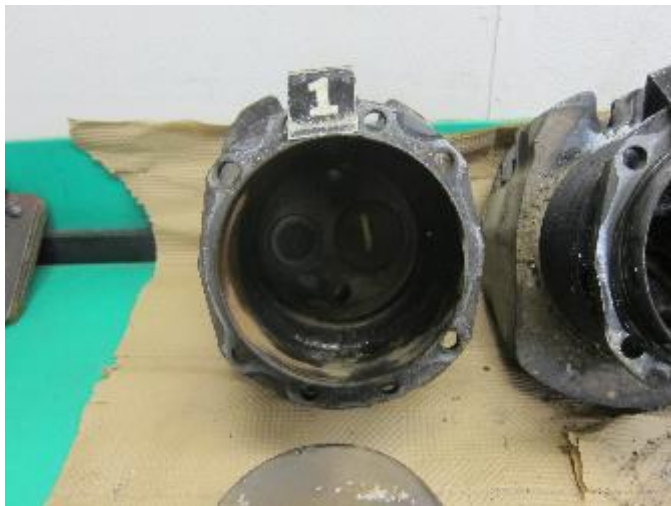
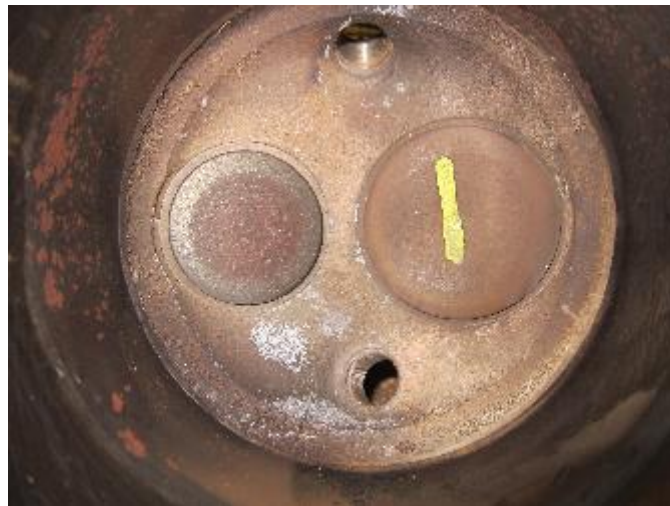
| <b>CYLINDER #1</b> | P/N: 658175A1 | S/N: AC14DA612 | Head Date: 4-14 |

| <b>Condition</b> | The cylinder exhibited normal operating signatures. Externally thermal damage was present. | | |

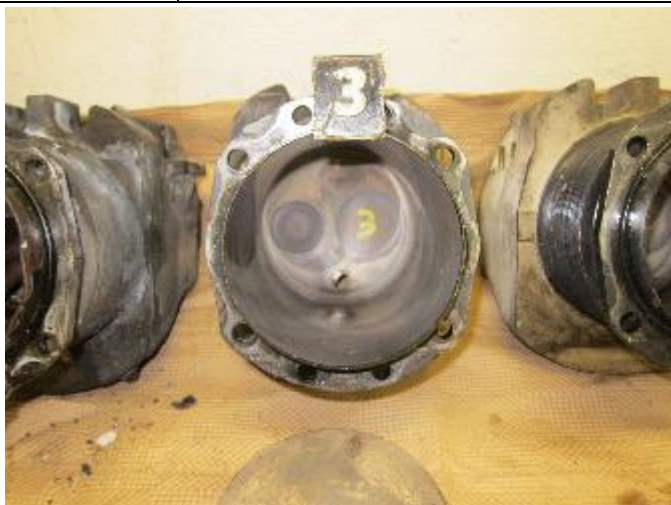
| <b>CYLINDER #3</b> | P/N: 658175A1 | S/N: AC14DA614 | Head Date: 4-14 |

| <b>Condition:</b> | The cylinder exhibited normal operating signatures. Externally thermal damage was present. | | |

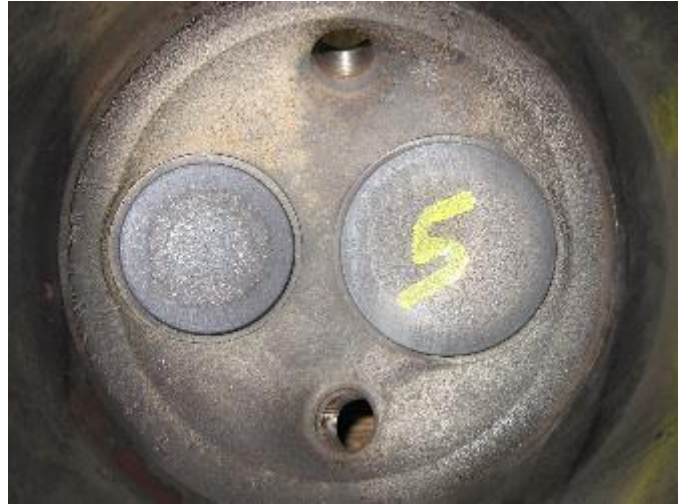
| <b>CYLINDER #5</b> | P/N: 658175A1 | S/N: AC14DA618 | Head Date: 4-14 |

| Condition: | The cylinder exhibited normal operating signatures. Externally thermal damage was present. |

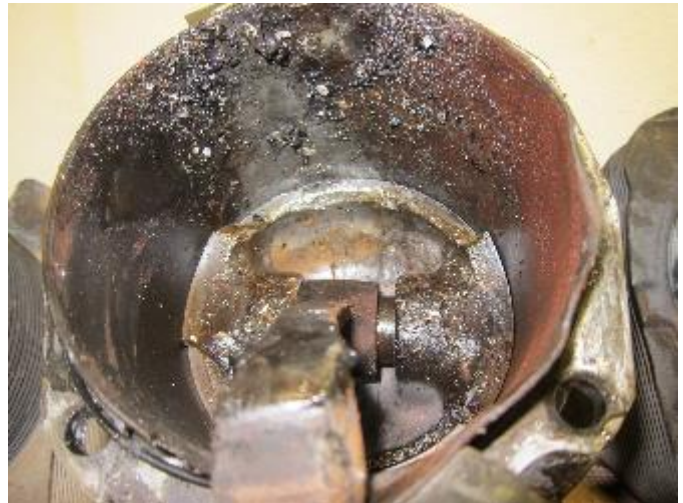
| <b>CYLINDER #2</b> | P/N: 658175A1 | S/N: AC14DA935 | Head Date: 4-14 |

| Condition: | The cylinder had impact damage from the connecting rod that released from the crankshaft. Externally thermal damage was present. |

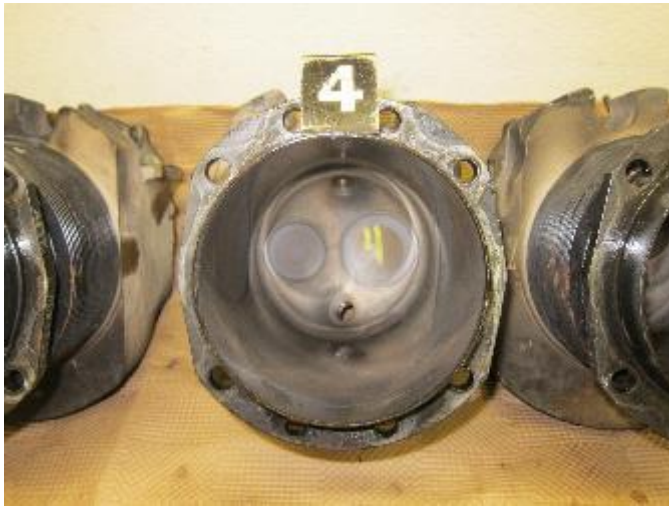
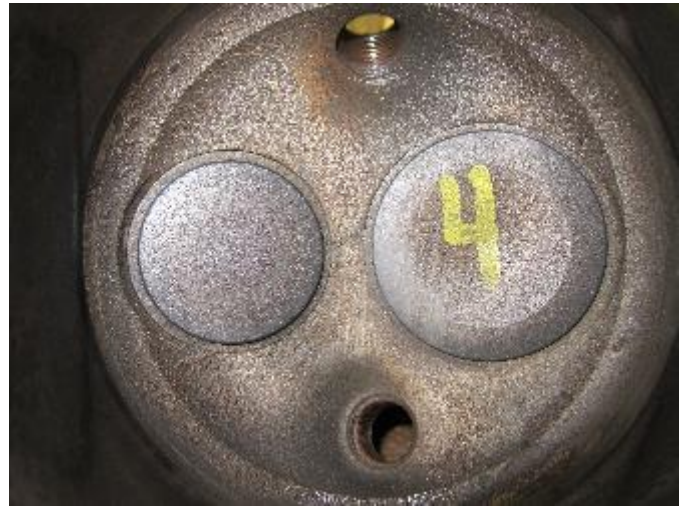
| <b>CYLINDER #4</b> | P/N: 658175A1 | S/N: AC14DA539 | Head Date: 4-14 |

| Condition: | The cylinder exhibited normal operating signatures. Externally thermal damage was present. |

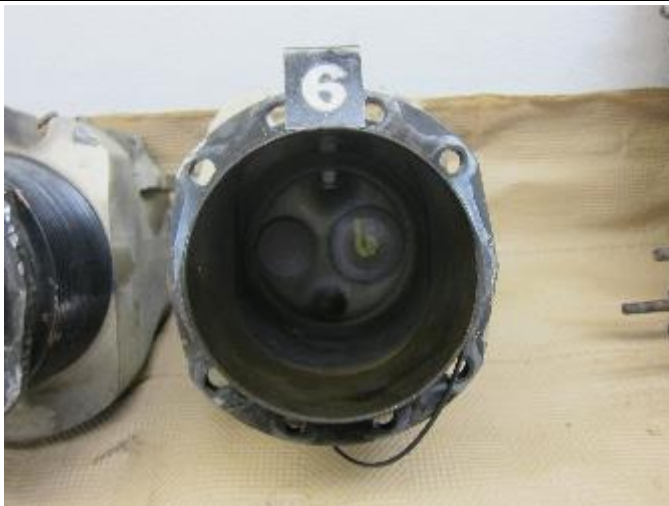
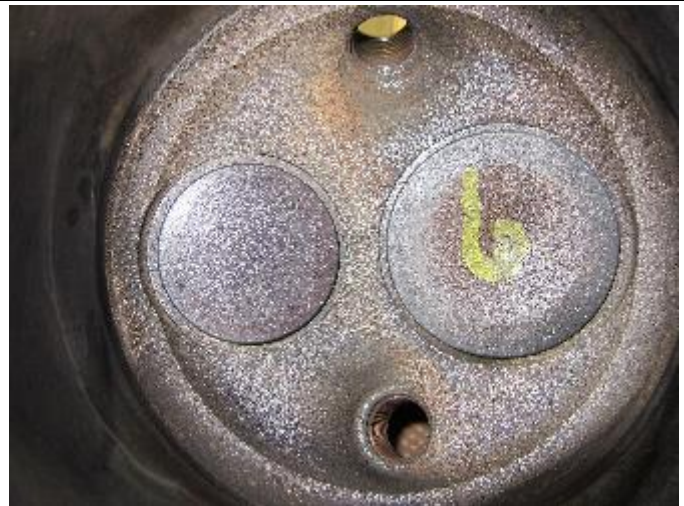
| <b>CYLINDER #6</b> | P/N: 658175A1 | S/N: AC14DA637 | Head Date: 4-14 |

| Condition: | The cylinder exhibited normal operating signatures. Externally thermal damage was present. |

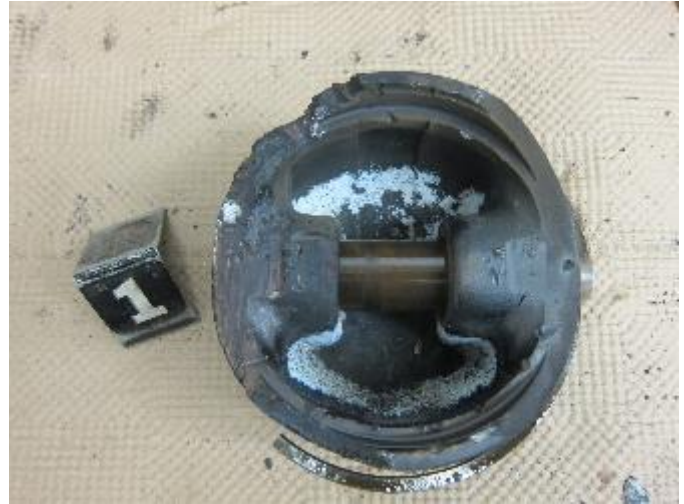
## #1 PISTON, RINGS AND PIN

Piston exhibited normal operating signatures. The piston had some mechanical damage.

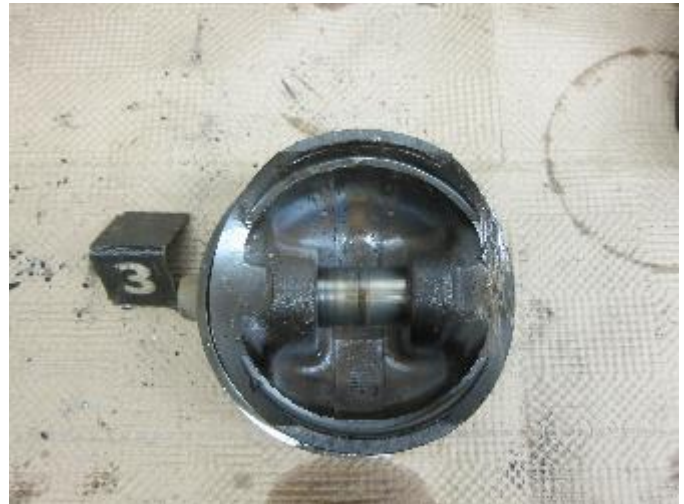
## #3 PISTON, RINGS AND PIN

Piston exhibited normal operating signatures. The piston had some mechanical damage.

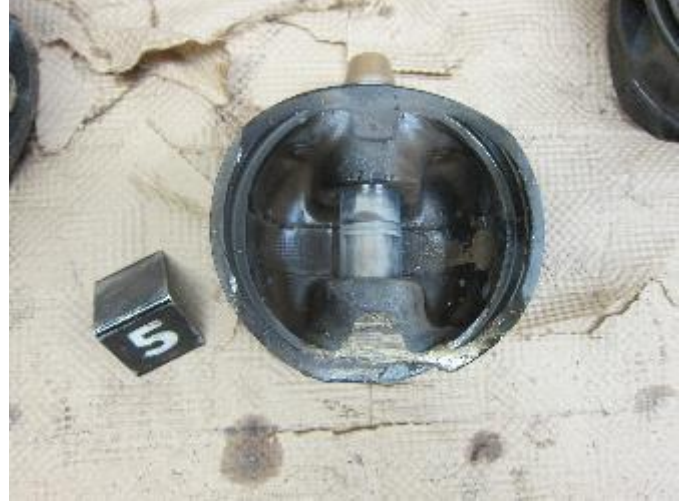
## #5 PISTON, RINGS AND PIN

Piston exhibited normal operating signatures. The piston had some mechanical damage.

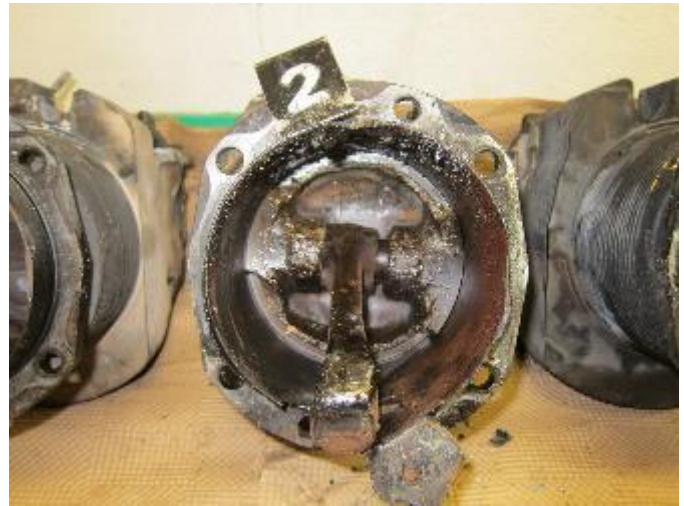
## #2 PISTON, RINGS AND PIN

The piston remained in the cylinder with the connecting rod attached. The piston exhibited mechanical damage.

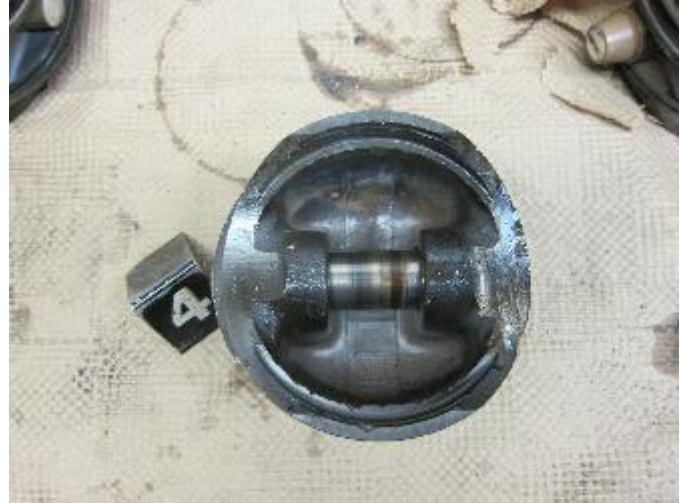
## #4 PISTON, RINGS AND PIN

Piston exhibited normal operating signatures. The piston had some mechanical damage.

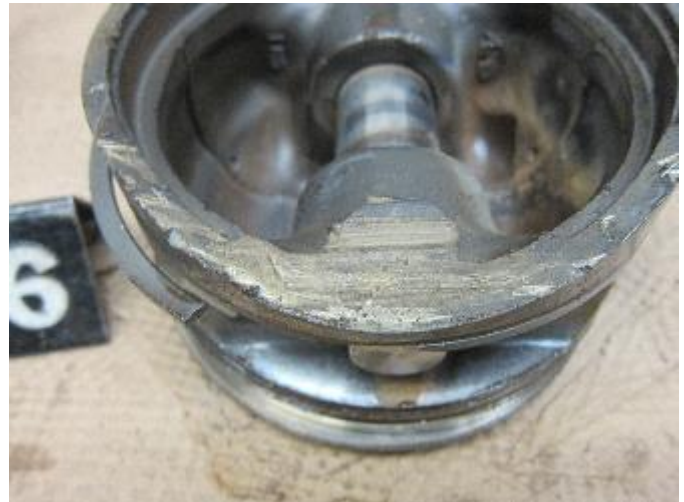
## #6 PISTON, RINGS AND PIN

Piston exhibited normal operating signatures. The piston had some mechanical damage.

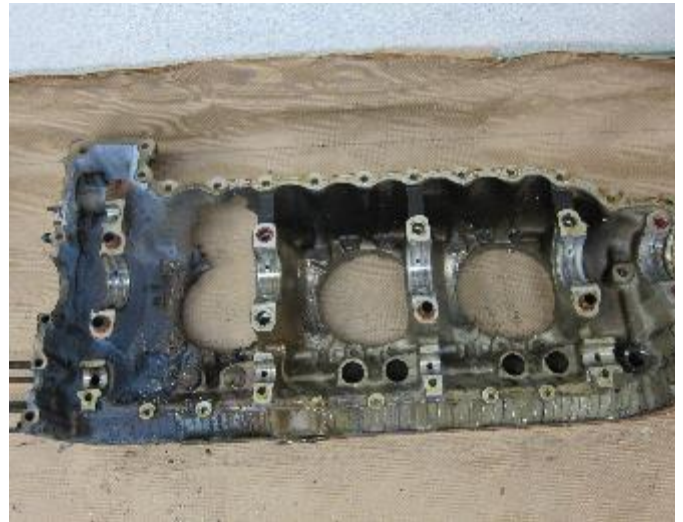
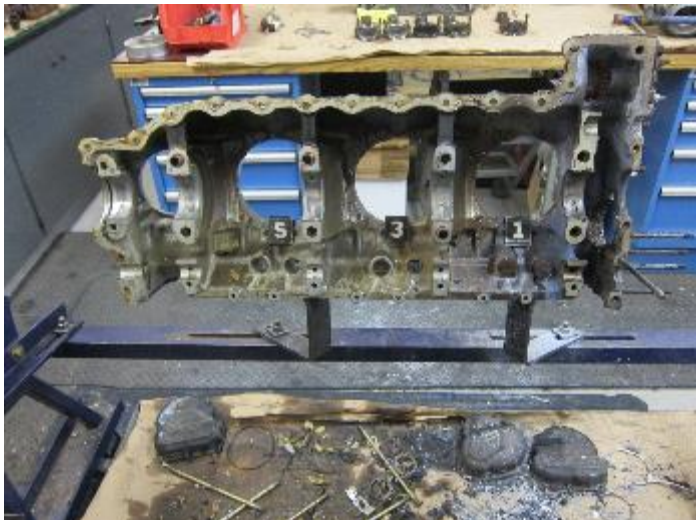
#### CRANKCASE

The crank case had thermal damage from the post-crash fire. There was a hole above the number two cylinder from the released connecting rod. The bearing lock slots exhibited normal operating signatures. Other parts of the crankcase exhibited mechanical damage from the internal engine components.

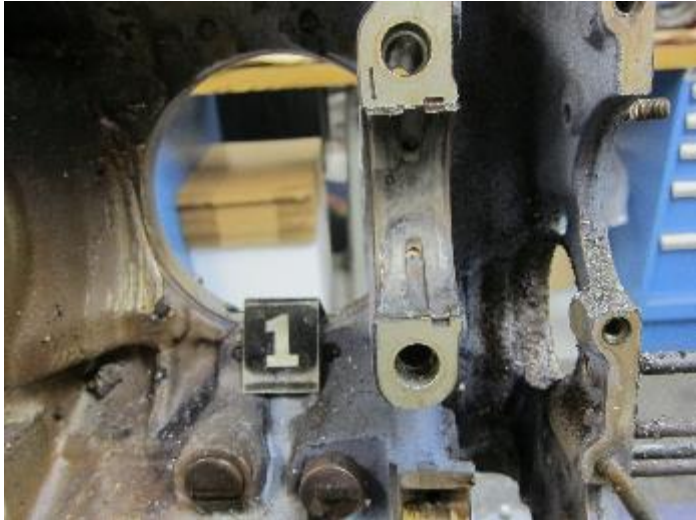
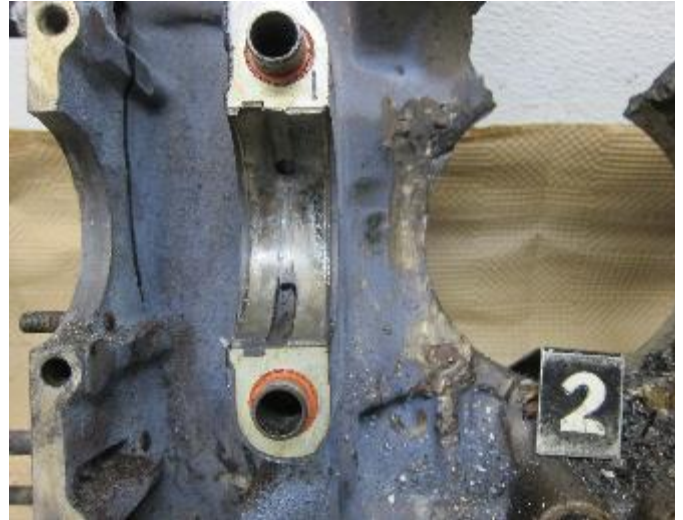
## #1 MAIN BEARINGS

Condition: The bearings exhibited thermal damage from the post-crash fire. The lock slots were intact and undamaged.

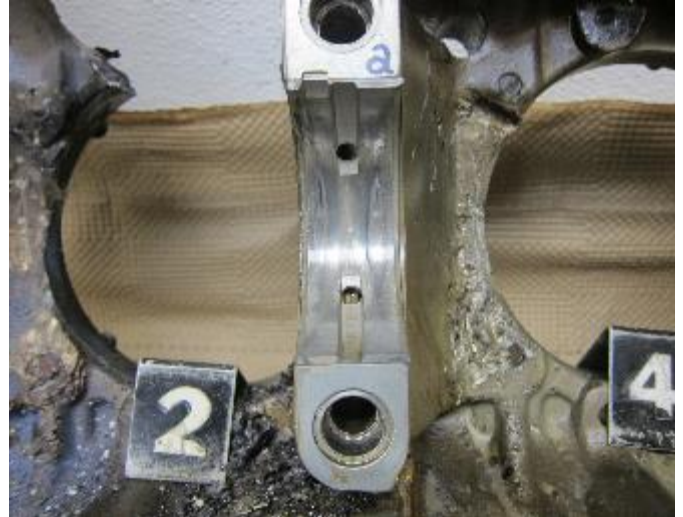
## #2 MAIN BEARINGS

Condition: The bearings exhibited thermal damage from the post-crash fire. The lock slots were intact and undamaged.

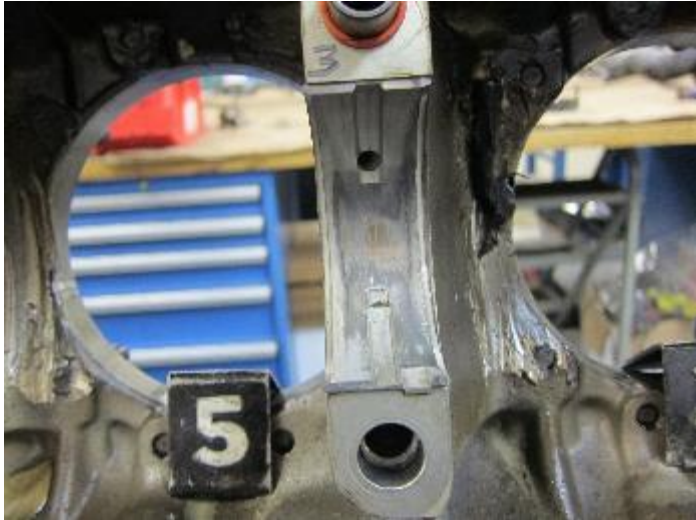
## #3 MAIN BEARINGS

The bearings exhibited normal operating. The lock slots were intact and undamaged.

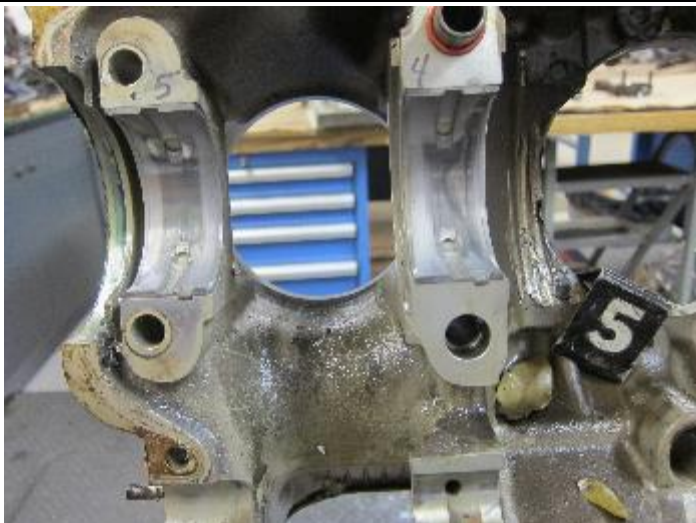
## #4 & 5 MAIN BEARINGS

The bearings exhibited normal operating. The lock slots were intact and undamaged.

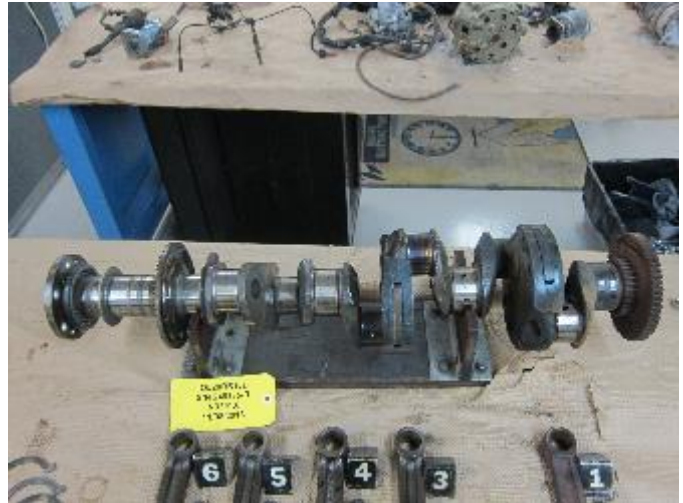
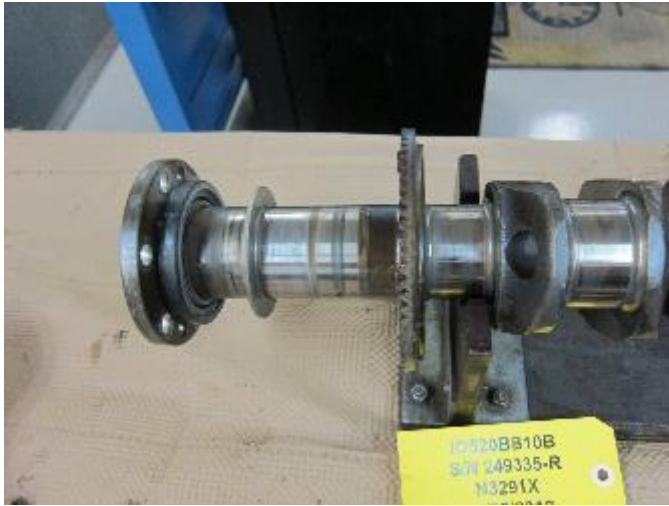
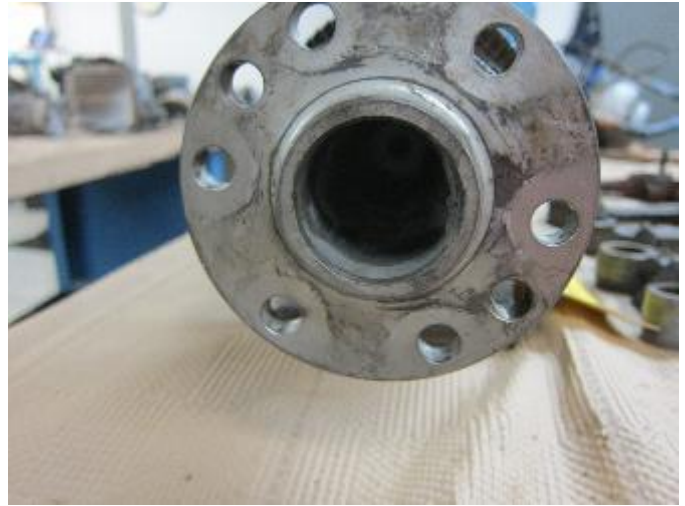
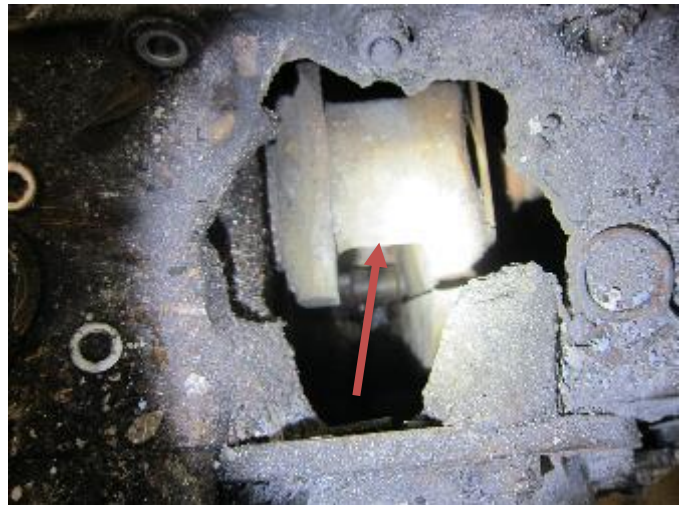
### CRANKSHAFT

The crankshaft exhibited thermal damage to the rear of the shaft and the gears. The number two rod journal was thermally damaged, and the oil passage melted and smeared over. The number three and four journal exhibited heat signatures consistent with lubrication distress. Except for the number two journal being melted closed, all oil passages in the crankshaft were open to allow oil flow.

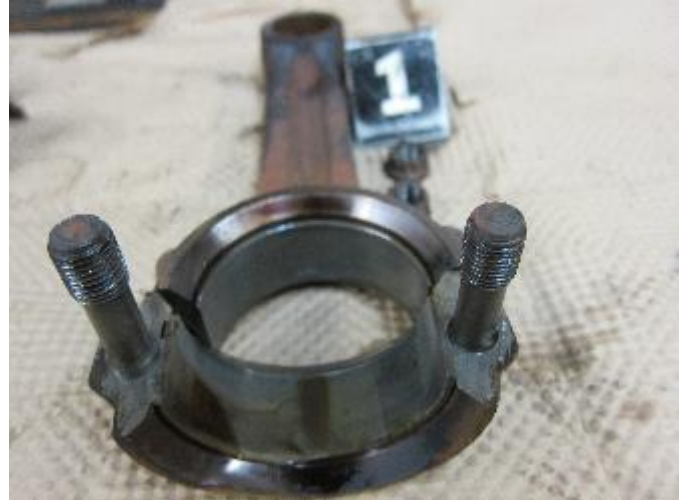
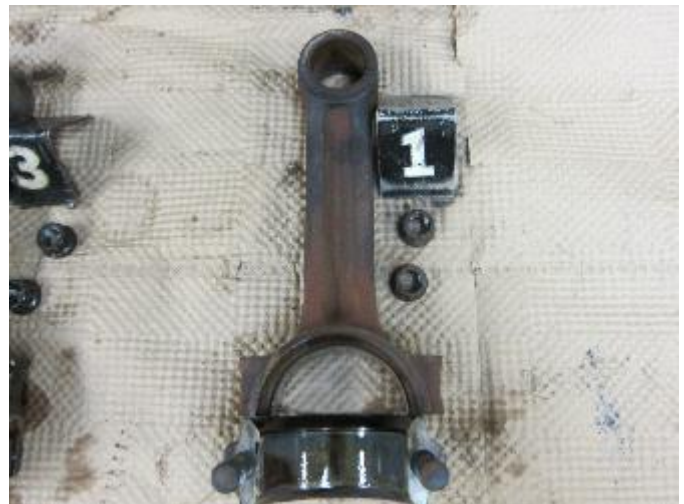
## #1 CONNECTING ROD

Condition: Exhibited thermal and mechanical damage

Condition: The bearing exhibited lubrication distress.

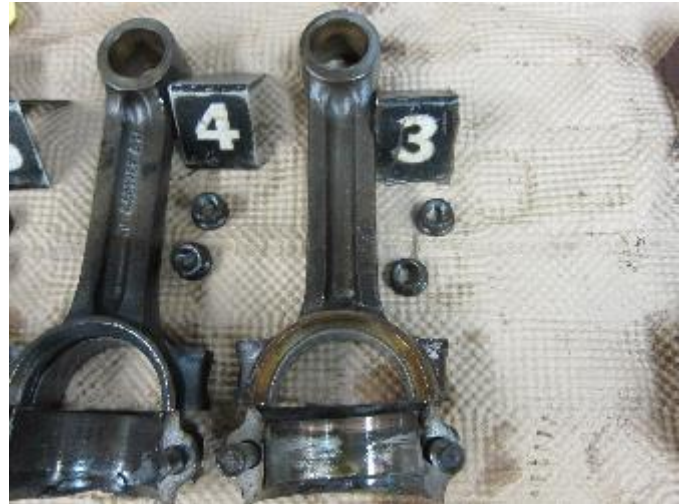
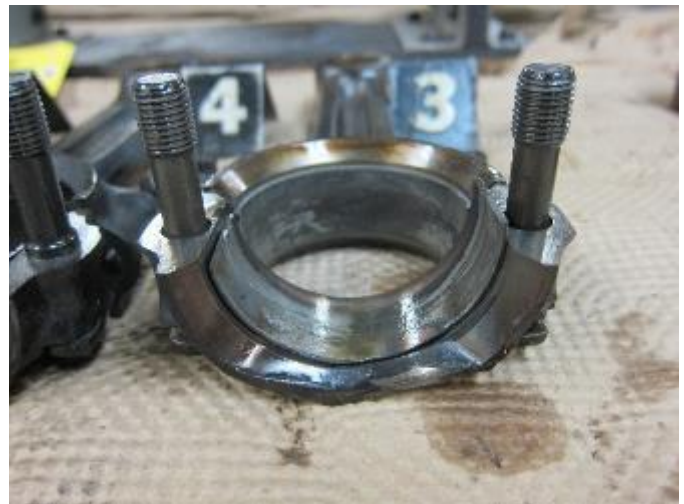
## #3 CONNECTING ROD

Exhibited thermal damage and mechanical damage to the cap.

The bearing exhibited lubrication distress and wear down to the copper layer.

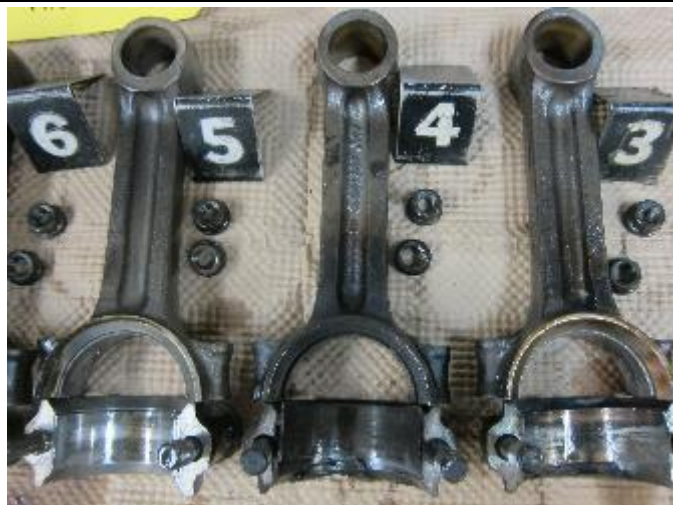
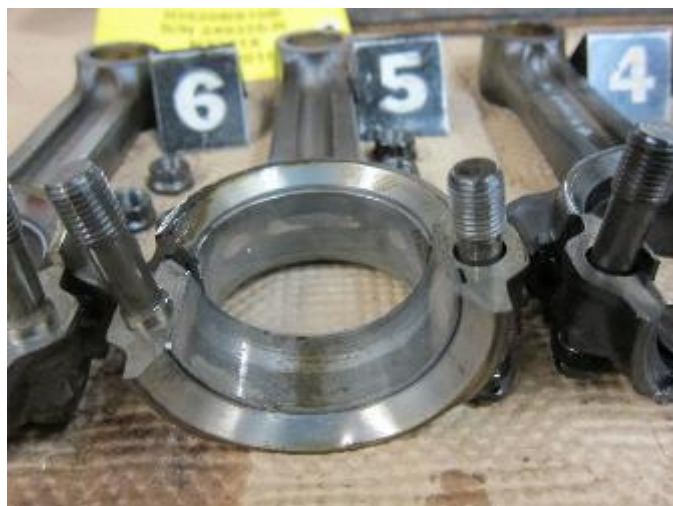
## #5 CONNECTING ROD

Condition: Exhibited normal operating signatures. Slight mechanical damage was noted on the cap.

Condition: Exhibited normal operating signatures.

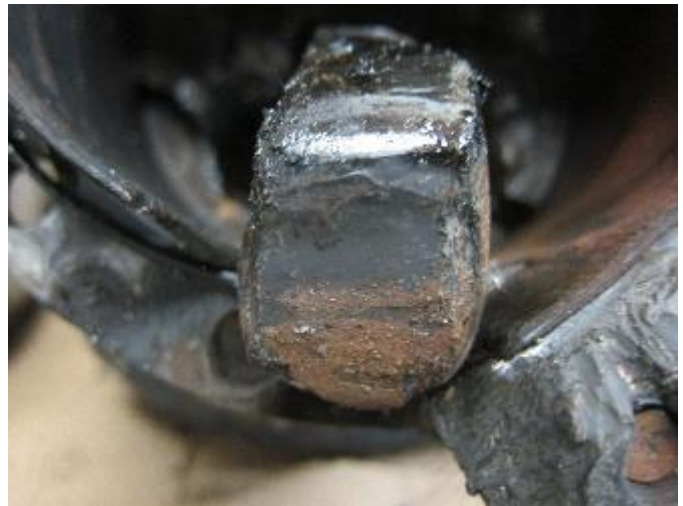
## #2 CONNECTING ROD

The large end of the rod was fragmented and melted away. Portions of the bearing were found in the oil sump.

The number two rod bearing was fragmented and melted away from oil starvation.

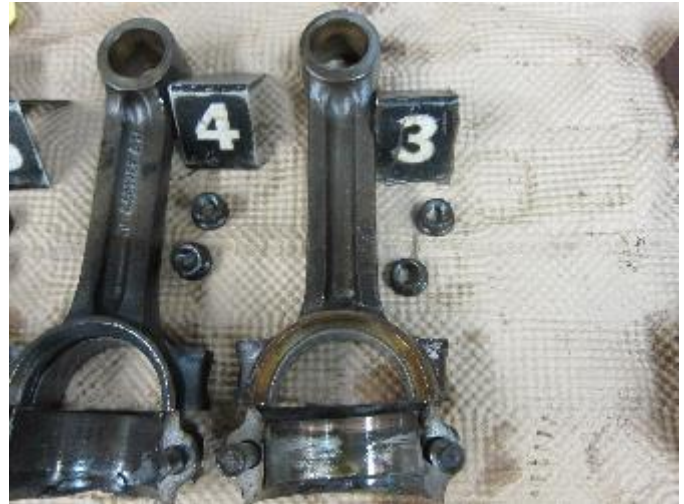
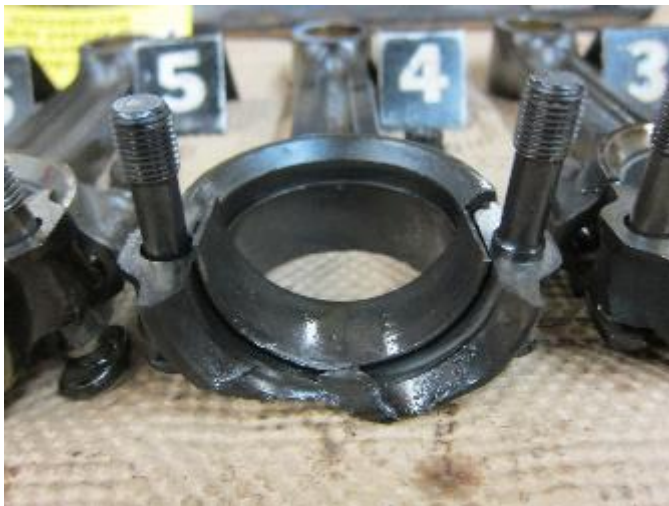
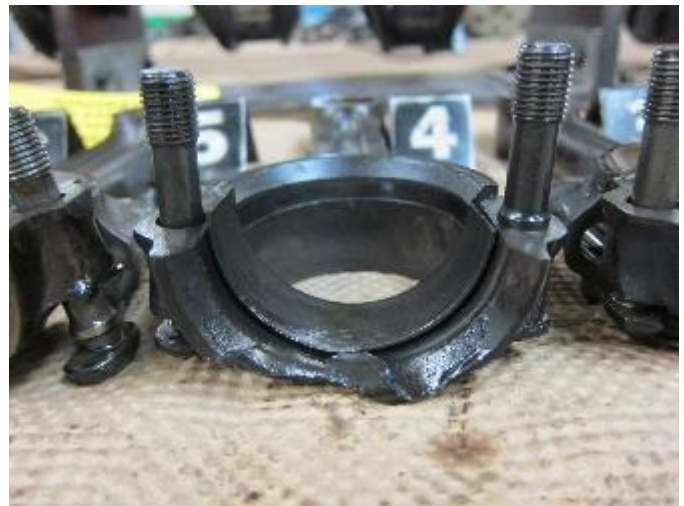
## #4 CONNECTING ROD

Condition: Exhibited normal operating signatures. The connecting rod had mechanical damage to the cap.

Condition: The connecting rod bearing exhibited thermal damage, wear thru the Babbitt layer.

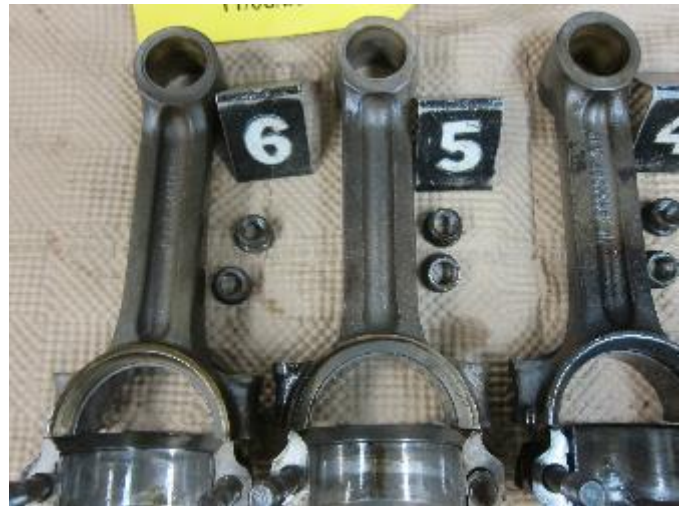
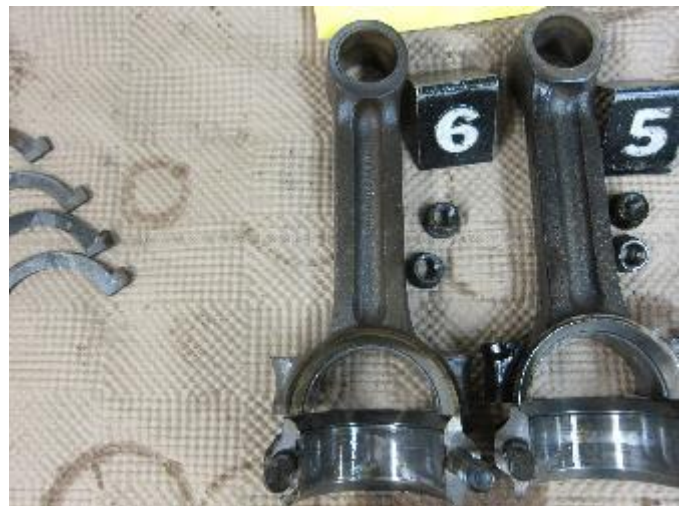
## #6 CONNECTING ROD

Condition: Exhibited normal operating signatures. The connecting rod had mechanical damage to the cap.

Condition: Exhibited normal operating signatures.

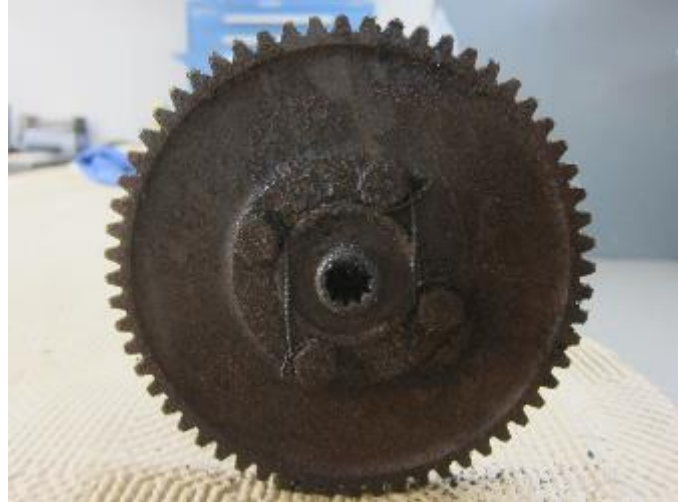
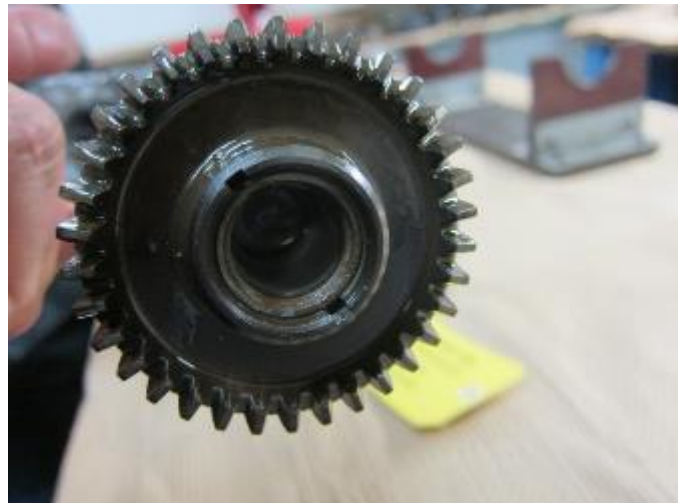
### CAMSHAFT

The camshaft exhibited thermal and mechanical damage and was intact.

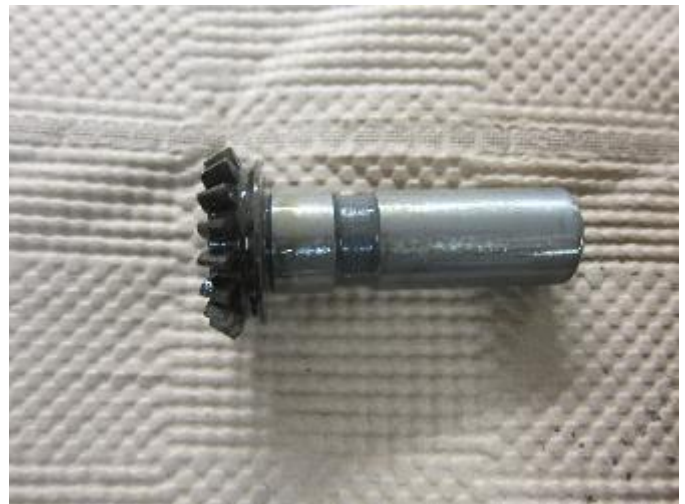
## ACCESSORY GEARS

Condition: The gears exhibited thermal damage and other wise intact and undamaged.

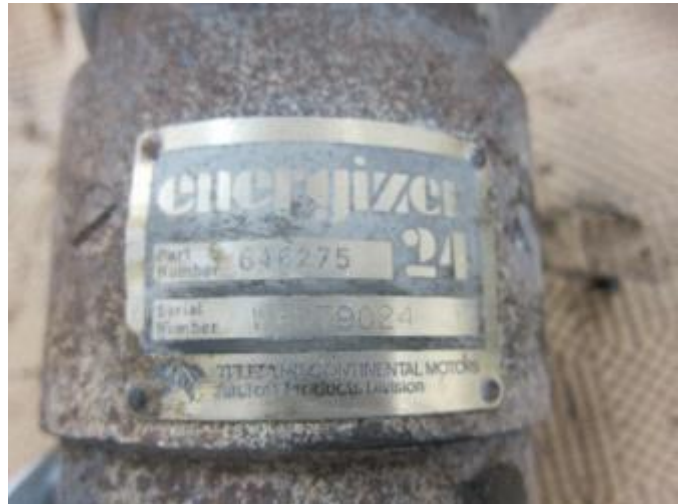
#### STARTER

The starter exhibited thermal damage.

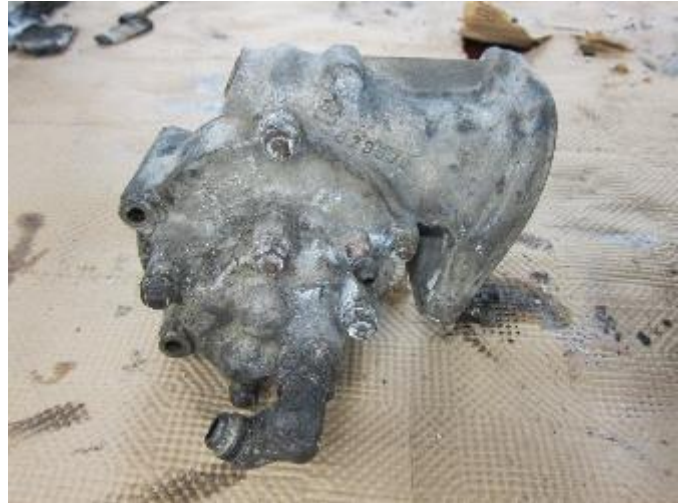
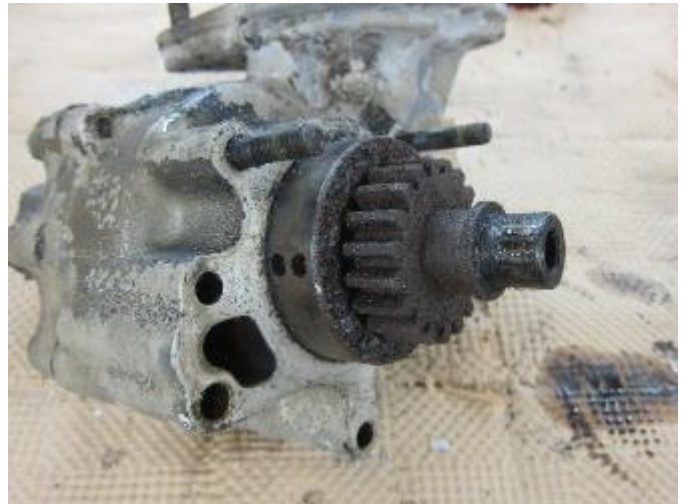
## STARTER ADAPTER

The starter adapter was thermally damaged, with impact signatures but otherwise intact.

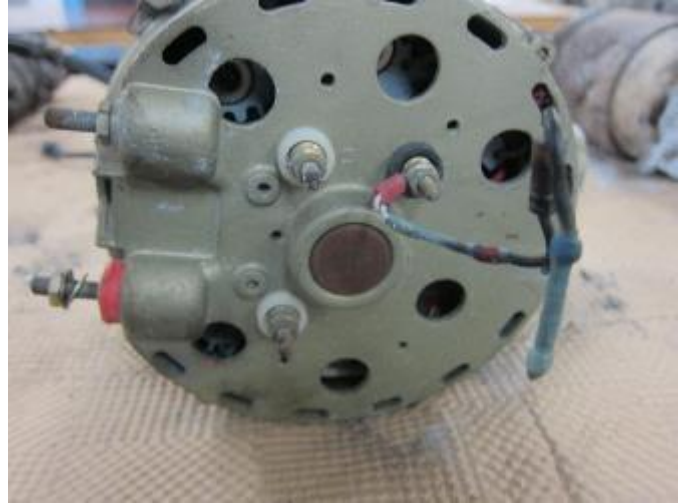
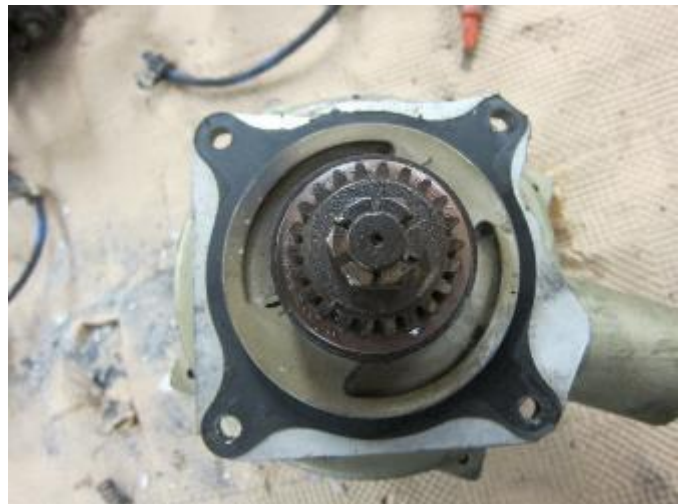
ALT.

The alternator was undamaged and had slight thermal signatures. The drive was intact, and rotation was possible.

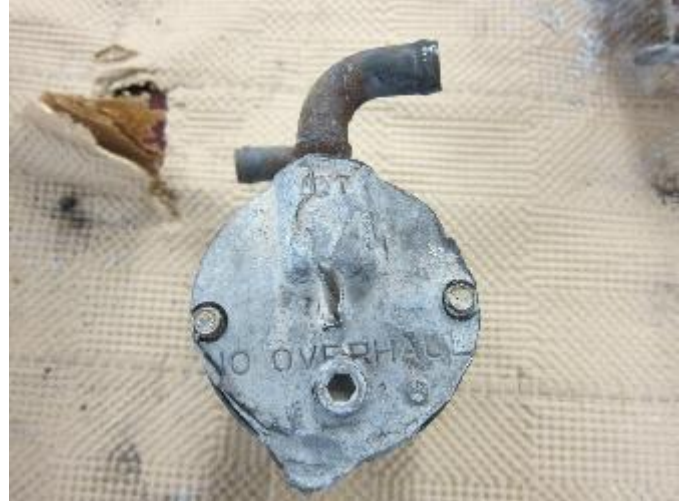
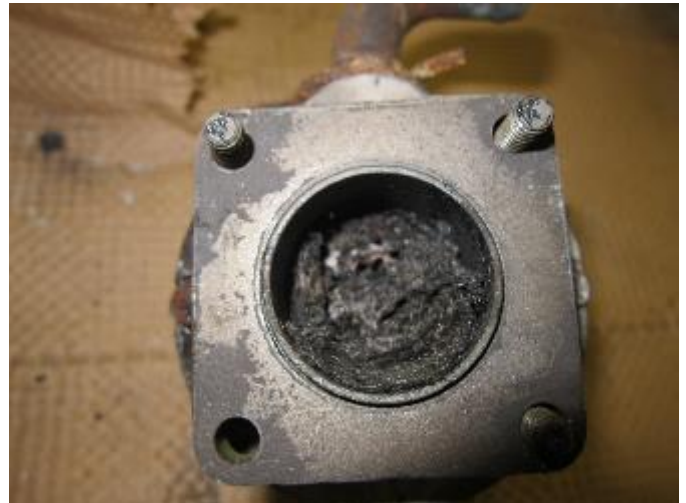
## VACUUM PUMP

The vacuum pump was thermally damaged, and the drive coupling melted from the post-crash fire.

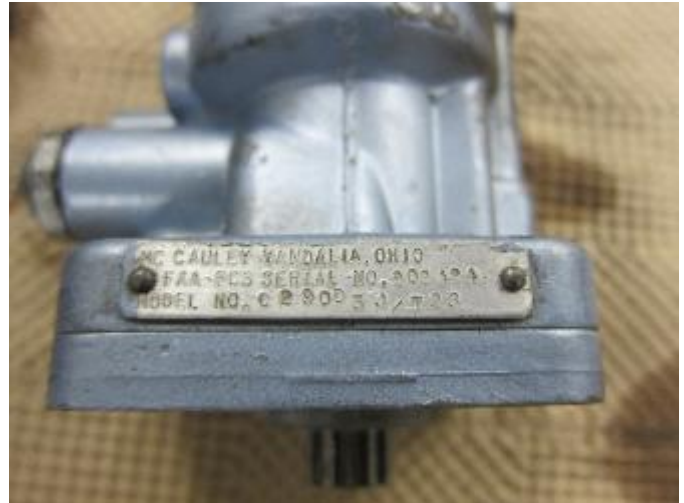
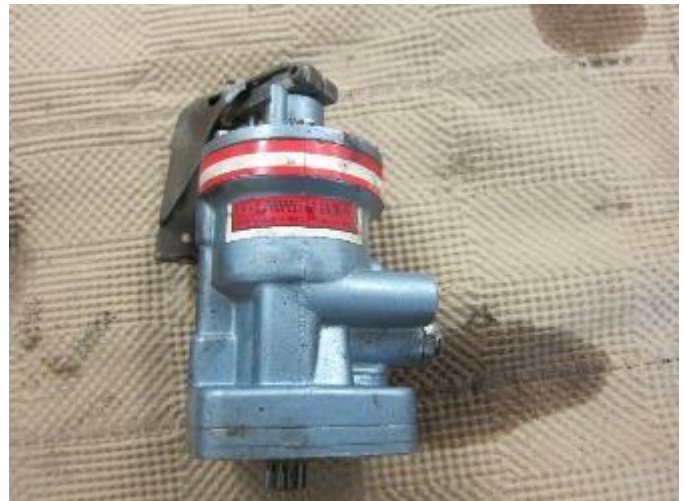
## PROPELLER GOVERNOR

Exhibited normal operating signatures.
