# Continental Motors

## ENGINE EXAMINATION REPORT

| ENGINE MODEL | IO520BB10B |
| FILE NUMBER | 17-603 |

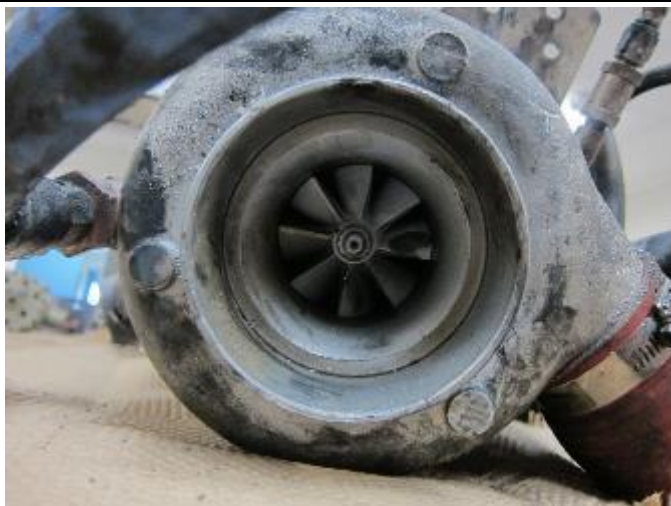
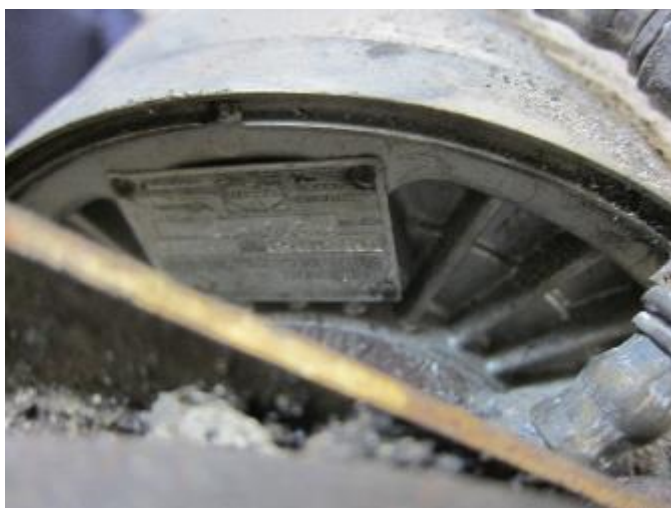
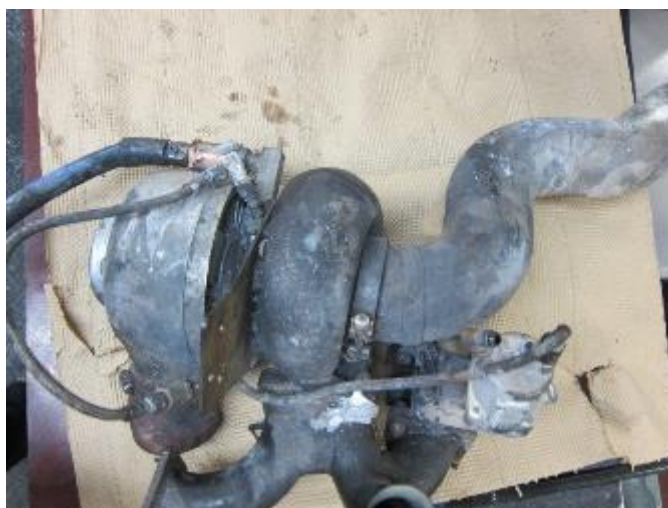
## TURBO

The turbo charger exhibited thermal damaged from the post-crash fire.

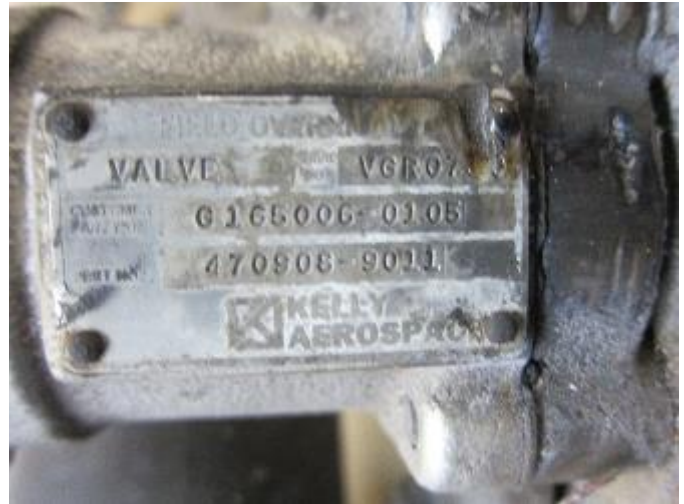
## WASTEGATE

The waste gate exhibited thermal damage from the post-crash fire.

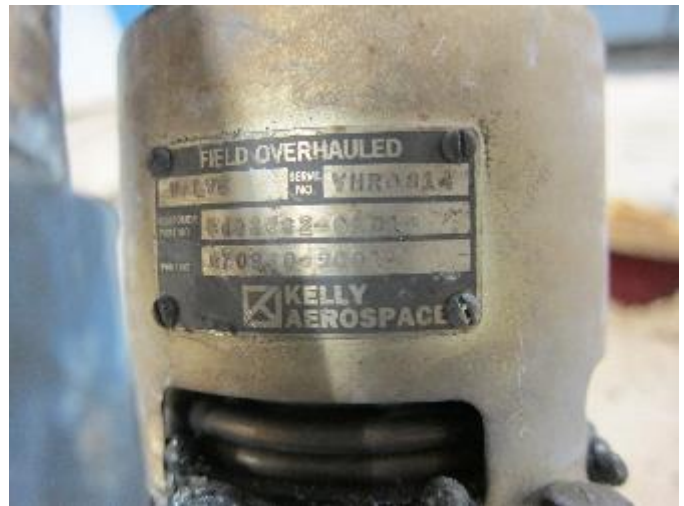
## OVERBOOST VALVE

The over boost valve exhibited thermal damage from the post-crash fire.
