**Photo 1 – The Steen Skybolt, N22GL, at the end of the runway. Note how the main landing gear has spread apart and the airplane has settled.**

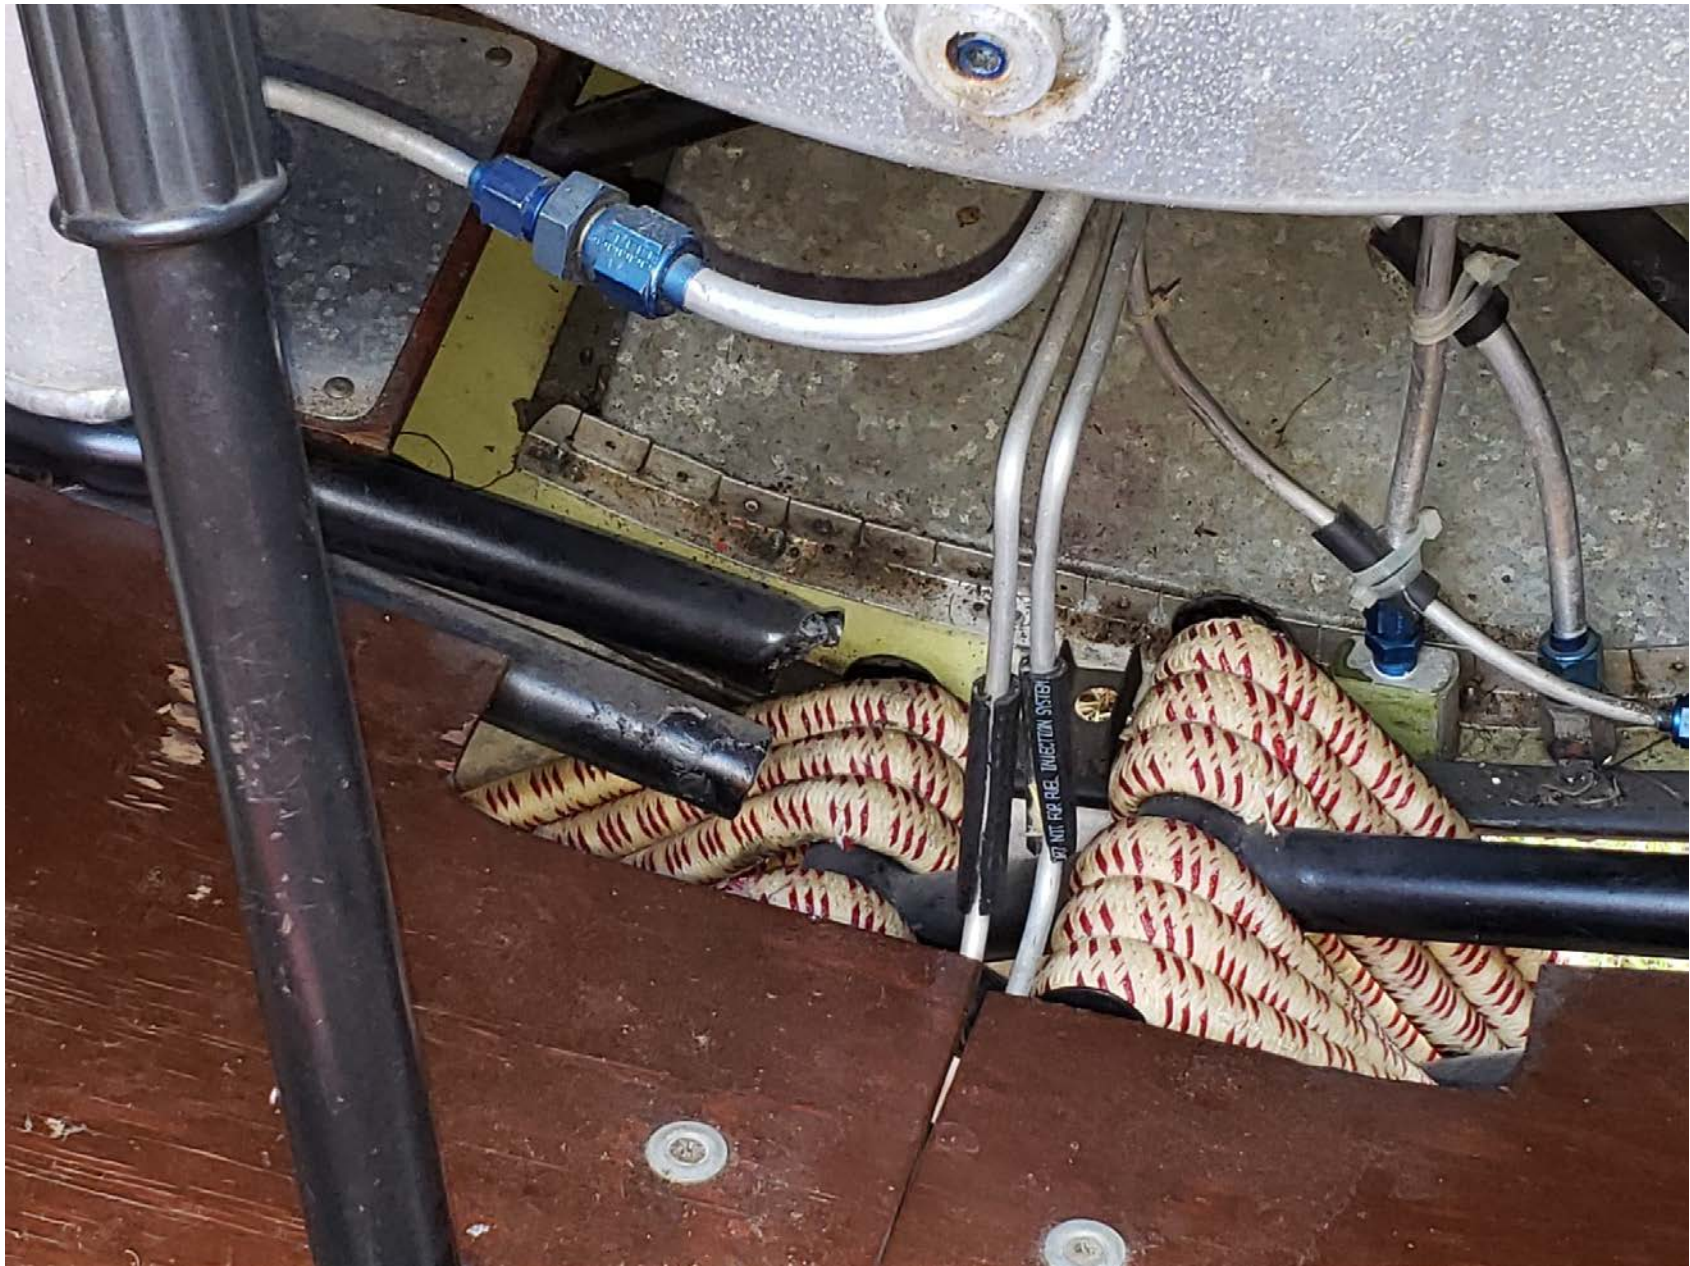
**Photo 2 - View at flooring inside cockpit. Note fractured landing gear shock cord truss.**
